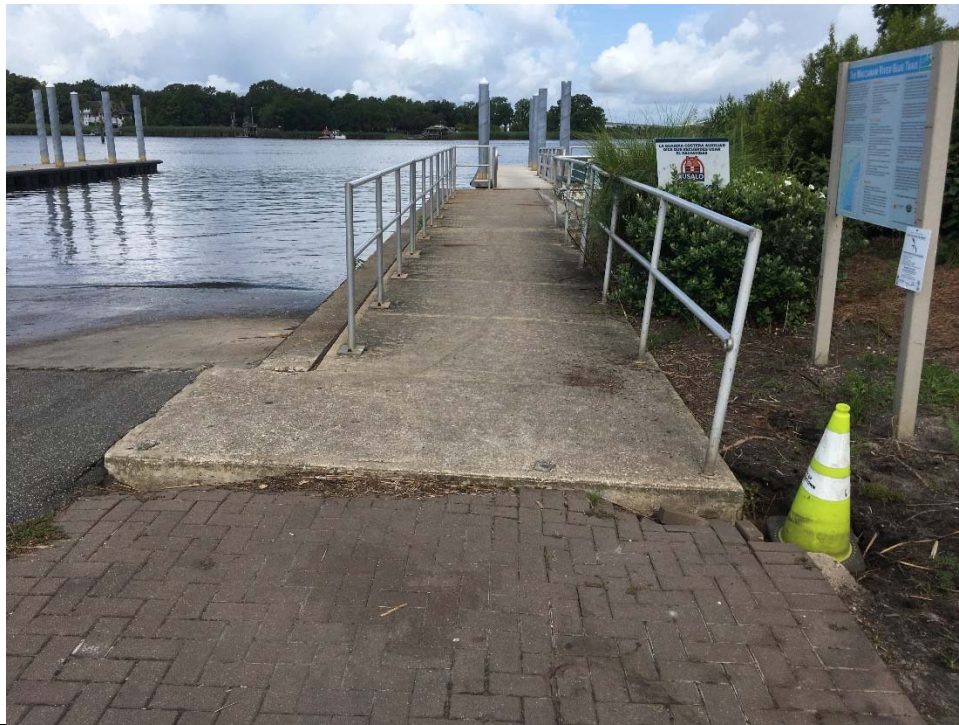
Photo No. 1

Description: View of walking pavers and concrete deck looking west.

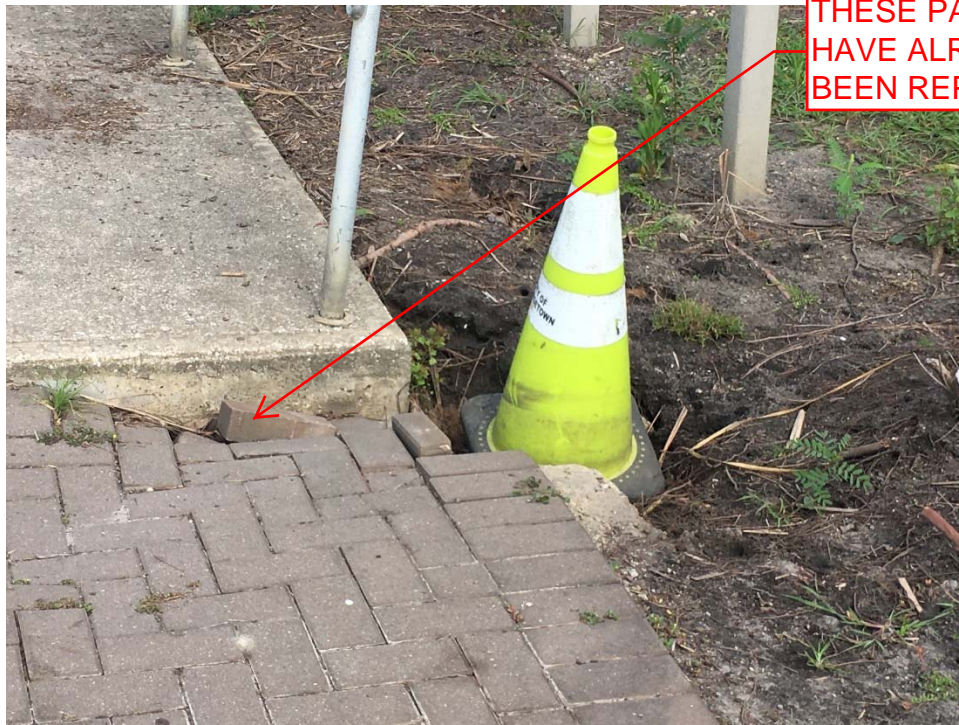
Photo No. 2

Description: Close-up view of defective walking pavers.

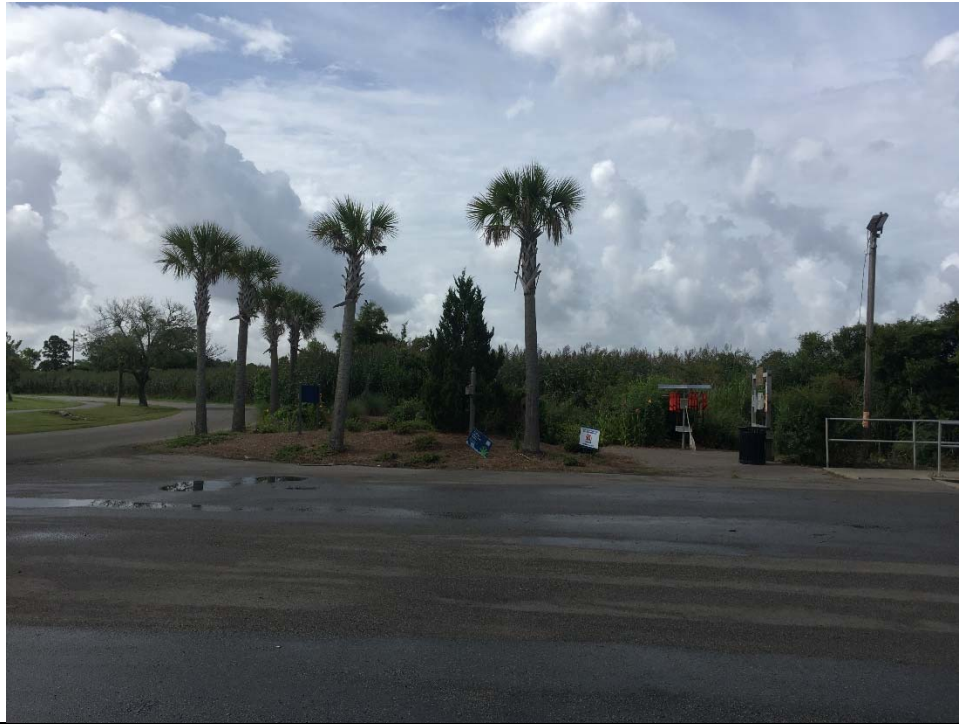
Photo No. 3

Description: View of landscape area at East Bay Park boat landing looking west.

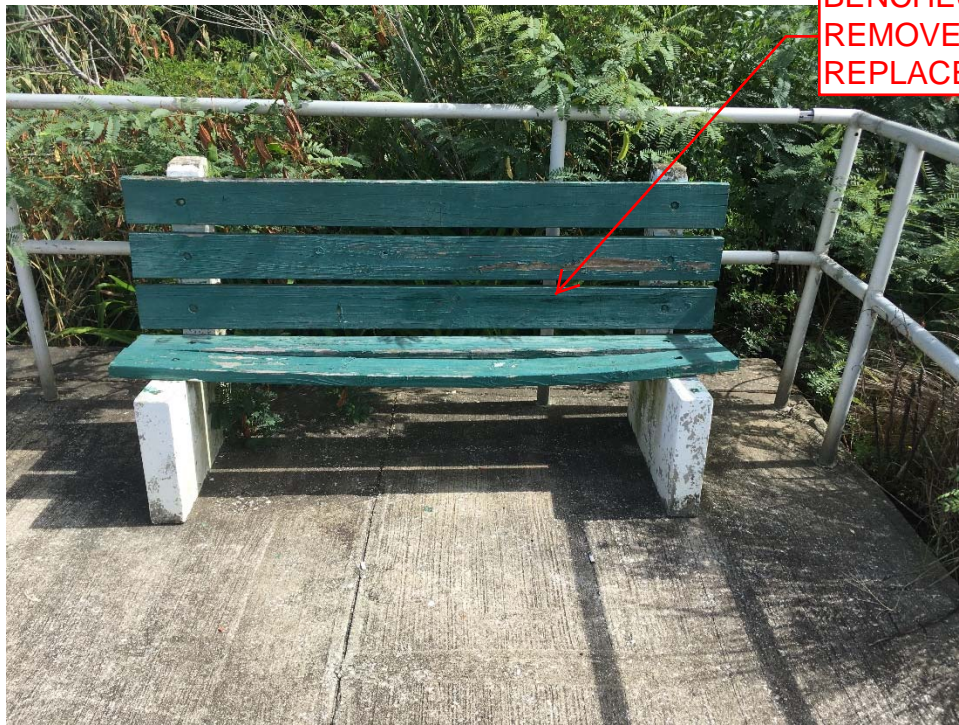
Photo No. 4

Description: View of existing bench at boat landing.

**BENCHES TO BE
REMOVED AND
REPLACED**

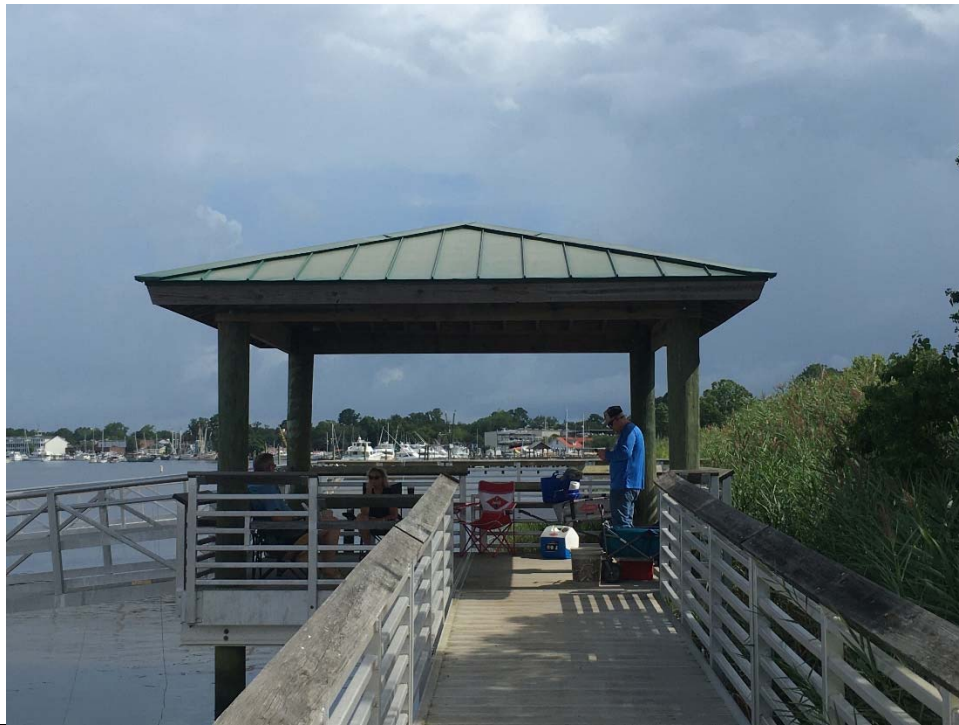
Photo No. 5

Description: View of wooden top handrails looking north.

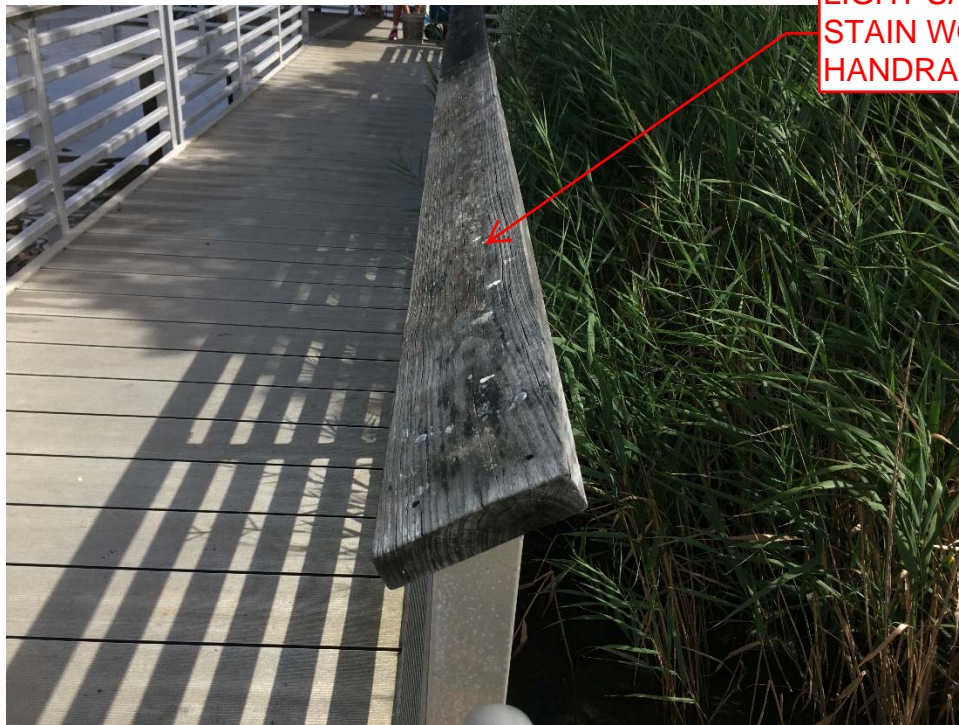
Photo No. 6

Description: Close-up view of wooden top handrail.

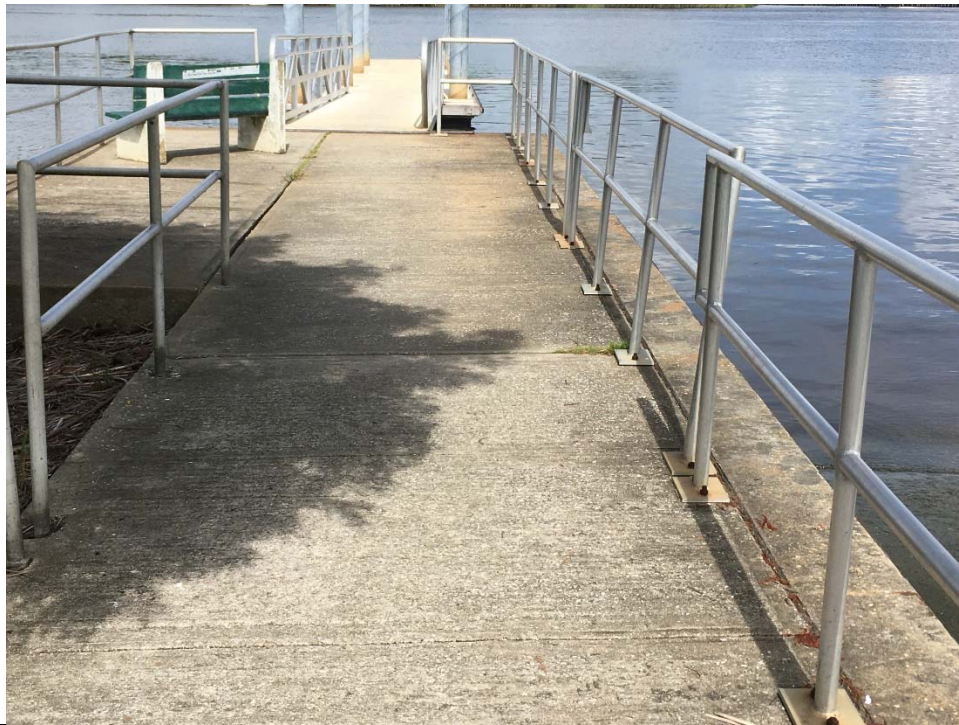
Photo No. 7

Description: View of boat landing deck looking west.

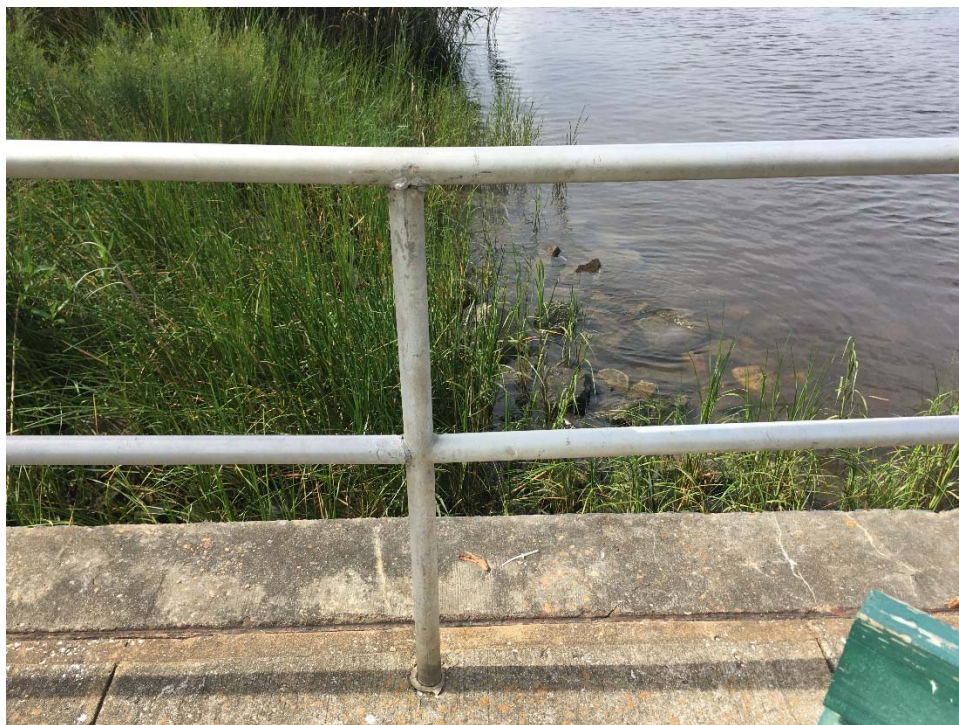
Photo No. 8

Description: View of existing handrails looking south.

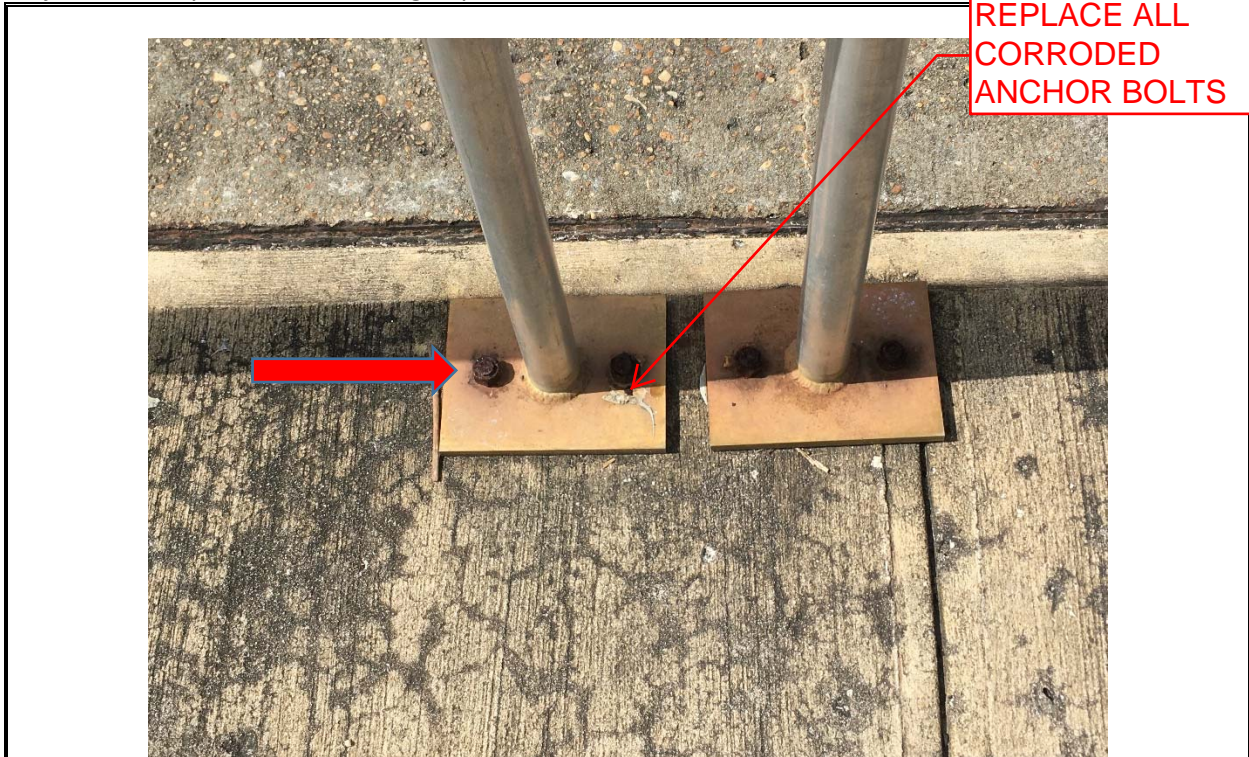
Photo No. 9

Description: View of handrail base plates. Arrow shows corrosion in anchor bolts.

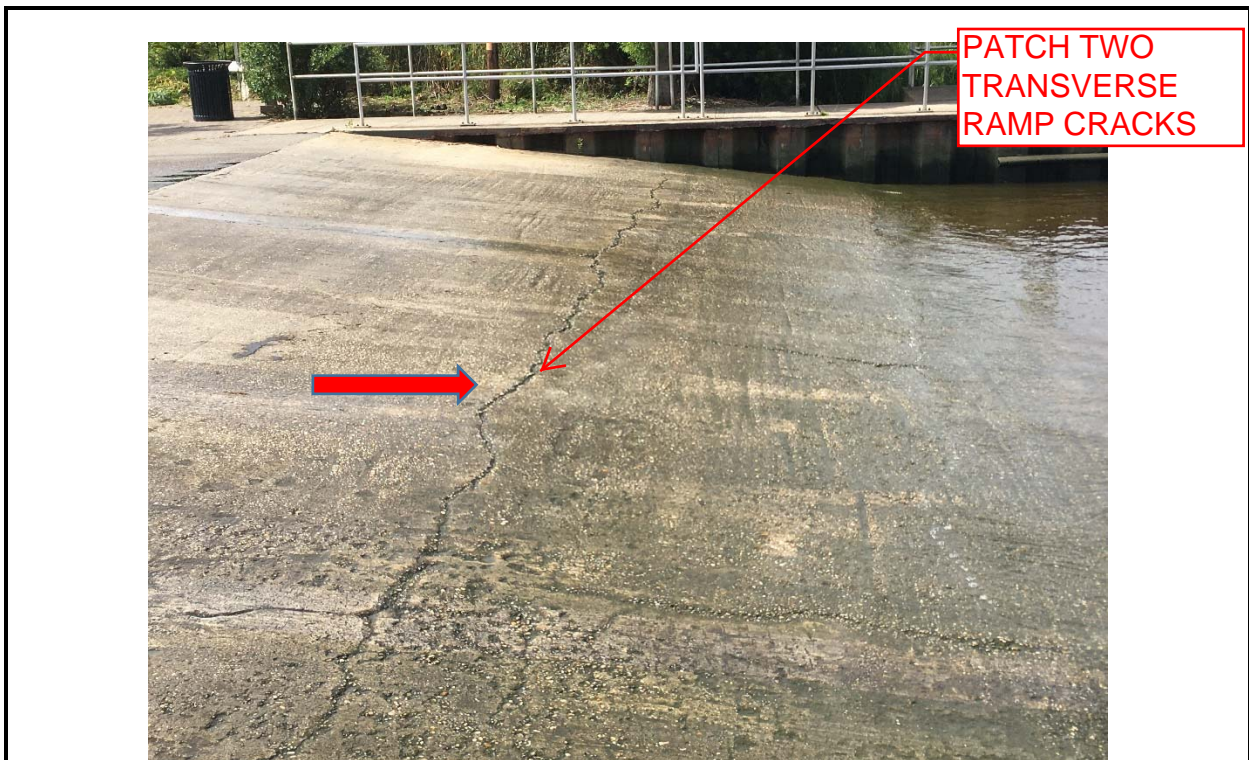
Photo No. 10

Description: View of boat ramp looking south. Arrow points to major concrete crack.
