# COMPREHENSIVE ASBESTOS SURVEY

**FIRE STATION #3  
1701 OLD TROLLEY ROAD  
SUMMERVILLE, SOUTH CAROLINA 29485**

**Trident Environmental Services, Inc.**

The comprehensive asbestos survey performed by Trident Environmental Services, Inc. on January 26, 2017 of the Fire Station #3 located at 1701 Old Trolley Road in Summerville, South Carolina **did not** reveal the presence of asbestos containing building materials. The following summary exhibits the asbestos containing building materials (ACBM) that were identified in the inspection.

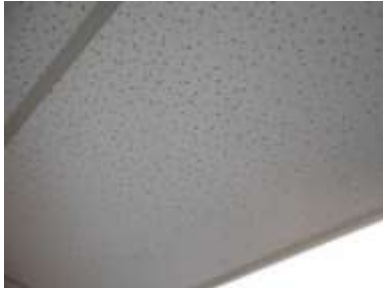
HOMOGENEOUS AREA 01  
2' X 4' CEILING TILE

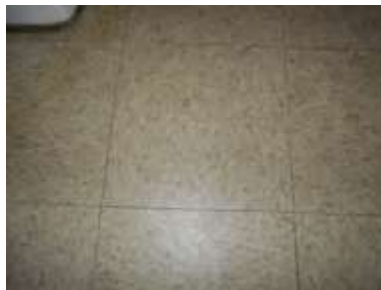
05-15	12" Floor Tile (green specks)	EMS Restroom	20 SF	N	0.0%	ND	7	N/A
05-16	12" Floor Tile (green specks)	EMS Restroom		N	0.0%	ND	7	N/A

HOMOGENEOUS AREAS 05, 06  
12" FLOOR TILE (GREEN SPECKS)  
MASTIC (YELLOW)

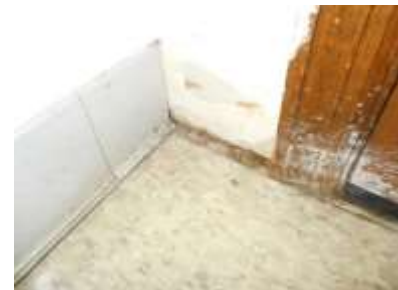
HOMOGENEOUS AREA 07  
COVE BASE MASTIC (YELLOW)

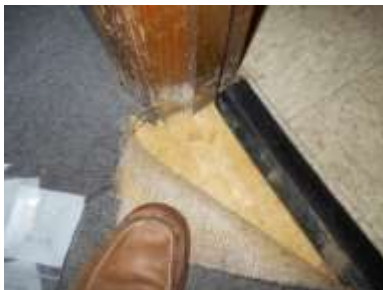
HOMOGENEOUS AREA 08  
CARPET MASTIC (YELLOW)

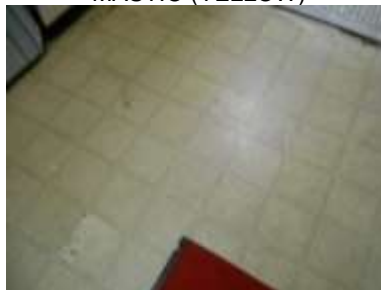
09-29 T	Vinyl Sheet Flooring (beige squares)	Laundry Room		N	0.0%	ND	7
10-30	Vinyl Mastie (yellow)	Laundry Room		N	0.0%	ND	7
10-31	Vinyl Mastie (yellow)	Laundry Room	100 SF	N	0.0%	ND	7
10-32 T	Vinyl Mastie (yellow)	Laundry Room		N	0.0%	ND	7

HOMOGENEOUS AREAS 09, 10  
VINYL SHEET FLOORING (BEIGE)  
MASTIC (YELLOW)

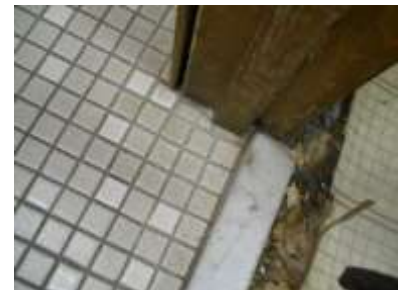
HOMOGENEOUS AREA 11  
CERAMIC TILE GROUT

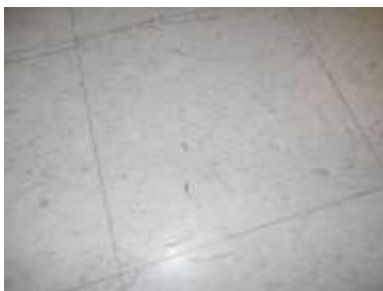
HOMOGENEOUS AREAS 12, 13  
12" FLOOR TILE (BEIGE)/MASTIC

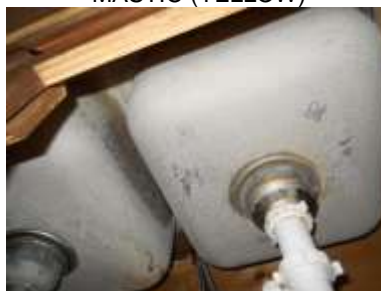
HOMOGENEOUS AREA 14  
SINK COATING

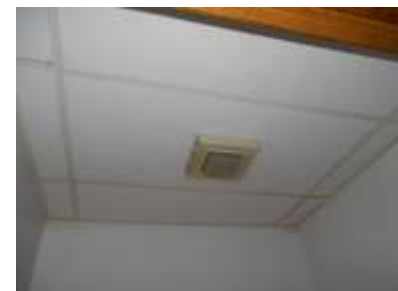
15-47	Ceiling Tile	Bathroom/Laundry Room		Y	0.0%	ND	7
15-48	Ceiling Tile	Bathroom/Laundry Room	210 SF	Y	0.0%	ND	7

HOMOGENEOUS AREA 15  
CEILING TILE

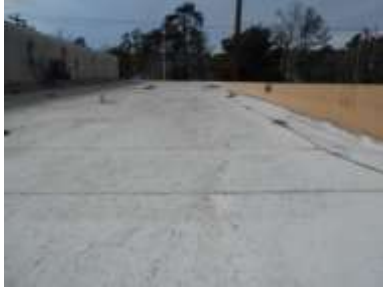
HOMOGENEOUS AREA 16  
EPDM ROOF MEMBRANE

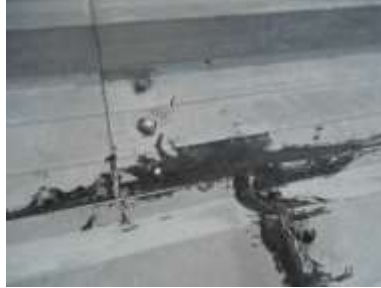
HOMOGENEOUS AREA 17  
METAL ROOF TAR

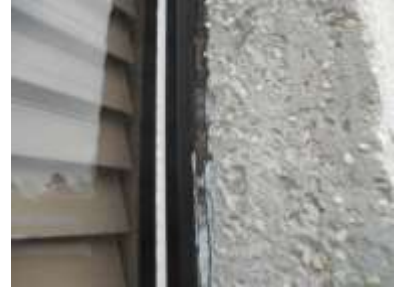
HOMOGENEOUS AREA 18  
EXTERIOR CAULK
