**PAVEMENT CORING AND GEOTECHNICAL ENGINEERING EVALUATION  
NE 34<sup>TH</sup> AVENUE, FROM SR-70 TO SR-710  
OKEECHOBEE COUNTY, FLORIDA**

AACE FILE NO. 16-166

AACE File No. 16-166  
August 25, 2016

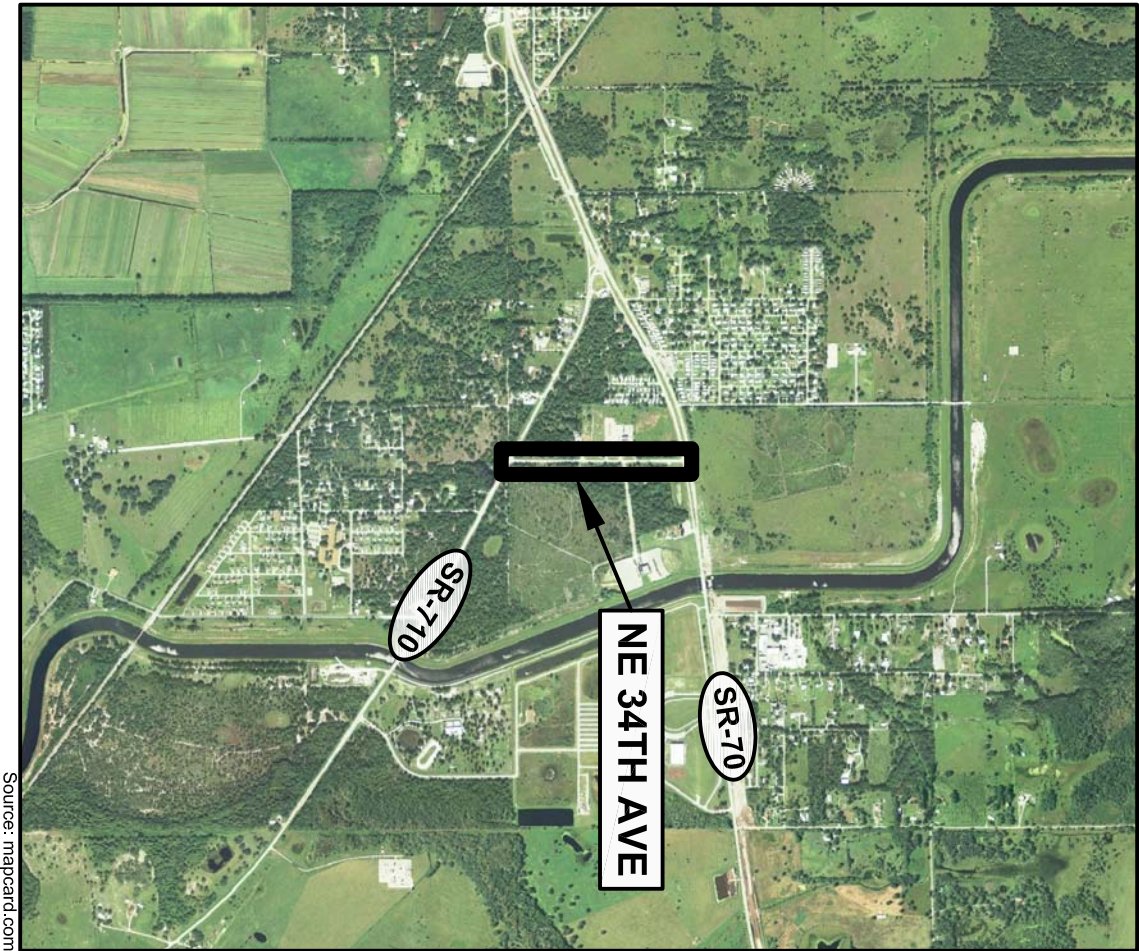
2016 AERIAL PHOTOGRAPH

The study area (i.e. site) for this evaluation consists of NE 34<sup>th</sup> Avenue (from SR-70 and extending south to SR-710/Beeline Highway) located on the east side of Okeechobee in Okeechobee County, Florida (within Section 13, Township 37 South, Range 35 East). A Site Vicinity Map (2016 aerial photograph) is presented on Sheet No. 1.

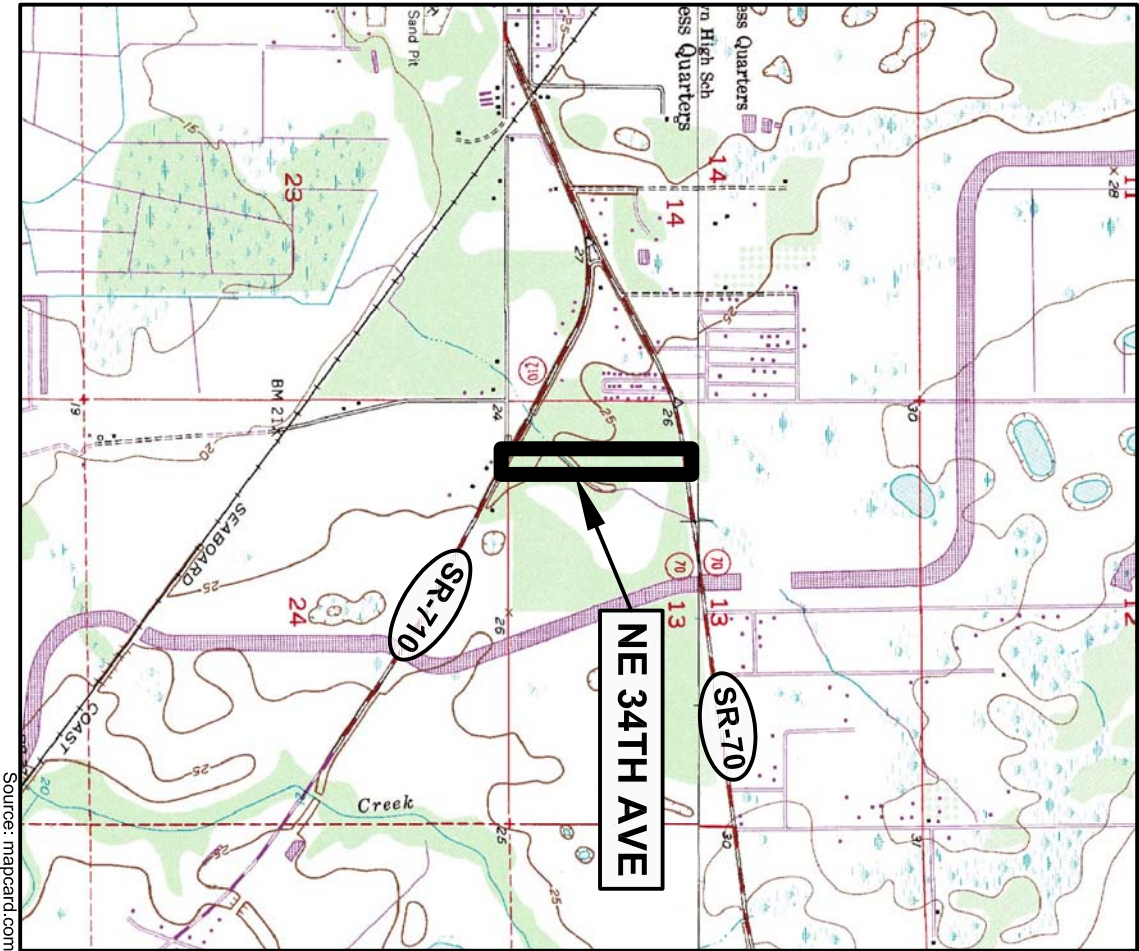
USGS TOPOGRAPHIC MAP  
(1987 USGS Quadrangle Map of "Okeechobee, Florida")

Based on our review of the 1987 U.S. Geological Survey (USGS) Topographic Quadrangle map of Okeechobee, Florida", the site appears to be relatively level with a ground surface elevation of about 25 feet with respect to the National Geodetic Vertical Datum (NGVD) of 1929. Further, what appears to be a natural drainageway or slough is shown crossing the roadway within the southern one-third segment of the roadway; a cursory review of readily available historical aerial photographs confirms the presence of this feature. The portion of the USGS map which includes the subject site has been reproduced on Sheet No. 1.

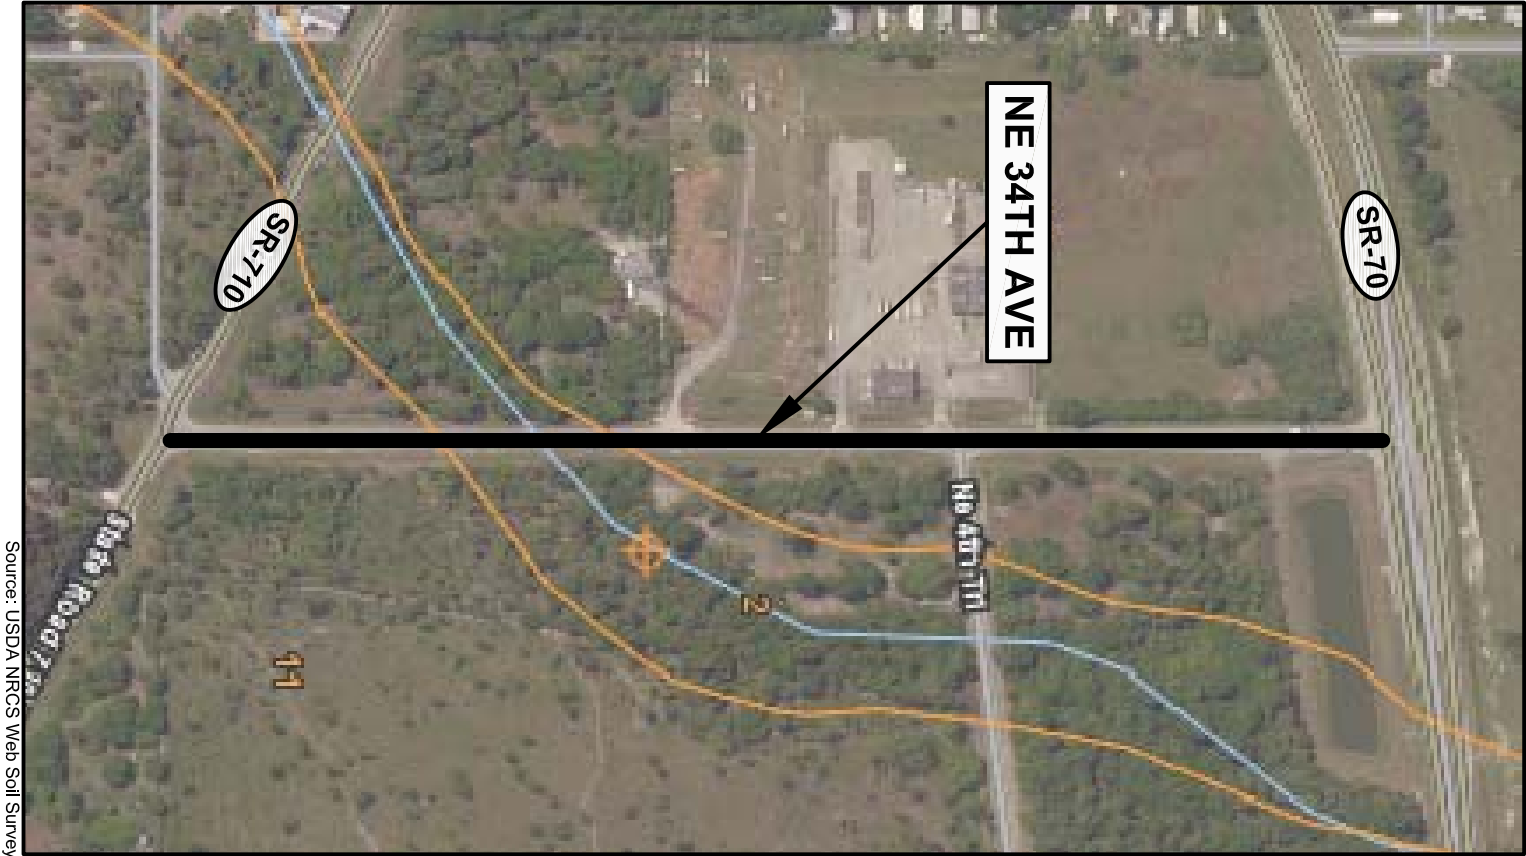
USDA SOIL SURVEY MAP

Based on the U.S. Department of Agriculture (USDA) NRCS Web Soil Survey, the majority of the subject roadway is located in an area characterized by the Immokalee fine sand, 0 to 2 percent slopes (Map Unit No. 11) soil type. This soil type is noted to consist of sandy marine deposits originating from flats on marine terraces, with fine sands and loamy fine sand present to depths in excess of 80 inches.

Also identified in the soil survey is a narrow section of the Basinger fine sand, 0 to 2 percent slopes (Map Unit No. 2) soil type which crosses the roadway at the location of the aforementioned slough feature. This soil type is noted to consist of sandy marine deposits originating from drainageways on marine terraces, with fine sands present to depths in excess of 80 inches.

The approximate location of the site is shown superimposed on a copy of the USDA Web Soil Survey aerial photograph, presented on Sheet No. 1, and the summary report obtained from the USDA Web Soil Survey is included in Appendix II.

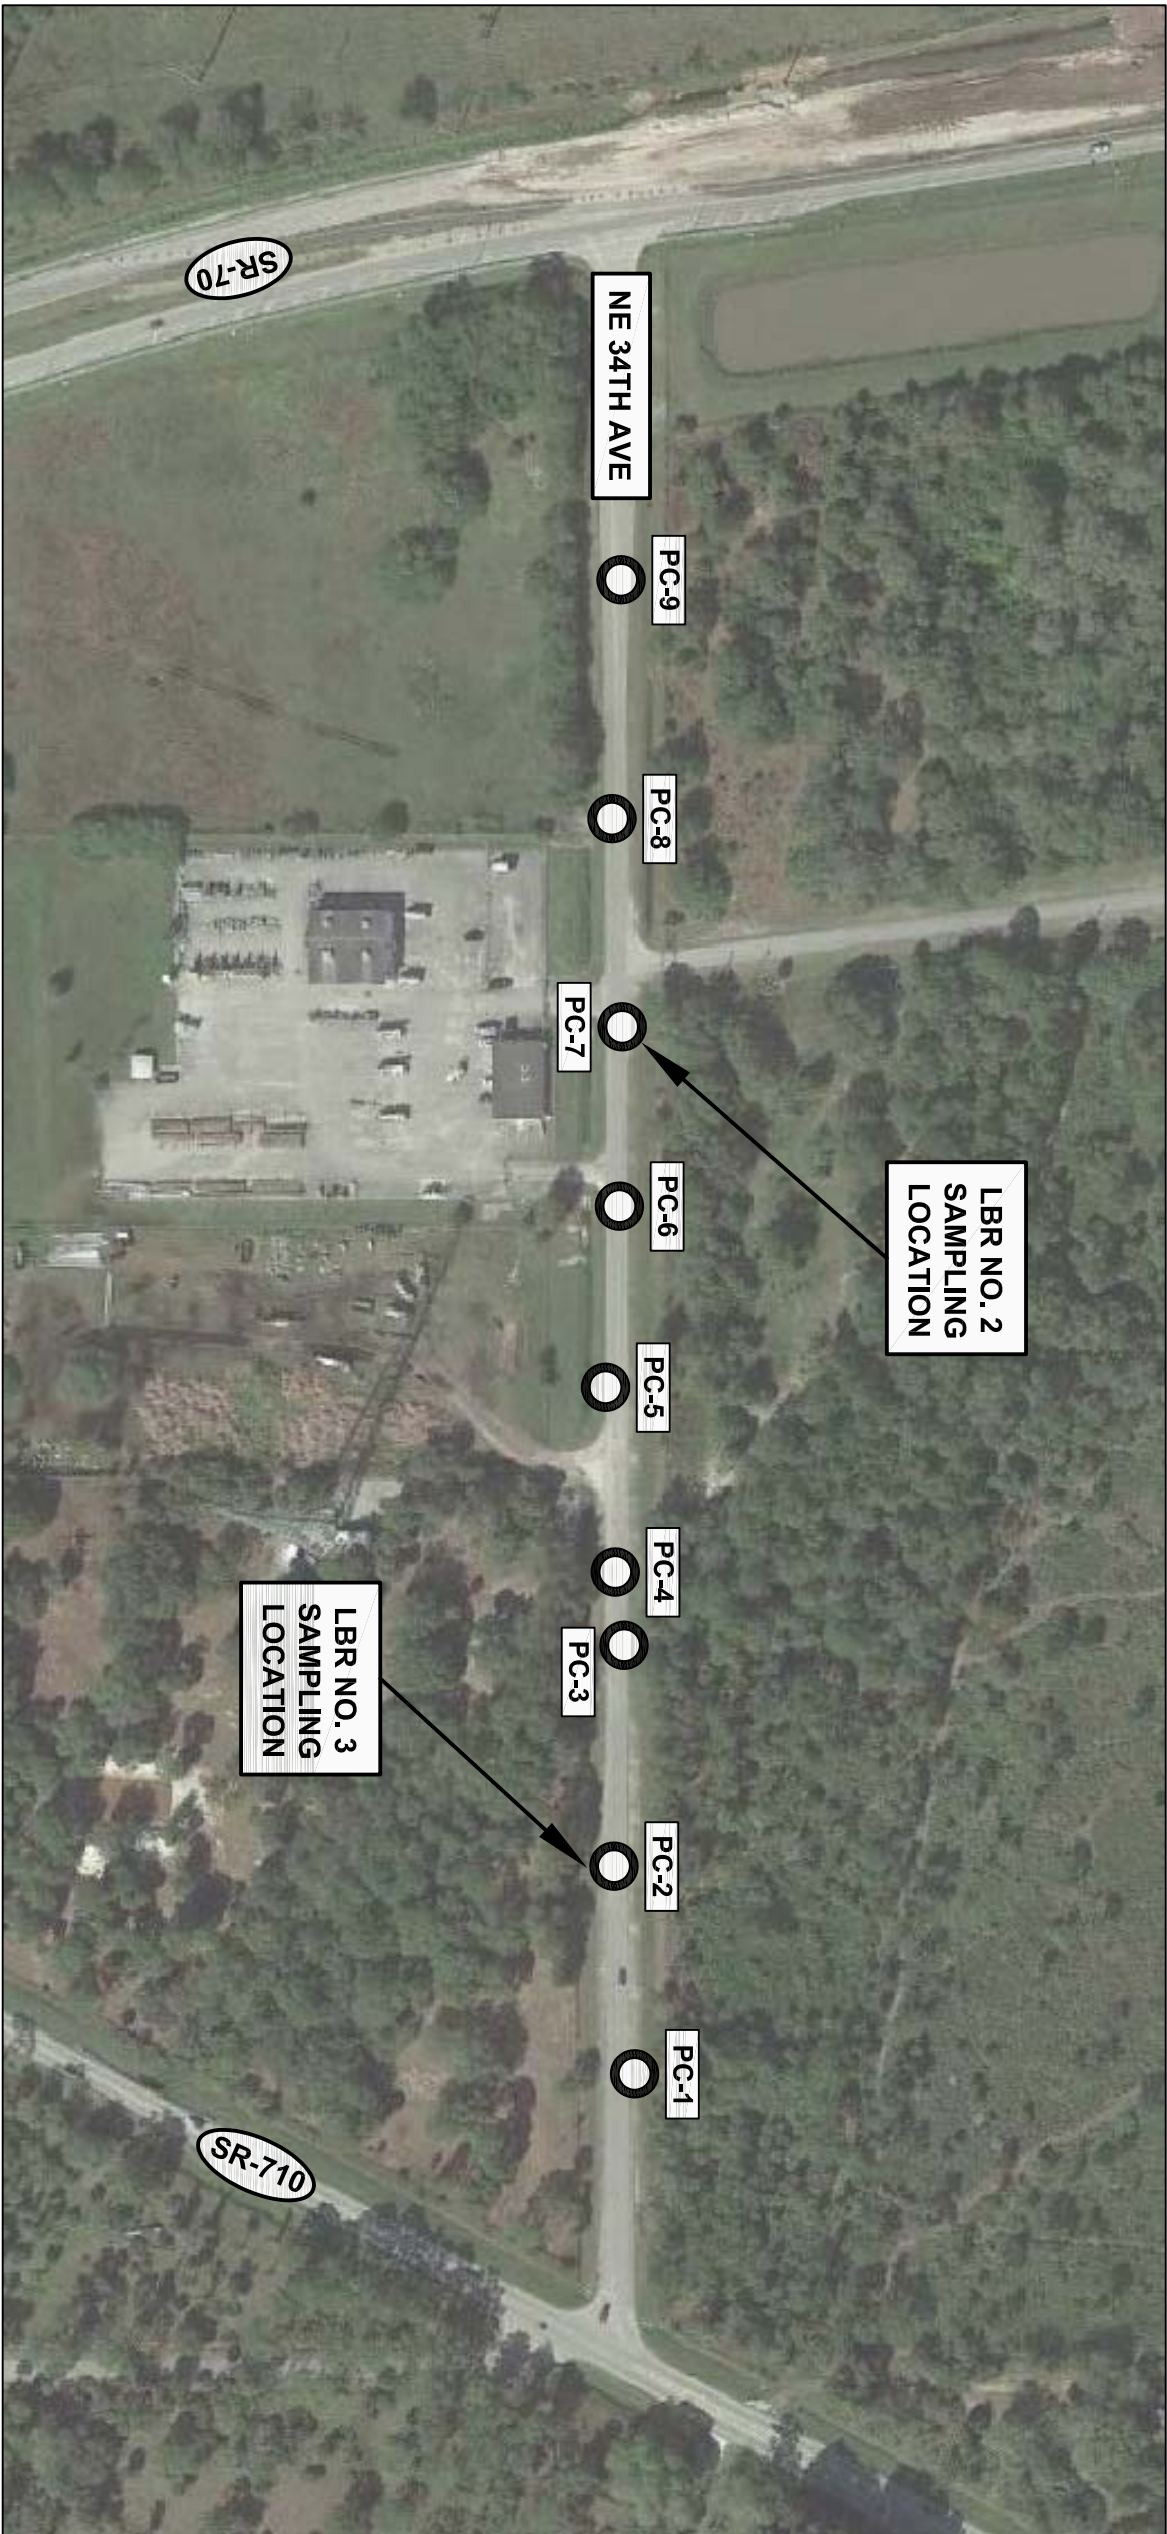
FIELD WORK LOCATION PLAN

As requested, to explore the existing pavement conditions and the underlying subgrade soils, nine (9) asphalt cores and shallow hand auger borings (ASTM D1452) were performed at the locations shown on Sheet No. 2. Our field work was performed on August 5, 2016. The auger boreholes were backfilled with accumulated soil cuttings upon completion of the field exploration program, and the pavement core holes were restored using asphalt cold-patch material.

Our borings and pavement cores were field located using obtained aerial photographs, existing site features, and a combination of tape/wheel measurements and a WAAS-enabled GPS instrument. The locations should be considered accurate only to the degree implied by the method of measurement used. We preliminarily anticipate that the borings were performed within 15 feet of the locations noted on Sheet No. 2.

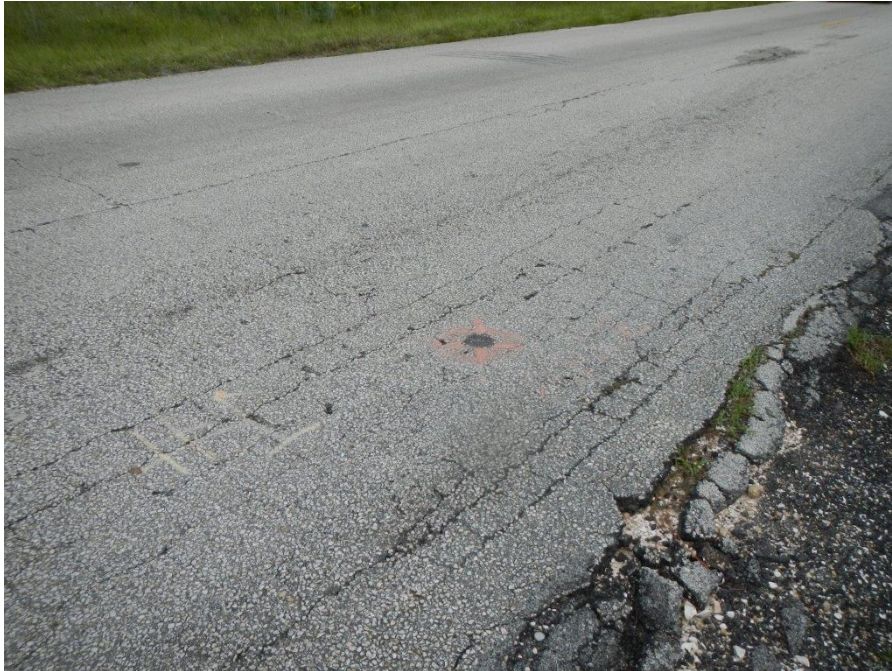
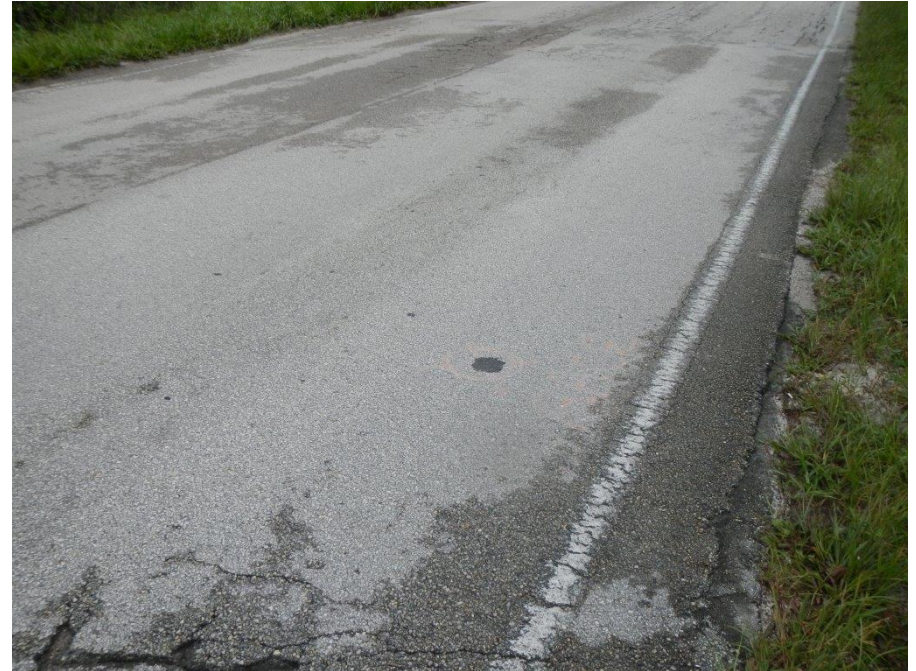
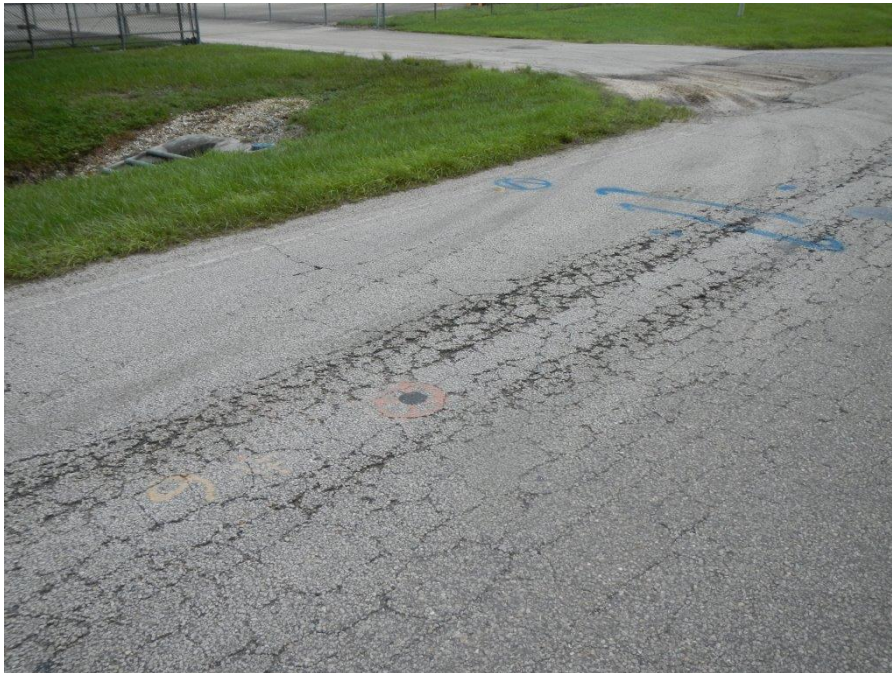
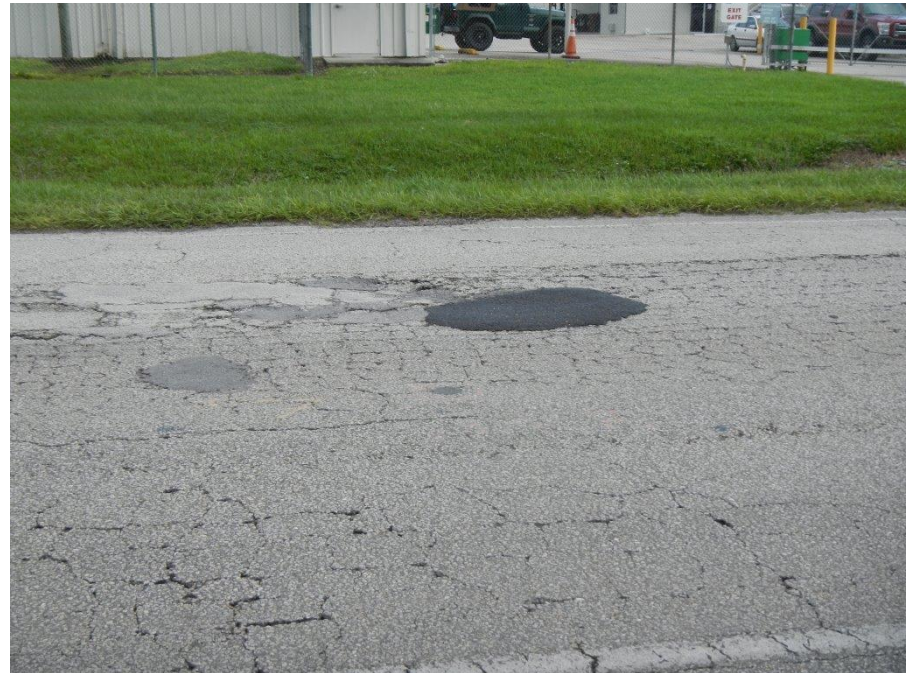
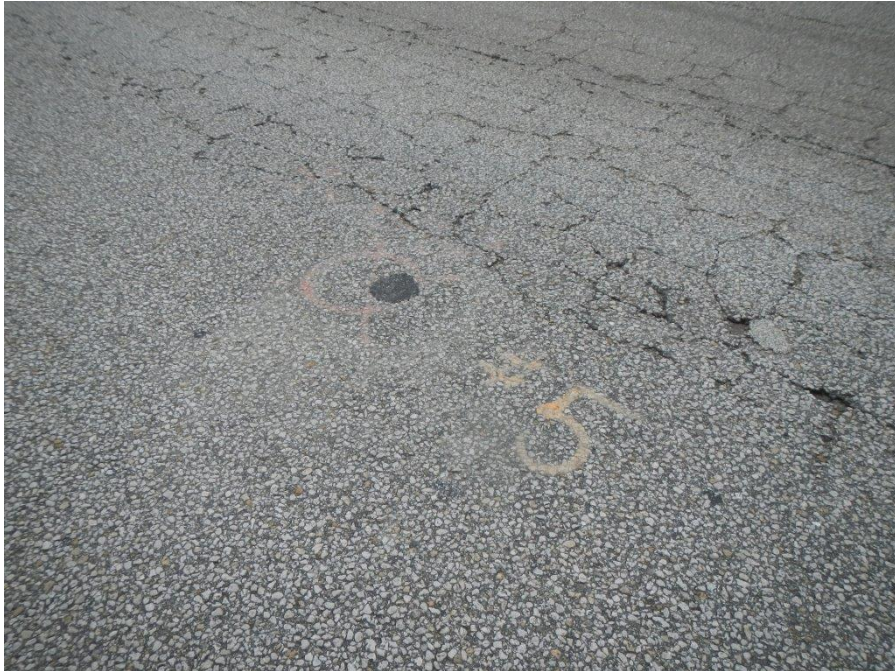
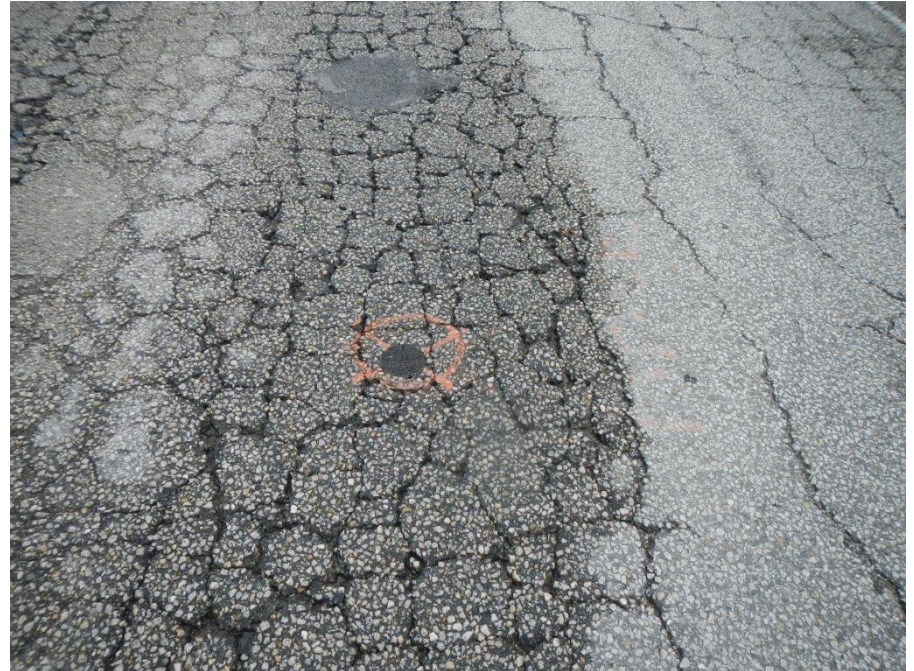
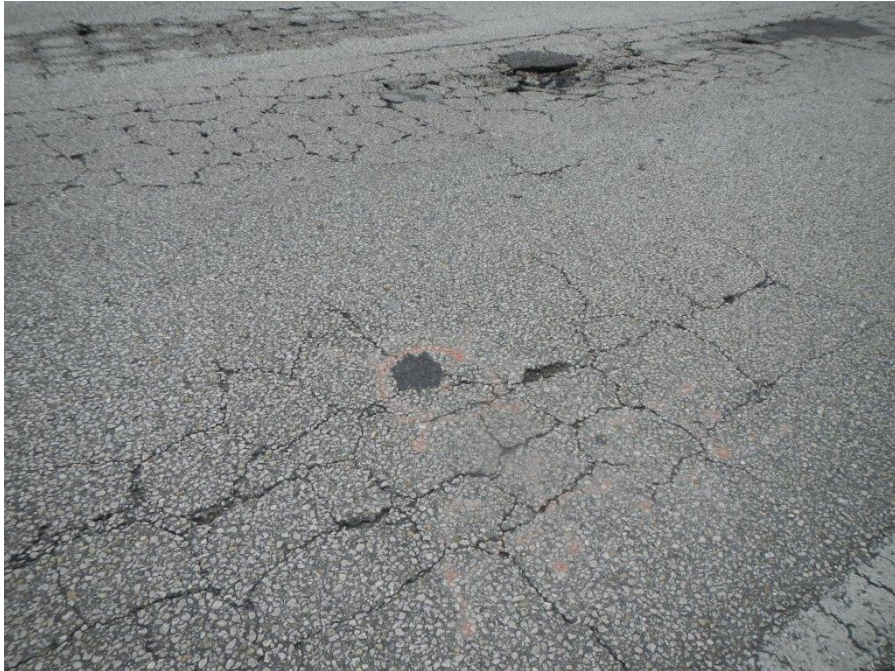
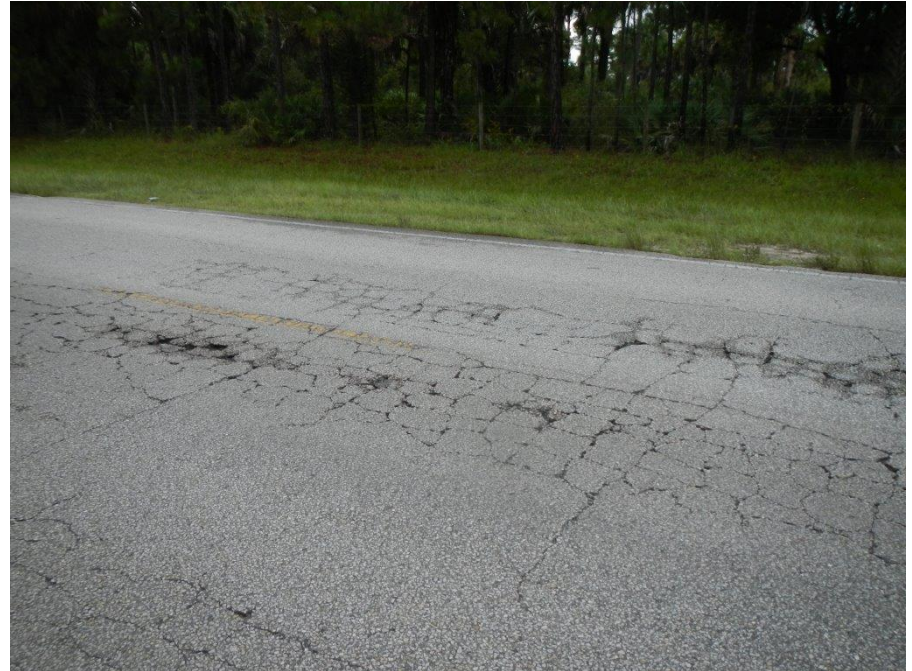
**REPRESENTATIVE SITE PHOTOGRAPHS**

The roadway is currently asphalt-paved with grassed shoulders and side swales. Based on our cursory field observations, the overall condition of the roadway can be considered as “fair to poor” with longitudinal cracking and “alligator” block cracking patterns of varying frequency (especially near driveway turnouts) as well as minor wheel rutting. Representative photographs presenting examples of the current roadway conditions are included in Appendix I.
