## City of Havelock Engineering Services Gray Fox Road Infrastructure Improvements

# Structure Safety Report

## 2 Year Complete Topside and Underwater Element Inspection

DIVISION: 2 COUNTY: CRAVEN STRUCTURE NUMBER: 240216 FREQUENCY: 24 MONTHS

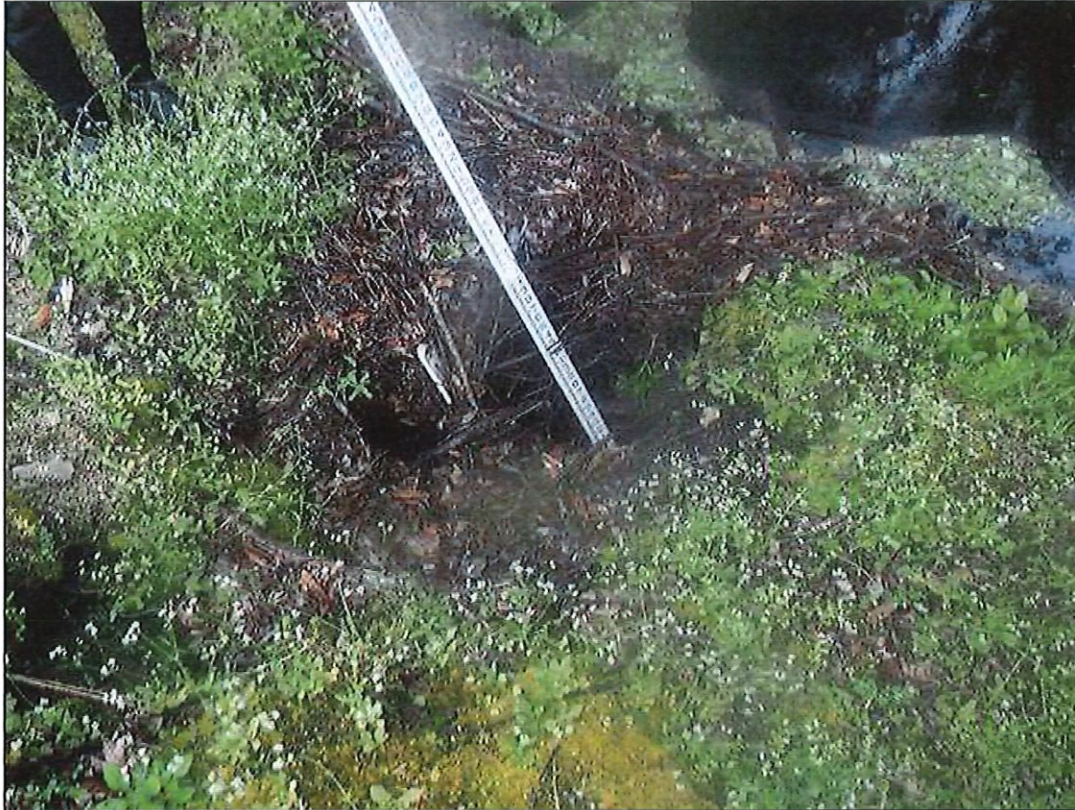
Priority Level	Defect Type	Quantity	Defect Description
②	Corrosion	6	Barrel 3 Section 1: CORRODED AND COLLAPSED ALONG TOP OF PIPE FROM SOUTH END BACK 6.0' (PAR)

Element Number	Defect Type	Defect Description	CS	CS Qty	Maint Qty
240	Corrosion	CORRODED AND COLLAPSED ALONG TOP OF PIPE FROM SOUTH END BACK 6.0' (PAR)	3	6	6 Feet
240	Corrosion	20" x 40" area of rust on top of barrel at upstream end	2	2	Feet
240	Corrosion	PREVIOUS 9" OF SCOUR UPSTREAM IS DRIFT COVERED AT THIS INSPECTION.	2	1	Feet
515	Effectiveness (Steel Protective Coatings)	COATING FAILED IN AREAS OF CORROSION.	4	140	140 Square Feet

Item	Culvert - Item 62	Grade 4	Maint Code	Qty. 0
Details	NEWLY STRUCTURALLY DEFICIENT MAINLY DUE TO THE UPSTREAM END OF LINE 3 COLLAPSING FROM THE END BACK 6.0'.

LINE 3, SOUTH END COLLAPSED FROM THE END BACK 6.0' (PAR)

3370	Maintenance and Repair of NBIS Pipes and Culverts	LF	6	Barrel 3 Section 1: CORRODED AND COLLAPSED ALONG TOP OF PIPE FROM SOUTH END BACK 6.0' (PAR)

MMS Code	MMS Description	Quantity
3370	Maintenance and Repair of NBIS Pipes and Culverts	6            LF
Location:		
Bent/Span No.		
Priority Level	Status	
	Request Awaiting Assignment	
Submitted Date:	Submitted By:	Assisted By:
04/15/2020	PATRICK G. RUTHERFORD	
Details		
Barrel 3 Section 1: CORRODED AND COLLAPSED ALONG TOP OF PIPE FROM SOUTH END BACK 6.0' (PAR)

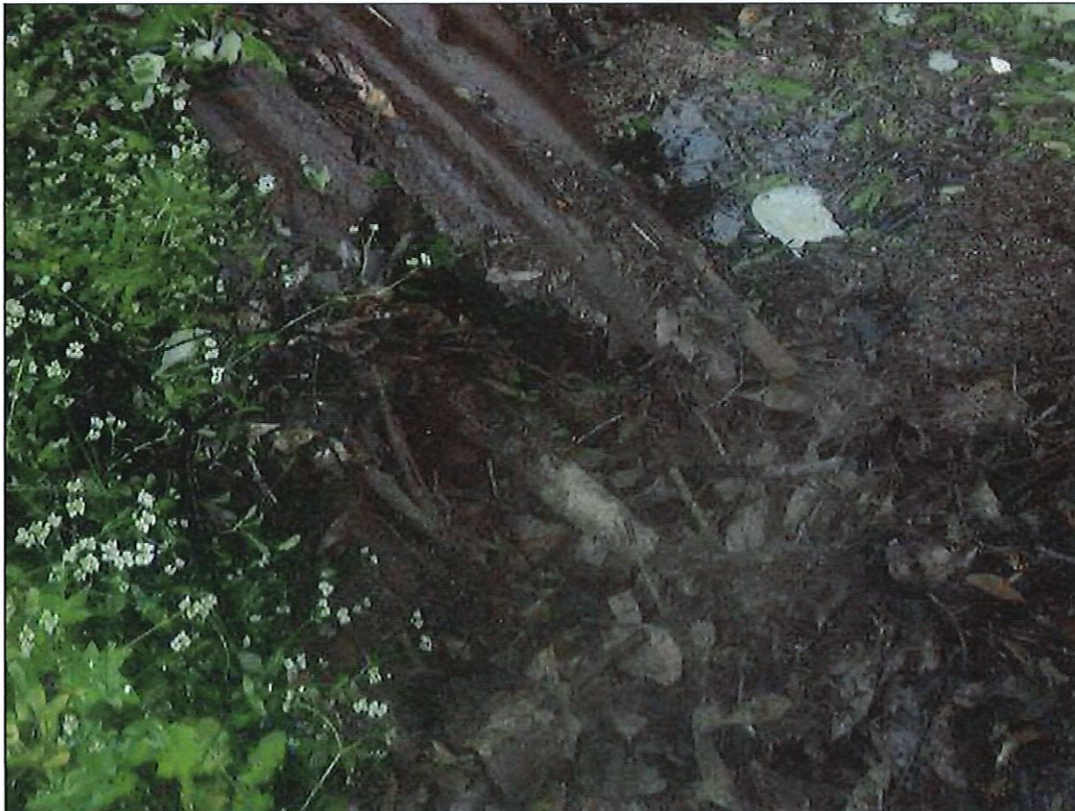
Priority Level	Defect Type	Quantity	Defect Description
②	Corrosion	2	Barrel 2 Section 1: SECTION LOSS, SOUTH END WEST SIDE FROM END BACK 2.0' (PAR)

Element Number	Defect Type	Defect Description	CS	CS Qty	Maint Qty
240	Corrosion	SECTION LOSS, SOUTH END WEST SIDE FROM END BACK 2.0' (PAR)	3	2	2 Feet
240	Scour	PREVIOUS 9" OF SCOUR AT THE UPSTREAM END REMAINS BLOCKED BY DRIFT AT THIS INSPECTION .	3	1	1 Feet
240	Corrosion	RUST ON EXPOSED PIPE ENDS	2	8	Feet
240	Distortion	2" x 40" area of up to 1" deformation at 12 o'clock at upstream end	2	1	Feet
515	Effectiveness (Steel Protective Coatings)	COATING FAILED IN AREAS OF CORROSION	4	140	140 Square Feet

SECTION LOSS LINE 2, FROM SOUTH END BACK 2.0' (PAR)

3370	Maintenance and Repair of NBIS Pipes and Culverts	LF	2	Barrel 2 Section 1: SECTION LOSS, SOUTH END WEST SIDE FROM END BACK 2.0' (PAR)

MMS Code	MMS Description	Quantity
3370	Maintenance and Repair of NBIS Pipes and Culverts	2            LF
Location:		
Bent/Span No.		
Priority Level	Status	
	Request Awaiting Assignment	
Submitted Date:	Submitted By:	Assisted By:
04/15/2020	PATRICK G. RUTHERFORD	
Details		
Barrel 2 Section 1: SECTION LOSS, SOUTH END WEST SIDE FROM END BACK 2.0' (PAR)

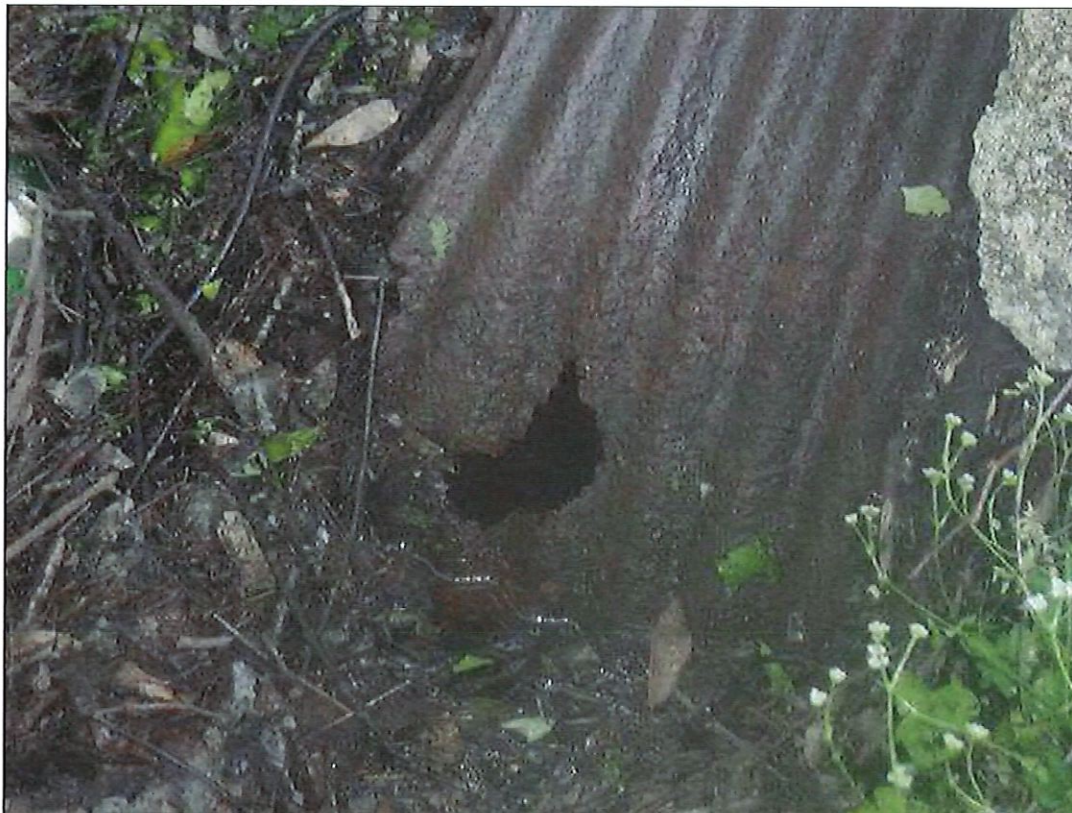
Priority Level	Defect Type	Quantity	Defect Description
②	Corrosion	2	Barrel 1 Section 1: SECTION LOSS SOUTH END, EAST SIDE FROM END BACK 1.0' X 8" VERT. (PAR). SECTION LOSS FROM NORTH END BACK 1.0' AT EAST AND WEST SIDES. (PAR)

Element Number	Defect Type	Defect Description	CS	CS Qty	Maint Qty
240	Corrosion	SECTION LOSS SOUTH END, EAST SIDE FROM END BACK 1.0' X 8" VERT. (PAR). SECTION LOSS FROM NORTH END BACK 1.0' AT EAST AND WEST SIDES. (PAR)	3	2	2 Feet
240	Corrosion	RUST ON EXPOSED PIPE ENDS	2	5	Feet
240	Distortion	3" x 20" area of up to 1" deformation at 12 o'clock at upstream end	2	1	Feet
515	Effectiveness (Steel Protective Coatings)	COATING FAILED IN AREAS OF CORROSION	4	125	125 Square Feet

SECTION LOSS LINE 1, FROM SOUTH END BACK 1.0' (PAR)

3370	Maintenance and Repair of NBIS Pipes and Culverts	LF	2	Barrel 1 Section 1: SECTION LOSS SOUTH END, EAST SIDE FROM END BACK 1.0' X 8" VERT. (PAR). SECTION LOSS FROM NORTH END BACK 1.0' AT EAST AND WEST SIDES. (PAR)

MMS Code	MMS Description	Quantity
3370	Maintenance and Repair of NBIS Pipes and Culverts	2      LF
Location:		
Bent/Span No.		
Priority Level	Status	
	Request Awaiting Assignment	
Submitted Date:	Submitted By:	Assisted By:
04/15/2020	PATRICK G. RUTHERFORD	
Details		
Barrel 1 Section 1: SECTION LOSS SOUTH END, EAST SIDE FROM END BACK 1.0' X 8" VERT. (PAR). SECTION LOSS FROM NORTH END BACK 1.0' AT EAST AND WEST SIDES. (PAR)

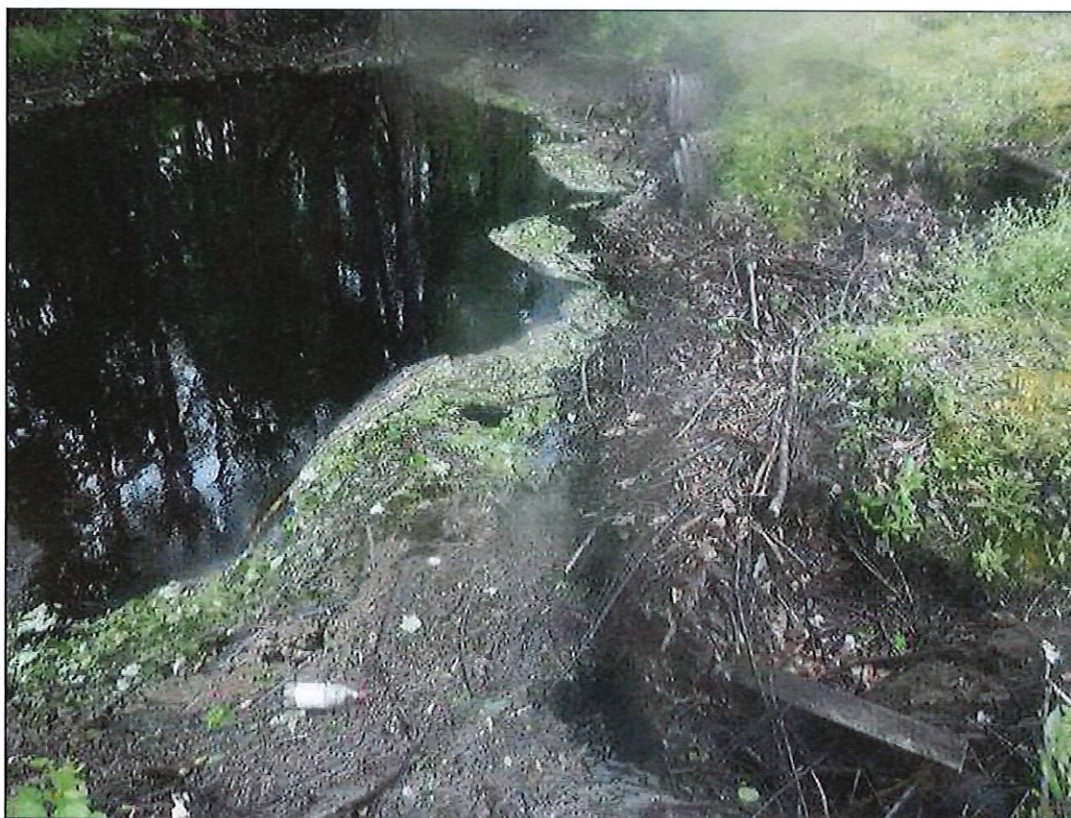
Priority Level	Defect Type	Quantity	Defect Description
②		80	DRIFT AT THE UPSTREAM END FROM MUDLINE TO 1' ABOVE TOP OF PIPES EXTEND +/- 5' INTO PIPES.(PAR)

Item	Scour	Grade F	Maint Code	Qty. 0
Details	PREVIOUS SCOUR AT THE UPSTREAM END IS DRIFT COVERED AT THIS INSPECTION.

DRIFT FROM MUDLINE TO 1' ABOVE TOP OF ALL LINES AT THE SOUTH END EXTENDING INTO PIPES +/- 5.0' (PAR)

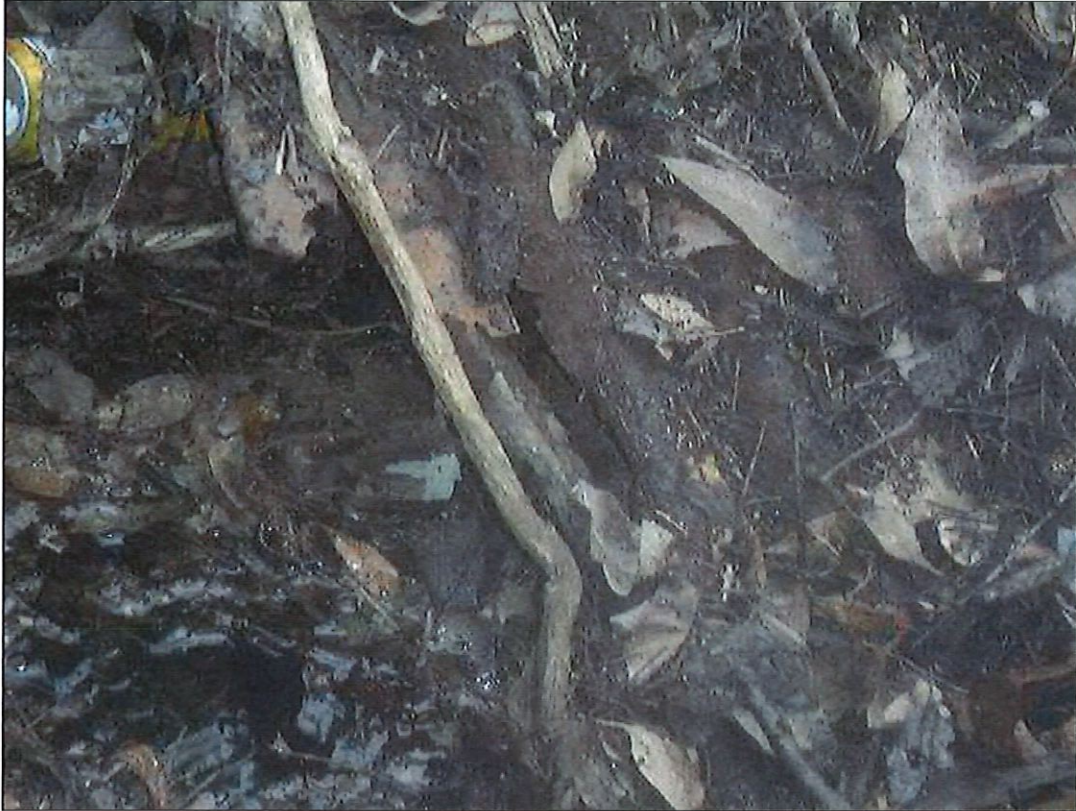
Priority Level	Defect Type	Quantity	Defect Description
②	Corrosion	1	Barrel 4 Section 1: SECTION LOSS, FROM SOUTH END BACK 1.0' AT THE EAST AND WEST SIDES AT THE WL. (PAR)

Element Number	Defect Type	Defect Description	CS	CS Qty	Maint Qty
240	Corrosion	SECTION LOSS, FROM SOUTH END BACK 1.0' AT THE EAST AND WEST SIDES AT THE W/L. (PAR)	3	1	1 Feet
240	Corrosion	SURFACE RUST AT EXPOSED PIPE ENDS	2	4	Feet
240	Distortion	1" x 7" area of up to 1/2" deformation at 12 o'clock at upstream end	2	1	Feet
240	Scour	PREVIOUS 6" OF SCOUR DRIFT COVERED AT THIS INSPECTION.	2	1	Feet
515	Effectiveness (Steel Protective Coatings)	COATING FAILED IN AREAS OF COROSION.	3	120	120 Square Feet

SECTION LOSS LINE 4 FROM SOUTH END BACK 1.0'(PAR)

3370	Maintenance and Repair of NBIS Pipes and Culverts	LF	1	Barrel 4 Section 1: SECTION LOSS, FROM SOUTH END BACK 1.0' AT THE EAST AND WEST SIDES AT THE W/L . (PAR)

MMS Code	MMS Description	Quantity
3370	Maintenance and Repair of NBIS Pipes and Culverts	1              LF
Location:		
Bent/Span No.		
Priority Level	Status	
	Request Awaiting Assignment	
Submitted Date:	Submitted By:	Assisted By:
04/15/2020	PATRICK G. RUTHERFORD	
Details		
Barrel 4 Section 1: SECTION LOSS, FROM SOUTH END BACK 1.0' AT THE EAST AND WEST SIDES AT THE W/L . (PAR)

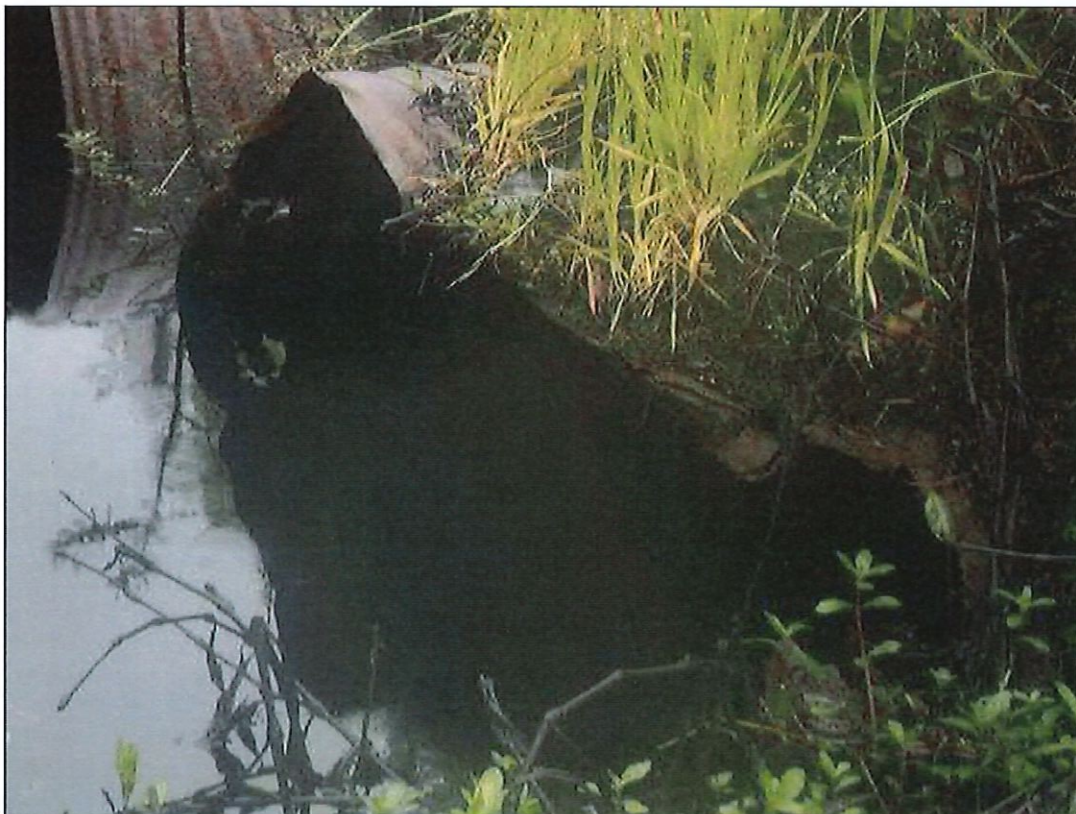
SECTION LOSS LINE 1, FROM NORTH END BACK 1.0' (PAR)

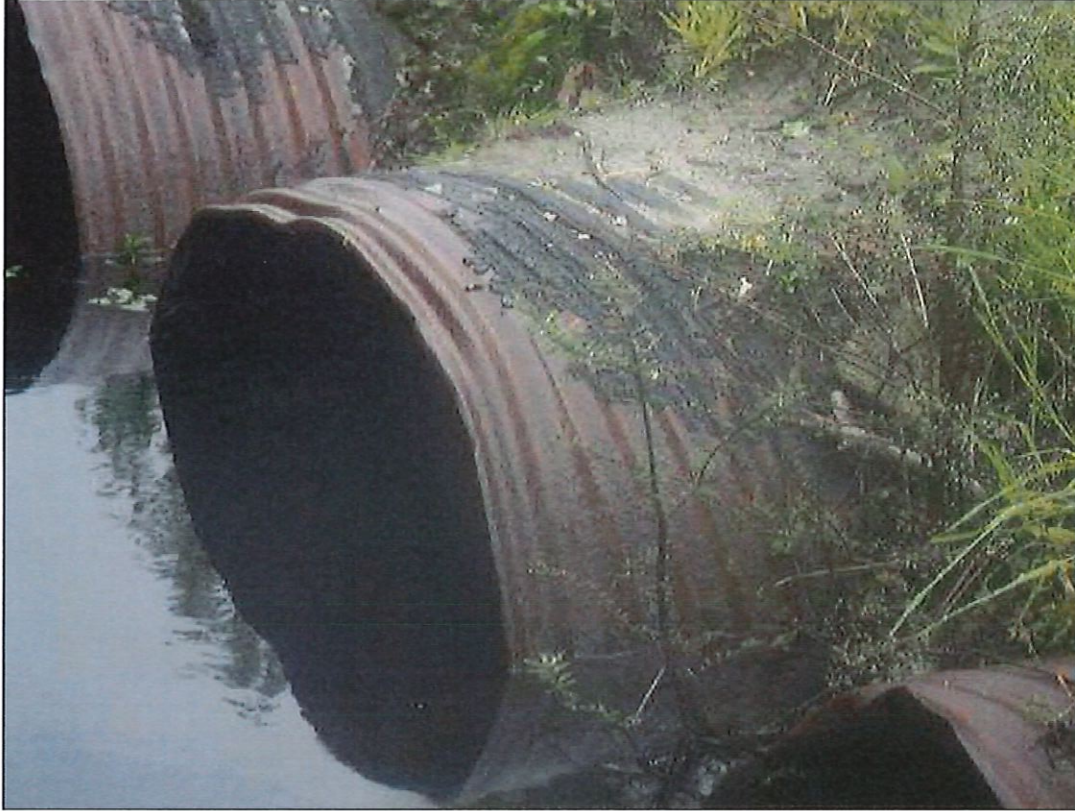
RUST AT EXPOSED PIPE ENDS
