As authorized by our client, Tabitha Busby, property owner, Applied Environmental Solutions (AES) has completed an Asbestos Building Inspection on the Commercial Property located at 1013 Carver St. in Myrtle Beach, South Carolina. The inspection was conducted by and the report was prepared and reviewed by the undersigned.

2.0 Executive Summary

Commercial Property – Residential Rentals
1013 Carver St.
Myrtle Beach, SC

AES Job # AS-1903

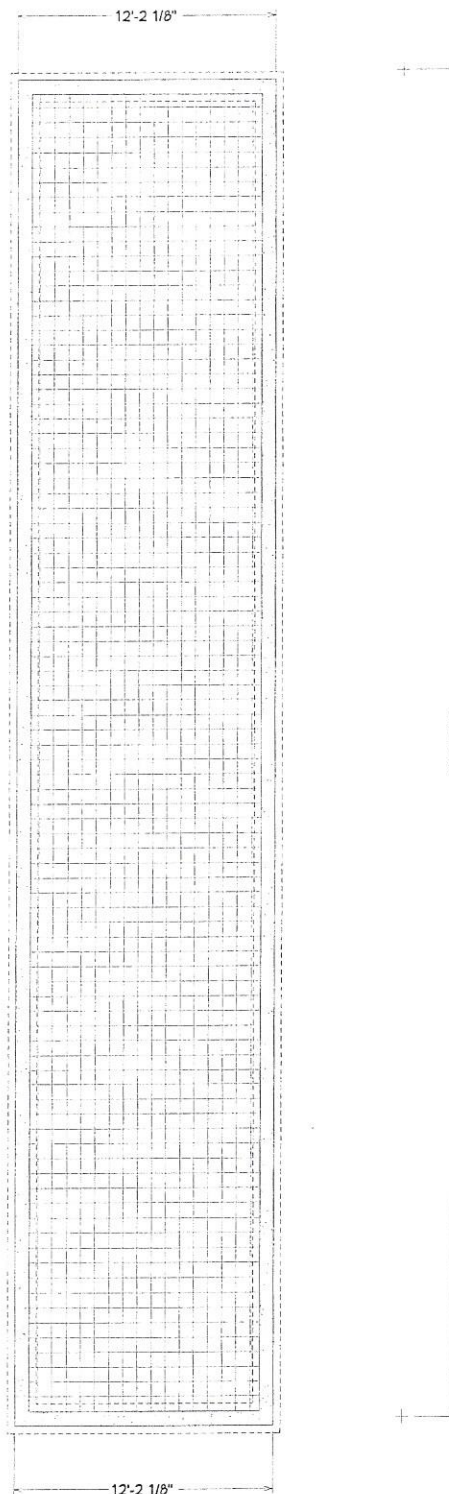
ACBM Site Plan - Roof Level

| HA # | AC M | MATERIAL DESCRIPTION | CATEGORY | FRIABLE F/NF | QUANTITY SQ FT± | NO. SAMPLE TAKEN | PRESENT CONDITION | POTENTIAL FOR DISTURBANCE | POSITIVE (P) OR NON DETECTED (ND) |
|--|---|---|---|---|---|---|--|---|---|
| 81 | P | ROOFING MATERIAL – BLACK TAR-LIKE | MISC | F | 925 SQ FT± | 3 | SD | PSD | 2% CHRYSOTILE PRESENT |
| LOCATION: ENTIRE ROOF, BOTTOM LAYER | | | | | | | NOTE: FRIABLE DUE TO EXCESSIVE DAMAGE | | |

HA81 - Roofing Materials - Tar-Like Material
2% Chrysotile Present in Black Tar-Like
Material
Approx. 925 sq ft

Due to excessive structural damage and contamination of ACBMs within the structure, it is recommended to proceed with Abatement by Demolition, as it would be unsafe for workers to enter the structure and perform standard Abatement procedures.

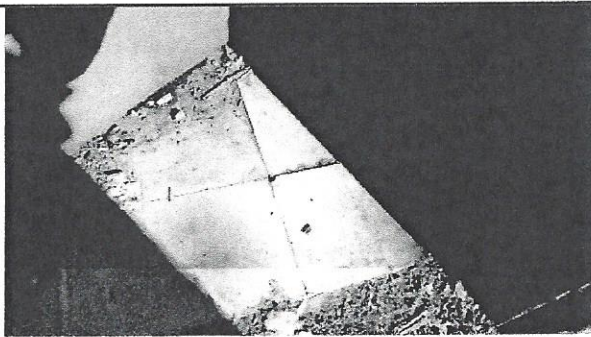
| HA # | AC M | MATERIAL DESCRIPTION | CATEGORY | FRIABLE F/NF | QUANTITY SQ FT± | NO. SAMPLE TAKEN | PRESENT CONDITION | POTENTIAL FOR DISTURBANCE | POSITIVE (P) OR NON DETECTED (ND) |
|--|---|---|---|---|---|---|--|---|---|
| 1 | AP | BLUE 9X9 FLOOR TILES | MISC | F | 787 SQ FT± | N/A | SD | PD | ASSUMED POSITIVE |
| LOCATION: ALL INTERIOR SPACES | | | | | | | NOTE: FRIABLE DUE TO EXCESSIVE DAMAGE | | |

Picture 5 – *HA1 9x9 Floor Tiles
Assumed Positive, Approx. 787 sq ft±

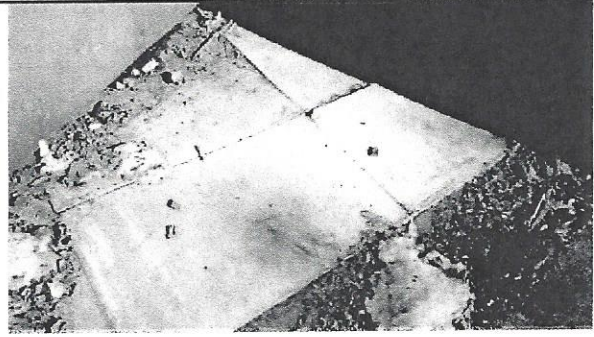
Picture 6 – *HA1 9x9 Floor Tiles
Assumed Positive, Approx. 787 sq ft±

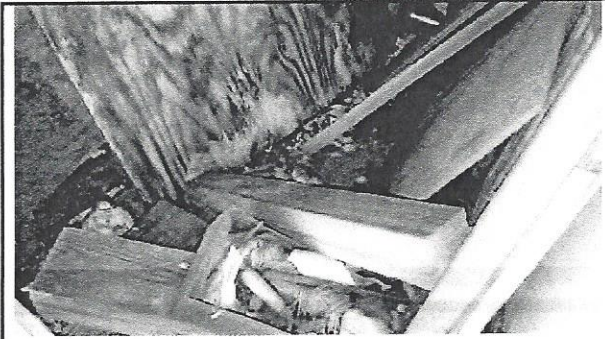
Picture 7 – Room Interior, excessive clutter and structural damage from ceiling collapse

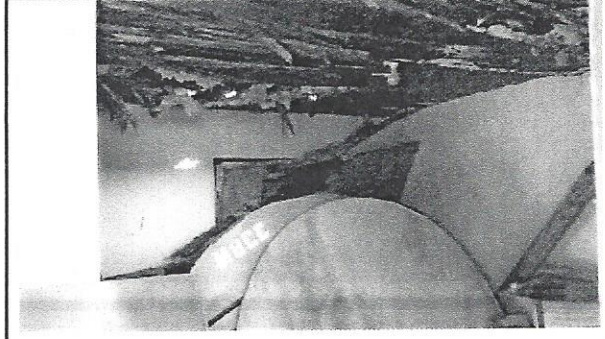
Picture 8 – Room Interior, excessive clutter and structural damage from ceiling collapse

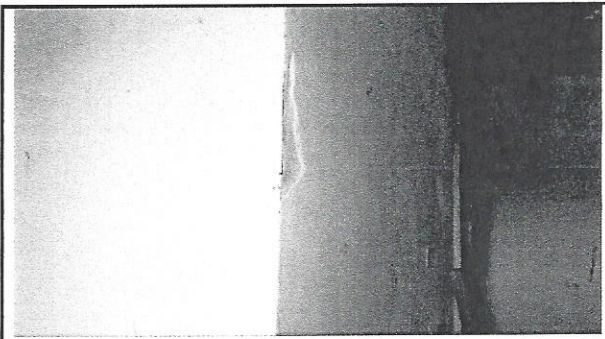
| HA # | AC M | MATERIAL DESCRIPTION | CATEGORY | FRIABLE F/NF | QUANTITY SQ FT± | NO. SAMPLE TAKEN | PRESENT CONDITION | POTENTIAL FOR DISTURBANCE | POSITIVE (P) OR NON DETECTED (ND) |
|--|---|---|---|---|---|---|--|---|---|
| 20 | ND | INTERIOR WALL TEXTURE | SURF | NF | 2,550 SQ FT± | 5 | D | LPD | ND |
| LOCATION: ALL INTERIOR WALLS | | | | | | | NOTE: POSITIVE BY CONTAMINATION OF ROOFING MATERIALS | | |

Picture 9 – *HA20 Concrete Walls w/Texture
