ROSA PARKS ESCAMBIA
COUNTY AREA TRANSIT (ECAT)
BUS WASH

**FACILITIES
ASSESSMENT
REPORT**

CAA Project No. 21003
Revised 18 AUGUST 2021
PHASE 1 - REPAIR

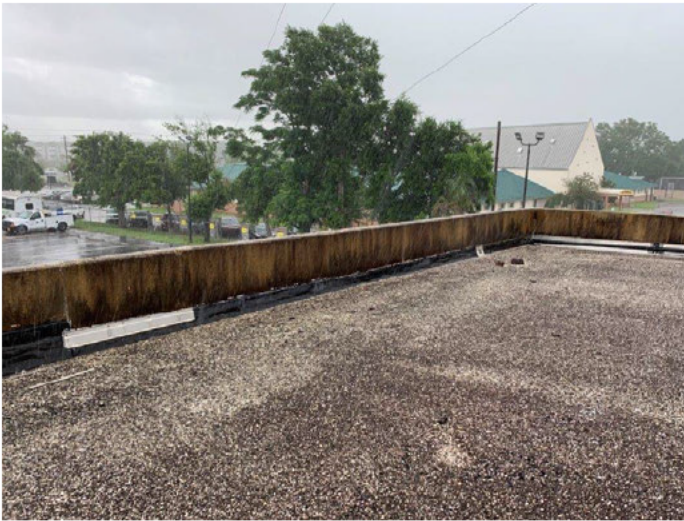
**Roof Perimeter -
Termination bar and coping flashing disconnected**

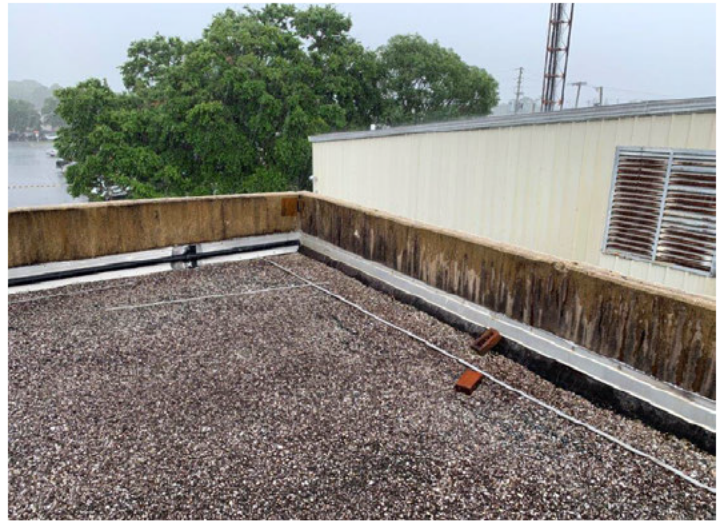
**Roof Perimeter -
Termination bar and coping flashing disconnected**

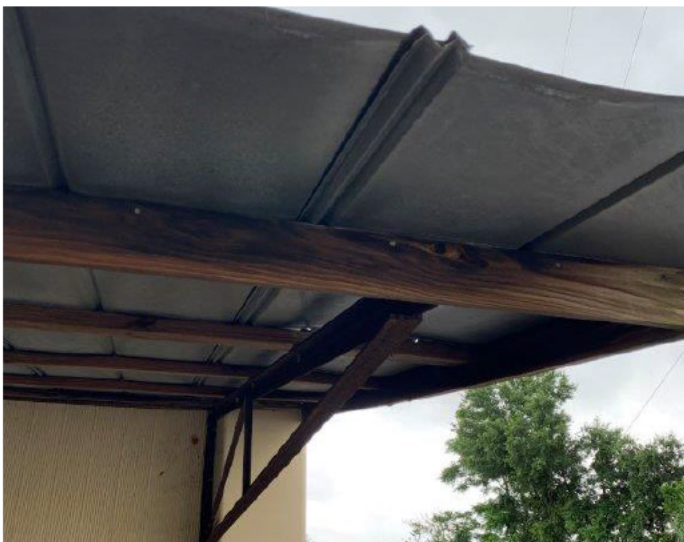
Exterior – Located to the South Side of the structure, a V-Crimp galvanized metal roof is attached and (2) panels were noted to be damaged.

**V-Crimp Roof -
Fasteners pulled through and torn metal**

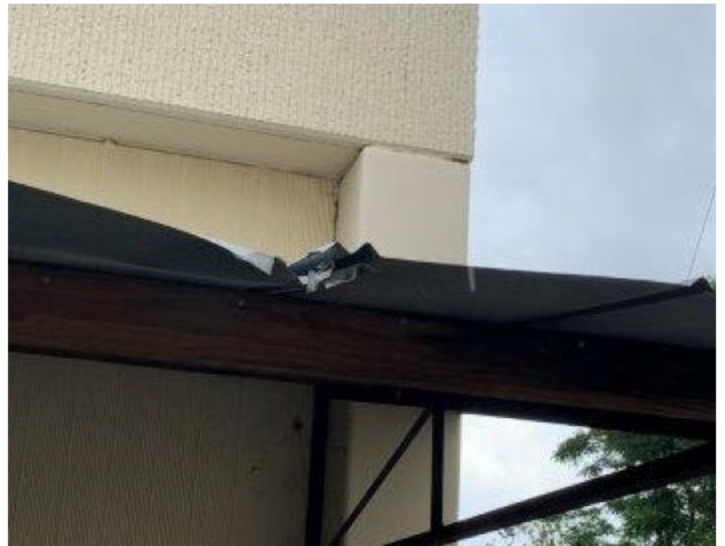
**V-Crimp roof -
Wind blown debris damage**
