# ASBESTOS CONTAINING MATERIALS SURVEY

## **Retail & Residential Structures**

**1375 & 1385 32nd St and 3136 & 3146 US 1  
Vero Beach, FL 32960**

**NOVA Project Number: 10101-3023019**

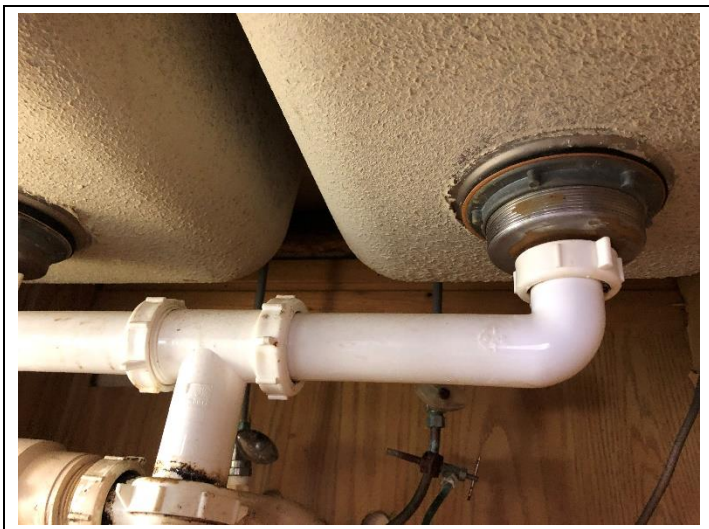
1. 1375 32nd St - White Sink Coating (Unit B): HSA 12.

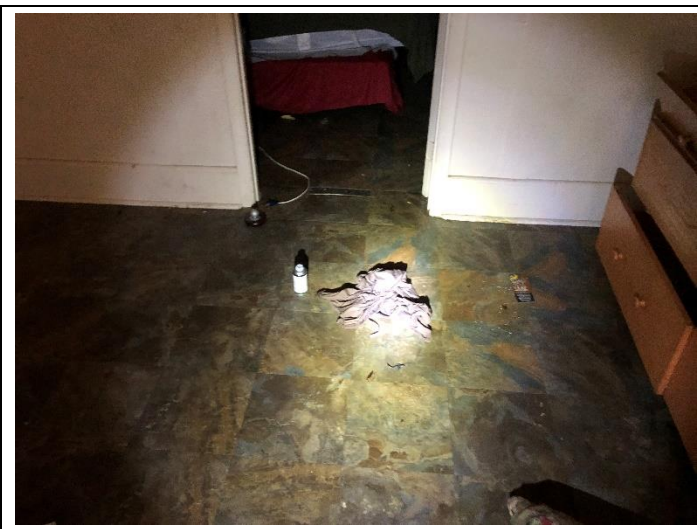
2. 1375 32nd St - Gray Vinyl Floor Tile & Black Mastic (Unit A Living Room Floor): HSA 21.

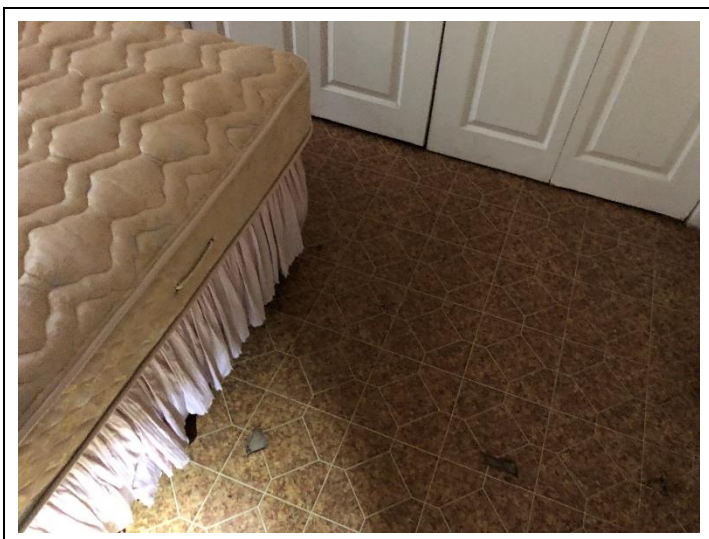
3. 1375 32nd St - Gray Vinyl Floor Tile & Black Mastic (Unit A Bathroom & Bedroom Doorways): HSA 22.

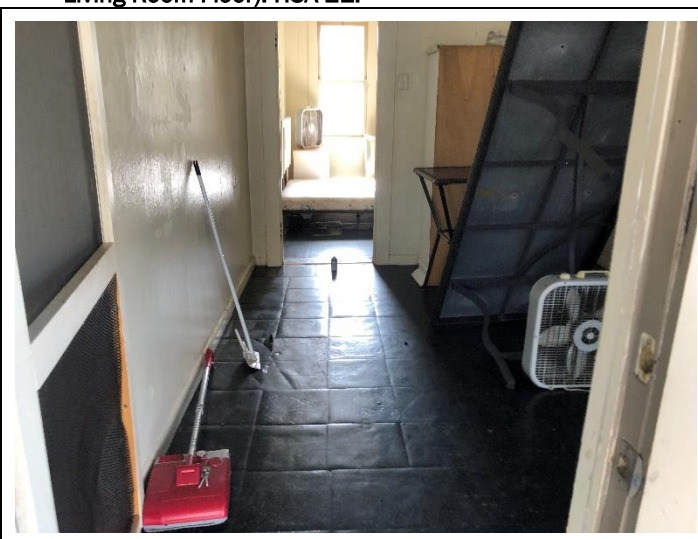
4. 1375 32nd St - Green Vinyl Floor Tile & Black Mastic (Unit B Living Room & Bedroom): HSA 28.

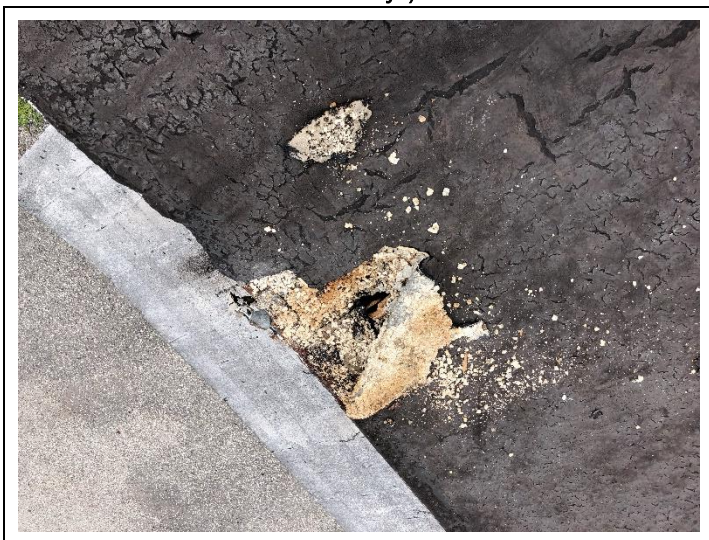
5. 1385 32nd St., Apts A & B - Black Tar (Center Roof Btwn. Pitches): HSA 3.

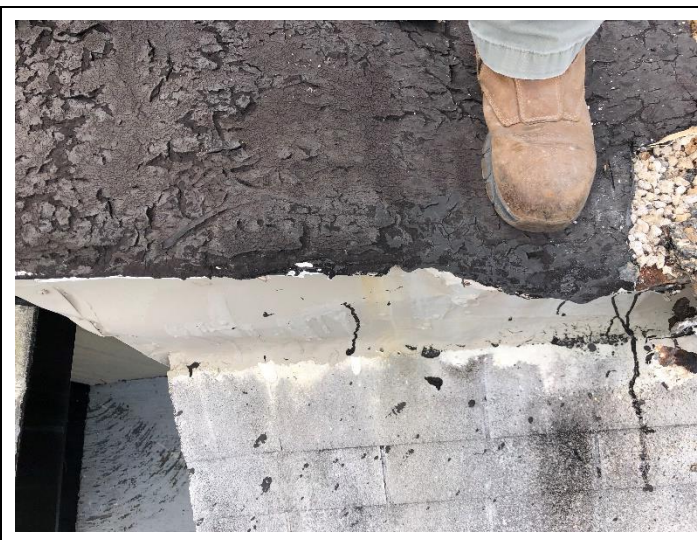
6. 1385 32nd St., Apts A & B - Black Tar (Roof Seams Under Eaves): HSA 4.

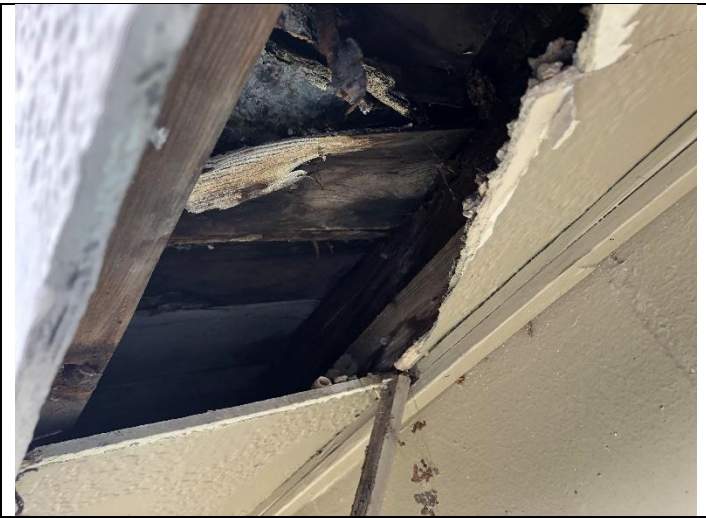
7. 1385 32nd St., Apts A & B - Black Tar & Silver Coating Material (Unit A Front Eaves): HSA 5.

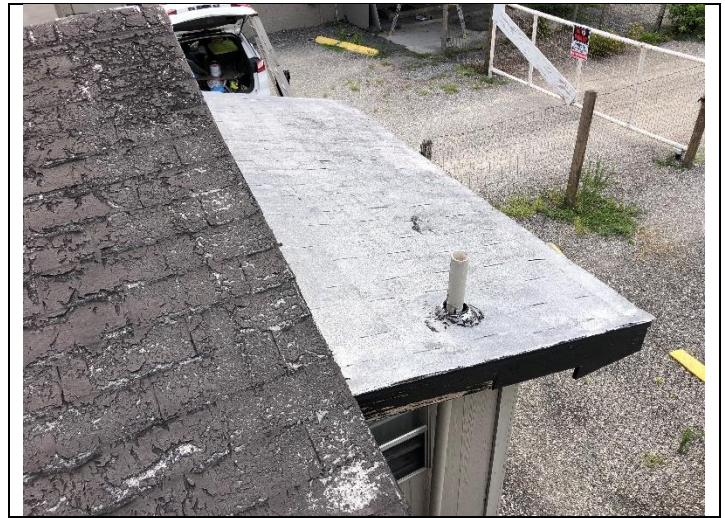
8. 1385 32nd St., Apts A & B - Black Tar & Silver Coating Material (Unit A & B Roof Overhang & Stacks): HSA 7.

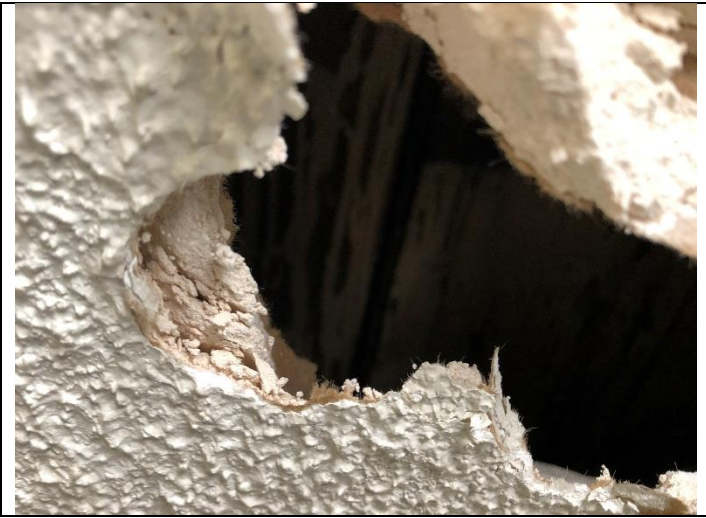
9. 1385 32nd St., Apts A & B - White Textured Material w/ Paint (Unit A Bedroom): HSA 14.

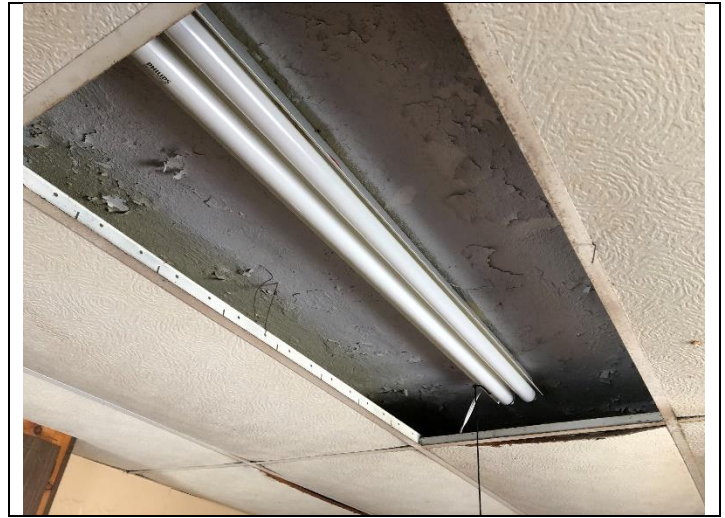
10. 1385 32nd St., Apts A & B - White Surfacing Material w/ Paint (Unit A Kitchen, Living Room & Bathroom): HSA 19.

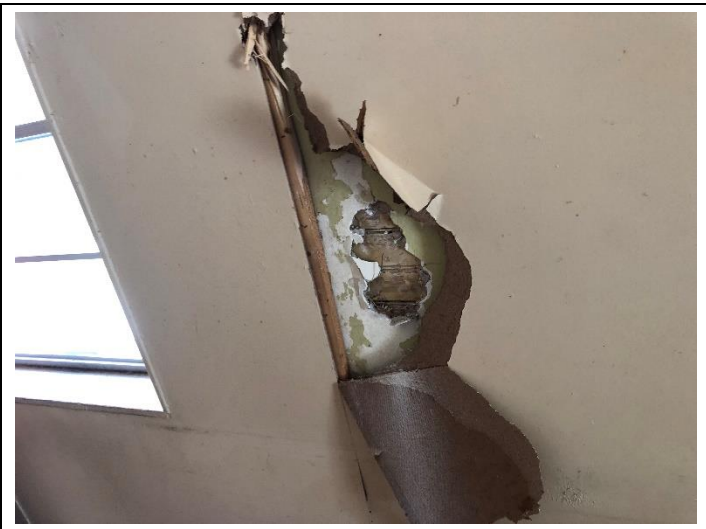
11. 1385 32nd St., Apts A & B - White Textured Material w/ Paint (Unit B Bedroom): HSA 21.

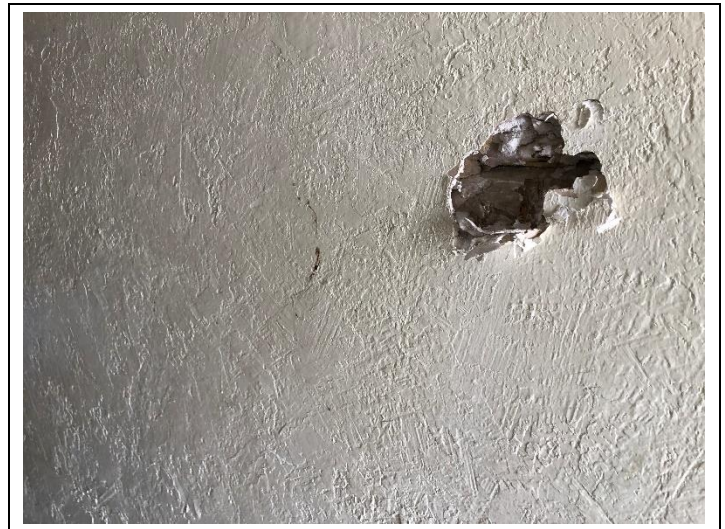
12. 1385 32nd St., Apts A & B - Rough Textured Wallboard Ceiling (Unit B Bedroom): HSA 22.

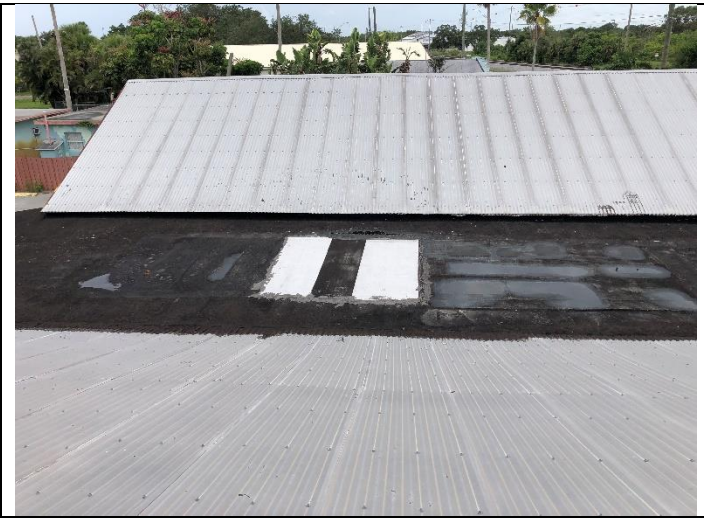
13. 3136-3146 US 1 - Silver Coating Material (Btwn Metal Roof Pitch): HSA 29.

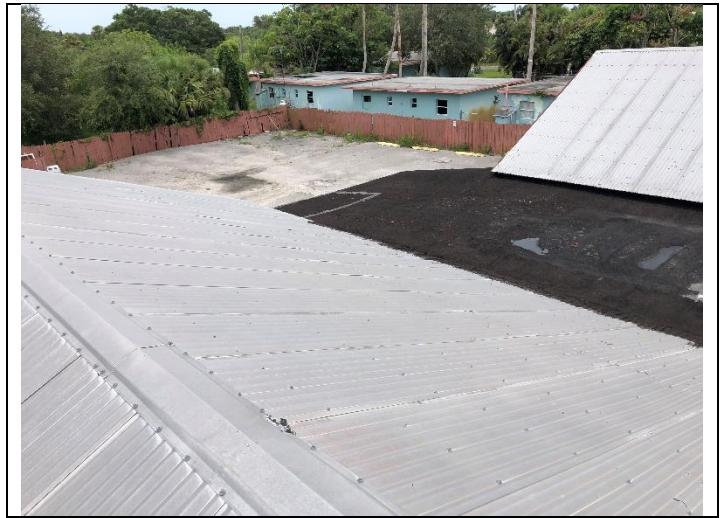
14. 3136-3146 US 1 - Silver Coating Material (Btwn Metal Roof Pitch): HSA 30.

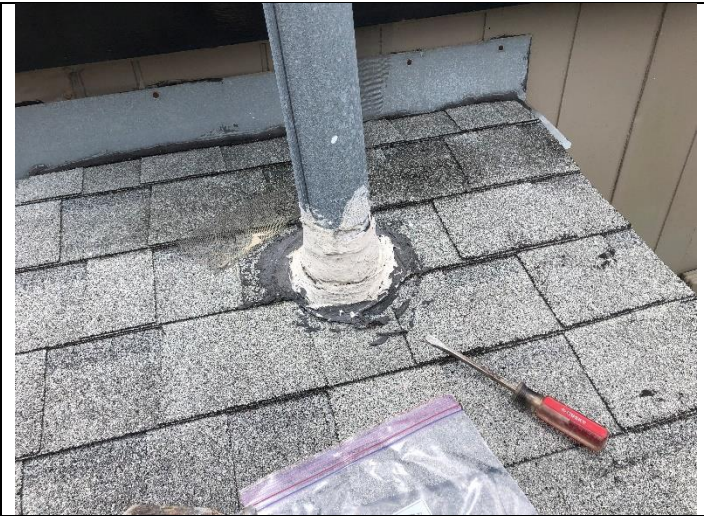
15. 3136-3146 US 1 - Black Roof Flashing & Silver Coating Material (Roof Stacks): HSA 33.

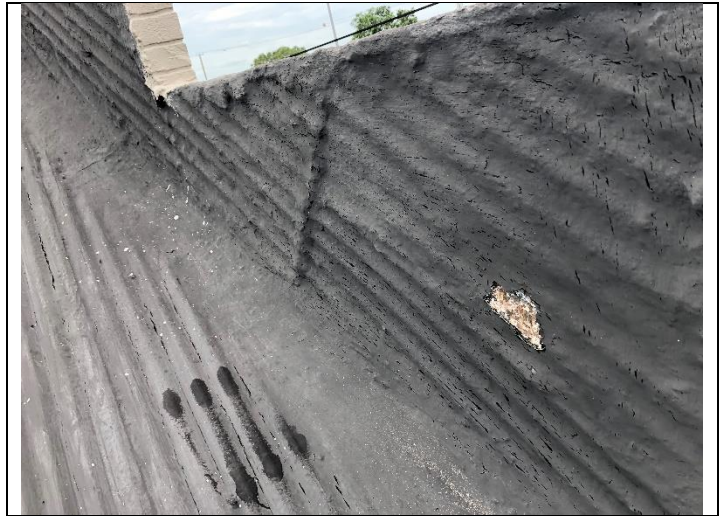
16. 3136-3146 US 1 - Black Tar & Silver Coating Material (Parapet Front of Bldg.): HSA 36.

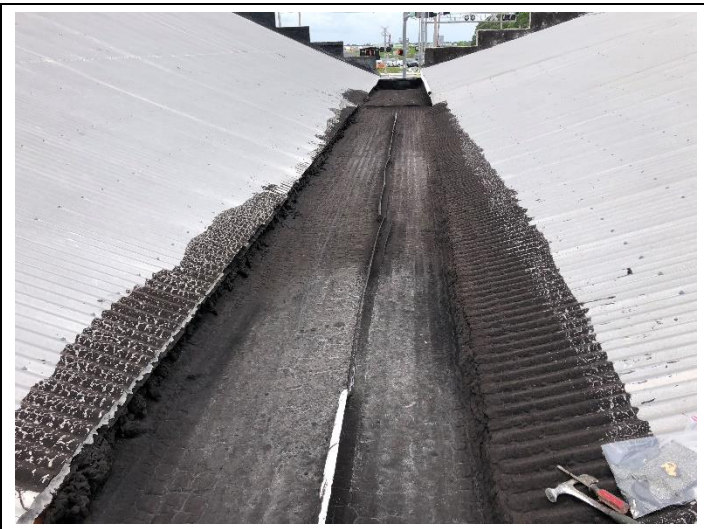
17. 3136-3146 US 1 - Black Flashing & Silver Coating Material (South Roof Seams at Metal and Gravel Roof): HSA 37.

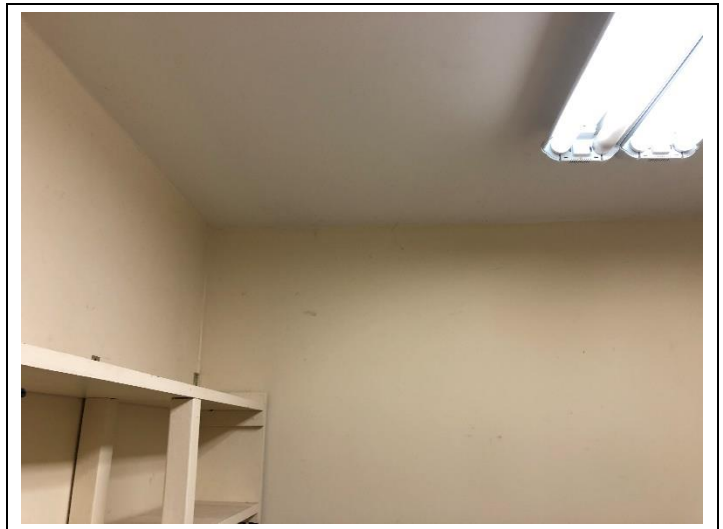
18. 3136-3146 US 1 - White Surfacing Material w/ Paint (Bldg. Interior): HSA 38.

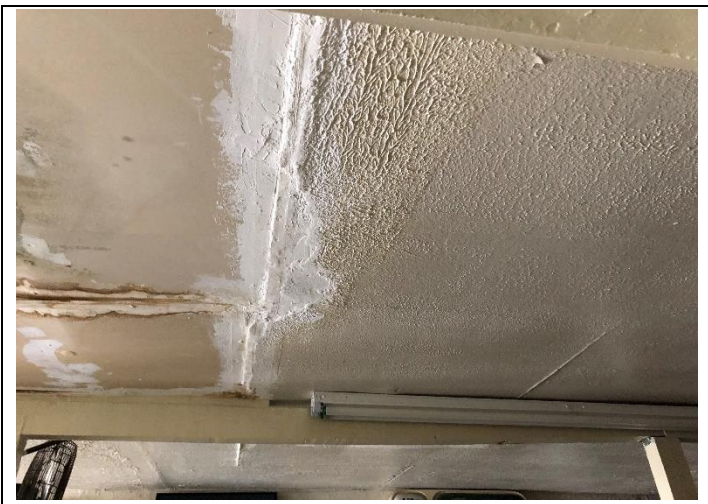
19. 3136-3146 US 1 - White Textured Material w/ Paint (Main Room Walls & Ceiling): HSA 41.

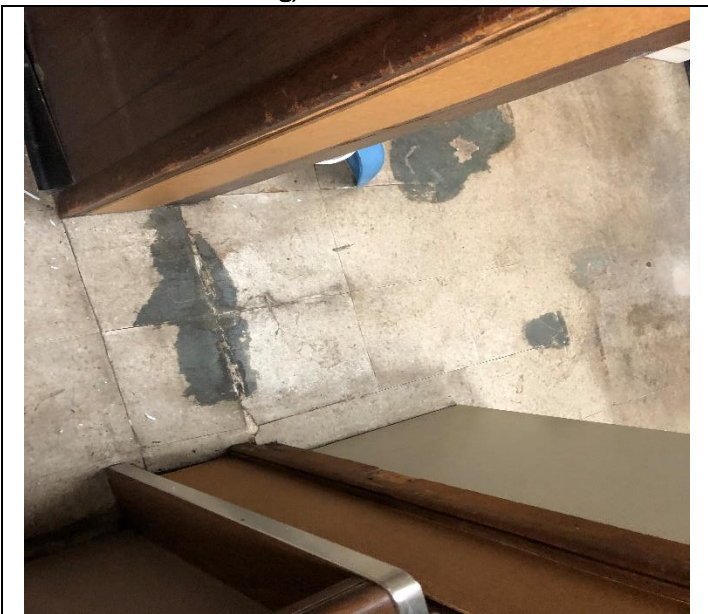
21. 3136-3146 US 1 - Black Mastic (Behind Office Wood Paneling): HSA 51.
