ASBESTOS SURVEY REPORT

**City of Canton
123 Fawcett Court NW, Canton, Ohio 44708**

Parcel Number: 214870

Subject: *Asbestos Survey Report for the Property Located at 123 Fawcett Ct. NW, Canton, Stark, County, Ohio 44708.*

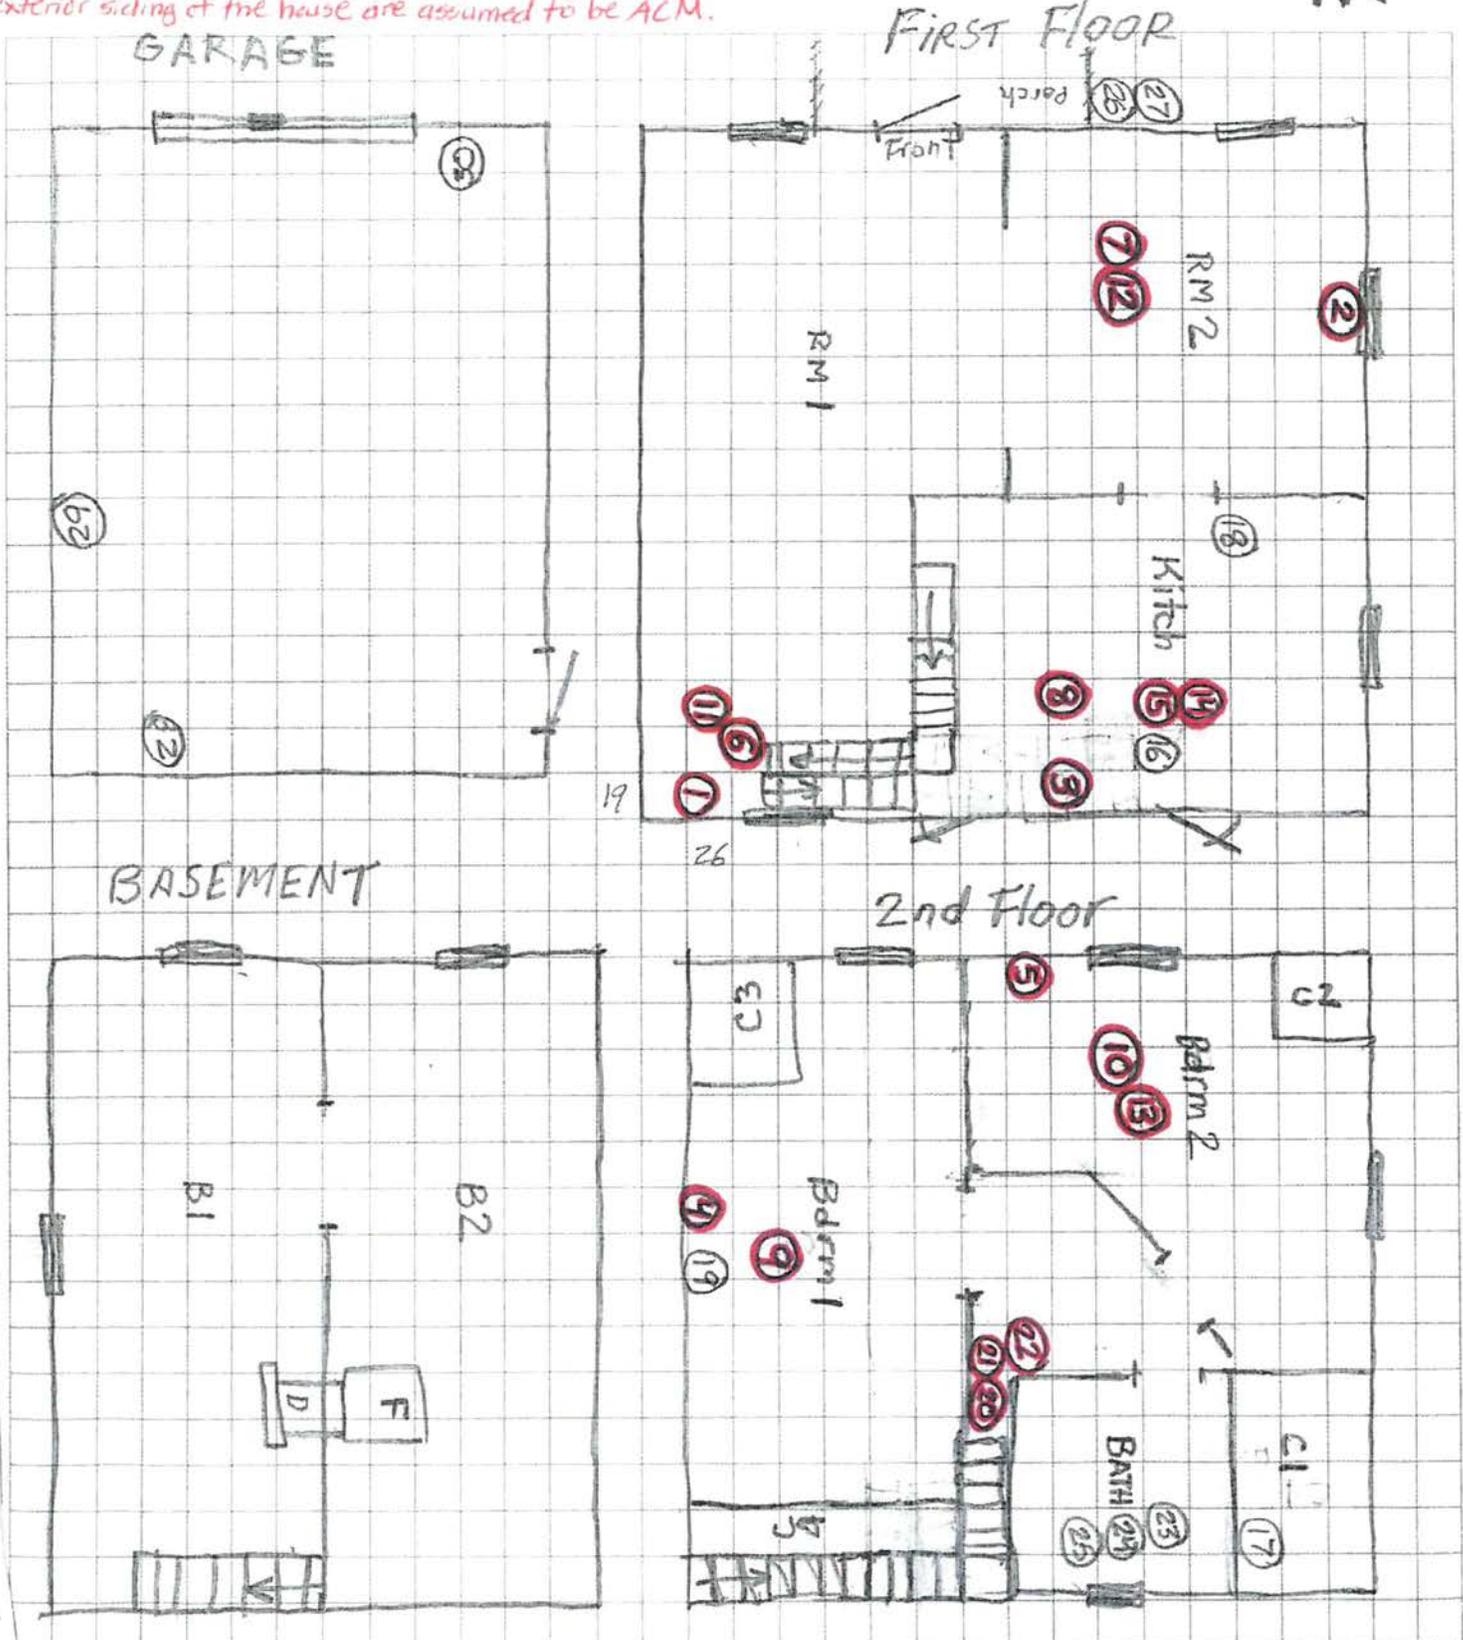
**ASBESTOS BULK SAMPLING INFORMATION LOG AND PROPERTY
FIGURE/SKETCH**

Red text is friable or may become friable RACM and must be abated before demolition of the structure.

① ACM Headquarters: 5070 Stow Road, Stow, Ohio 44224
 (800) 940-4025
Friable duct wrap in the basement and transite paneling on the exterior siding of the house are assumed to be ACM.
