# ***ASBESTOS SURVEY REPORT***

**City of Canton  
133 Fawcett Court NW, Canton, Ohio 44708**

**April 2020**

**Subject: Asbestos Survey Report for the Property Located at 133 Fawcett Ct. NW, Canton, Stark, County, Ohio 44708.**

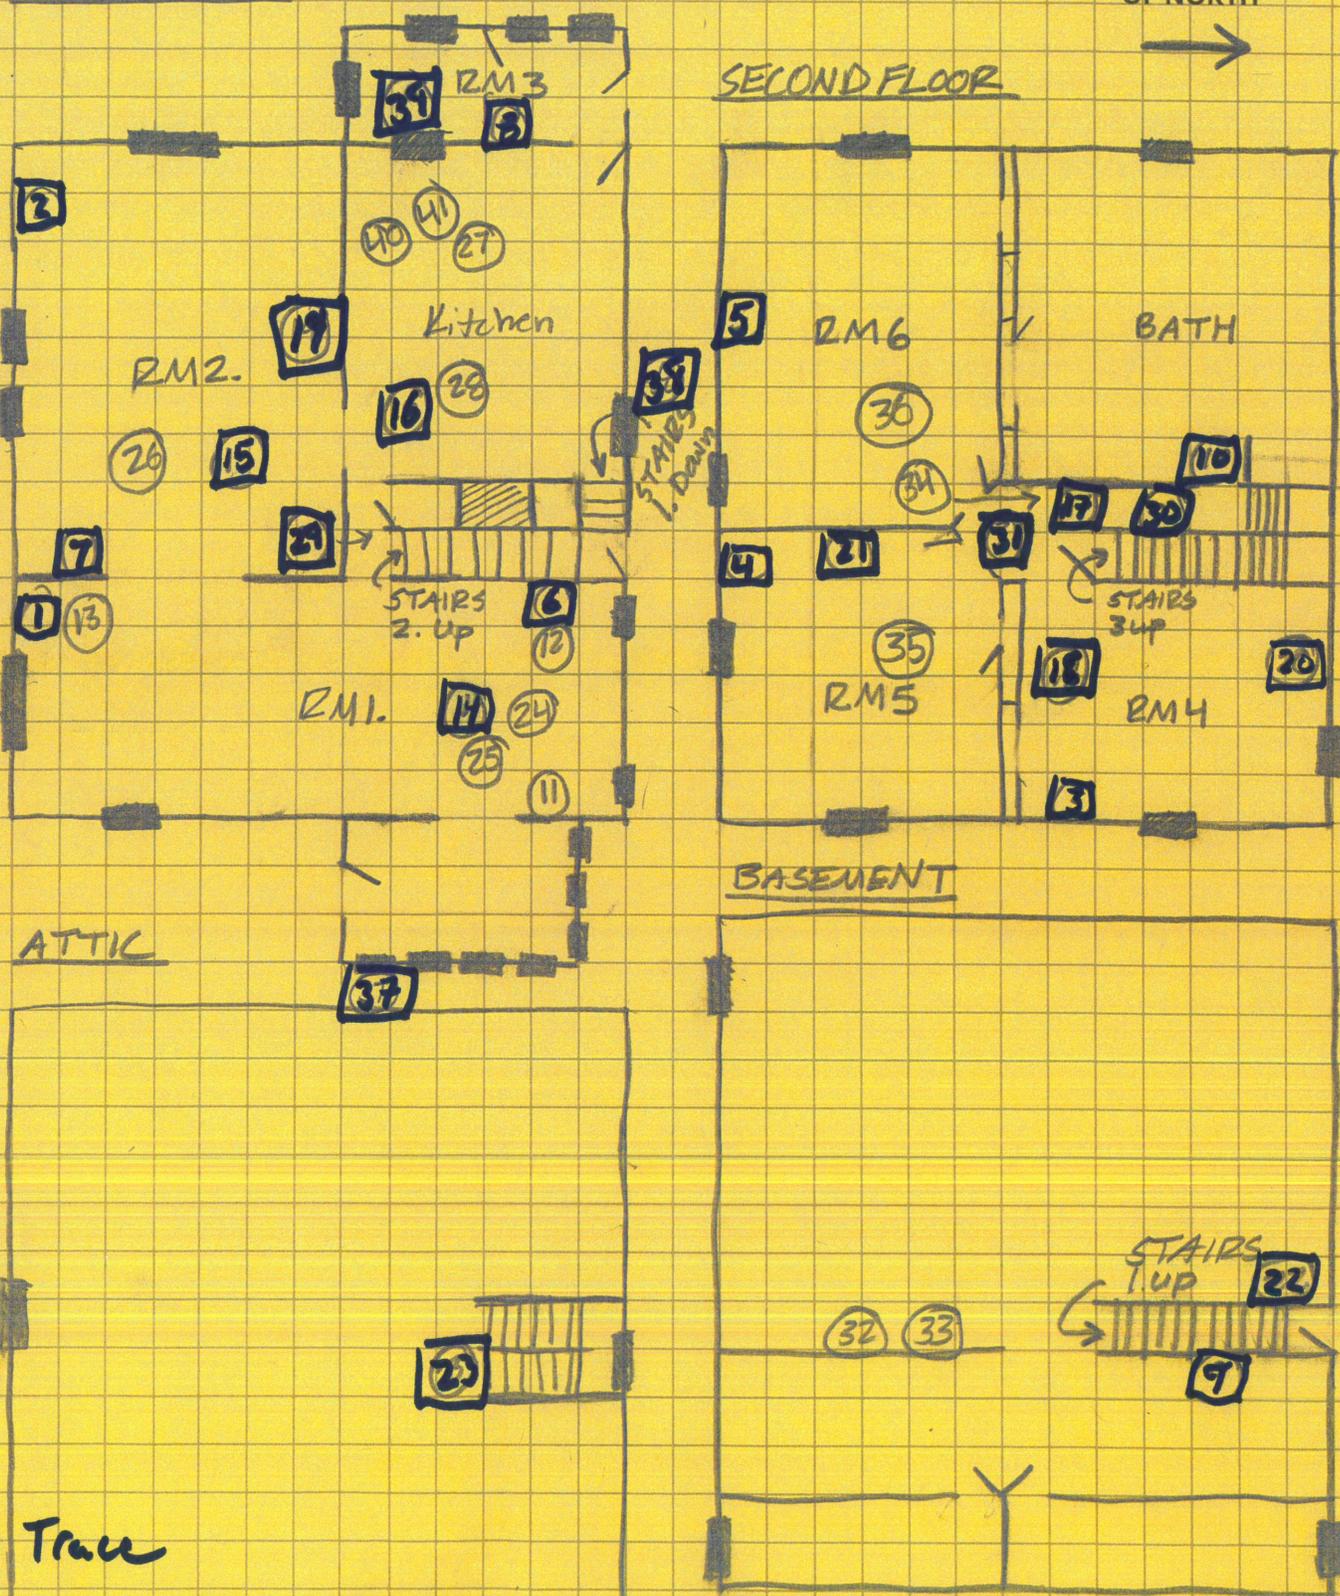
□ Trace

*Friable Dust wrap located on the duct runs to all levels is assumed to be ACM*

Red text is friable or may become friable RACM and must be abated before demolition of the structure.
