ASBESTOS SURVEY REPORT

**City of Canton
121 Fawcett Court NW, Canton, Ohio 44708**

April 2020

Subject: Asbestos Survey Report for the Property Located at 121 Fawcett Ct. NW, Canton, Stark, County, Ohio 44708.

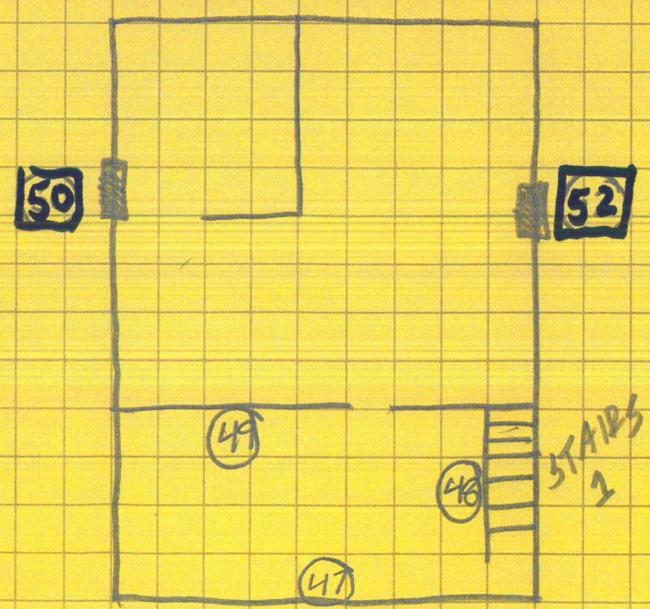
BASEMENT

9 Trace
1 ACM

Frangible dust wrap located on one boot. Located in basement is assumed to be ACM
