ASBESTOS SURVEY REPORT

**City of Canton
130 Fawcett Court NW, Canton, Ohio 44708**

April 2020

Subject: *Asbestos Survey Report for the Property Located at 130 Fawcett Ct. NW, Canton, Stark, County, Ohio 44708.*

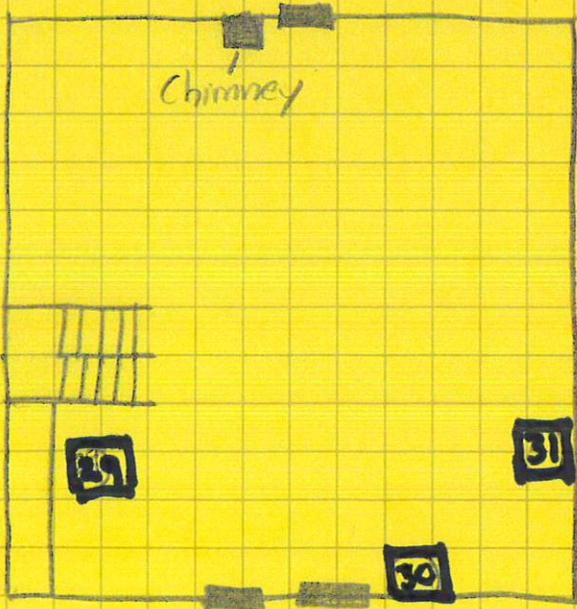
ATTIC

- Friable material containing trace amounts of asbestos (1% or less) was identified via sampling as tan drywall with joint compound located in the attic contains less than 1% Chrysotile. *It should be noted that the joint compound in that attic was found to be greater than 1% asbestos by PLM analysis. The drywall and joint compound were point counted with the point counting results verifying the joint compound greater than 1% asbestos. The drywall and joint compound were composited; however, and the asbestos content was less than 1%. The U.S. EPA and Ohio EPA does not consider this to be an asbestos-containing material (or ACM). As such, the drywall/joint compound system does not need abated prior to demolition. However, OSHA does consider this an asbestos-containing material. Therefore, OSHA worker protection must be provided during demolition. The drywall/joint compound system also should be disposed of at an approved asbestos C&D or municipal landfill.*
