ASBESTOS SURVEY REPORT

**City of Canton
129 Fawcett Court NW, Canton, Ohio 44708**

April 2020

Subject: Asbestos Survey Report for the Property Located at 129 Fawcett Ct. NW, Canton, Stark, County, Ohio 44708.

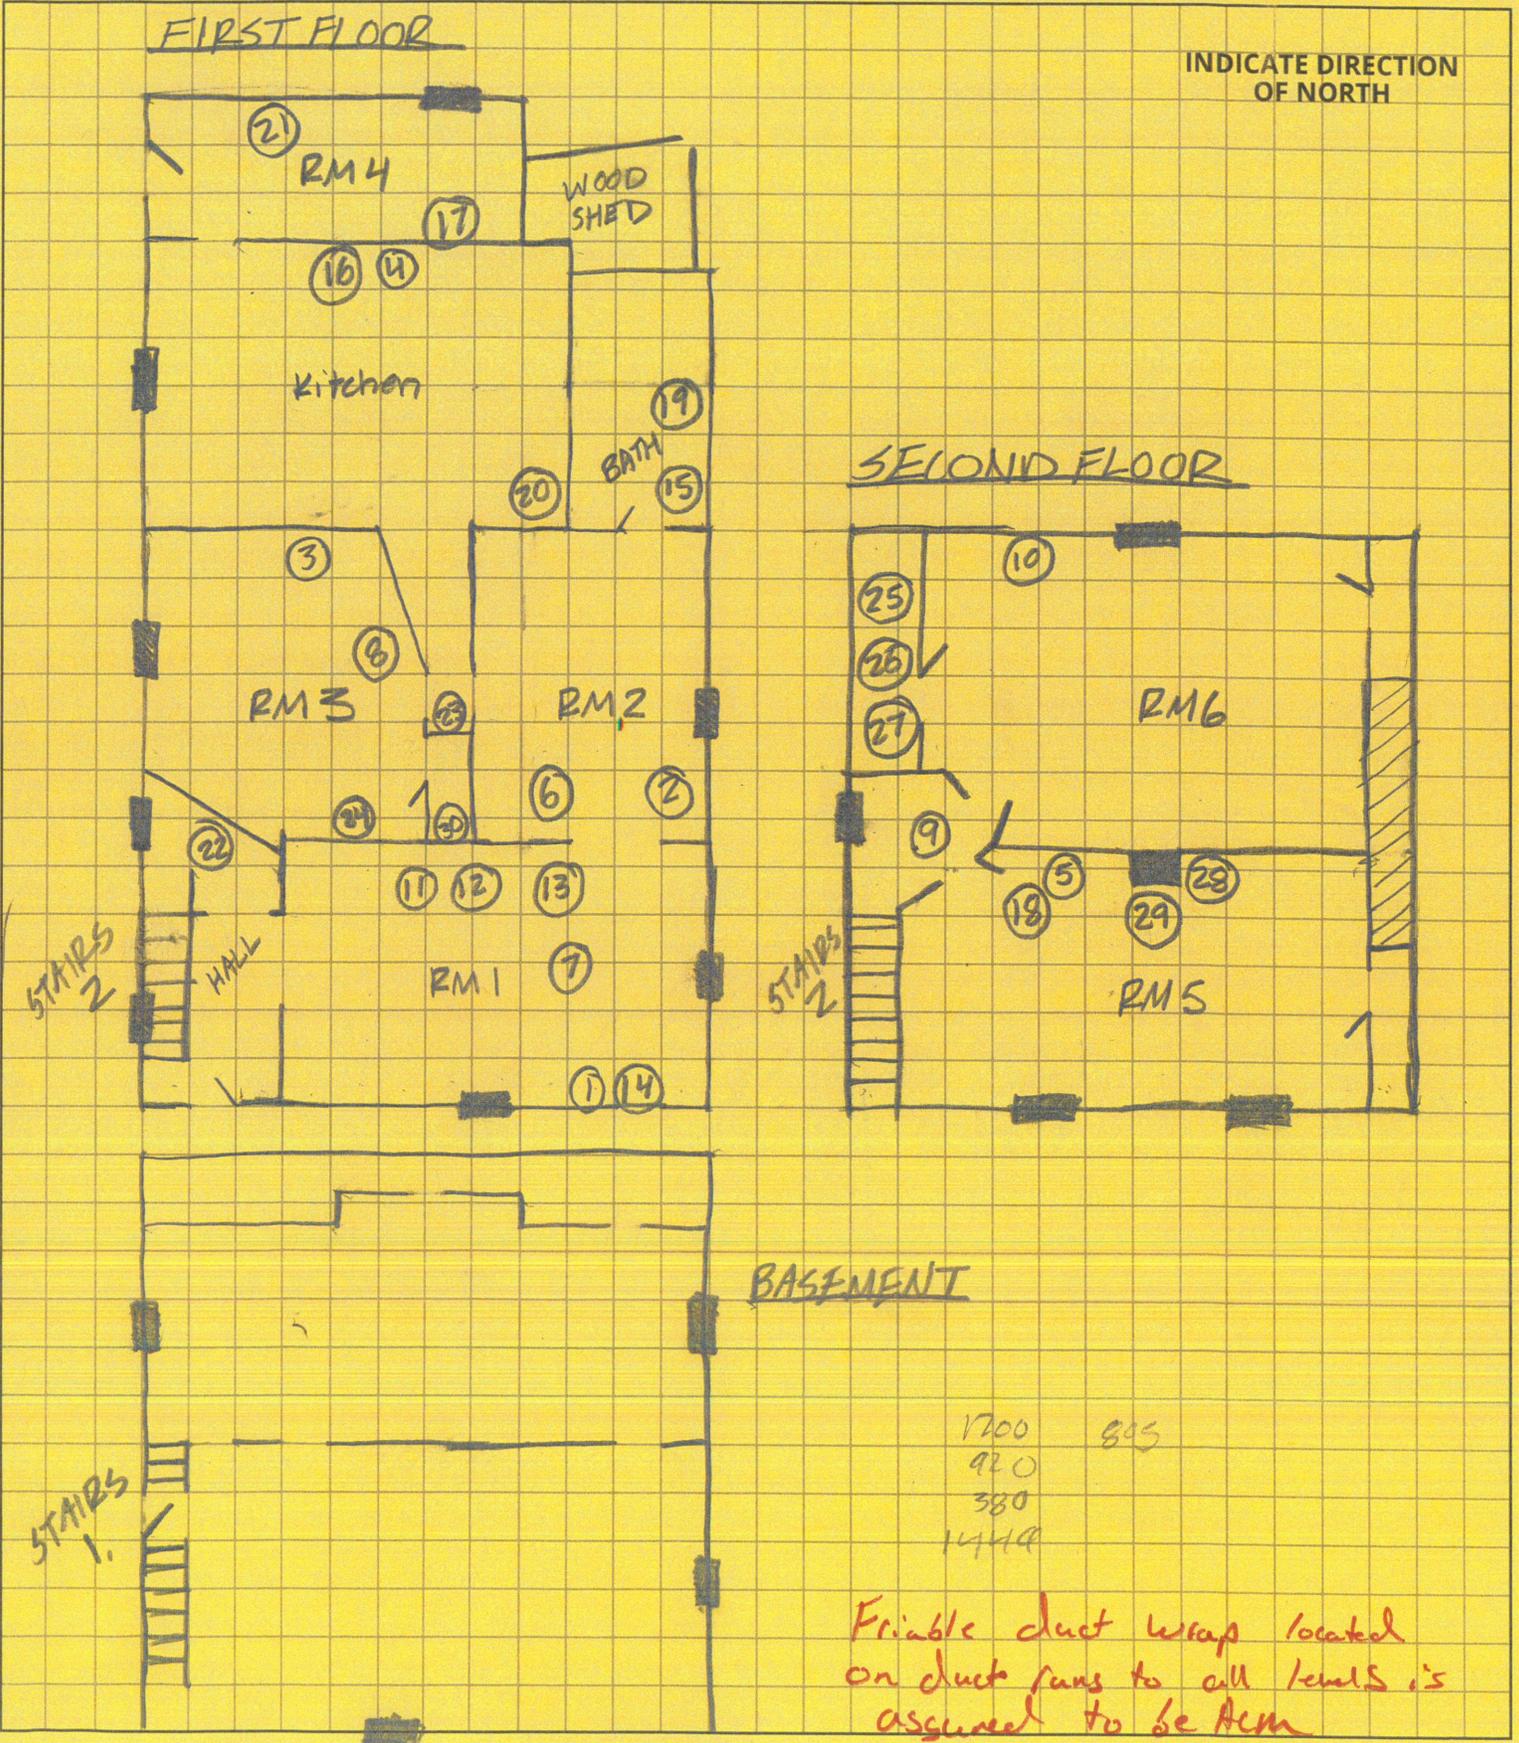
**ASBESTOS BULK SAMPLING INFORMATION LOG AND PROPERTY
FIGURE/SKETCH**

Sample #	Asbestos Content	Material Description	Location	Condition	Friable (Y/N)	Approximate Quantity
1	None	Smooth Plaster on Lath Walls	Rooms 1, 2, 3, 4, 5, 6, Stairs 1, 2, Kitchen	Good	Yes	Approx. 3,950 sf
2		Smooth Plaster on Lath Walls	Rooms 1, 2, 3, 4, 5, 6, Stairs 1, 2, Kitchen	Good	Yes	
3		Smooth Plaster on Lath Walls	Rooms 1, 2, 3, 4, 5, 6, Stairs 1, 2, Kitchen	Good	Yes	
4		Smooth Plaster on Lath Walls	Rooms 1, 2, 3, 4, 5, 6, Stairs 1, 2, Kitchen	Good	Yes	
5		Smooth Plaster on Lath Walls	Rooms 1, 2, 3, 4, 5, 6, Stairs 1, 2, Kitchen	Good	Yes	
6	None	Smooth Plaster on Lath Ceilings	Rooms 1, 2, 3, 4, 5, 6, Stairs 1, 2, Kitchen	Good	Yes	Approx. 1,430 sf
7		Smooth Plaster on Lath Ceilings	Rooms 1, 2, 3, 4, 5, 6, Stairs 1, 2, Kitchen	Good	Yes	
8		Smooth Plaster on Lath Ceilings	Rooms 1, 2, 3, 4, 5, 6, Stairs 1, 2, Kitchen	Good	Yes	
9		Smooth Plaster on Lath Ceilings	Rooms 1, 2, 3, 4, 5, 6, Stairs 1, 2, Kitchen	Good	Yes

10		Smooth Plaster on Lath Ceilings	Rooms 1, 2, 3, 4, 5, 6, Stairs 1, 2, Kitchen	Good	Yes	
11	None	Heavy Stipple Textured Surfacing Material on Ceilings	Room 1	Good	Yes	Approx. 300 sf
12		Heavy Stipple Textured Surfacing Material on Ceilings	Room 1	Good	Yes	
13		Heavy Stipple Textured Surfacing Material on Ceilings	Room 1	Good	Yes	
14	None	Stipple Textured Surfacing Material on Walls and Ceilings	Rooms 2, 3, 4, 5, 6, Stairs 2, Bathroom, Kitchen	Good	Yes	Approx. 3,800 sf
15		Stipple Textured Surfacing Material on Walls and Ceilings	Rooms 2, 3, 4, 5, 6, Stairs 2, Bathroom, Kitchen	Good	Yes	
16		Stipple Textured Surfacing Material on Walls and Ceilings	Rooms 2, 3, 4, 5, 6, Stairs 2, Bathroom, Kitchen	Good	Yes	
17		Stipple Textured Surfacing Material on Walls and Ceilings	Rooms 2, 3, 4, 5, 6, Stairs 2, Bathroom, Kitchen	Good	Yes	
18		Stipple Textured Surfacing Material on Walls and Ceilings	Rooms 2, 3, 4, 5, 6, Stairs 2, Bathroom, Kitchen	Good	Yes

19	None	Drywall System with Joint Compound	Room 4, Bathroom, Kitchen	Good	Yes	Approx. 675 sf
20		Drywall System with Joint Compound	Room 4, Bathroom, Kitchen	Good	Yes	
21		Drywall System with Joint Compound	Room 4, Bathroom, Kitchen	Good	Yes	
22	None	Dripping Textured Surfacing Material	Room 3 and Hall	Good	Yes	Approx. 425 sf
23		Dripping Textured Surfacing Material	Room 3 and Hall	Good	Yes	
24		Dripping Textured Surfacing Material	Room 3 and Hall	Good	Yes	
25	None	Thin Drywall	Room 6 Closet	Good	Yes	Approx. 100 sf
26		Thin Drywall	Room 6 Closet	Good	Yes	
27		Thin Drywall	Room 6 Closet	Good	Yes	
28	None	Plaster on Brick	Room 3 Closet, Room 5	Good	Yes	Approx. 55 sf
29		Plaster on Brick	Room 3 Closet, Room 5	Good	Yes	
30		Plaster on Brick	Room 3 Closet, Room 5	Good	Yes	
31	None	Asphalt Shingle Siding	Exterior Siding	Good	No	Approx. 2,325 sf
32		Asphalt Shingle Siding	Exterior Siding	Good	No	
	Assumed	Vinyl Floor Sheet with Mastic	Bathroom, Kitchen and Room 4	Good	No	Approx. 675 sf

Assumed	12"x12" White Floor Tile with Mastic	Kitchen	Good	No	Approx. 120 sf
	Assumed	12"x12" Beige Floor Tile with Mastic	Room 4	Good	No	Approx. 75 sf
	Assumed	Stone Floor Sheet with Mastic	Entry	Good	No	Approx. 9 sf
	Assumed	Duct Wrap	Duct Runs Only	Good	Yes	Approx. 240 sf
	Assumed	Asphalt Shingles	Exterior Roof House and Shed	Good	No	Approx. 1,400 sf

Red text is friable or may become friable RACM and must be abated before demolition of the structure.
