Nighthawk **Imaging Services**

1069 Thunderbolt Dr
Report

RE: Thunderbolt Career & Tech - 1069 Thunderbolt Dr. Walterboro, SC 29488

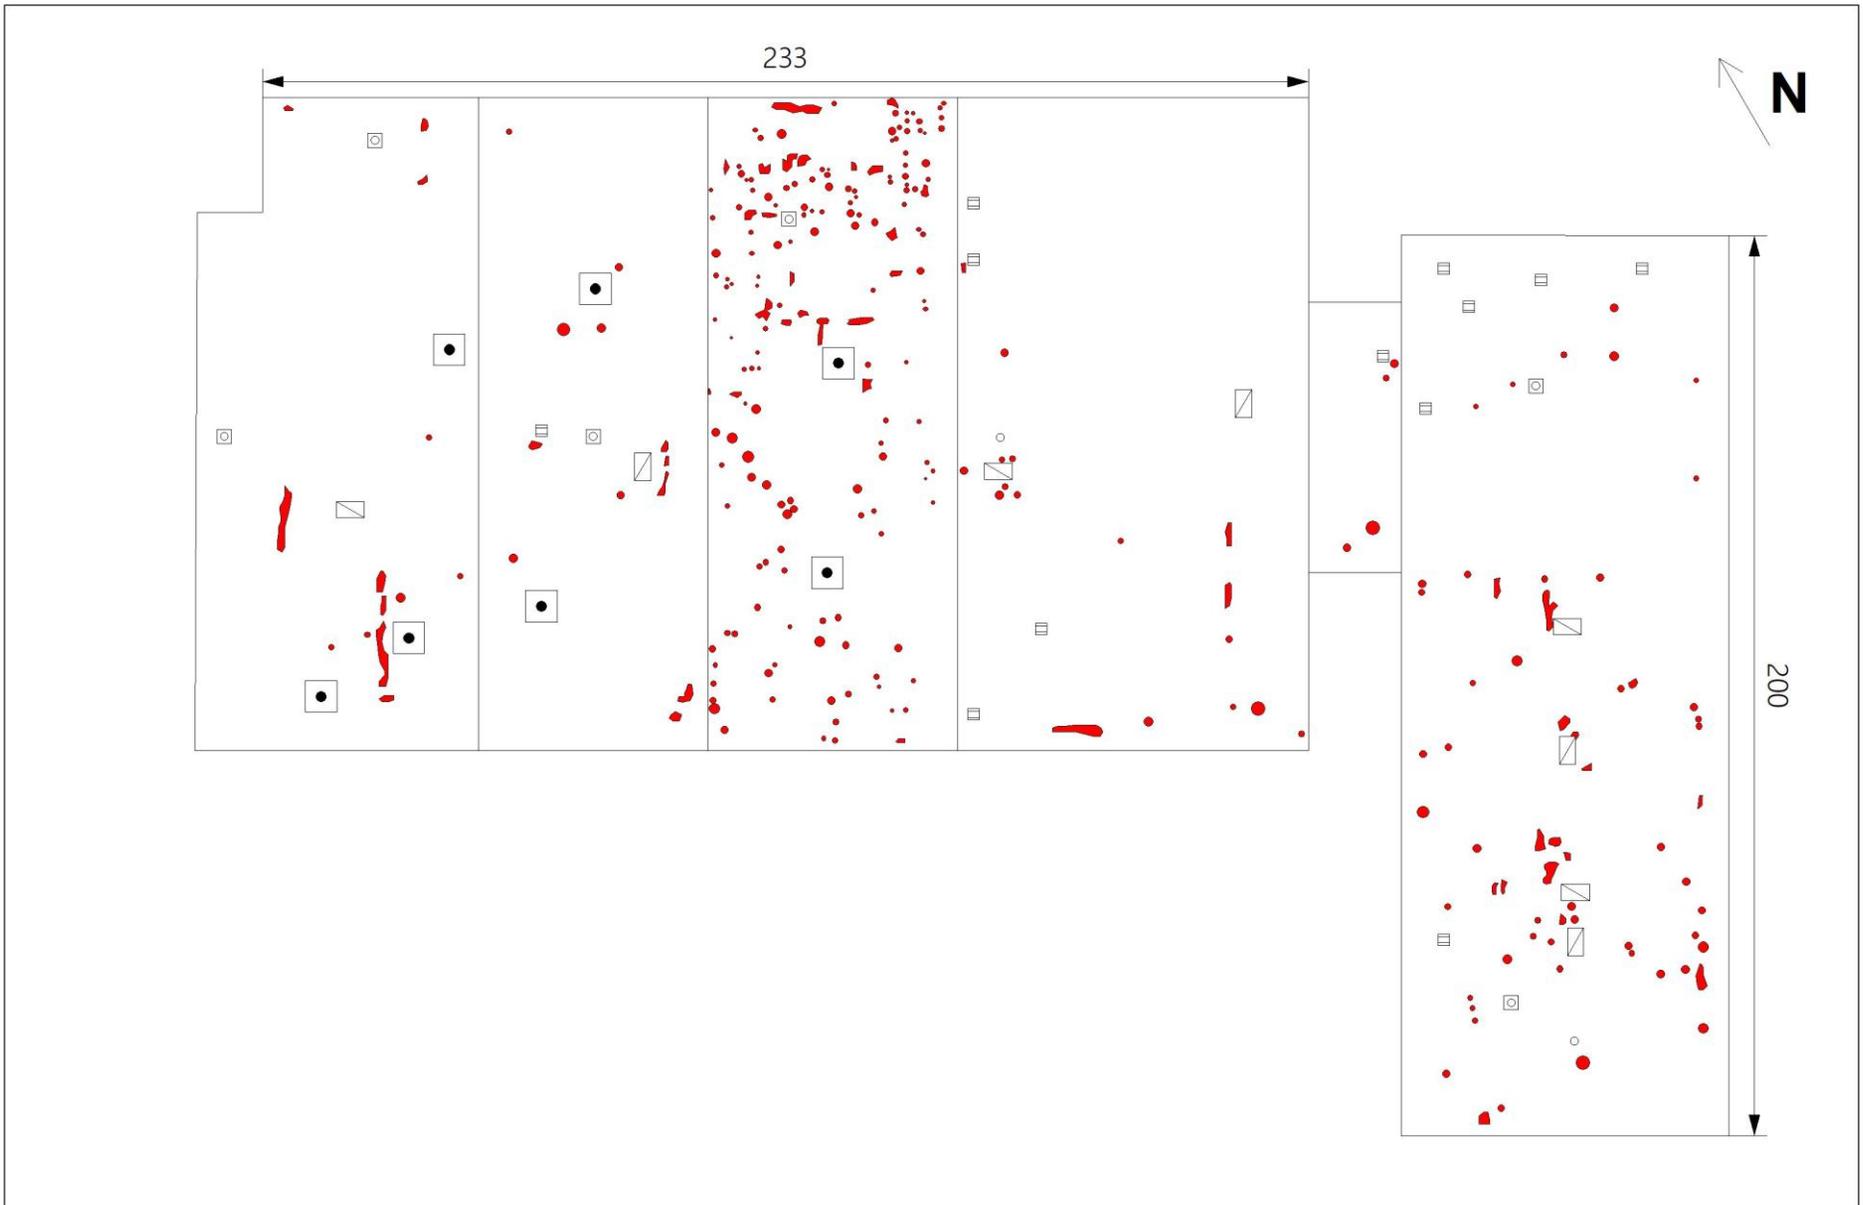
Wet: 659 Sq. Ft. - 276 Areas

- Roofing contractors and/or consultants need to verify the type, depth of insulation, and the total square footage of roof insulation needing to be replaced.
