## **Asbestos & Lead Based Paint Assessment**

City of Spartanburg  
417 Ammons Road  
Spartanburg, South Carolina 29306

Project Number: 0119-09

December 20, 2019

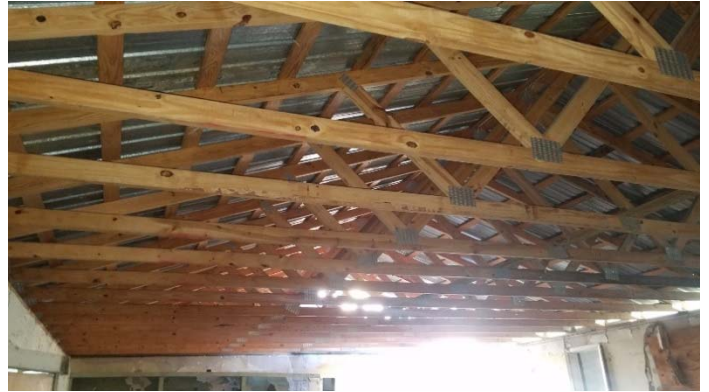
Photo 2 – New metal and wood roof system.

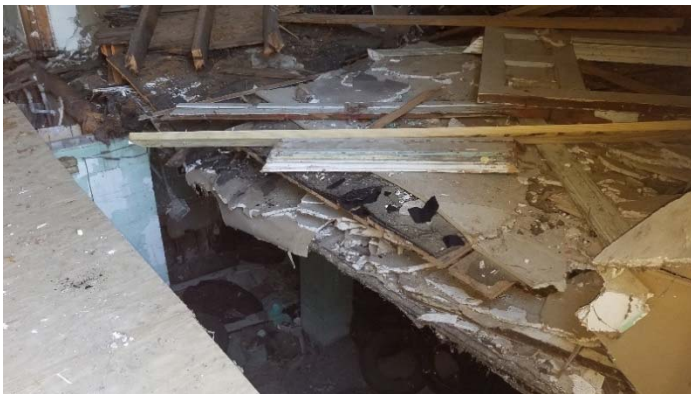
Photo 3 – Collapsed roof and ceiling systems.

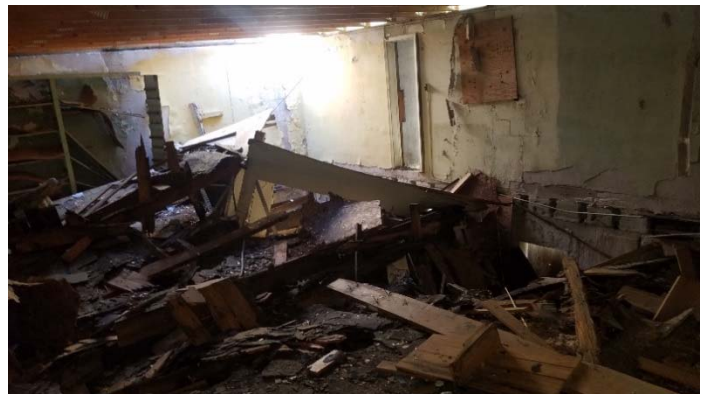
Photo 4 – Collapsed roof and ceiling systems.

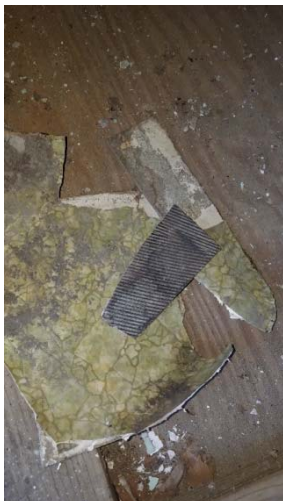
- Approximately 2,500 square feet of green stone pattern roll vinyl flooring and associated brown mastic.
- Approximately 2,500 square feet of tan 9" x 9" floor tile and associated black mastic.

Photo 5 – Green stone pattern flooring.

1. Abate the asbestos containing materials in the structure prior to renovation or demolition.
2. Follow applicable asbestos regulations during renovation or demolition of the structure. You should be aware that stringent requirements are imposed upon anyone renovating or demolishing a structure in which ACM will be disturbed. This work must be performed in accordance with OSHA asbestos regulations, 29 CFR 1910 & 1926, and NESHAP asbestos regulations 40 CFR 61, subpart M. South Carolina regulations require the accreditation of personnel who work in the asbestos field and notification and permitting fees for asbestos removal projects. There is a 10 working day notification period required prior to abatement of asbestos in a facility. Failure to take proper precautions and actions to protect human health and the environment can result in penalties, danger to personnel, and construction delays.

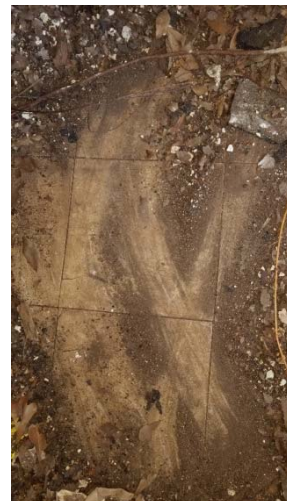
Photo 6 – Tan 9" x 9" floor tile.

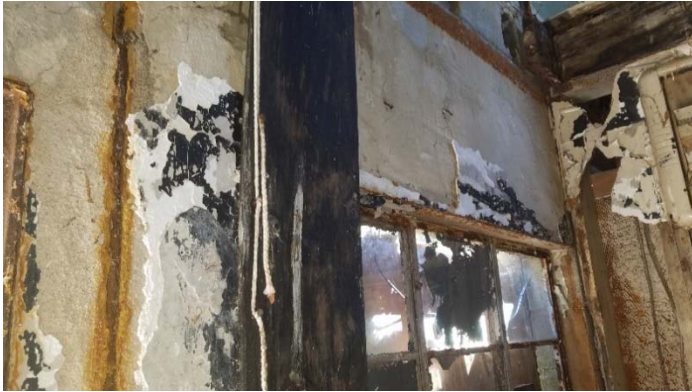
Photo 7 – Plaster over dry wall.

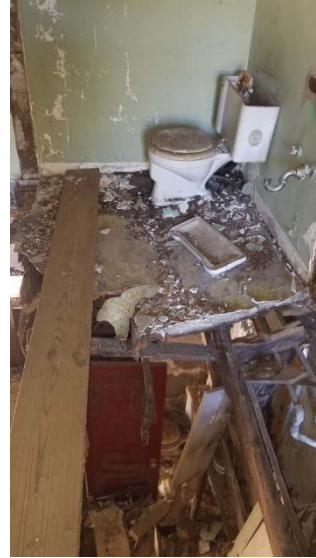
Photo 8 – 1st floor bathroom flooring.

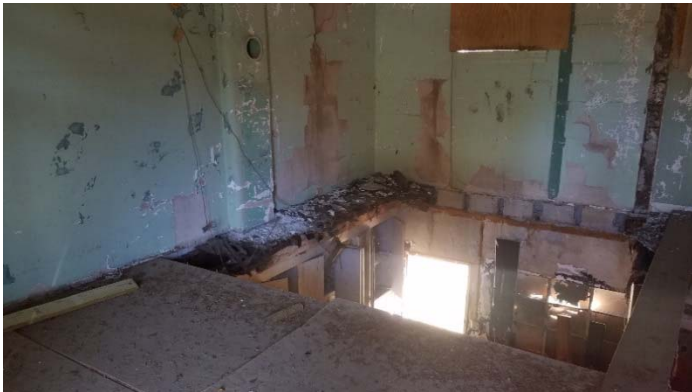
Photo 9 – 1<sup>st</sup> floor plaster over drywall.

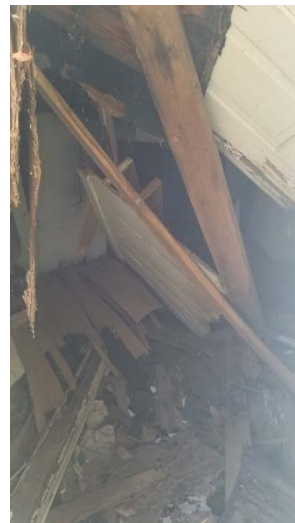
Photo 10 – Basement collapsed ceiling.
