# Addendum 1

Engineering Design Services – Canton Water Department Facilities – TAG 587A & TAG 587B

**Section 3**  
Existing Conditions

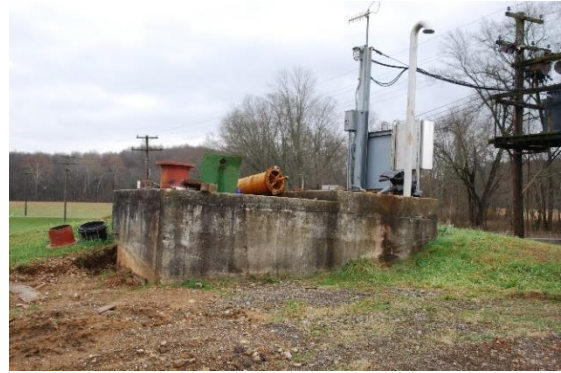
**Figure 3.2 Well #1 Valve Vault**

Well #1 through Well #6 have an 8' x 12' x 8' high concrete valve vault houses the piping to the pump connection, meter, and the pump discharge valve. Currently, the well base plate is bolted to the casing flange that is at the top of the valve vault, elevating the pump motor approximately 7' above grade. The ground surrounding the well head is sloped up to the pump, making servicing and pulling the pump and motor difficult due to the sloped grade. Research shows that the pumps are 7' above the 100-year floodplain and can be lowered by 4' while maintaining a 3-foot all equipment a minimum of 3-feet above flood level after improvements are complete.

The valve vault shown in **Figure 3.2** will be demolished, reducing the stresses in the piping due to settlement. A new valve house should be constructed to house meter, controls, and electrical equipment. The discharge will be directed to either the original transmission main or proposed transmission mains. A pre-fab insulated metal building will be installed to house the meter and controls. Connections to the existing transmission main will be connected to the original main using a tapping sleeve and valve. The operator can re-direct the flow to either transmission main.

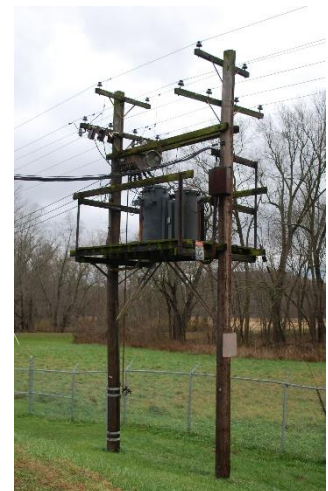
**Figure 3.3 Electrical Feed to Wells**

Overhead 4160-volt lines are strung between poles along the length of the wells. Transformers are mounted on overhead platforms as shown in **Figure 3.3** with feeds that drop down to the local power panel and control panel for the pumps. The overhead lines are high voltage, and not redundant. Any break along the path interrupts power to other transformers. A looped system similar to that installed at the Northeast WTP wellfield is recommended to replace the existing overhead lines. Two cables in buried duct bank should be provided so

if a feeder is cut accidentally or power is lost during a storm a redundant power supply to each well pump. New transformers located indoors in the new well house to provide 480-volt power to the pump and controls is recommended.

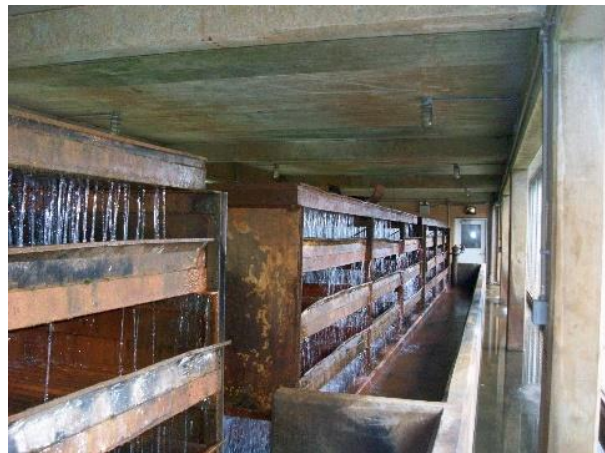
**Figure 3.5 Aerator Trays**

Both aerators were evaluated to determine their ability to handle the peak hourly pumped flows from the wells. The old trays shown in **Figure 3.5** were fabricated for the project and are constructed of aluminum. It was determined that the frame and trays are corroded and needed to be replaced. The holes in the original design restricted flow and caused the trays to back up and overflow. The holes in the trays need to be properly sized with the new unit. Several manufacturers offer stand-alone cascade aerator or packed towers, but not could be used to retrofit the existing units and were not considered.

The most troublesome problem with the aerator tray operation is the buildup of sediment in the trays. Several suggestions included the use of vibratory shaker mechanism to attached to trays to dislodge the scale. Currently, flow to the aerator is shut off, which has allowed the scale to dry, so it can be scraped off. Sediment that passes through the openings collects in the reaction basins and drains to backwash junction chamber so that it can be flushed to the lagoons, where it would settle out and be removed.

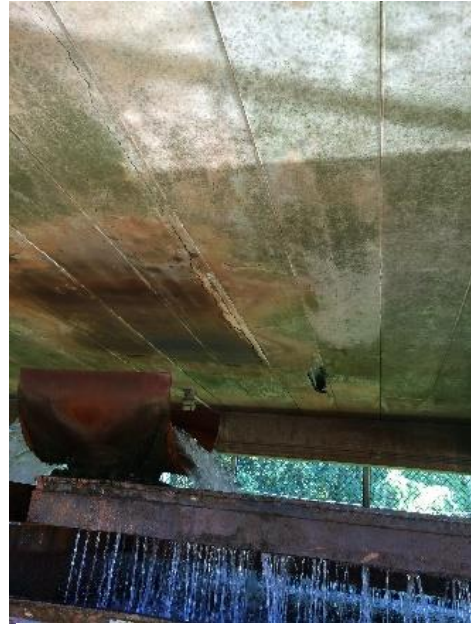
**Figure 3.6 Aerator Roof**

The precast concrete planks roof shown in **Figure 3.6** is in the original West Aerator Building is spalled from the moisture and outdoor freeze-thaw of the planks, and rebar is exposed. Various products used to patch the concrete were not suited for outdoor conditions and are expected to delaminate after several years of service. Existing concrete roof beams are in good condition, so it was determined that removal and replacement of the roof deck is the most cost-effective means to restore the structural integrity of the roof. A chemical additive should be specified for the concrete mix, and a spray on moisture sealant should be applied when construction is complete.

Moisture and water collection behind the masonry face brick is apparent below the waterline of the clearwells of the original west aerator, but not the newer east unit. Moisture appears to be due to condensation buildup in the air space. During construction, each aerator should be taken out of service to determine if any cracks in walls are allowing water to seep into the wall cavity. The entire brick facing of the concrete structure should be cleaned of moss and grime, and resealed. New weep holes need to be added around the base of all walls around the perimeter of the building. During design, the flashing for the roof, openings, and masonry-faced concrete wall of the storage should be evaluated to determine the best method to eliminate the problems and correct any defects.

During the 2007 improvements, the roof of the new aerator was not replaced. The replacement of roof planks and installation of new roof drains requires both aerator roofs to be replaced with a single-ply roofing system. There is currently no means of accessing the roof, so a new roof hatch and ladder should be installed to create a roof scuttle instead of relying on a crane or ladder to access and inspect the roof. All new handrail for the stairwell should be provided.

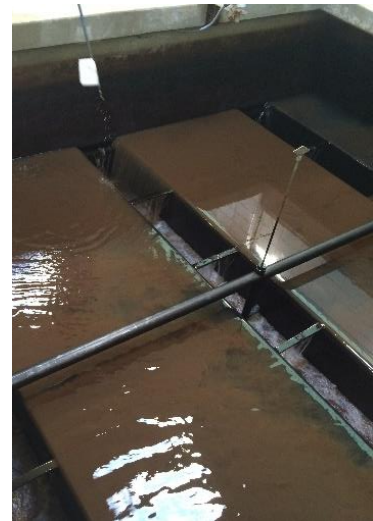
**Figure 3.7 Anthracite Filters**

While observing the backwash operations when the new holding lagoons were being put into service, a concern was raised regarding the effectiveness of the existing backwash operations. After three successive days of backwashing the dual-cell filters, samples were collected on the fourth day. Influent waters were still very turbid with solids in spite of the intensive backwashing schedule. This indicated possible plugging of the filter underdrains with scale and deposits.

Anthracite filter media is being lost over time and is periodically replaced. The current filter design allows 24" between the bottom of the trough and the filter media. Ten States Standards recommends allowing for a 50% bed expansion to prevent washout of filter media. A review of the current clearance is 21" or 40% bed expansion when using 30" of media as shown in **Exhibit 3-6**. The only way to increase the clearance is to either raise the trough to provide more clearance since the filter bottom is fixed by the depth of the filter box, or by reducing the media depth to less than 30" is not recommended.

The recommendations include adding 36" isolation valves to the transfer pipes for improving access to the clearwell so that a portion can be taken out of service for cleaning. Although 60-hour run times between backwashes is achievable, the existing media needs to be removed to expose the filter block to clean and add new media.

Improvements to the backwash system, improved metering, and new valves and operators will improve control to minimize carryover of filter media. More frequent monitoring of filter bed depth and filter grain particle size distribution is recommended to replace media before fines are created through repetitive backwashing that leads to particle size reduction and medial loss. Instrumentation is available to monitor the filter bed expansion and a pilot test to determine its effectiveness in optimizing backwash rates versus expansion may help minimize the loss of filter media.

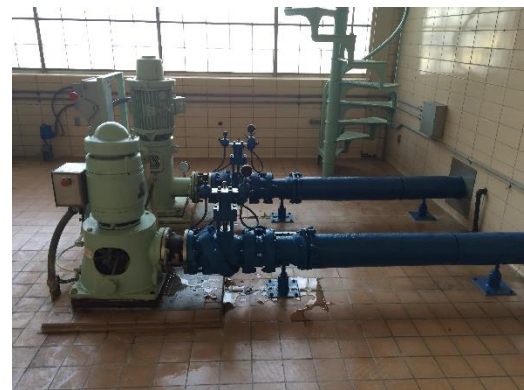
**Figure 3.10 Backwash Reservoir Fill Pumps**

The total backwash volume to clean 2 filter cells is 110,000 gallons when F-T-W is implemented. The backwash reservoir is completely drained after backwashing both cells of a single filter. The current 350 gpm and 700 gpm transfer pumps shown in **Figure 3.10** refill the reservoir in approximately 5.25 hours and 2.6 hours respectively. A new 4,500 gpm backwash pump that draws from the clearwell is needed to provide additional backwash capabilities and flexibility for when and how long each filter is backwashed. The existing backwash makeup water reservoir should be maintained as a backup to a new pump, and both transfer pumps should be refurbished.

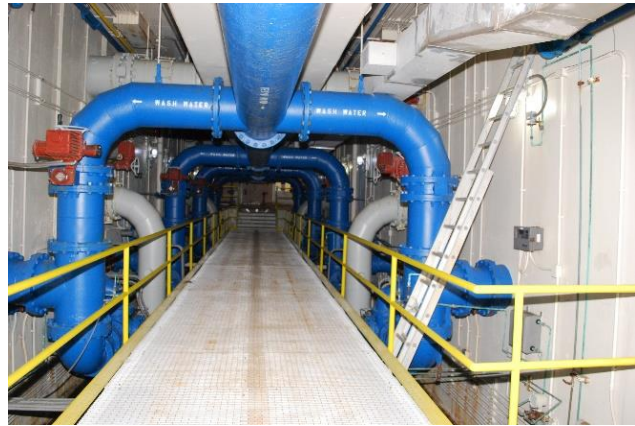
**Figure 3.11 Filter Pipe Gallery**

Several areas of the 24” steel backwash header is corroded and needs to be removed and replaced. All backwash piping should be insulated to minimize condensation in the pipe gallery. The existing Kathabar dehumidification system is costly to operate and does not dehumidify the pipe galleries using the amount of air being circulated. A new desiccant dryer system is proposed, and by installing

All process valves in the filter gallery shown **Figure 3.11** and throughout the plant should be replaced. A sampling of the larger 24", 30", and 36" butterfly valves that were installed in the clearwells during the 1995 upgrade are not frequently used. These valves should be inspected during construction to see if they can be reused or if the seats are worn and need to be replaced. Motor operators and gear-operated manual valves should be replaced throughout the plant. Filter influent, effluent, drain, surface wash, and Filter-to-Waste valves that are critical to the backwashing and filter automation are frequently used and need replaced. In 2018, 6 influent valves and 12 washwater valves motor operators were replaced and should be reused with the new valves.

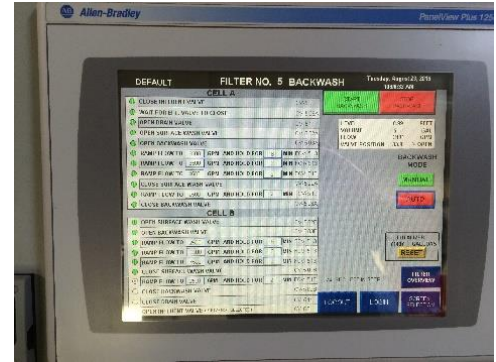
**Figure 3.12 Backwash Controls**

The existing backwash supply from the makeup reservoir enters the filter pipe gallery at the rear of the building. An existing flow tube venturi meter and modulating flow control valve were installed in 1995 and should be replaced with a new magnetic flow meter and modulating butterfly valve. This will become the standby backwash system if the proposed backwash pump is not operational. The level controls, headloss gauges, turbidity meters that were installed in 2007 upgrade should be

replaced and used as spare units. New mag meters should be installed to replace the flow tubes and venturi meters currently used to measure flows associated with the filter operation. All these should be replaced with new magnetic flow meters. A new 16" magnetic flow meter should be installed on the new main header of the backwash pump discharge for the new filter. The 20" flow tube meter used to meter flows from the Makeup Reservoir should be replaced with a new 16" magnetic flowmeter.

The backwash sequence shown in **Figure 3.12**, time intervals for steps, and rates should be reviewed and optimized once the filter blocks are cleaned, the new surface sweeps are installed, and the new backwash pump is installed and operational. Ten States Standards do allow for full depth anthracite filters to be operated at a reduced rate of 10 gpm/SF. This would result in reducing backwash water volumes being used and improve holding basin operation.

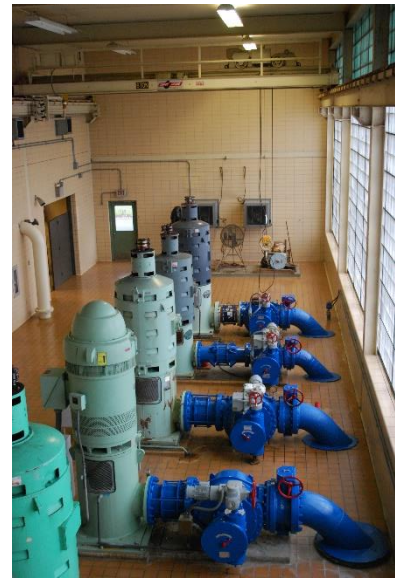
**Figure 3.14 High Service Pumps**

Pump curves and service records for the Peerless High Service pumps were reviewed with two local Peerless pump service providers, North Shore Pumps and Ohio Drilling Company. All five High service Pumps are in good condition. Pump 1 has been recently rebuilt, and Pump #4 was installed in 1997 with a 4,160- volt induction rather than the synchronous motors used on the original pumps. We recommend that Pumps 2, 3, 4, and 5 be rebuilt in a manner similar to Pump 1, including removing the pumps one at time to inspect, clean, and rebuild in the shop. Pump 4 has an induction motor but needs the motor base and head replaced with a heavy duty Schedule 80 discharge elbow similar to the one installed on Pump 1.

The existing synchronous motors need to be cleaned, inspected, and rewound. In Workshop #3, costs were compared to refurbish the motors or replace them with new induction motors. If the existing motors could be reused, there is a potential saving of \$100,000 per motor compared to replacing it. In addition, if the existing synchronous motors could be reused, the existing motor starters and 4,160-volt switchgear were found to be in good condition, then the motor controls could be cleaned, inspected, and reconditioned and the synchronous motors reused at a savings in excess of \$400,000. It was decided to contact Eaton and have them inspect and test the switchgear and recommend whether it could remain in service. Eaton’s service report is due by the end of March 2020. Therefore, it was decided that the CIP should proceed with assuming the motors could be reused, but new motor switchgear would be provided. If Eaton recommends that the 1995 switchgear is cost-effective to refurbish, the design would not replace motors or switchgear. Currently this CIP contains the cost to replace the switchgear, but this should be reevaluated during detailed design based on the findings included in Eaton’s report.

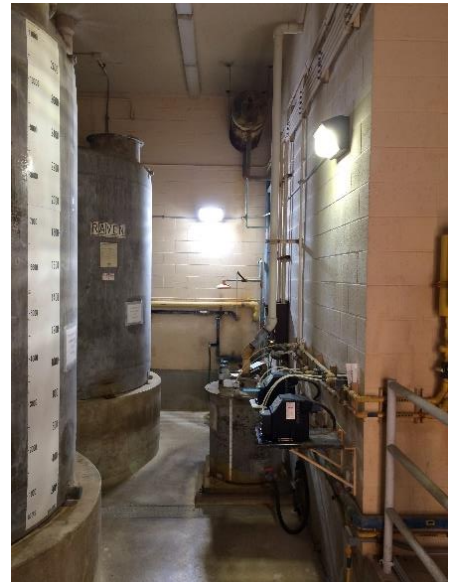
**Figure 3.16 Fluoride Room**

Due to the corrosive nature of hydrofluoric acid, all equipment, conduit, and supports are severely corroded and need to be replaced with proper materials to suit the corrosive environment. A plastic chemical-resistant transfer vertical wet pit pump is provided on the entry level to the building and used in case of a leak or spill during filling operations to pump out the below-grade containment sump. This pump should be removed and rebuilt with new bearings and seals.

In 2007, new concrete bases were constructed to elevate the tanks to flow by gravity to the day tank. New level controls were installed at that time; however, all process piping, heating and ventilation, plumbing lighting, and work equipment needs to be replaced. Currently, even the 316 stainless steel valves, switches, boxes, and motor disconnects are severely corroded and need to be replaced. The lighting and all electrical conduit and wiring are damaged and need to be replaced with gas tight plastic or CPVC lighting fixtures and conduit. The existing unit heater, safety shower, overhead safety shower water tempering tank, door, and hardware also need to be replaced due to the corrosive nature of the fluoride. Level transmitters dials and the glass entry window in the door are hazed by the corrosive fumes.

During Workshop #3, a plan was presented to construct a new wall at the main floor level of the room. Stairs lead down into the floor of the containment area to service the day tank and pumps. In the new plan, an operator room would be provided to house

the electrical equipment, pumps, and motor controls. All conduit in the new building would be CPVC, and all boxes, switches, and lighting would be designed for a corrosive environment and gas-tight LED lighting. Any metal components should be 316 SS with epoxy coating, since this appears to be the most durable finish for metals. New chemical piping would be installed. A new door with epoxy coating would be provided, and all new hardware mounted in the operator room. New PVC exhaust fans would be provided on the roof. A rooftop makeup air unit would be provided to provide a constant air supply to the room to mitigate the buildup of corrosive fumes.

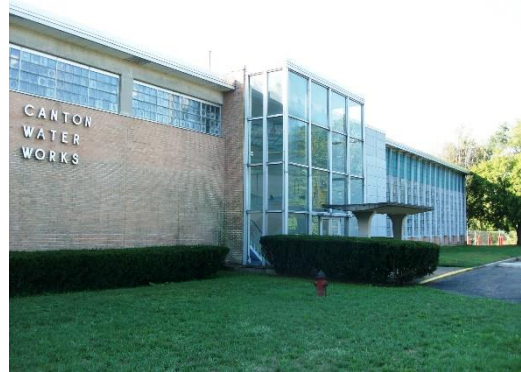
**Figure 3.19 Front of WTP Main Building**

High Service Pump Room. The front of the building faces north elevation, and the north wall of the High Service Pump Room is comprised of existing glass block windows mounted between aluminum mullions which create the 80' side x 20' high glass block system that extends from 4 feet above ground to the top of the building as shown in **Figure 3.19**. Several options were considered, including replacing the glass blocks window wall, installing translucent insulated window panels (Kalwall or equal), or a storefront window system using thermopane windows and new aluminum frames. Glass block windows were not considered due to experience with cracking and leakage and they are not energy efficient. Translucent panels were not recommended because of experience with discoloration over time and they cost approximately the same as an aluminum storefront system. Use of a storefront system is economical and window mullions can be used that will maintain a fresh and modern appearance. Clear or tinted glass samples were provided, and a final selection will be made during design.

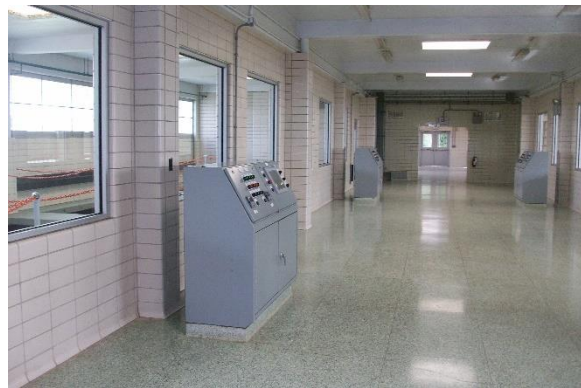
**Figure 3.21 2nd Floor Filter Gallery**

Windows and doors. The filters are isolated from the main Filter Gallery as shown in **Figure 3.21**. There is not spalling of paint on the ceilings, but the translucent windows are discolored and new energy efficient translucent windows and frames should be provided to replace all existing units. Since the original building was constructed in 1950 and the addition in 1995, the caulk and sealants used for the windows and doors should be tested to determine if they contain asbestos materials. If asbestos is detected, the materials will need to be properly removed and disposed of offsite in an approved landfill. The existing aluminum windows that enclose the filters are in good condition and should be cleaned and re-used. The doors to access the filters and the double doors at the two ends of the gallery should be replaced with new doors, frames, and hardware. A plan of the Filter Building is provided in **Exhibit 3-9**.

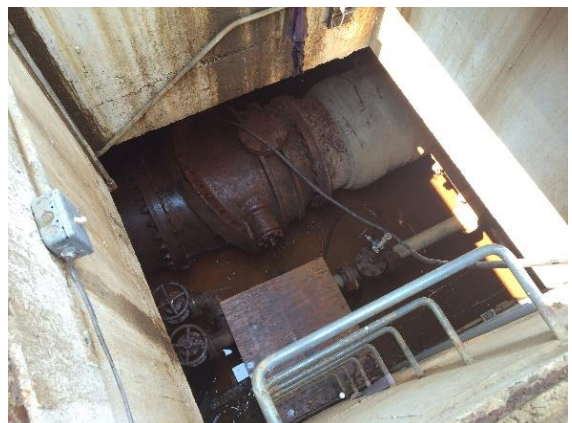
**Figure 3.28 Surge Tank Valve Vault**

Two 30-inch lines from each surge tank are connected to the 42" raw water transmission main at high points in the line. A concrete valve vault shown in **Figure 3.28** houses two 30" butterfly used to isolate the tank for inspection. Between the valve and the tank is a 30" diameter swing check valve that is normally closed, but it opens when the line pressure drops in the 42" transmission main. When flow stops, the water at the high point can flow in either direction causing column separation to occur. The vacuum created allows the check valves to open automatically and water from the surge tank to be introduced to the main. When the surge passes and normal conditions are restored, a 4-inch altitude valve is provided that allows the tank to be refilled to a predetermined level so that water is available in the Surge Tank for the next incident.

Water levels in the tank are monitored by the SCADA system, but there are no position switches to detect if a check valve opens nor a pressure transmitter in the valve vault. The check valves appear to leak, and the butterfly valves and operators are 50 years old and should be replaced. A new aluminum double-leaf access hatch should be installed to replace the original hatch. A small submersible sump pump should be installed in the valve vault to minimize submergence of the new magnetic flow meter, and alarms provided to warn of high-water levels.

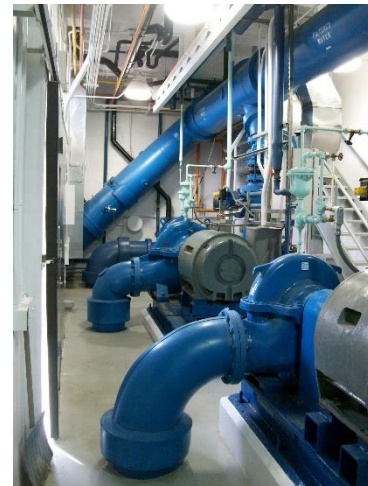
**Figure 3.29 Northwest WTP  
High Service Pump Room**

The ceiling, walls, and portions of the floor were sampled and found to contain lead in the underlying paint. Scaling along the stairway presents a health hazard and should be covered to protect against traffic brushing up against the loose paint. To remove the peeling paint, tarping of each pump, equipment, and electrical controls will be required to prevent dust from infiltrating motors and controls. It may be necessary to take the plant off-line to expedite the removal process. This scope of work is not included in this CIP budget since it will be addressed with the annual budgeting process. No platforms are needed, but the work is complicated by the amount of conduit and piping on the walls that cannot be removed and will have to be protected. An estimate of approximately \$50,000 should be allotted for the remediation work.
