October 5, 2017

SUBJECT: ASBESTOS SURVEY REPORT

530 S. EUCALYPTUS STREET A·C·T PROJECT NO. 18863

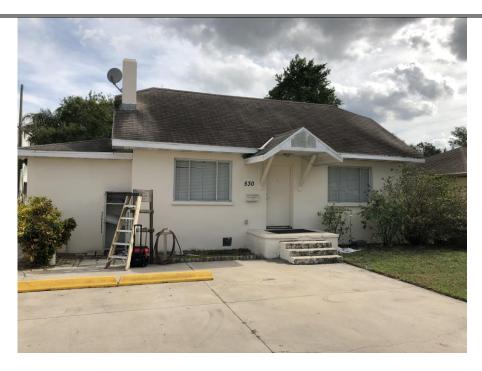
PHOTO # 1: VIEW OF 530 S. EUCALYPTUS STREET, SEBRING, FLORIDA.

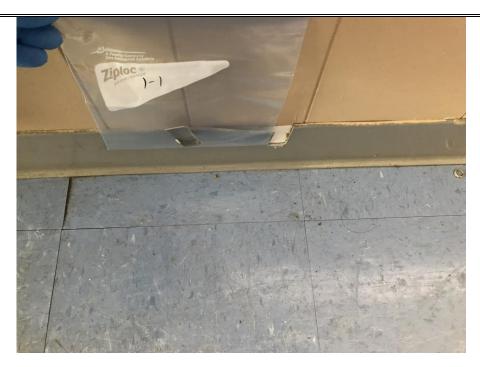
PHOTO # 2: VIEW OF SAMPLED COVE BASE AND MASTIC.

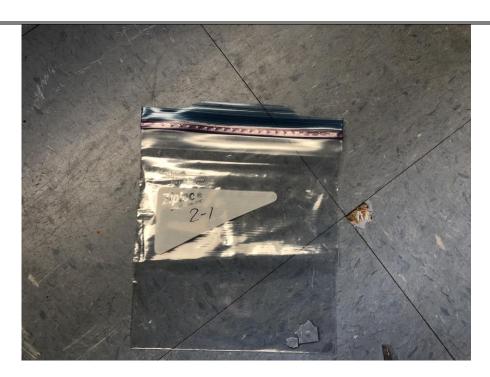
PHOTO # 3: VIEW OF SAMPLED FLOOR TILE AND MASTIC.

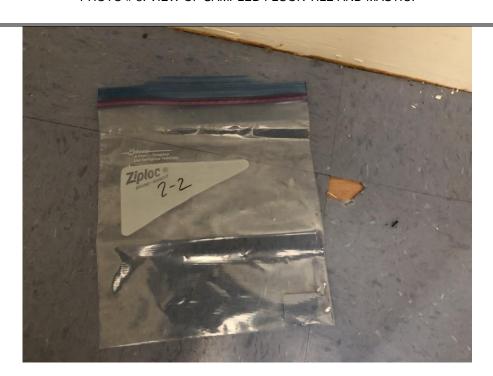
PHOTO # 4: VIEW OF SAMPLED FLOOR TILE AND MASTIC.

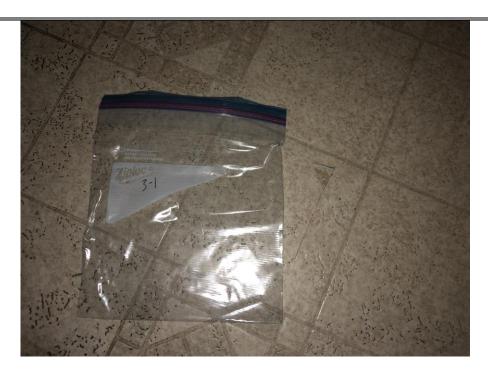
PHOTO # 5: VIEW OF SAMPLED ROLLED VINYL FLOORING.

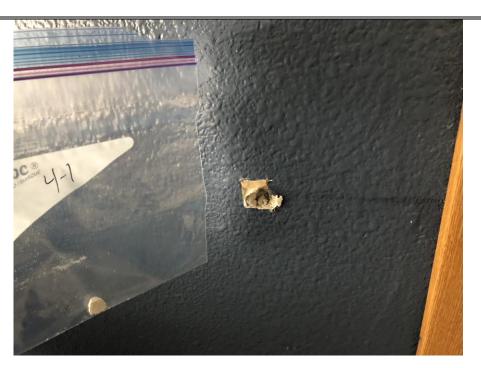
PHOTO # 6: VIEW OF SAMPLED DRYWALL.

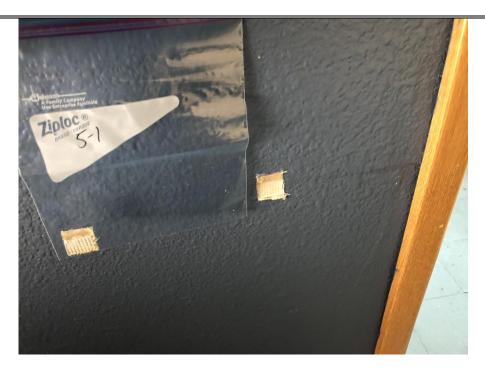
PHOTO # 7: VIEW OF SAMPLED JOINT COMPOUND.

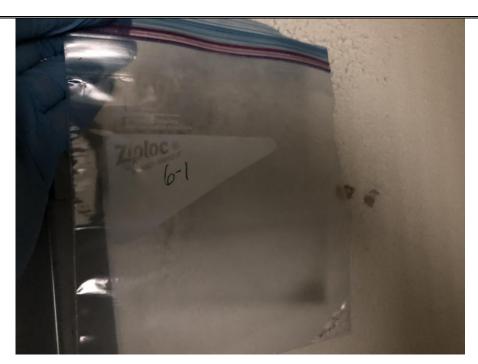
PHOTO #8: VIEW OF SAMPLED SKIM COAT PLASTER.

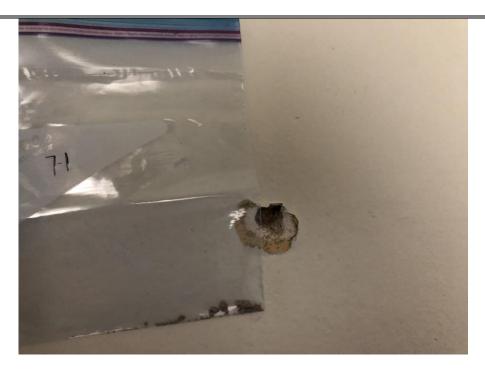
PHOTO # 9: VIEW OF SAMPLED BASE COAT PLASTER.

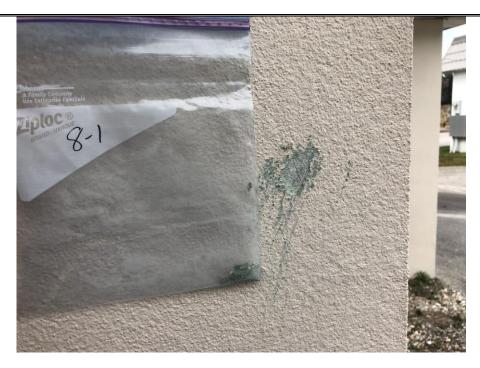
PHOTO # 10: VIEW OF SAMPLED STUCCO SURFACING.

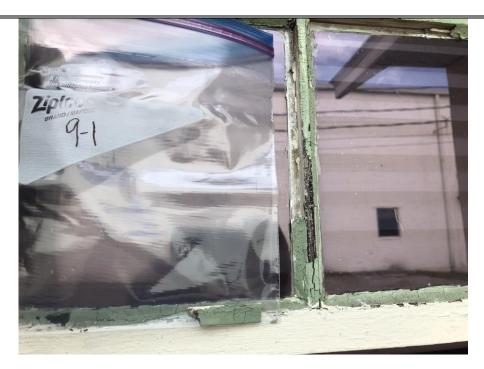
PHOTO # 11: VIEW OF SAMPLED WINDOW CAULK.

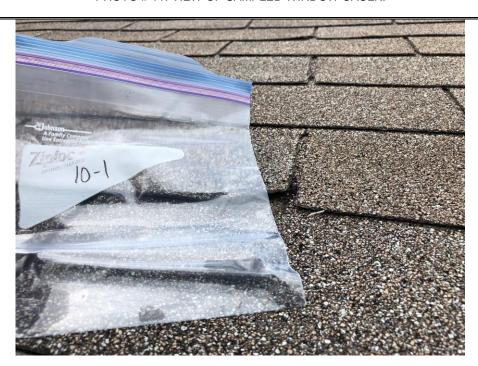
PHOTO # 12: VIEW OF SAMPLED ROOF MATERIAL.

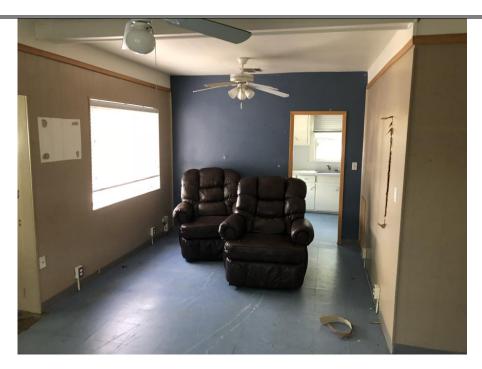
PHOTO # 13: VIEW OF GENERAL INTERIOR CONDITIONS.

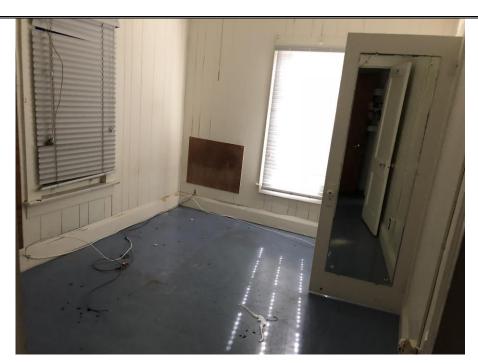
PHOTO # 14: VIEW OF GENERAL INTERIOR CONDITIONS.
