Report of Limited Asbestos Survey

4748 Wright Avenue North Charleston, South Carolina ECS Project Number 49-2970

September 30, 2016

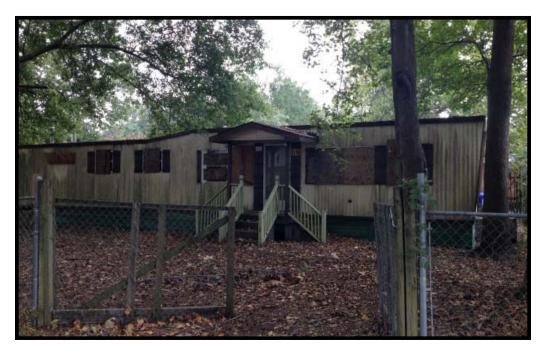
Photo 1: View of the residence at 4748 Wright Avenue.

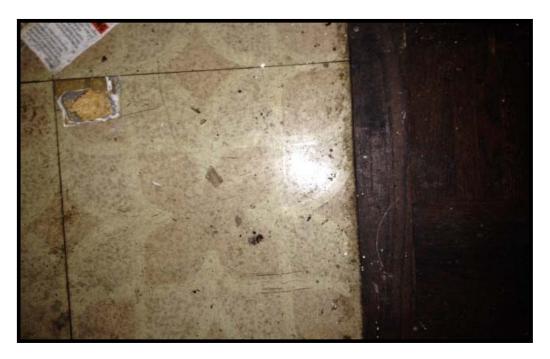
Photo 2: Multi-layered 12"x12" floor tile/linoleum & associated adhesive.

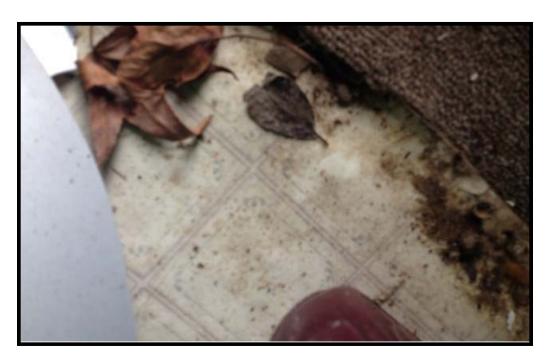
Photo 3: White linoleum.

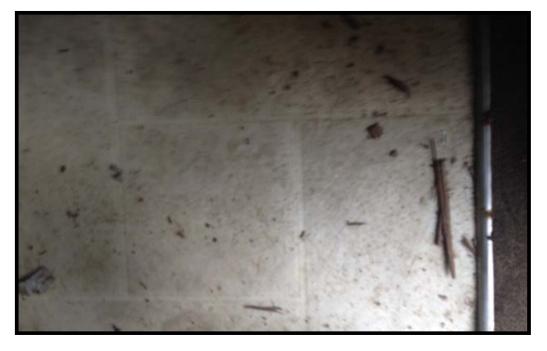
Photo 4: Off-white linoleum.

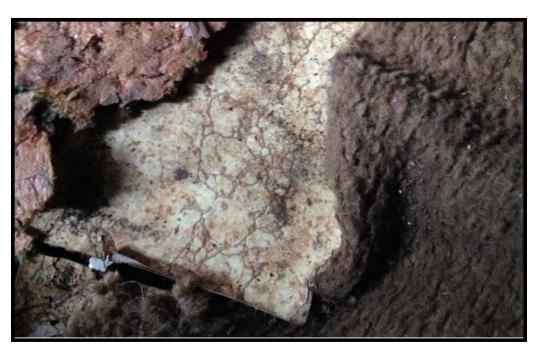
Photo 5: Tan linoleum.

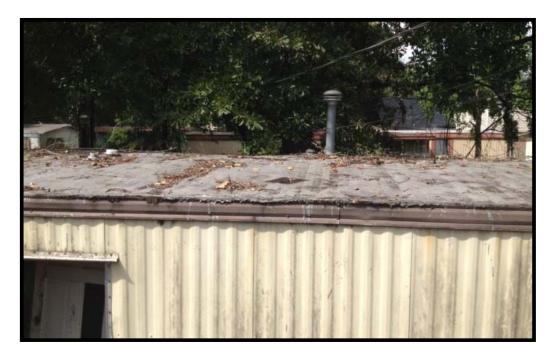
Photo 6: Roof material.
