# COMPREHENSIVE ASBESTOS SURVEY

SINGLE FAMILY RESIDENCE  
7604 ALLWOOD AVENUE  
NORTH CHARLESTON, SC 29418

*Prepared For:*

CITY OF NORTH CHARLESTON  
Attn: Angela McJunkin, CCEA, CFM  
P.O. Box 190016  
North Charleston, SC 29419

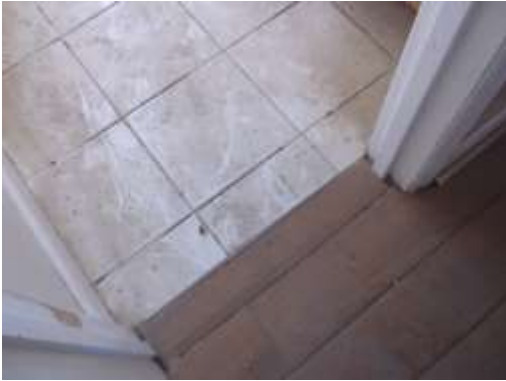
HOMOGENEOUS AREA 01  
CERAMIC TILE GROUT

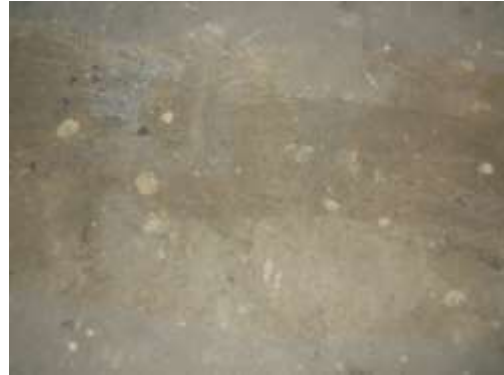
HOMOGENEOUS AREA 02  
CARPET MASTIC (TAN)

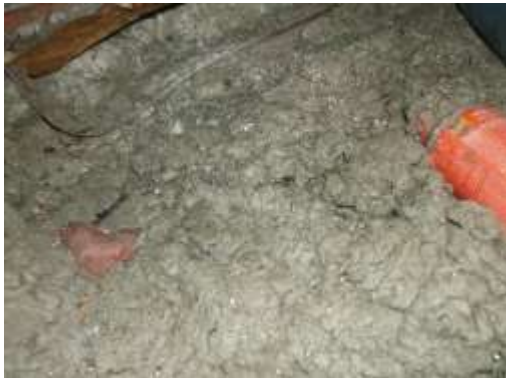
HOMOGENEOUS AREA 03  
ATTIC INSULATION

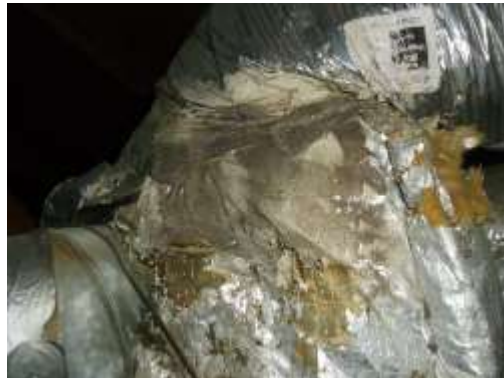
HOMOGENEOUS AREA 04  
HVAC DUCT MASTIC (WHITE)

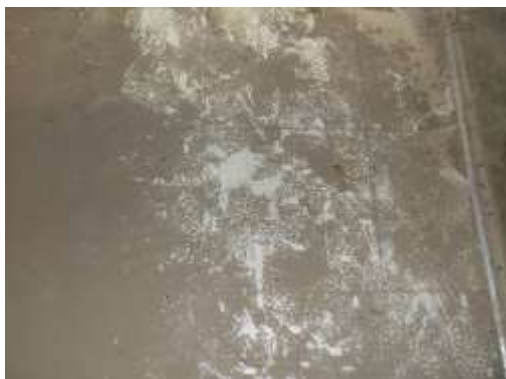
HOMOGENEOUS AREA 05  
12" SELF-STICK FLOOR TILE (WHITE)

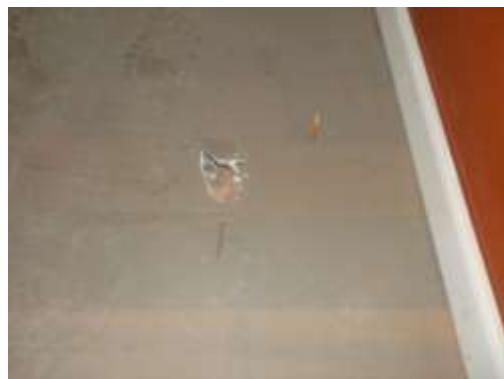
HOMOGENEOUS AREAS 06, 07  
VINYL SHEET FLOORING (WOOD)  
MASTIC (BEIGE)

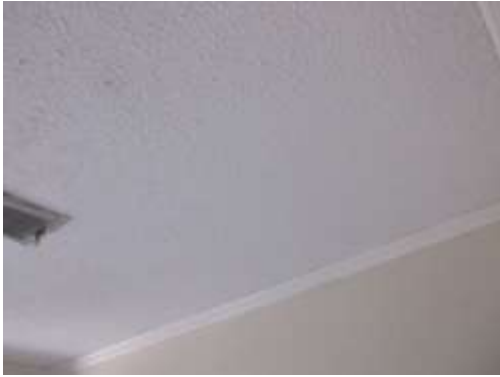
Asbestos fibers were identified in the Ceiling Texture. Approximately 418 square feet of this material is present and in good condition. This material is considered RACM – Friable Asbestos and is located on the ceilings in the closets, bathroom, bedroom 1 and bedroom 2 and in the electrical junction boxes and as overspray in the attic area throughout the structure.

HOMOGENEOUS AREA 08  
CEILING TEXTURE

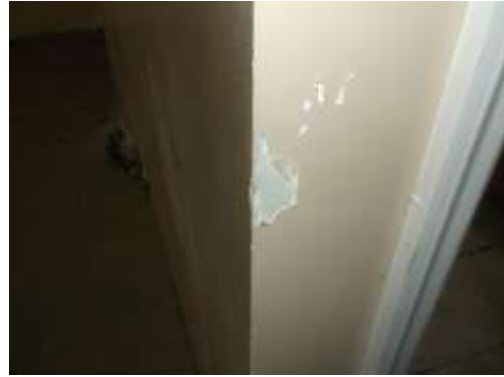
Asbestos fibers were identified in the Drywall/Joint Compound. Approximately 5,879 square feet of this material is present and in good condition. This material is considered RACM – Friable Asbestos and is located throughout the interior of the structure

HOMOGENEOUS AREAS 09, 10  
DRYWALL/JOINT COMPOUND

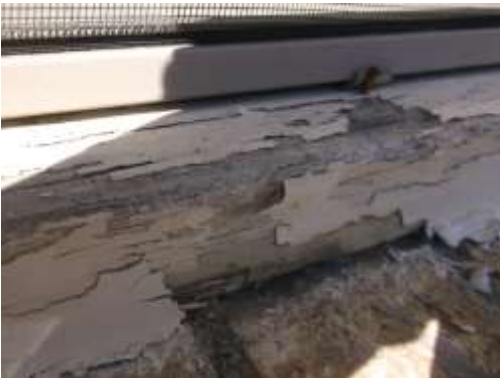
HOMOGENEOUS AREA 11  
WINDOW/DOOR CAULK

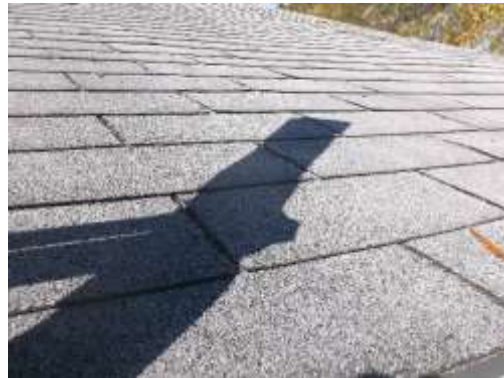
HOMOGENEOUS AREA 12  
ROOF SHINGLE

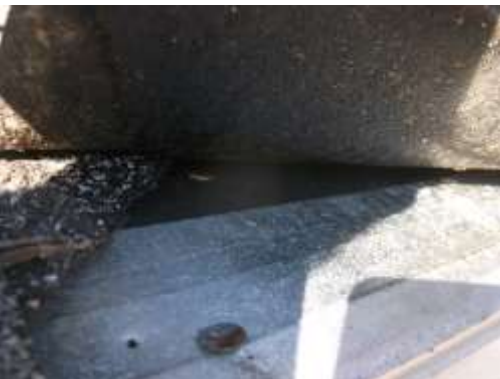
HOMOGENEOUS AREA 13  
FELT PAPER

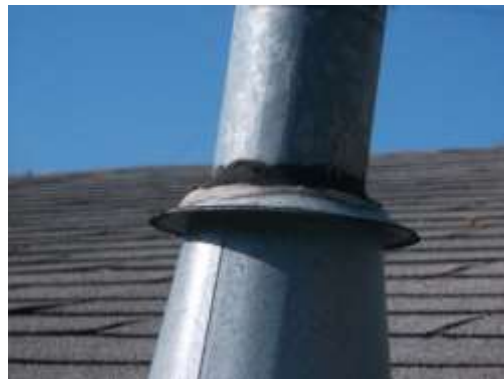
Asbestos fibers were identified in the Roof Cement (black). Approximately 9 square feet of this material is present and in good condition. This material is considered Category I – Non Friable Asbestos and is located at the roof penetrations.

HOMOGENEOUS AREA 14  
ROOF CEMENT (BLACK)

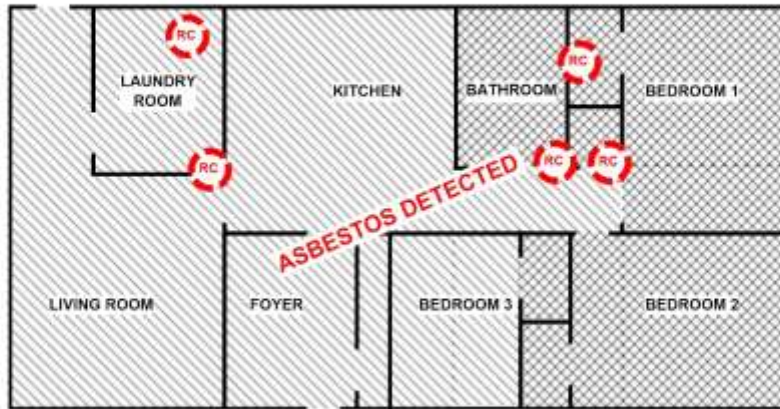
DIAGRAM 1:  
 LOCATION OF ACM

-   FRIABLE ACM DRYWALL/JOINT COMPOUND
-   FRIABLE ACM CEILING TEXTURE & DRYWALL/JOINT COMPOUND
-   NON FRIABLE ACM ROOF CEMENT

NOTE: FRIABLE ACM CEILING TEXTURE EXISTS IN ELECTRICAL JUNCTION BOXES AND AS OVERSPRAY IN THE ATTIC AREA THROUGHOUT THE STRUCTURE
