**ADDENDUM THREE  
AVONDALE YOUTH AND FAMILY DEVELOPMENT CENTER  
BUILDING ABATEMENT AND DEMOLITION  
CONTRACT NO. Y-15-008-202  
CITY OF CHATTANOOGA, TENNESSEE**

# ASBESTOS NESHAP REPORT

**The Avondale Youth and Family Development Center  
1305 Dodson Avenue  
Chattanooga, Tennessee**

**NESHAP Inspection – “The Avondale Youth and Family Development Center”  
1305 Dodson Avenue, Chattanooga, Tennessee**

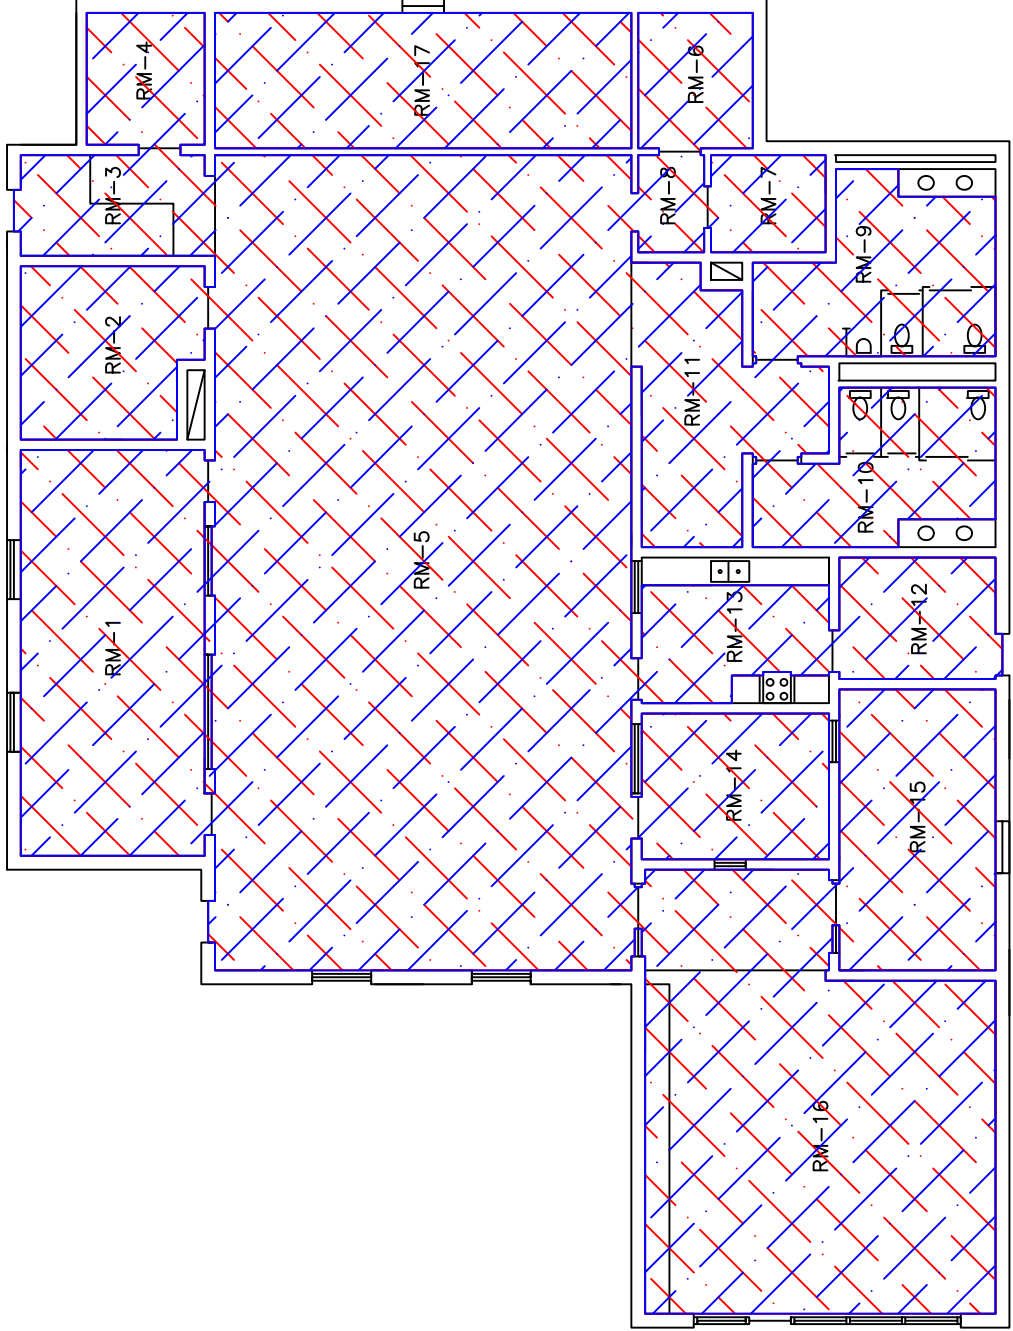
Asbestos Locations  
The Avondale Youth and Family Development Center  
1305 Dodson Avenue, Chattanooga, TN

4763-02	Yellow/ Black Mastic in RM-12
4763-06	Black Mastic in RM-1,2,5
4763-08C	Yellow/ Black Mastic in RM-5
4763-09	Yellow/ Black Mastic in RM-9,10
4763-11	Yellow/ Black Mastic in RM-14,15
4763-12	Yellow/ Black Mastic in RM-16
4763-13	Yellow/ Black Mastic in RM-16
4763-15	Yellow/ Black Mastic in RM-16
4763-26	White Duct Tape in Basement HVAC

Contaminated Floor Tile    Black Mastic    White Duct Tape

It is recommended to remove the asbestos floor tile prior to demolition. This work will need to be performed by a State of Tennessee accredited asbestos contractor using accredited supervisor and workers. All material and debris must be properly disposed of at an approved asbestos landfill. While EPA looks upon this material as non-friable, OSHA Regulations require special training and other requirements for anyone disturbing any asbestos material. OSHA also has procedural requirements pertaining to asbestos removal and handling. Contractor must comply with State of Tennessee Asbestos Program requirements and TOSHA. Once removed, the concrete slab can be used for fill or normal disposal.

**Duct Tape** - Duct tape is considered a Regulated Asbestos Containing Material (RACM). It will easily release fibers when disturbed. Duct tape must be removed prior to demolition in a proper and controlled method and disposed of at an approved asbestos landfill. The removal crew as outlined by the Federal and State OSHA Regulations must use proper protection. Due to removal requirements, it is required that the duct tape removal be performed by an accredited abatement contractor.

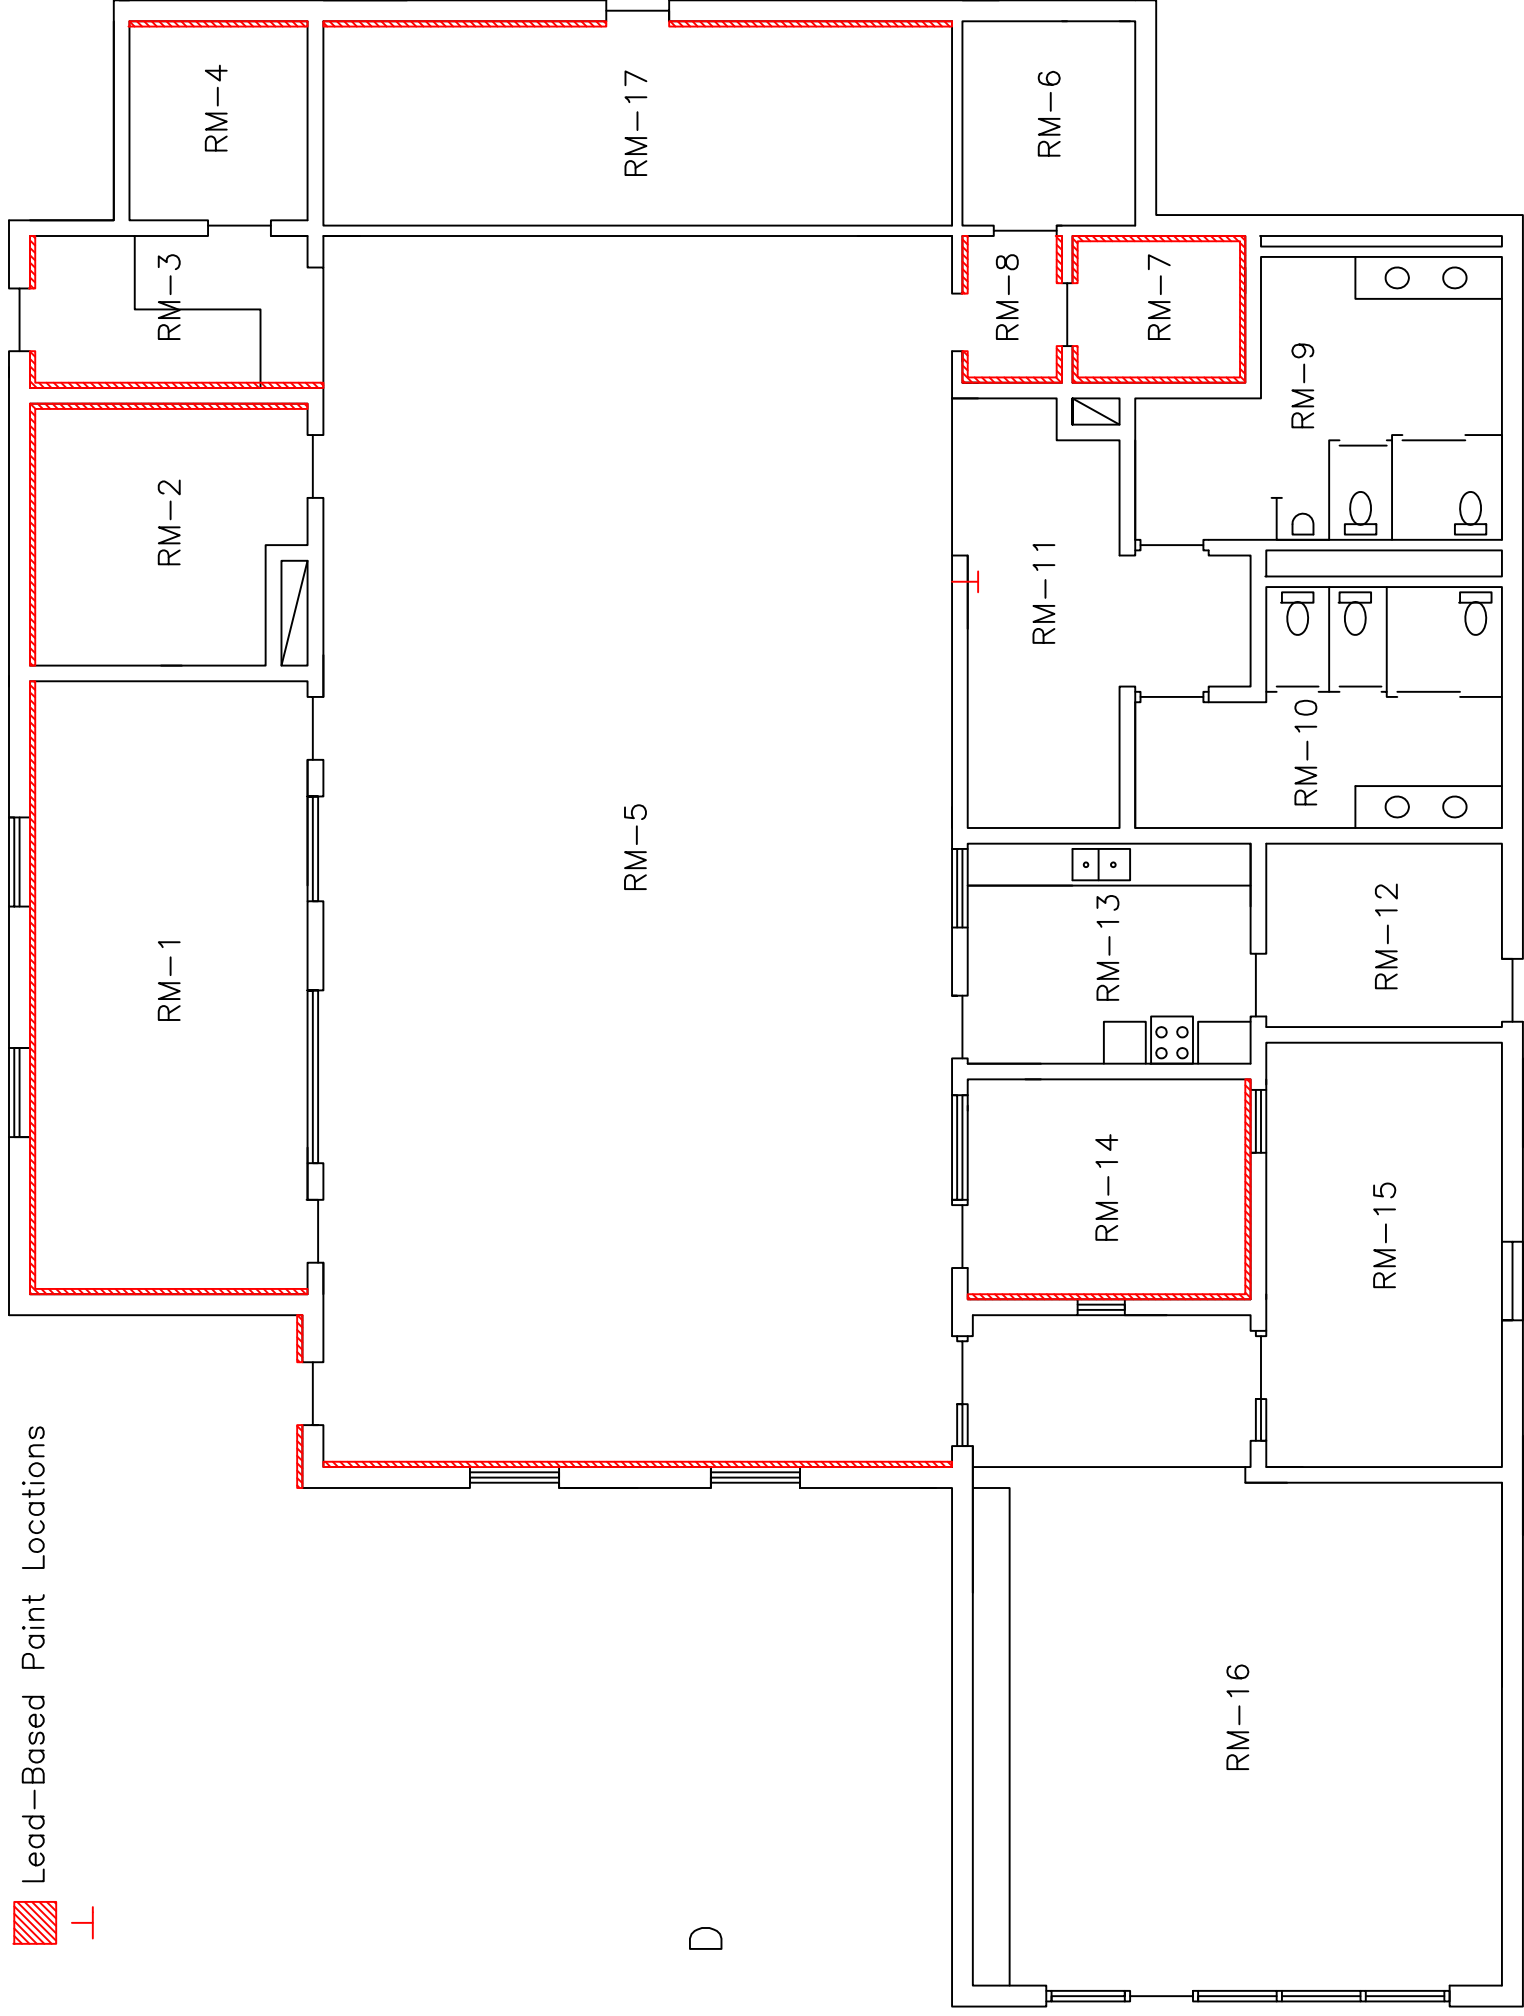
Lead-Based Paint Locations  
T

Lead based paint was found on interior and exterior components. Items noted as peeling represent a current lead hazard.

<u>Component</u>	<u>Location</u>	<u>Condition</u>
Walls	RM-1, Side A,D	Intact
	RM-2, Side A,B	Intact
	RM-3, Side A,D	Intact
	RM-4, Side B	Intact
	RM-5, Side D	Peeling
	RM-7, Side A,B,C,D	Intact
	RM-8, Side A,C,D	Intact
	RM-14, Side C,D	Intact
	RM-17, Side B	Intact
Column	RM-11, Side A	Intact

<u>Component</u>	<u>Location</u>	<u>Condition</u>
Wall	Exterior, Side A	Peeling
Basement door casing	Exterior, Side B	Peeling
Basement door jamb	Exterior, Side B	Peeling
