Asbestos & Lead Based Paint Assessment

City of Spartanburg 735 Fulton Ave Spartanburg, South Carolina

Project Number: 0417-66

May 31, 2017

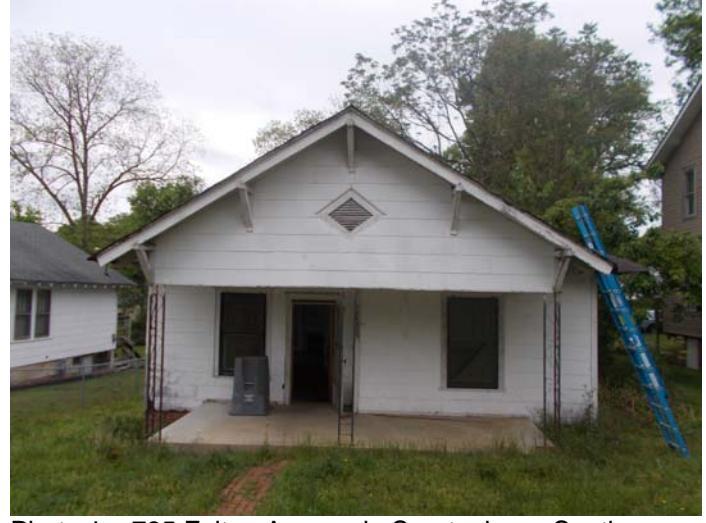
Photo 1 – 735 Fulton Avenue in Spartanburg, South Carolina.

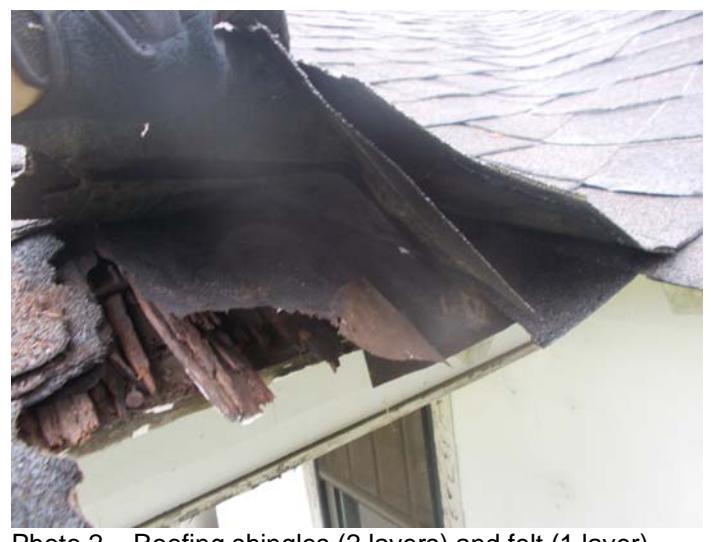
Photo 2 – Roofing shingles (2 layers) and felt (1 layer).

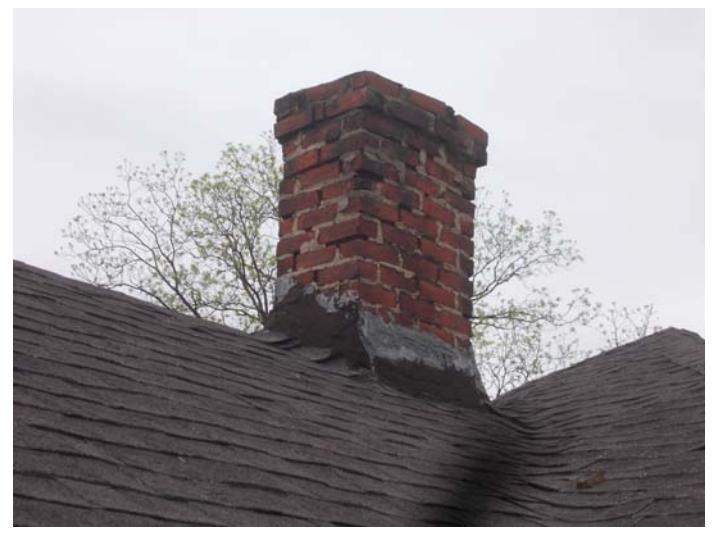
Photo 3 – Two chimneys with tar/mastic assumed positive.

1. Abate the asbestos containing materials in the structure prior to renovation or demolition.

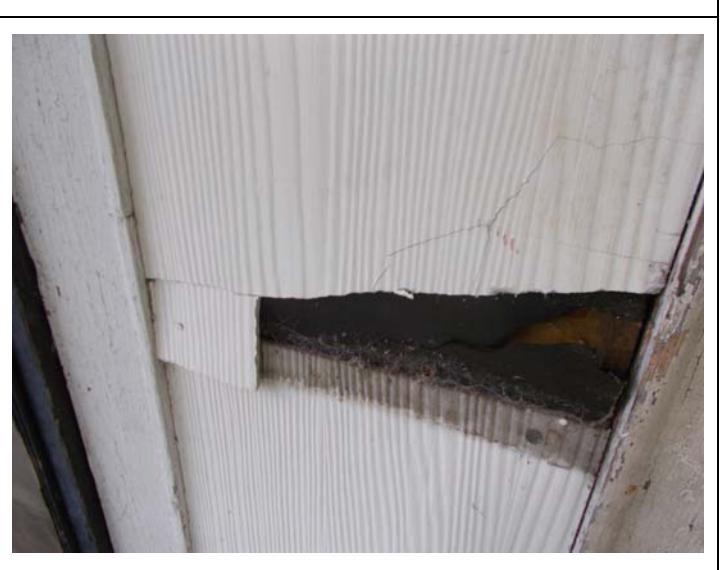
Photo 4 – Cement board siding with felt beneath.

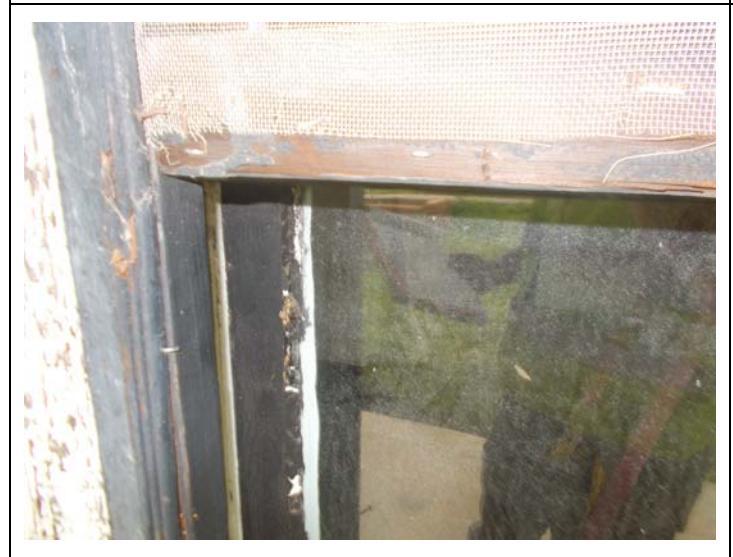
Photo 5 - Glazing on wooden windows.

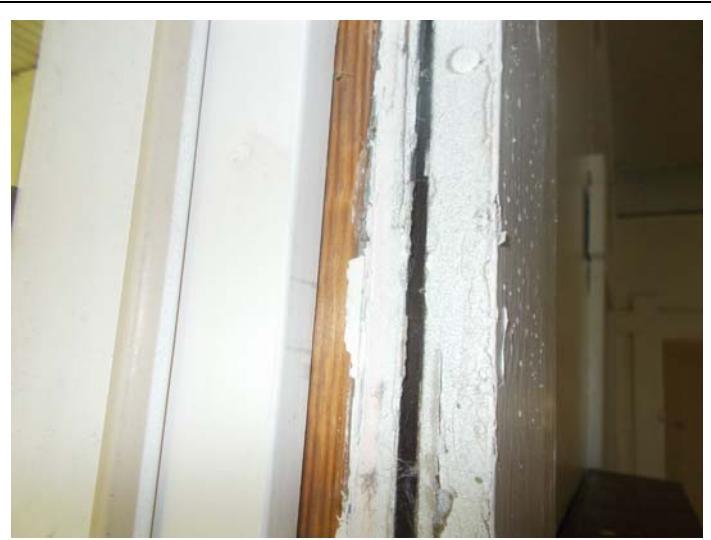
Photo 6 – Caulk on interior door frame.

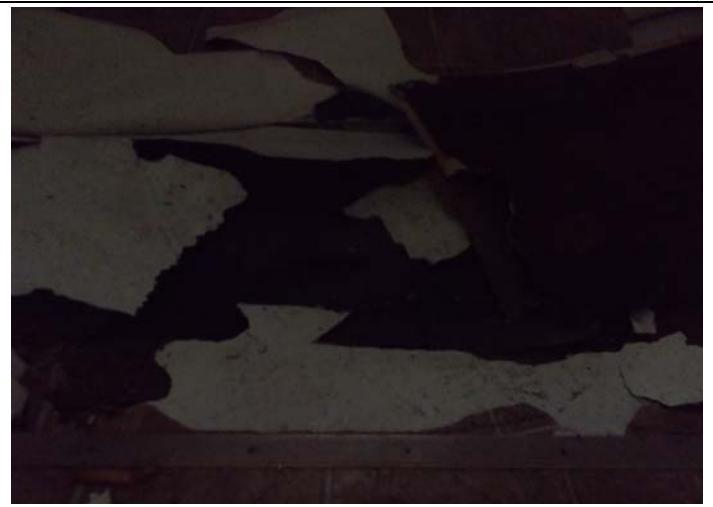
Photo 13 – White pattern vinyl floor with no mastic over dark vinyl floor with no mastic in pantry (2nd and 3rd layers).
