Asbestos Survey for Greenwood School District 50

Final Report – Nov 2021

804 Gage Street

D&F Job No. 013948.00

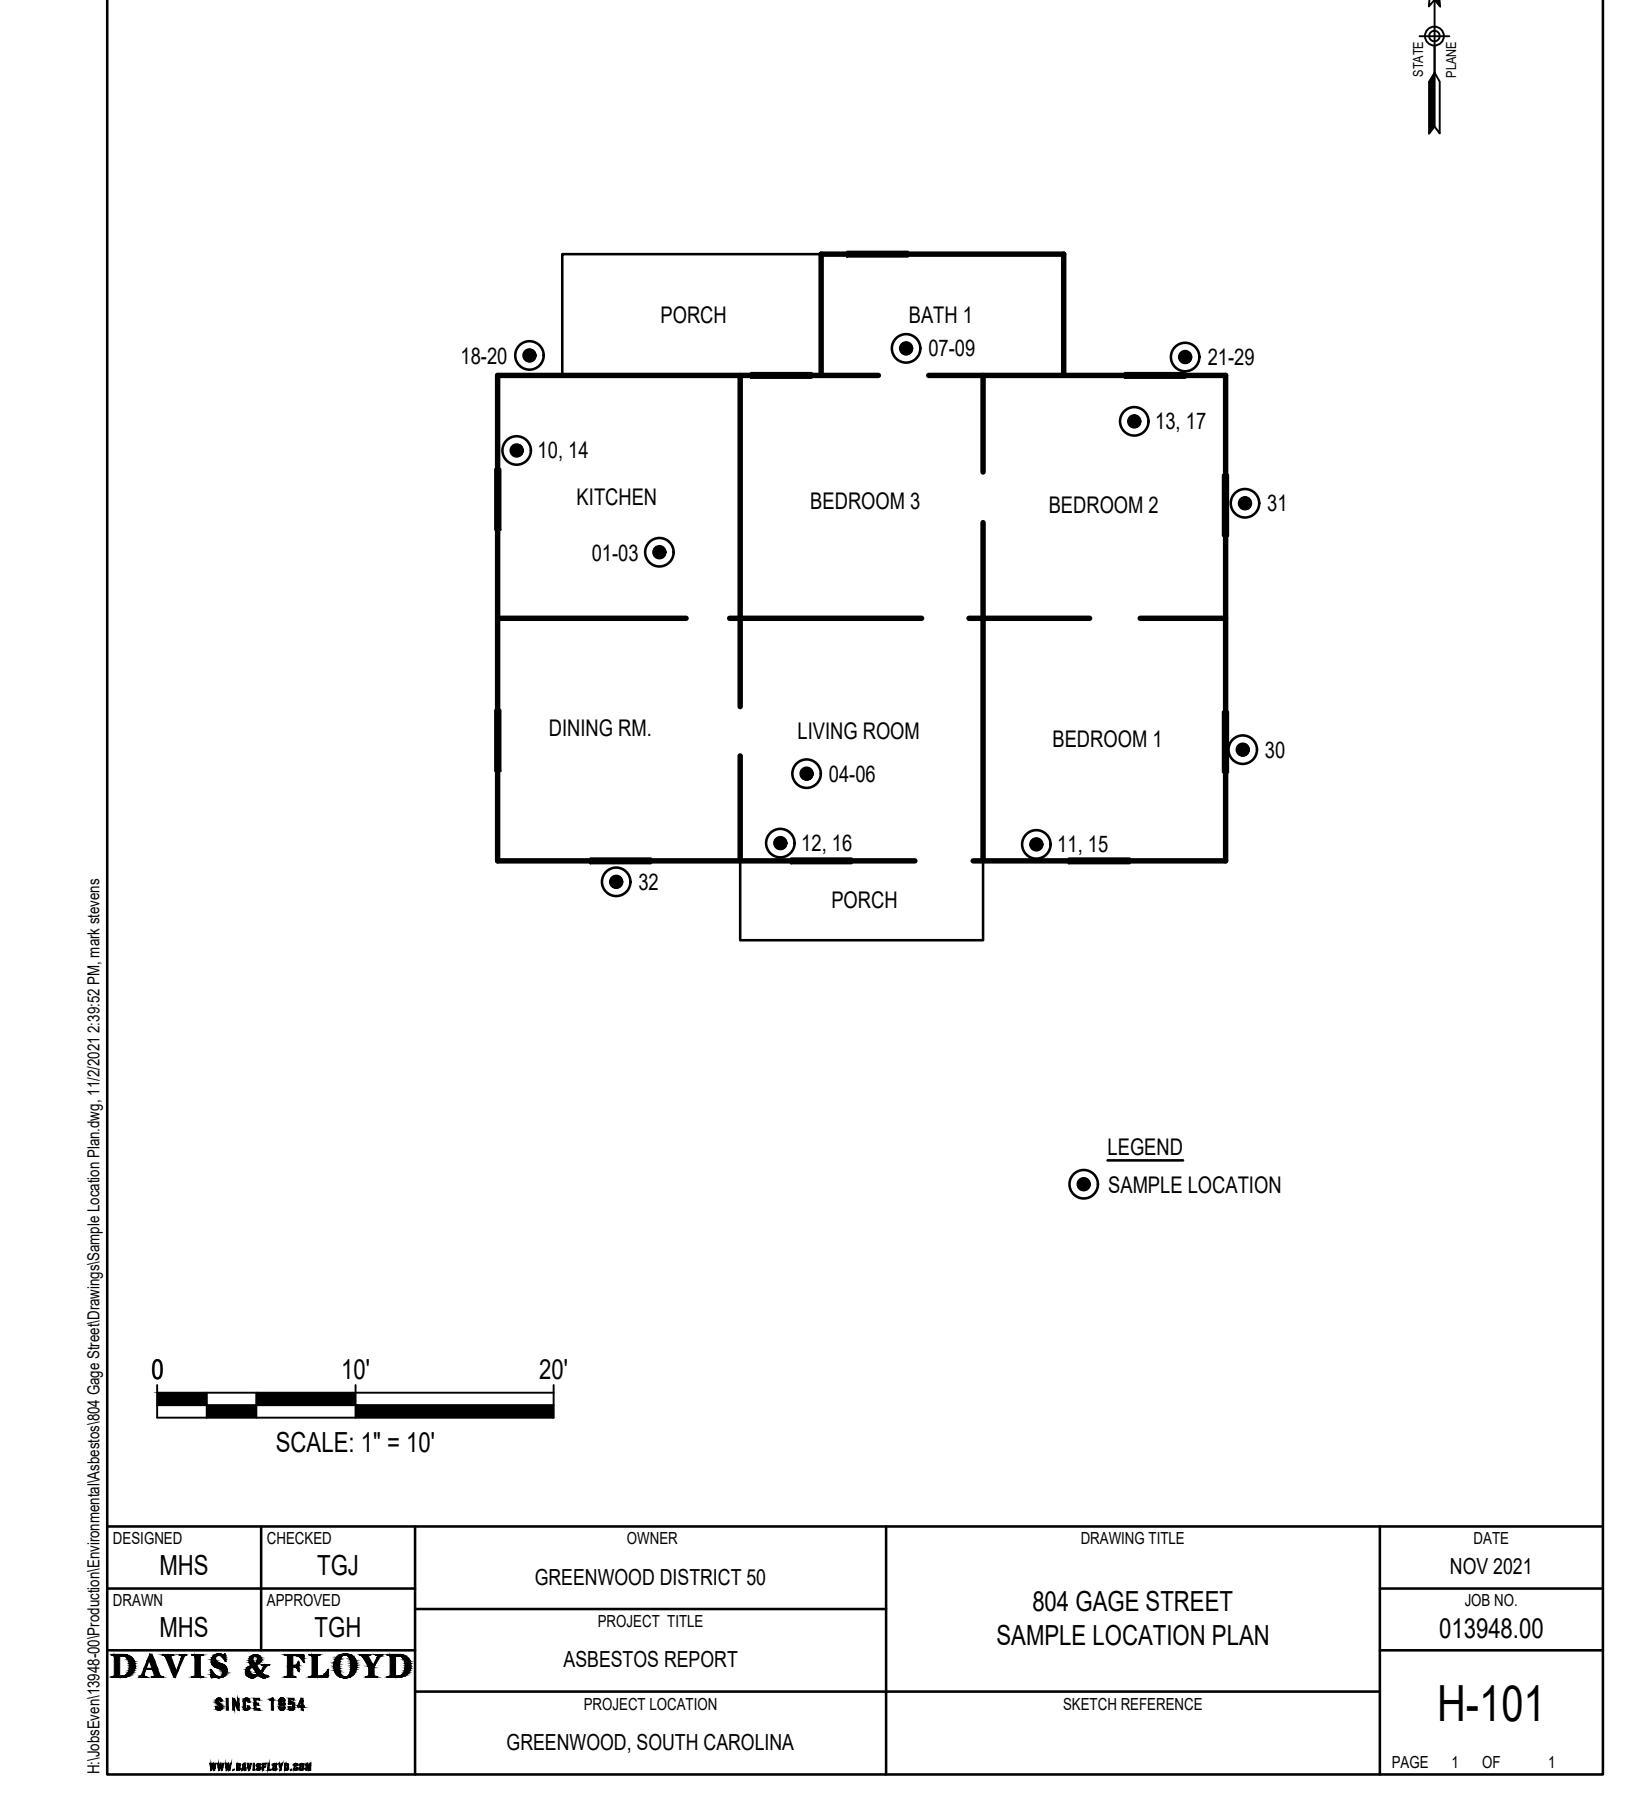
Section 5.0 Sample Location Plan & Photographs

| DAVIS & FLOVD | | Building Name: Building Address: | 804 Gage | Street | Job No. | 1394 | 8.00 | | |
|---|---|---|---|---|---|---|---|---|---|
| <mark>804-14</mark> | Joint Compound | Kitchen | | F-Good | High | 5 | | 3,336 sf | 2.00% |

| | | Non-Asbestos | | | Asbestos |
|---|---|---|---|---|---|
| 804-14 | Joint Compound @ Kitchen | Tan Non-Fibrous | | 98% Non-fibrous (Other) | 2% Chrysotile |

Asbestos joint compound on gypsum board

- Confirmed asbestos containing materials (ACM's) should not be disturbed by untrained personnel. Damaged or ACM in poor condition should be removed or repaired by trained asbestos workers. Confirmed ACM should be periodically inspected.
- Before starting a renovation/demolition project, which involves disturbing the ACM, the ACM should be removed by a licensed asbestos abatement contractor. A copy of this report must be submitted to SCDHEC, along with the demolition license application, ten (10) weekdays prior to renovation / demolition activities.
- Any activity involving the ACM should be in compliance with South Carolina Department of Health and Environmental Control Regulation 61-86.1, "Standards of Performance for Asbestos Projects", latest edition.
