**Escambia County - Neighborhood Enterprise Division
Housing Repair – SCOPE**

LEAD-BASED PAINT SURVEY

**MIDDLETON RESIDENCE
30 NORWOOD DRIVE
PENSACOLA, FLORIDA 32506**

February 27, 2023

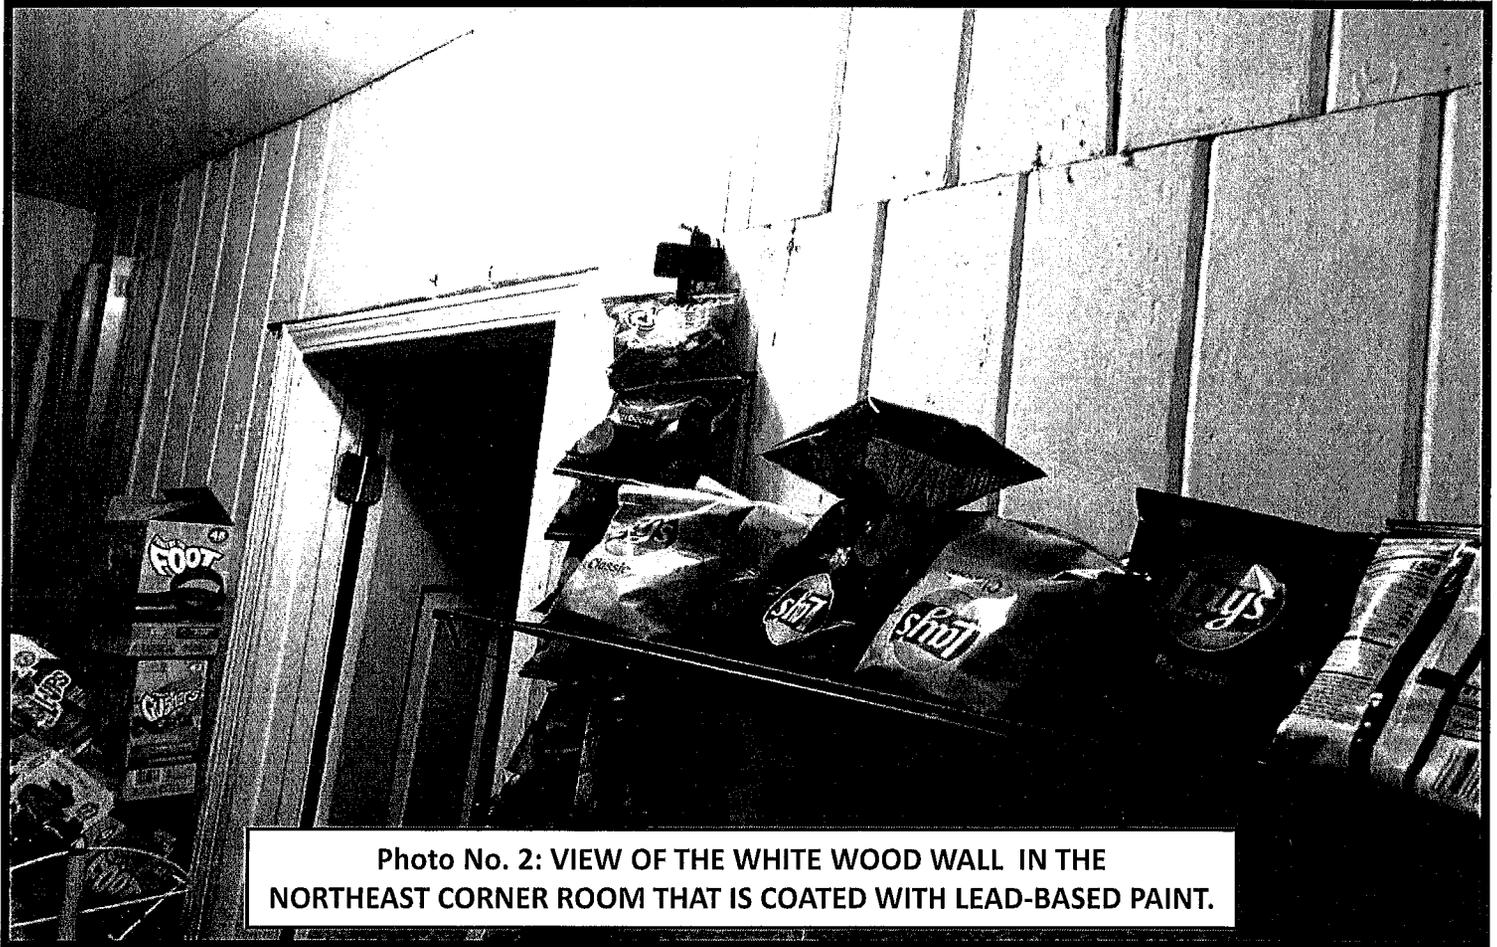
- Interior White Wood Wall – *south wall of the northeast corner room.*
- Interior White Wood Horizontal Support Member – *located in the east bedroom.*

Photo No. 2: VIEW OF THE WHITE WOOD WALL IN THE NORTHEAST CORNER ROOM THAT IS COATED WITH LEAD-BASED PAINT.

- Interior White Wood Wall (*south wall of the northeast corner room*) – Encapsulation and Enclosure
- Interior White Wood Horizontal Support Member (*located in the east bedroom*) – Encapsulation and Enclosure
