SECTION 02 82 00 ASBESTOS ABATEMENT SPECIFICATION

The Fayette County Public School (Owner) has acquired the residential property located at 2160 Versailles Road in Lexington, Kentucky. The abatement project involves an approximately 9,000 square foot three-story residential home (main house) and a 5,000 square foot two-story guest house/garage.

August 16, 2023 | Terracon Project Number: N1237347

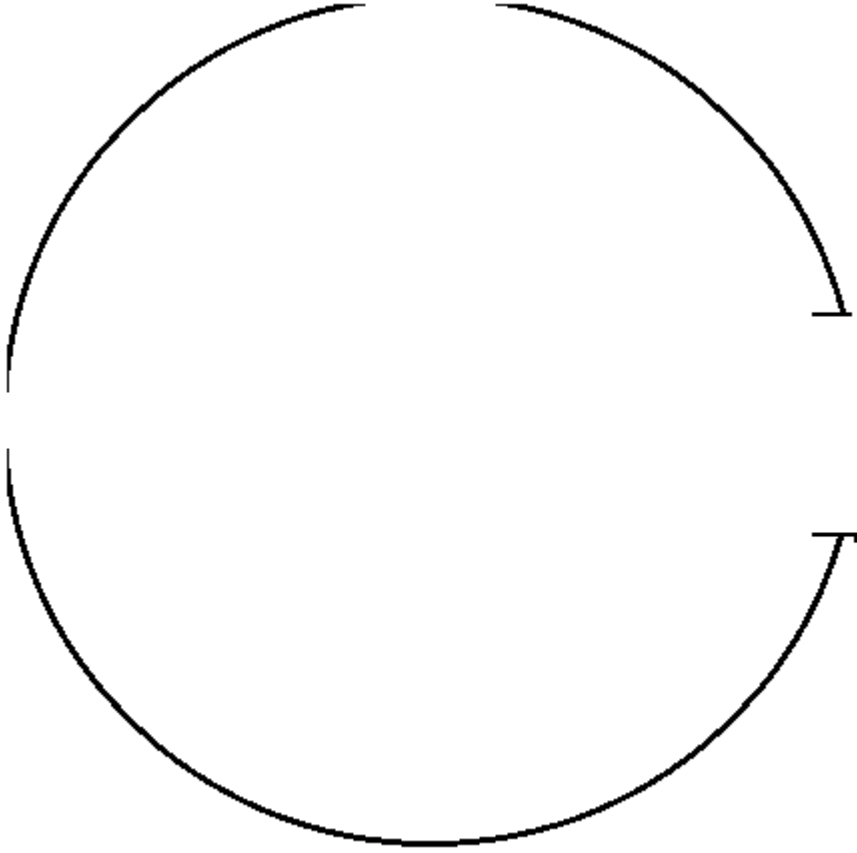
Project No. N1237347	  Consulting Engineers and Scientists 611 Lunken Park Drive Cincinnati, Ohio 45226 PH: (513) 321-05816 FAX (513) 321-0294	Silo Diagram	Exhibit
Survey Date: August 2-4, 2023			
Project Manager: Josh Vogel			
APR: Joe Tussey

No suspect ACM associated with the silo structure observed

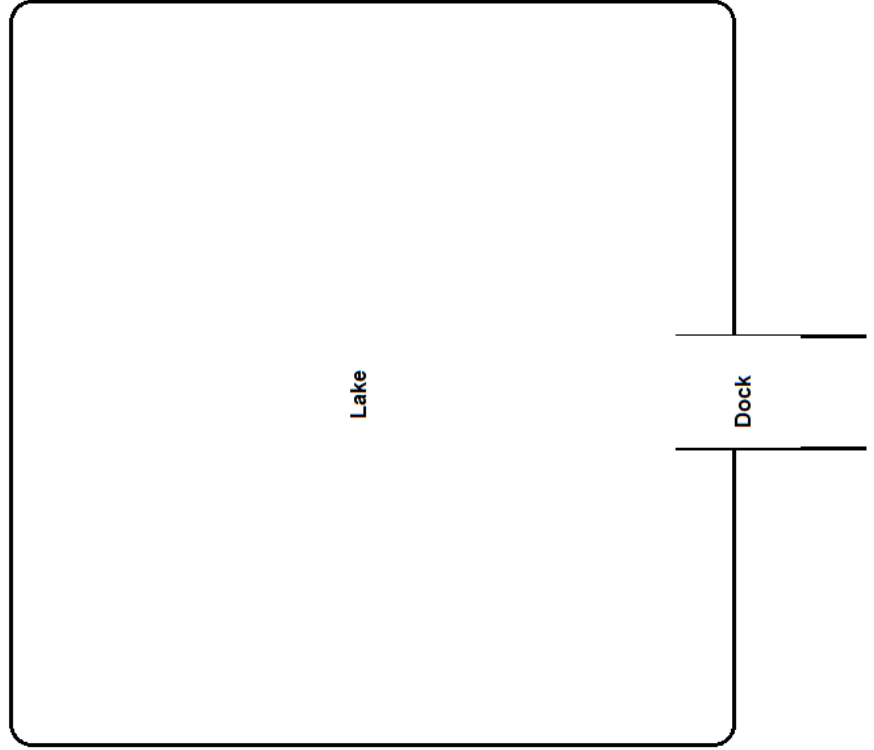
No suspect ACM associated with the lake structures

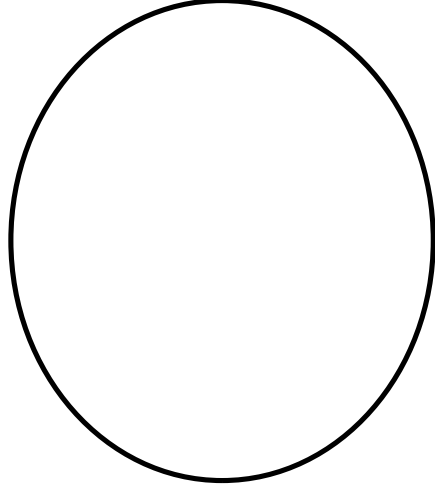
No suspect ACM
associated with
the House
Gazebo
Structure

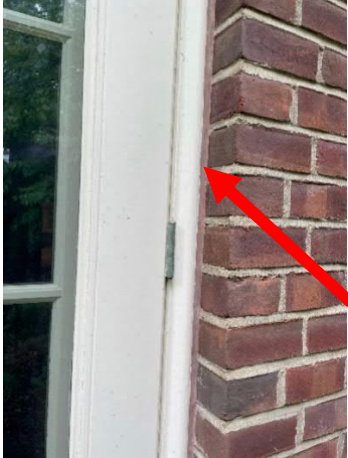
<p>Photo 7 HA 66: Asbestos-Containing Brown Exterior Door Caulking (Front Door, East Addition)</p>	<p>Photo 8 HA 67: Asbestos-Containing Brown Exterior Door Caulking (East Addition)</p>

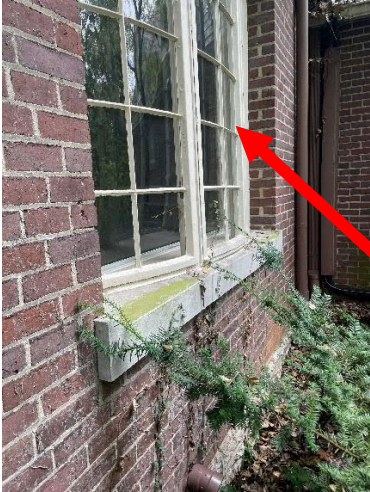
<p>Photo 9 HA 72: Asbestos-Containing White/Brown Exterior Window Caulking (Main House, Dining Room West Window).</p>	<p>Photo 10 HA 73: Asbestos-Containing Gray Exterior Door Caulking (West Addition)</p>
<p>Photo Unavailable</p>	<p>Photo Unavailable</p>
<p>Photo 11 HA 74: Asbestos-Containing Brown Exterior Window Caulking (West Addition)</p>	<p>Photo 12 HA 105: <1% Asbestos-Containing Vermiculite Fill Insulation (Garage/Guest House).</p>

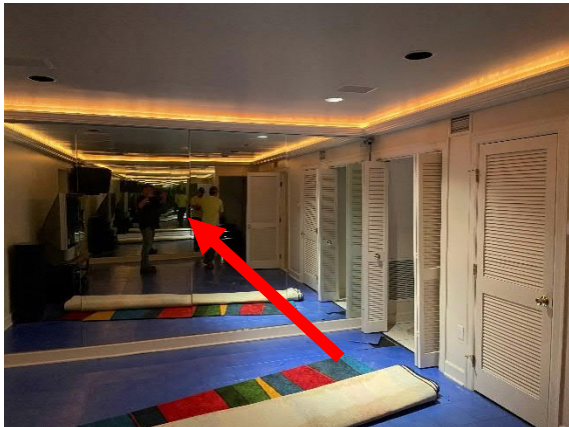
Photo 15 HA 117: Assumed Asbestos-Containing Glue Dots Behind Mirrors (Main House, Basement)
