**Escambia County - Neighborhood Enterprise Division
Housing Repair – SCOPE**

LEAD-BASED PAINT SURVEY

**JAMES RESIDENCE
3426 W. BRAINERD STREET
PENSACOLA, FLORIDA 32505**

Project Number: M23-091

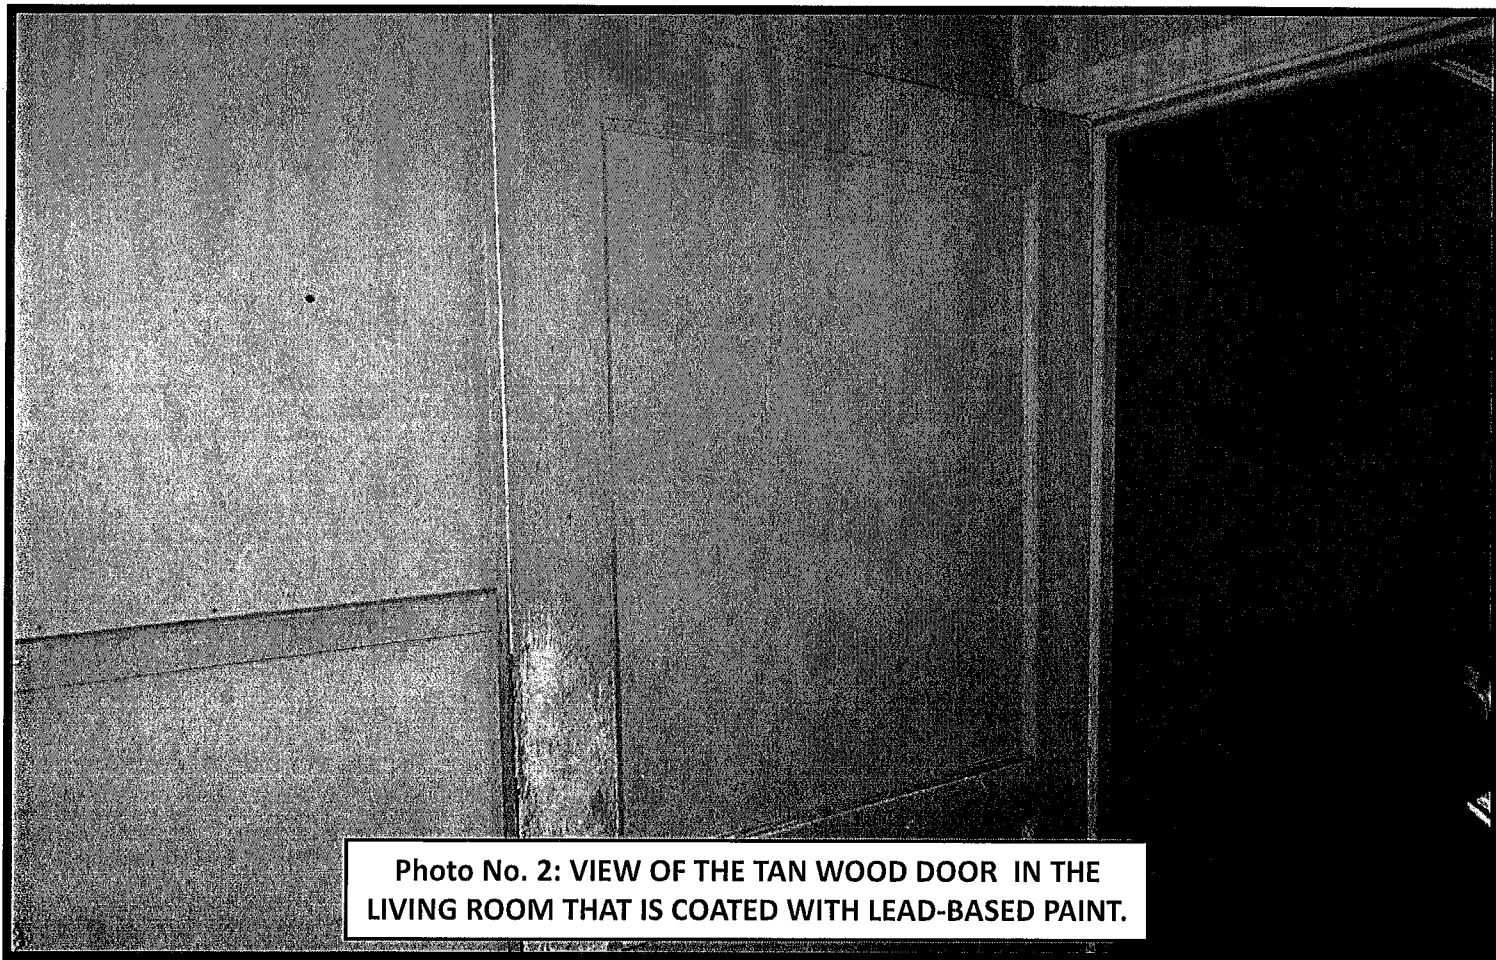
- Interior Tan Wood Door – *north wall of the living room (Photo No. 2)*
- Interior White Wood Window Assembly – *located in the hallway bathroom (Photo No. 3)*
- Interior White Door Casing – *located in the hallway bathroom*
- Exterior Brown Wood Front Porch Ceiling, Horizontal Support Members and Crown Molding (*Photo No. 4*)
- All Exterior Green and Brown Wood Window Assemblies (*Photo No. 5*)
- Exterior Red/Brown Gable End Rafters, Roof Decking and Fascia Boards (*Photo No. 6 and 7*)

Photo No. 2: VIEW OF THE TAN WOOD DOOR IN THE LIVING ROOM THAT IS COATED WITH LEAD-BASED PAINT.

- Interior Tan Wood Door (Living Room) – Component Removal
- Interior White Wood Window Assembly (Hall Bathroom) – Component Removal
- Interior White Door Casing (Hall Bathroom) – Component Removal
- Exterior Brown Wood Front Porch Ceiling, Horizontal Support Members and Crown Molding - Component Removal and Encapsulation and Enclosure
- All Exterior Green and Brown Wood Window Assemblies – Component Removal
- Exterior Red/Brown Gable End Rafters, Roof Decking and Fascia Boards – Encapsulation and Enclosure

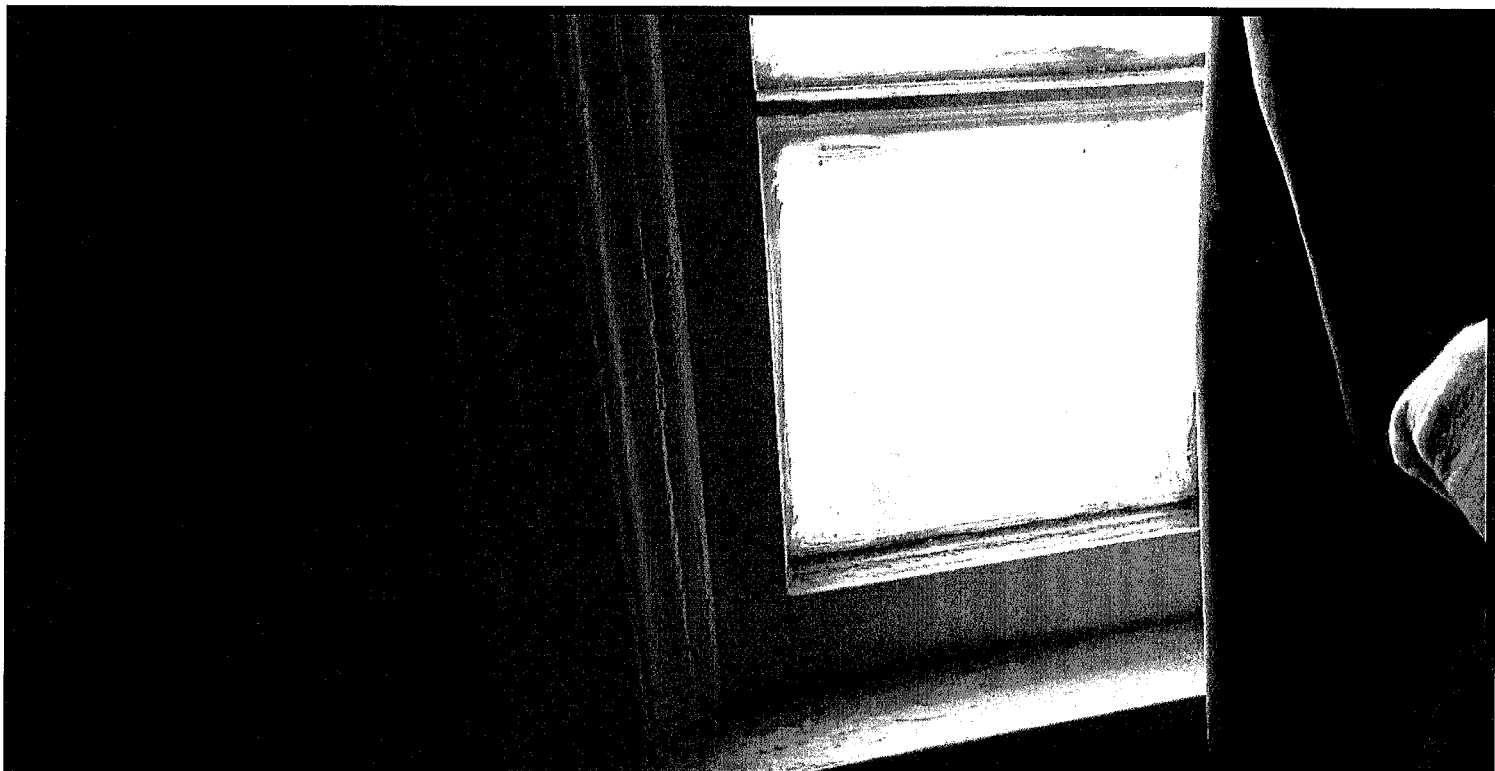
Photo No. 3: VIEW OF THE WHITE WOOD WINDOW ASSEMBLY IN THE BATHROOM THAT IS COATED WITH LEAD-BASED PAINT. THE DOOR CASING IS ALSO COATED WITH LEAD-BASED PAINT.

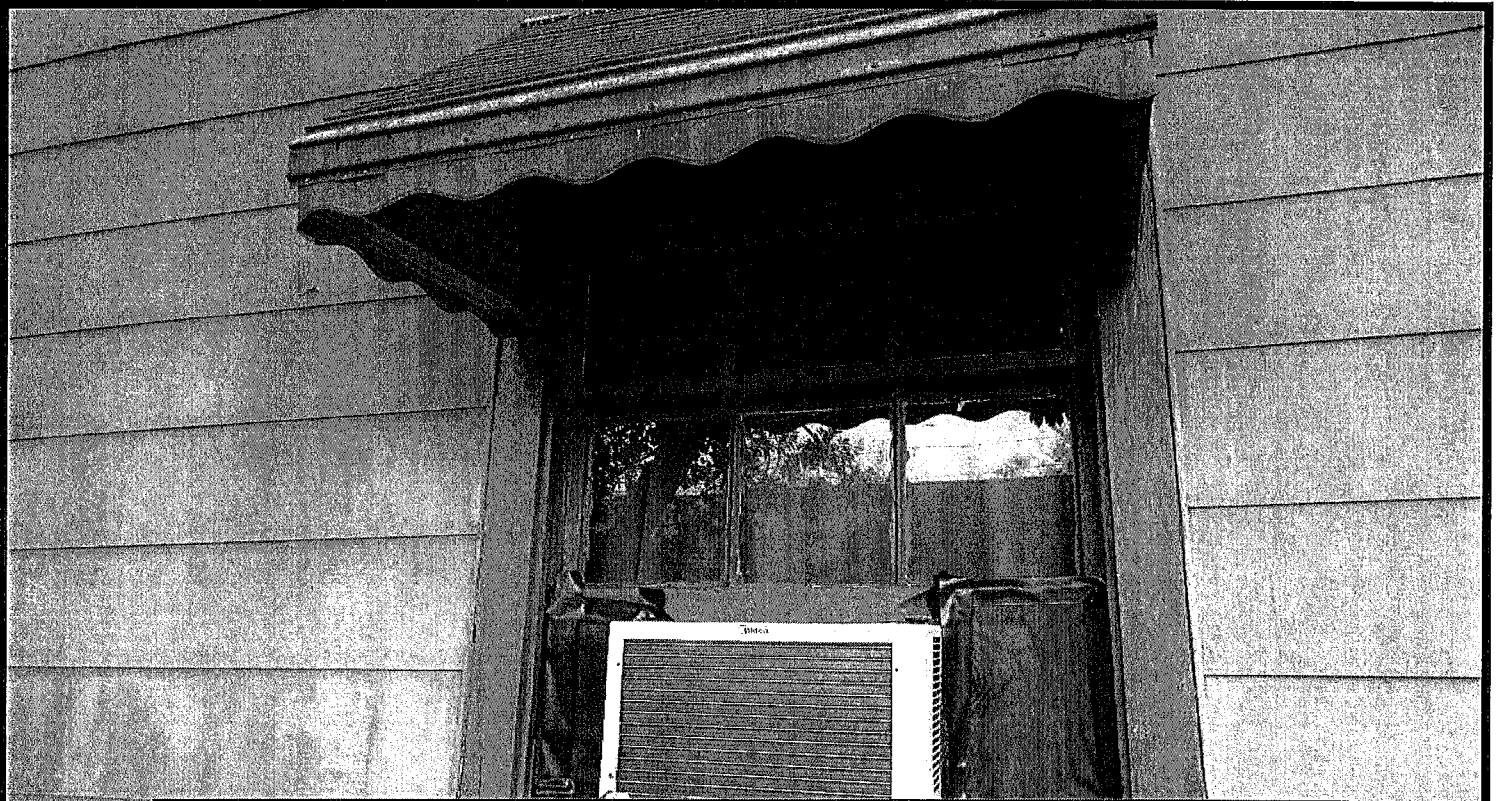
Photo No. 5: REPRESENTATIVE VIEW OF THE EXTERIOR WOOD WINDOW ASSEMBLIES THAT ARE COATED WITH LEAD-BASED PAINT.

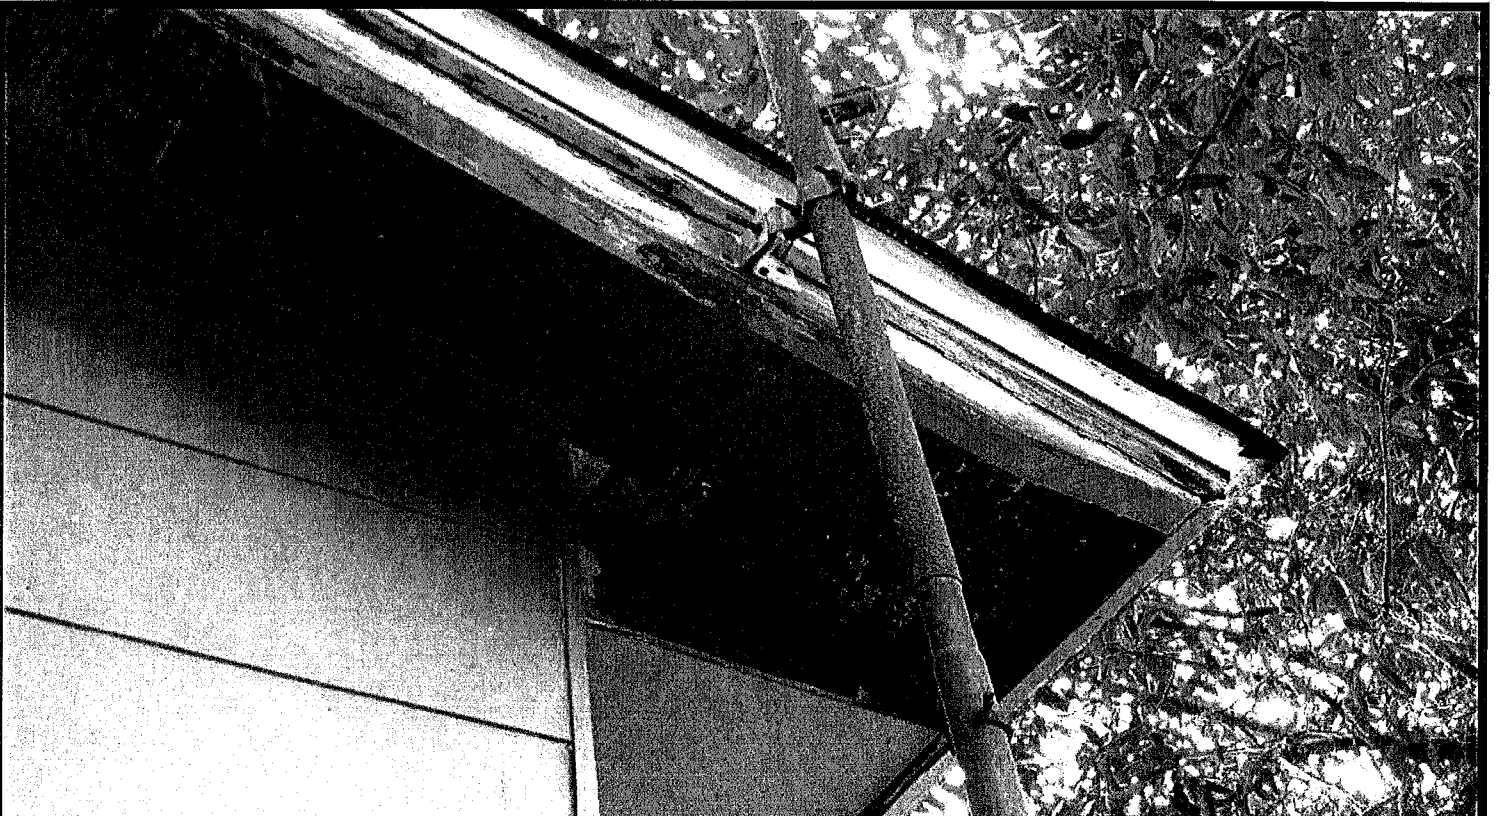
Photo No. 6: REPRESENTATIVE VIEW OF THE EXTERIOR WOOD ROOF DECK, GABLE END RAFTER AND FASCIA BOARDS THAT ARE COATED WITH LEAD-BASED PAINT.

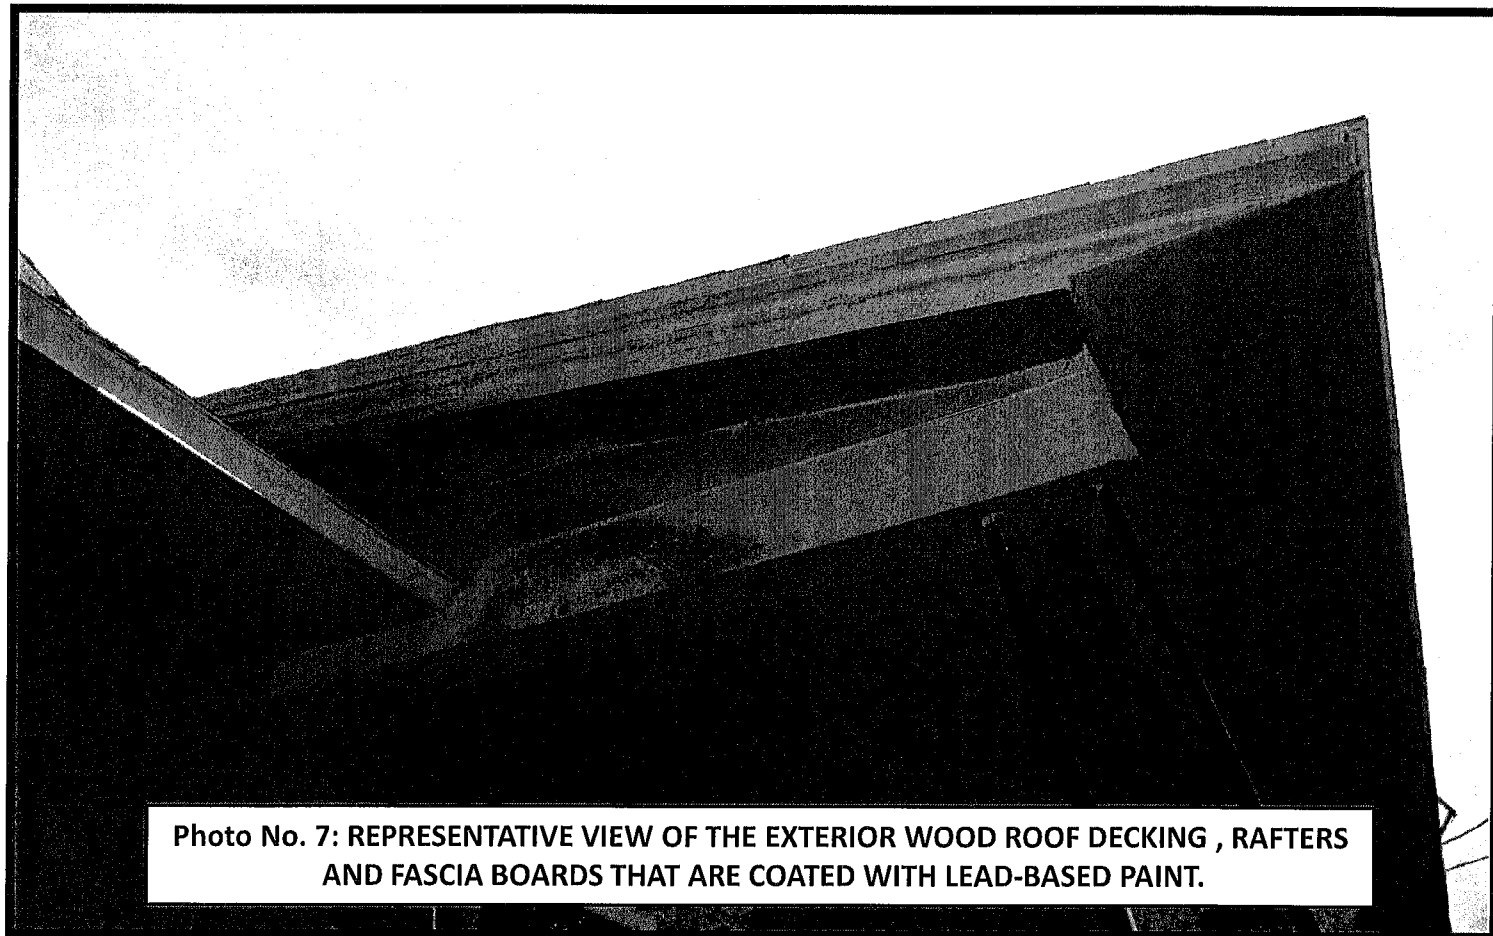
**Photo No. 7: REPRESENTATIVE VIEW OF THE EXTERIOR WOOD ROOF DECKING , RAFTERS
AND FASCIA BOARDS THAT ARE COATED WITH LEAD-BASED PAINT.**
