## **Feasibility Study:**

### **Stream Restoration of Beeson Creek and Tributaries**

### **Located Near Ivey M. Redmon Sports Complex, Kernersville, NC**

November 21, 2016

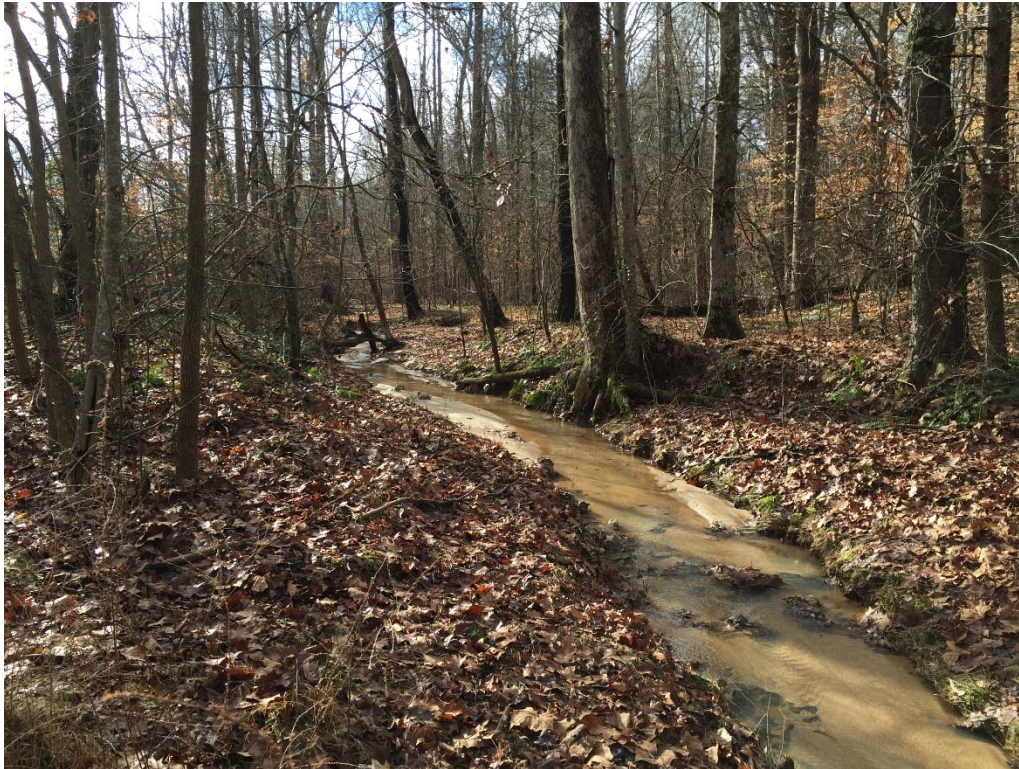
**Reach 1 Typical Condition.**

*Reach 1:* Reach 1 is currently not incised or entrenched, with a narrow valley and mature riparian vegetation. A stream restoration project on Reach 1 will focus on enhancing habitats and improving water quality through repair of localized bank erosion. Opportunities exist for stormwater management in the watershed of Reach 1, specifically in the vicinity of the cross-country running trail. Specific components of restoration on Reach 1 may include:

- Leave the stream channel in its existing planform location, with the exception of localized realignment to mitigate eroding streambanks
- As needed, grade streambanks to reduce erosion, provide floodplain access, and maintain the design channel width (approximately 6-7 feet)
- As needed, install log and boulder structures in the streambed to enhance habitat, promote sediment transport, provide grade control, and protect streambanks
- Vegetate bare areas and areas disturbed by grading with appropriate native riparian vegetation
- Manage stormwater within the watershed through use of sediment traps, bare area stabilization, vegetated swales, and infiltration

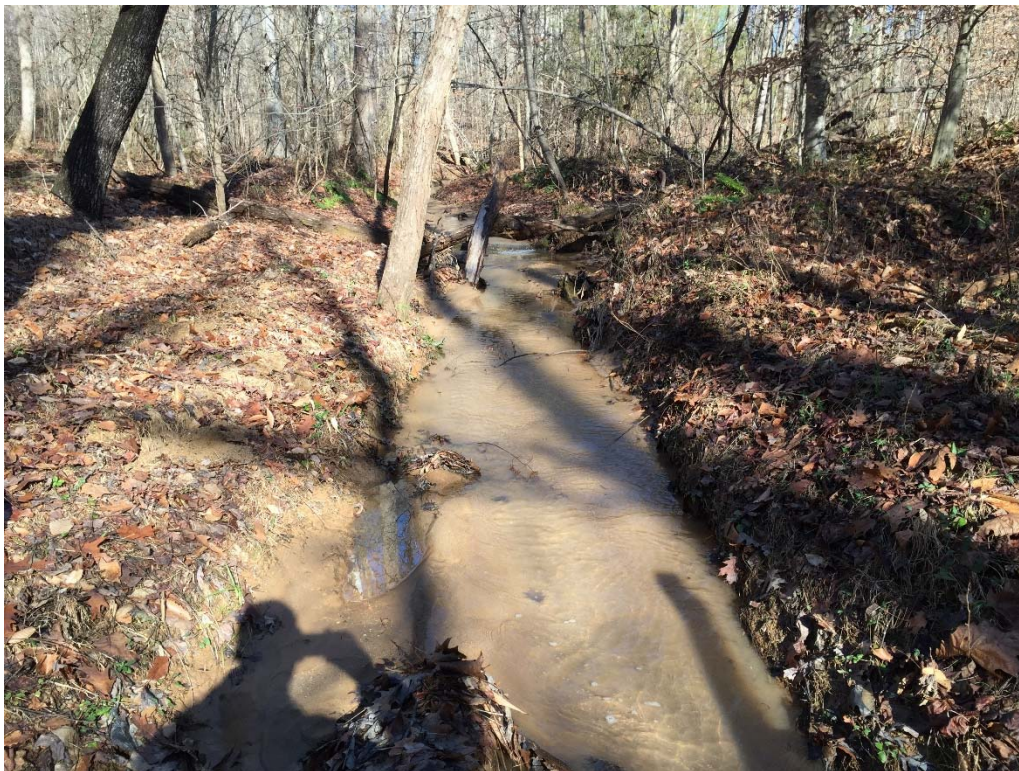
**Reach 2 Typical Condition.**

*Reach 2:* Much like Reach 1, Reach 2 is currently not incised or entrenched, with a narrow valley and mature riparian vegetation. A stream restoration project on Reach 2 will focus on enhancing habitats and improving water quality through repair of localized bank erosion. Opportunities exist for stormwater management in the watershed of Reach 2, specifically in the agricultural fields to the north and east, and in the residential area to the west. Specific components of restoration on Reach 2 may include:

- Leave the stream channel in its existing planform location, with the exception of localized realignment to mitigate eroding streambanks
- As needed, grade streambanks to reduce erosion, provide floodplain access, and maintain the design channel width (approximately 8-9 feet)
- As needed, install log and boulder structures in the streambed to enhance habitat, promote sediment transport, provide grade control, and protect streambanks
- Vegetate bare areas and areas disturbed by grading with appropriate native riparian vegetation
- Manage stormwater within the watershed through use of sediment traps, bare area stabilization, and infiltration

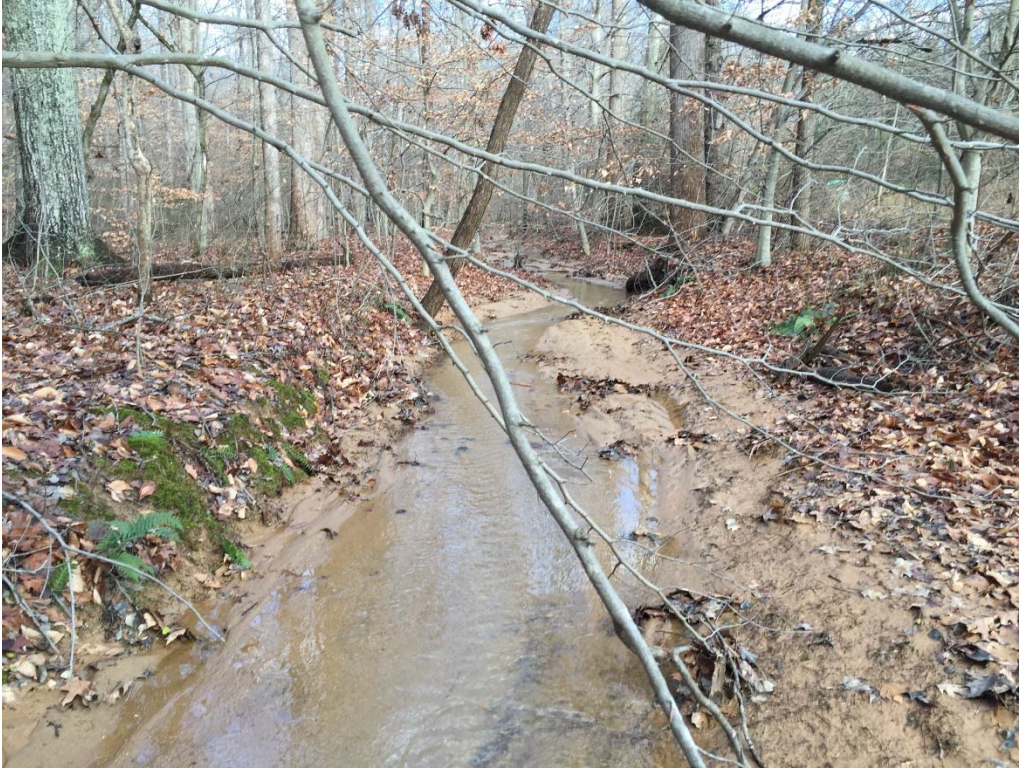
**Reach 3 Typical Condition.**

*Reach 3:* Reach 3 is a relatively short, stable reach below the confluence of Reach 1 and 2. Reach 3 is not currently not incised or entrenched, though upstream migration of the existing headcut in Reach 4 could change the morphology of Reach 3 over time. A stream restoration project on Reach 3 will focus on enhancing habitats and improving water quality through repair

- Leave the stream channel in its existing planform location, with the exception of localized realignment to mitigate eroding streambanks (Note: the valley width and utility locations would allow for realignment of portions of Reach 3 if needed to facilitate restoration of Reach 4)

- As needed, grade streambanks to reduce erosion, provide floodplain access, and maintain the design channel width (approximately 10-12 feet)
- Install boulder structure downstream of sewer line crossing to provide grade control and infrastructure protection

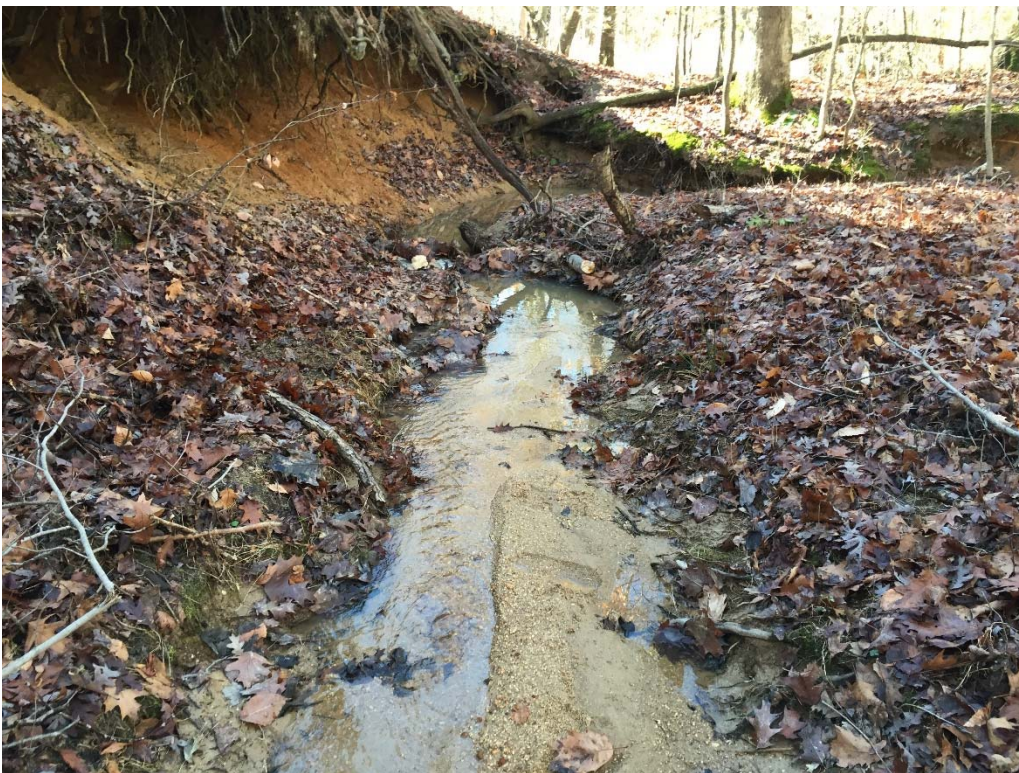
BEHI scores for Reaches 4 and 5 were generally 'High' and 'Moderate', with some areas of 'Very High'. In Reach 4, this high erodibility, combined with a large streambank height (approximately 5 feet), resulted in very high predictions for streambank erosion rates. It is estimated that 174 tons per year of sediment is generated by streambanks within Reach 4 (compared to <10 tons per year for Reaches 1, 2, and 3 combined). This high erodibility in Reach 4 is supported by visual observations of eroding banks, fallen trees, and downstream sediment deposition.

*Reach 4:* Reach 4 begins at a large head cut, which has left the entire reach incised and unstable, with eroding streambanks, poor floodplain access, and poor vegetation. Restoration of Reach 4 will create a stable, meandering stream with appropriate cross-section dimensions, a wide floodplain, and healthy riparian vegetation. Two conceptual options have been developed for Reach 4. Both options include:

**Reach 4 Typical Condition at Upstream End.**

- Replace the elevation drop over existing unstable head cut with a series of log and boulder step structures
- Downstream of the drop structures, excavate a wide (approximately 55 feet) floodplain through the length of the valley
- Realign the stream channel through the new valley at the existing streambed location

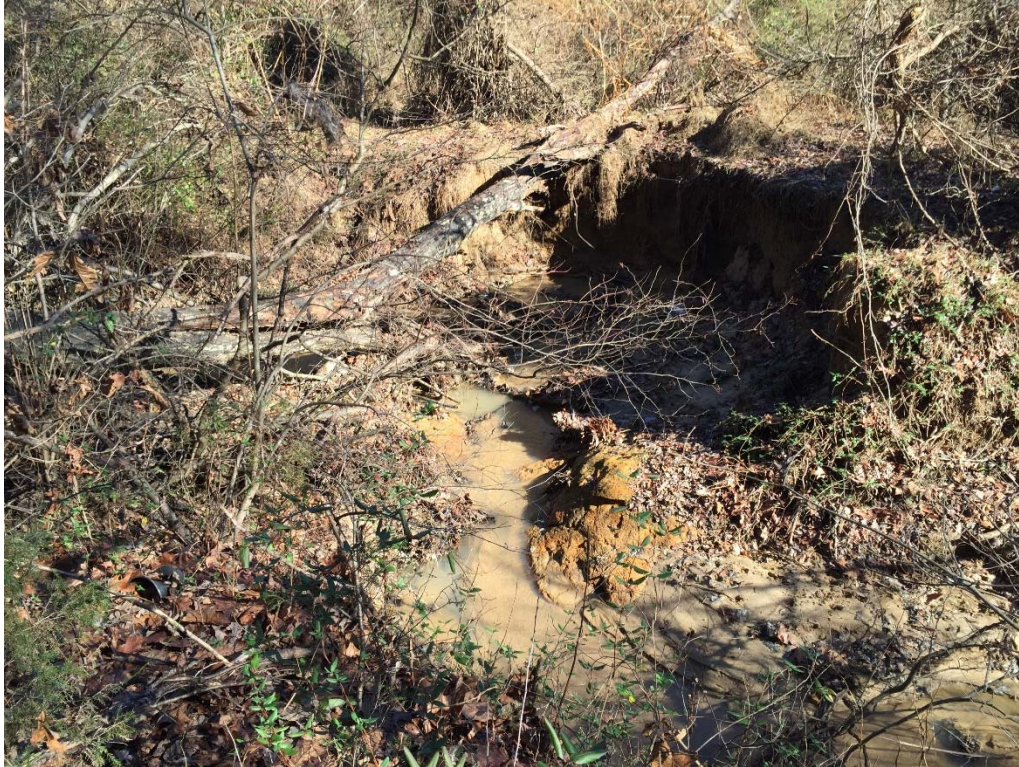
*Utilities:* A sewer main parallels Reaches 2, 3, 4, and 5. It crosses under the streambed at the upstream end of Reach 3 and again within Reach 4. Additionally, one closely parallels most of Reach 6, and crosses Reach 6 once, toward the downstream end. Reach 7 is not affected by sewer utilities, with the exception of a crossing near the confluence with Beeson Creek. There are restoration options that will co-exist with these sewer lines, while providing increased protection from erosion for the utilities.

**Reach 4 Typical Condition Near Sewer Line.**

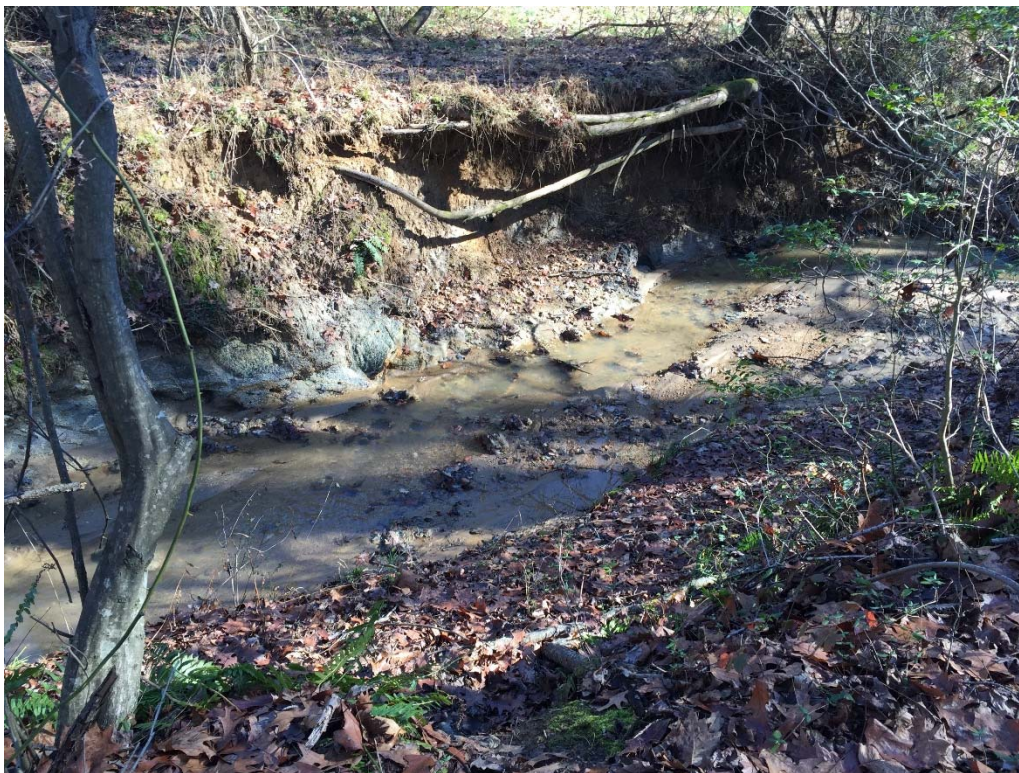
**Reach 4 Typical Condition at Downstream End.**

- Near the downstream end of Reach 4, transition the floodplain and channel to match conditions downstream of the project

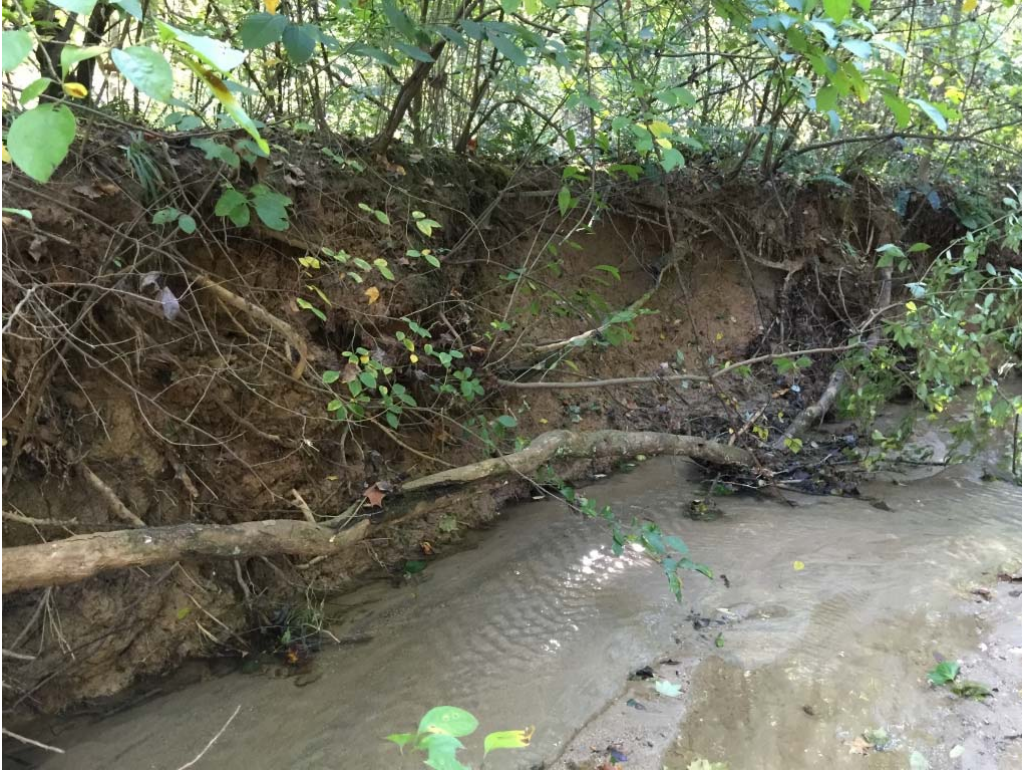
*Reach 5:* Reach 5 spans from the downstream end of Reach 4, at the Sports Complex property boundary, to I-40. The reach is generally incised, due to a head cut that has migrated upstream into Reach 4. Reach 5 does contain eroding streambanks, poor floodplain access, and poor vegetation. Restoration of Reach 5 would create a stable, meandering stream with appropriate cross-section dimensions, a wide floodplain, and healthy riparian vegetation. Two conceptual options have been developed for Reach 5. Both options include:

**Reach 5 Typical Condition.**

- Create a new stream channel with appropriate meander pattern, bedform profile, cross-section dimension (channel width of approximately 14-16 feet), and stable streambanks
- As needed, install log and boulder structures in the streambed to enhance habitat, promote sediment transport, provide grade control, and protect streambanks
- Revegetate the streambanks and floodplain with appropriate native riparian vegetation
- Fill much of the old stream channel, with portions used to treat stormwater runoff from the adjacent forest and sewer right-of-way
- Manage stormwater within the watershed through use of sediment traps, bare area stabilization, vegetated swales, and infiltration

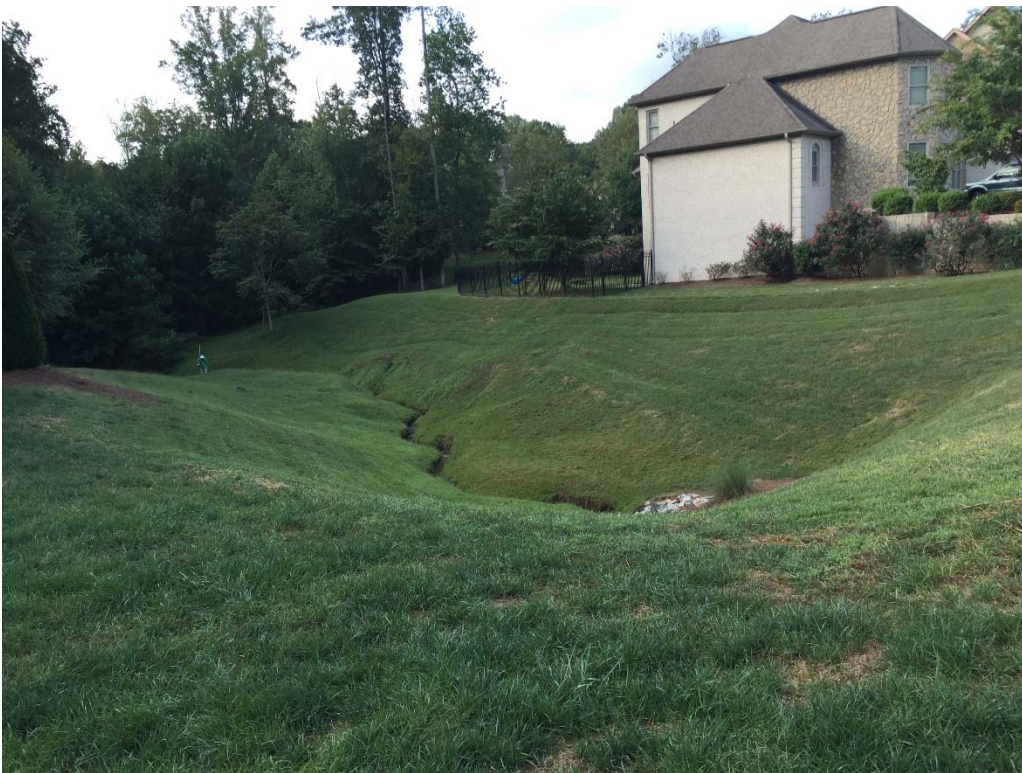
BEHI scores for Reach 6 were generally either 'Low' or 'High,' with instances of 'Moderate' and 'Very Low' (through the piped section). The upper third (approximately 350 feet) of Reach 7 had 'High' and 'Very High' BEHI, while the remainder of the reach had 'Low' and 'Moderate' BEHI. Within Reaches 6 and 7, the BEHI/NBS analysis likely did not fully capture erosion potential, due to the presence of head cuts and eroding bluffs. The high erodibility in all reaches is supported by visual observations of eroding banks, fallen trees, and downstream sediment deposition.

**Reach 6 Typical Condition at Upstream End.**

- Within the forested area downstream of the residential area, grade streambanks to reduce erosion, provide floodplain access, and create the design channel width (approximately 6-7 feet)

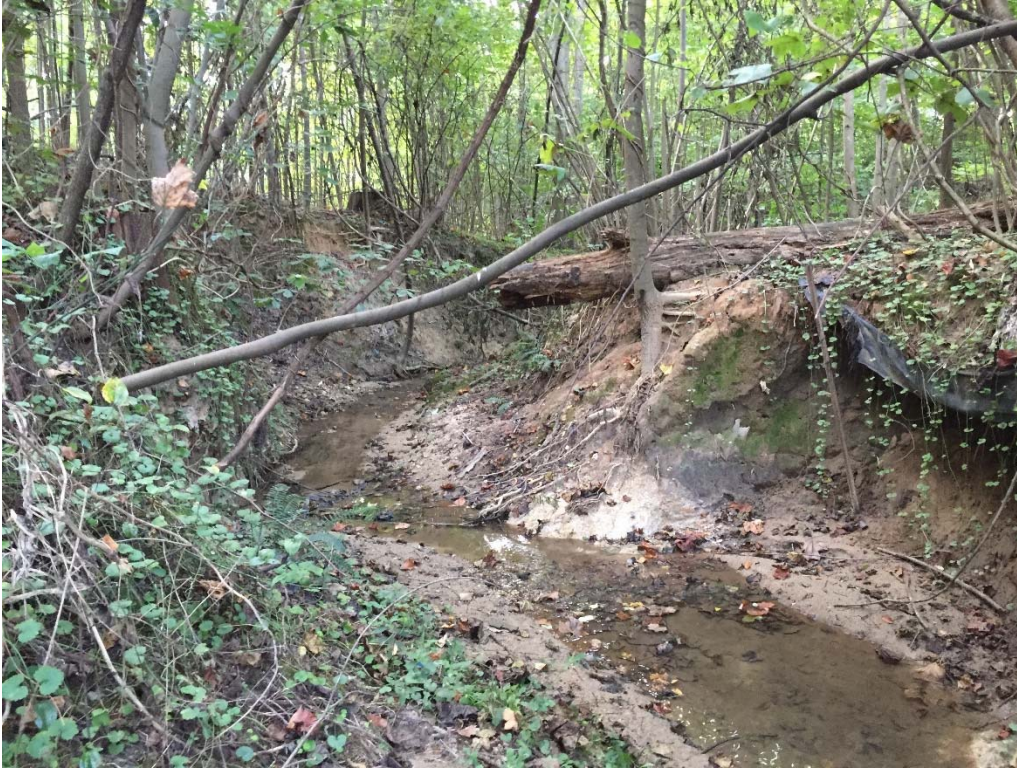
**Reach 6 Typical Condition at Downstream End.**

- Within the lowest 200 feet of Reach 6, where the stream closely parallels the sewer line, make no changes to stream dimension or planform, but install appropriate riparian vegetation

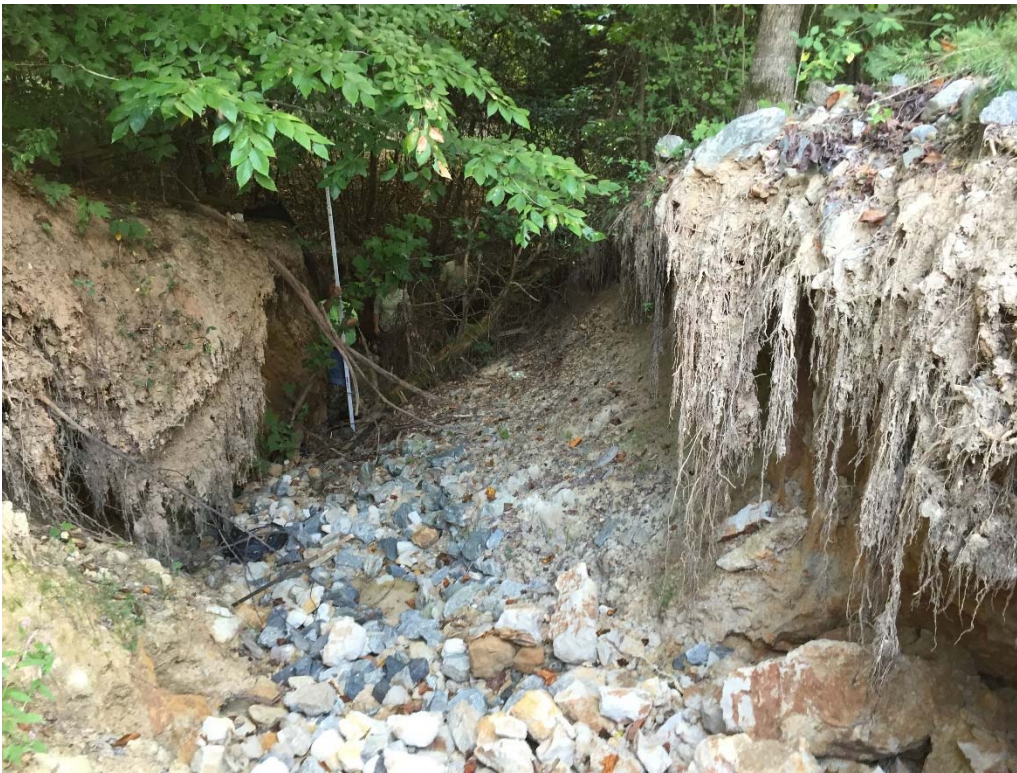
**Reach 6 Side Channel Head Cut.**

- Stabilize the stormwater-driven head cut off of Constantine Place with one of two options that include a Regenerative Stormwater Conveyance (RSC):
  - Option 1: Install a rock-lined energy dissipation basin at an elevation near the upper elevation of the head cut; fill the head cut with a 56-foot long RSC, with multiple steps, to convey flow from the basin to Reach 6

- Option 2: Install a stormwater inlet/drop structure at an elevation near the upper elevation of the head cut (build an earthen berm to force flow into the inlet); convey flow through a pipe for approximately 20 feet into an energy dissipation basin, then into a 36-foot long RSC

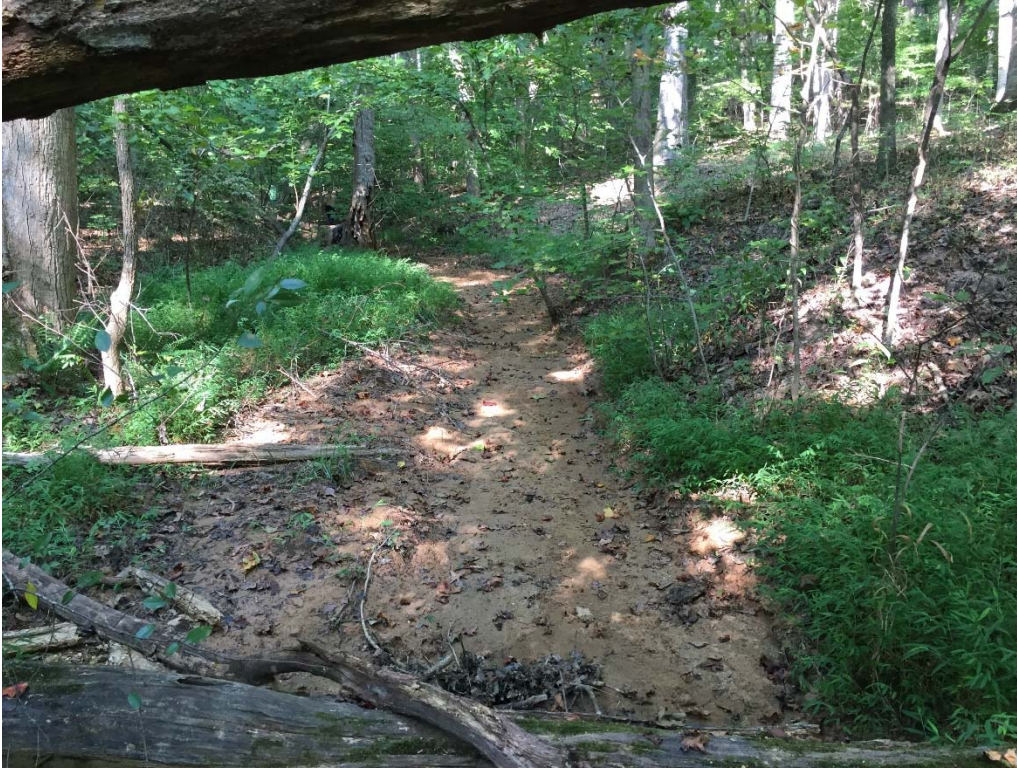
The downstream portion of Reach 7 is not incised or entrenched. Further upstream on Reach 7, the stream transitions to an incised, entrenched gully, with eroding head cuts migrating up valley during storm events.

**Reach 7 Typical Condition at Downstream End.**

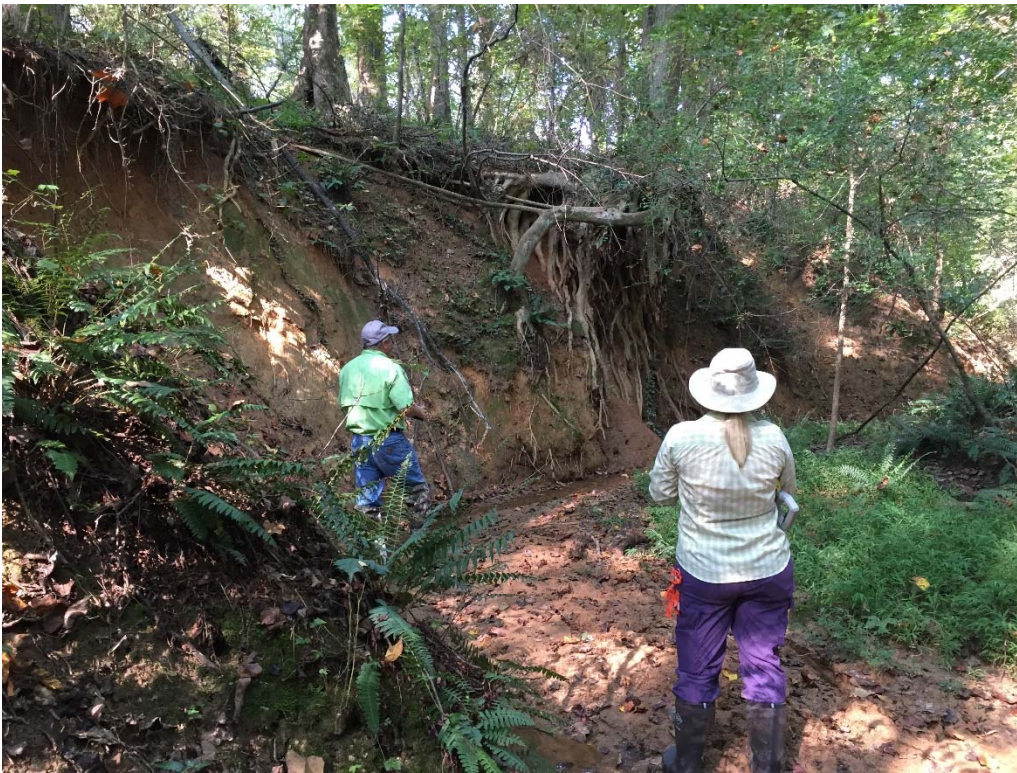
*Reach 7:* The upper end of Reach 7 is characterized by severe head cuts and eroding banks. By the lower end of the reach, the stream has stable dimensions and some floodplain access. A stream restoration project on Reach 7 would focus on enhancing habitats and improving water

**Reach 7 Typical Condition at Upstream End.**

- Leave the stream channel in its existing planform location, with the exception of localized realignment to mitigate eroding streambanks and head cuts

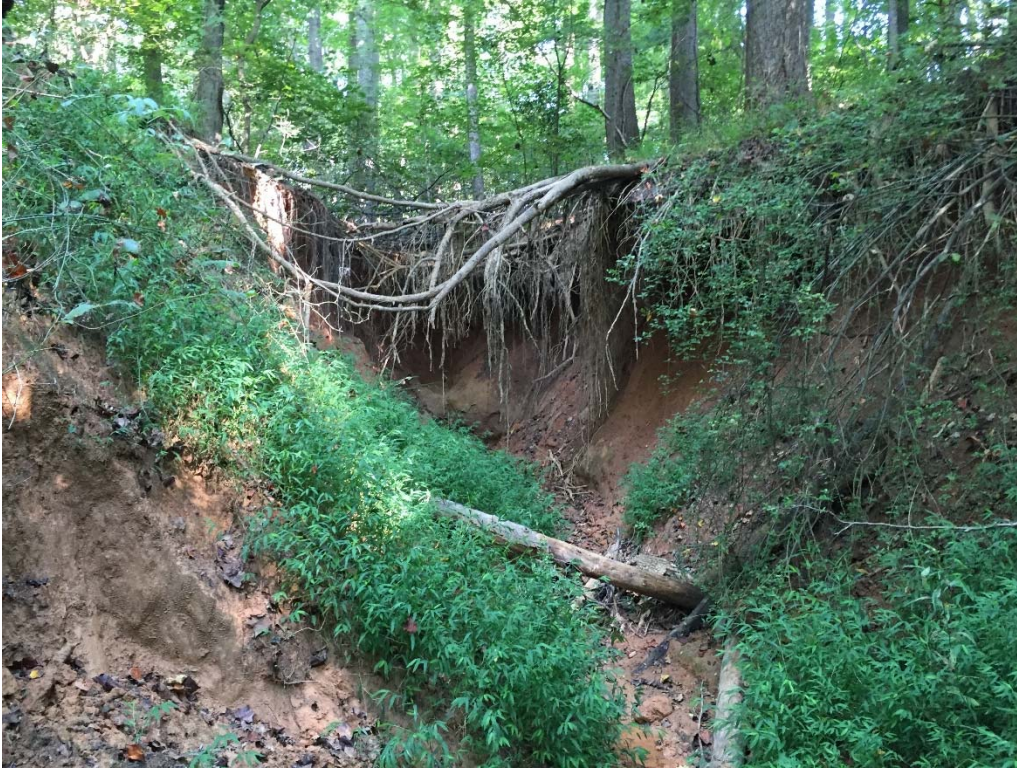
**Reach 7 Head Cut at Upstream End.**

- Install a log or boulder grade control structure downstream of the sewer line crossing
- Stabilize the head cuts at the upstream end of the reach using a Regenerative Stormwater Conveyance (RSC) with multiple steps
