January 7, 2022

RE: Hazardous Materials Testing Report Contract # 22-0005 Pamplin Building Roof Asbestos Sampling Dinwiddie, Virginia 23841 KBJW Project No. 2021-2021

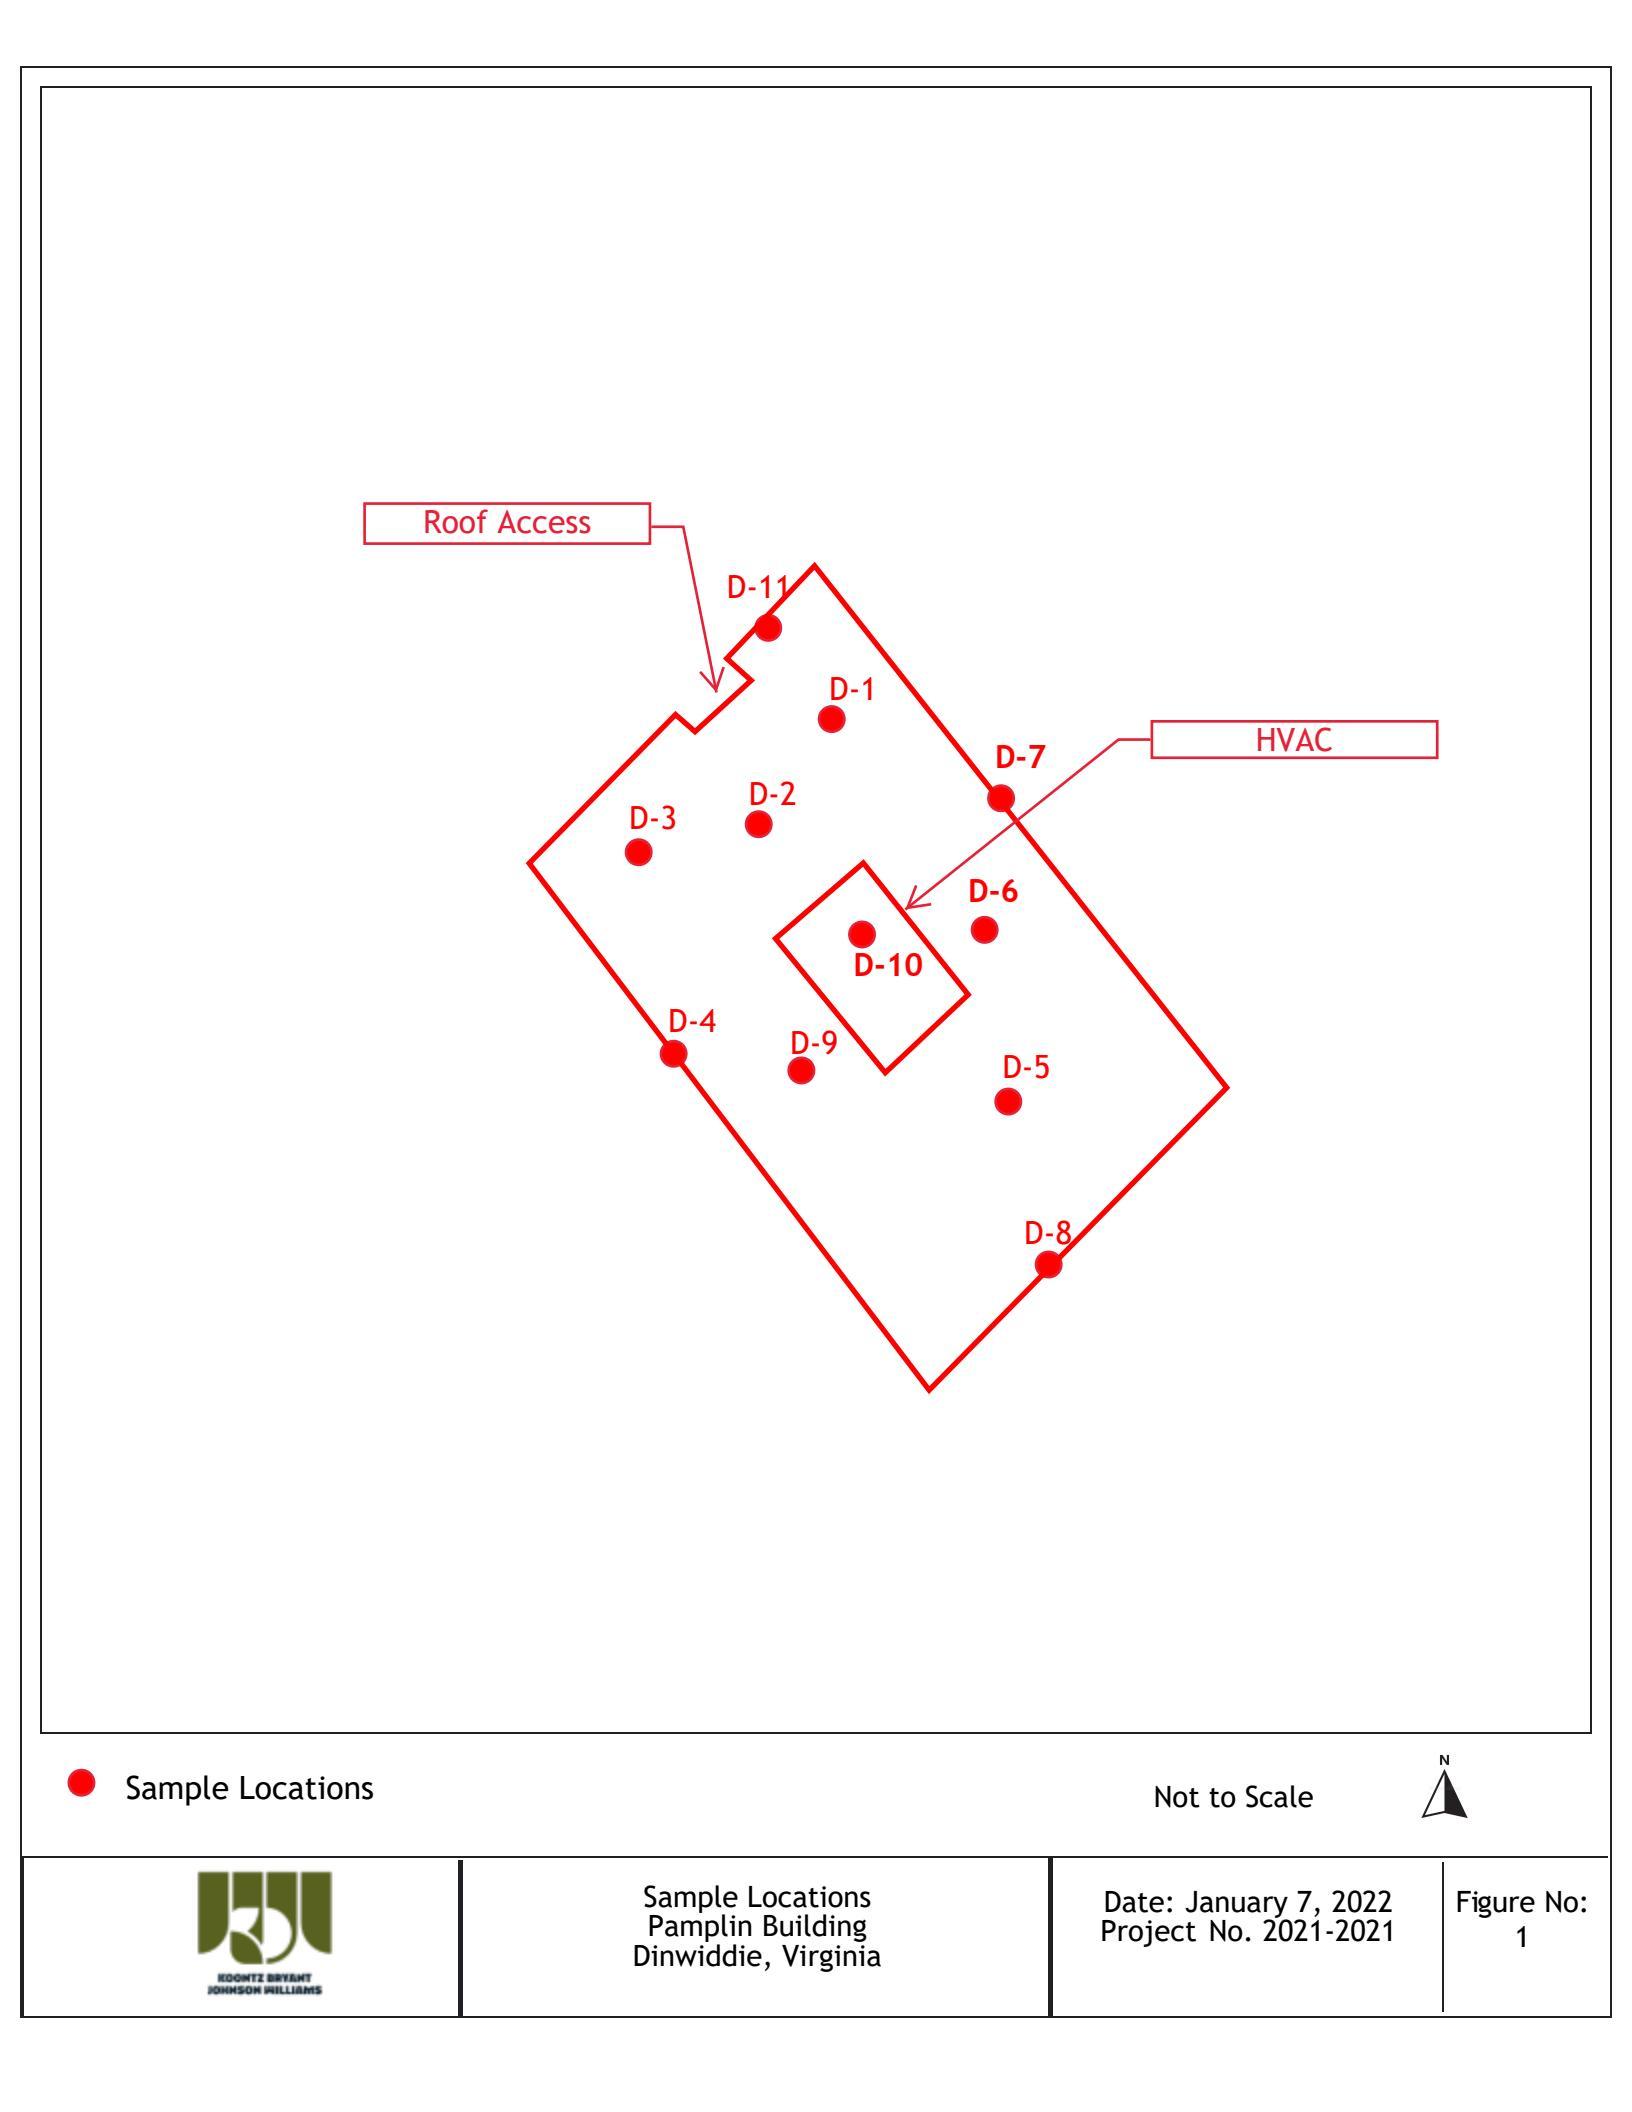
SAMPLE LOCATIONS

A summary of the sampling and analysis results (Attachment B) is presented in the following table. Sample locations are shown on Figure 1.

SampleID	Description	Asbestos Percent/Type	Condition
D-1	Field roofing felts, insulation	NAD	Good
D-2	Field roofing felts, insulation	NAD	Good
D-3	Field roofing felts, insulation	NAD	Good
D-4	Field roofing felts, insulation	NAD	Good
D-5	Field roofing felts, insulation	NAD	Good
D-6	Field roofing felts, insulation	NAD	Good
D-7	Flashing parapet wall	NAD	Good
D-8	Flashing parapet wall	NAD	Good
D-9	Flashing parapet wall	NAD	Good
D-10	Flashing, pitch pocket HVAC	Trace <1%	Good
D-11	Flashing parapet wall	NAD	Good
