5533 and 5535 Sun Valley Drive ACM Abatement and Demolition Scope of Work to Procure Abatement and Demolition Contractor

ASBESTOS CONTAINING MATERIALS SURVEY

ESCAMBIA COUNTY PROPERTIES
Single-Family Residence
5535 Sun Valley Drive
Pensacola, Escambia County, Florida

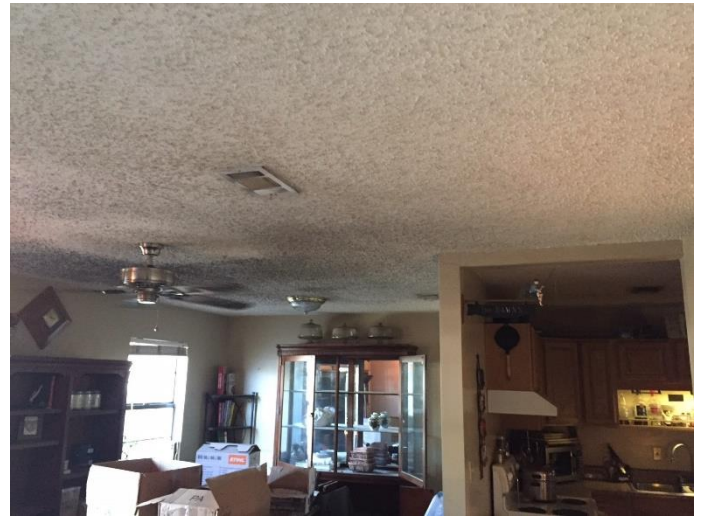
4. Representative view of drywall ceiling with spray texture (SV3-9 - SV3-14)

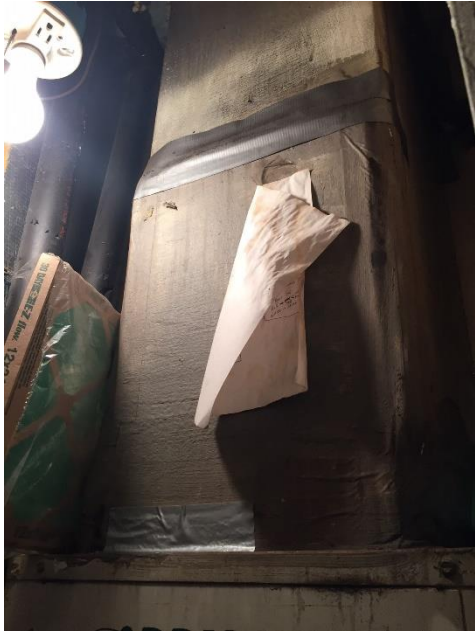
5. View of HVAC unit/ HVAC Mastic (SV3-22 – SV3-24)

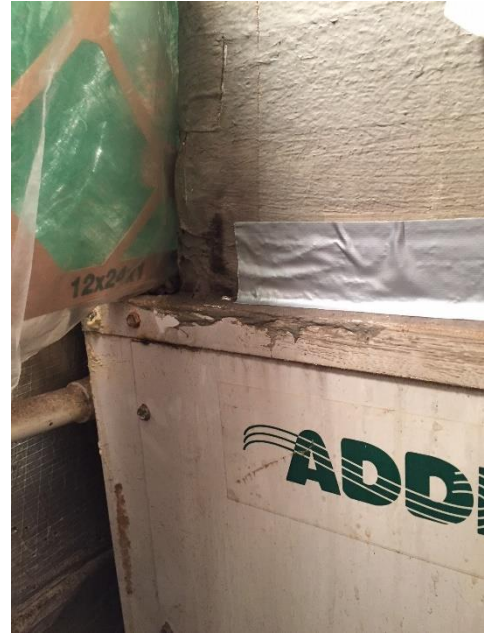
6. Alternative view of HVAC unit/ HVAC Mastic (SV3-22 – SV3-24)

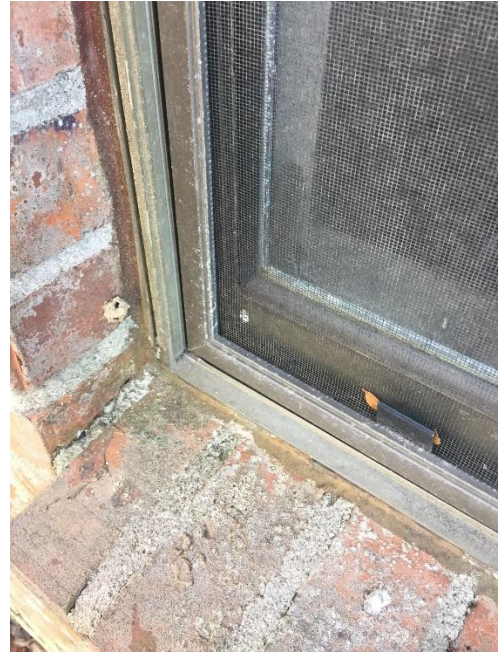
10. Representative view of window sealant (SV3-25 - SV3-27)

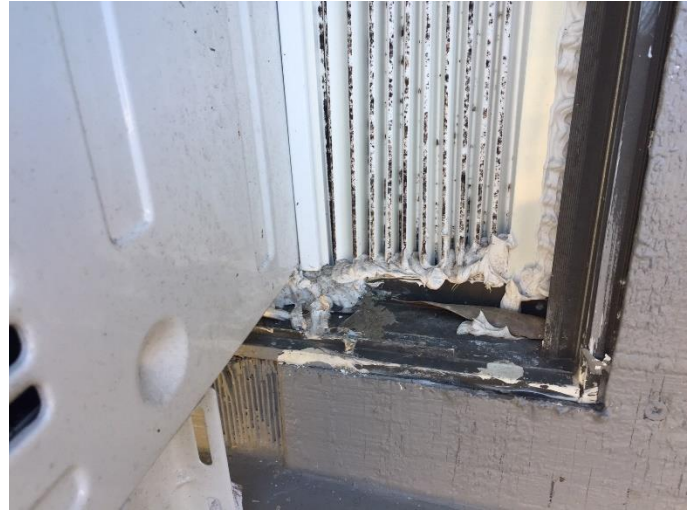
2. Representative view of window sealant material (SV5-16 – SV5-18)

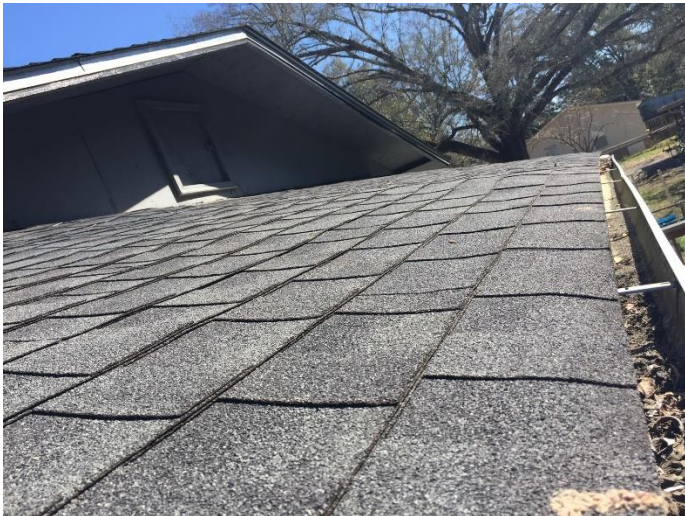
3. Representative view of roofing shingle material (SV5-1 – SV5-3)

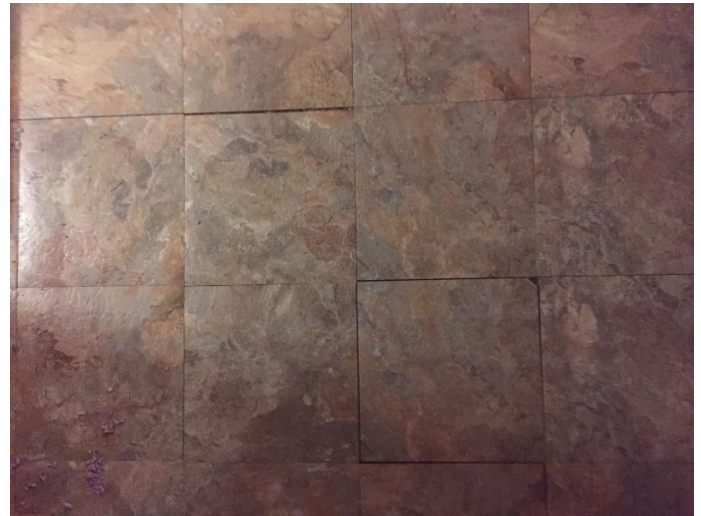
4. Representative view of vinyl flooring material (SV5-23)

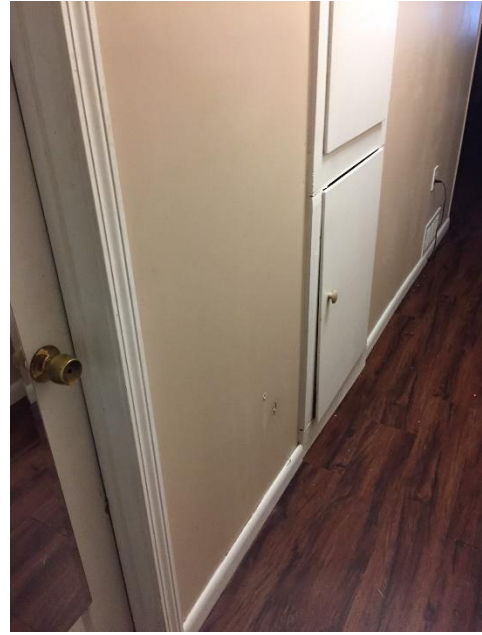
6. Representative view of drywall partition walls material (SV5-13 - SV5-15)

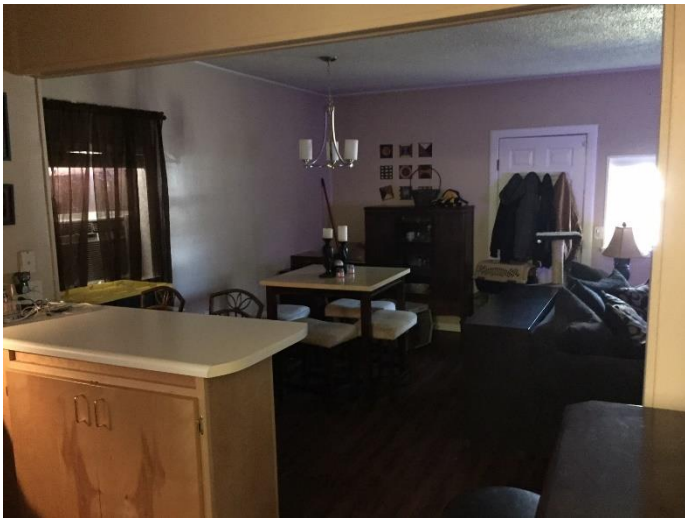
During this study, twenty-five (25) samples of building materials including flooring materials, wall texture, sealant materials, pipe material, and roofing material were collected by NOVA and evaluated using Polarized Light Microscopy (PLM), with one (1) of the analyzed homogeneous sample layers indicating asbestos containing materials (ACM). The drywall ceiling with spray texture (popcorn ceiling) was found to be positive for asbestos. If this material becomes damaged or is otherwise compromised, or if it is subject to impact from renovation or demolition activities the material must be removed by a Florida Licensed Asbestos Contractor.

7. View looking at room 1 (Including ACM positive 2% drywall ceiling w/ spray texture)

During abatement, third party monitoring is recommended to review if the asbestos is adequately managed and contained during the abatement process and to document clearance and re-occupancy criteria established for the project.

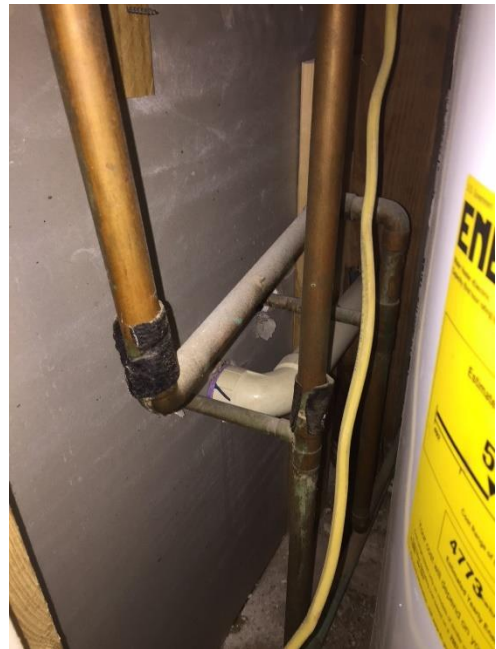
8. Representative view of pipe insulation material (SV5-19 - SV5-21)
