CITY OF BATTLE CREEK
NOTICE OF INVITATION FOR BIDS

IFB# 2019-050B Demolition

**NESHAP RENOVATION / DEMOLITION INSPECTION OF
ASBESTOS CONTAINING MATERIALS
AND OTHER HAZARDOUS WASTE MATERIALS**

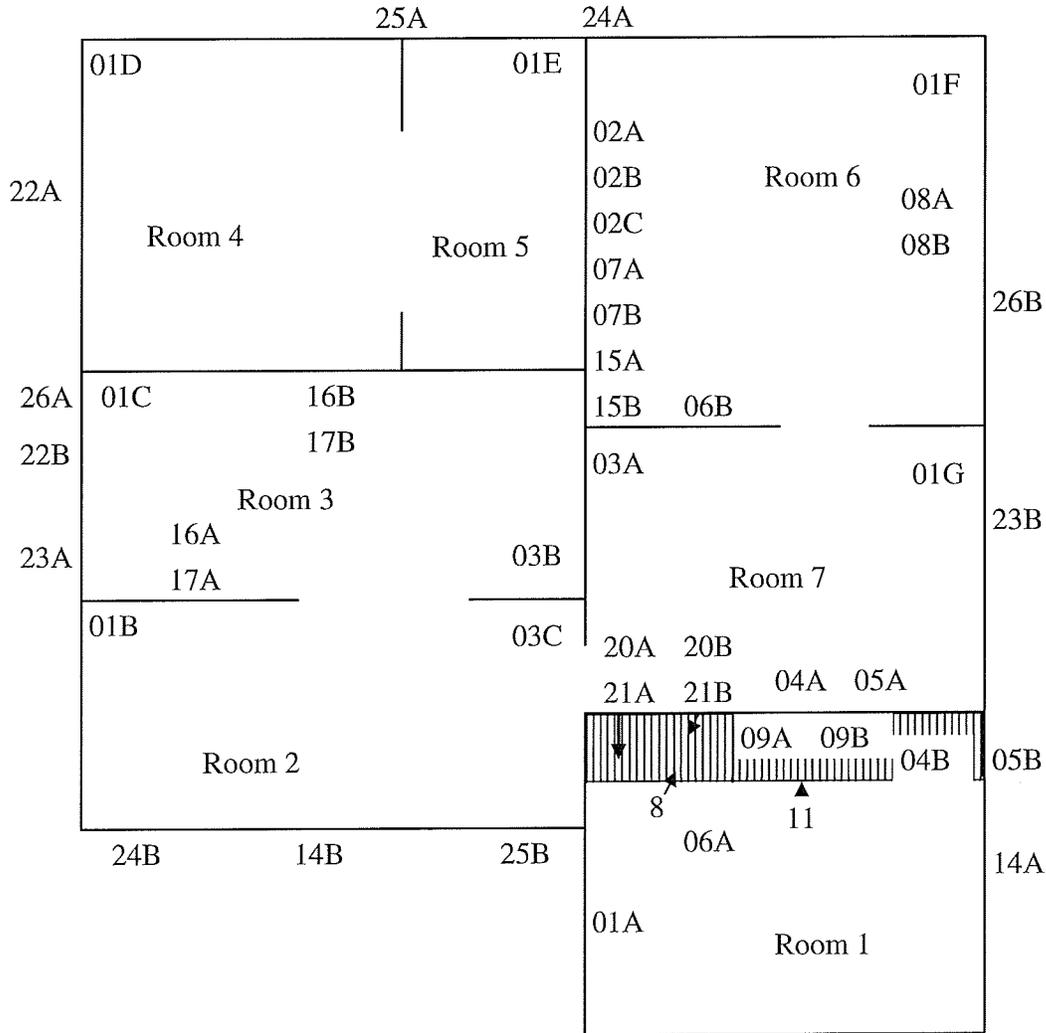
1st floor

Please Note: This is a rough floor plan only. All items, (doorways, Windows, etc.) may not be included in this illustration. Also, room and component sizes are not drawn to scale.

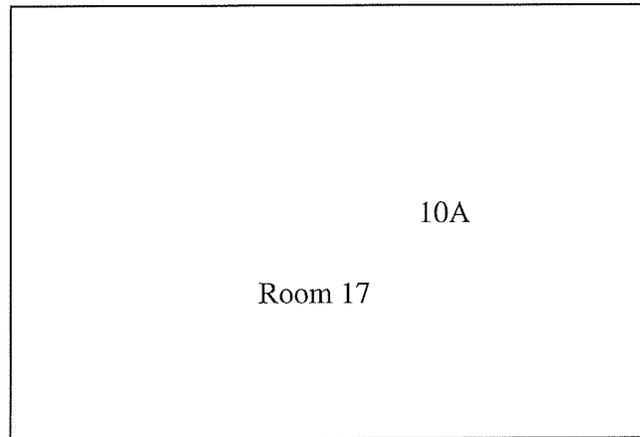
Attic

Please Note: This is a rough floor plan only. All items, (doorways, Windows, etc.) may not be included in this illustration. Also, room and component sizes are not drawn to scale.

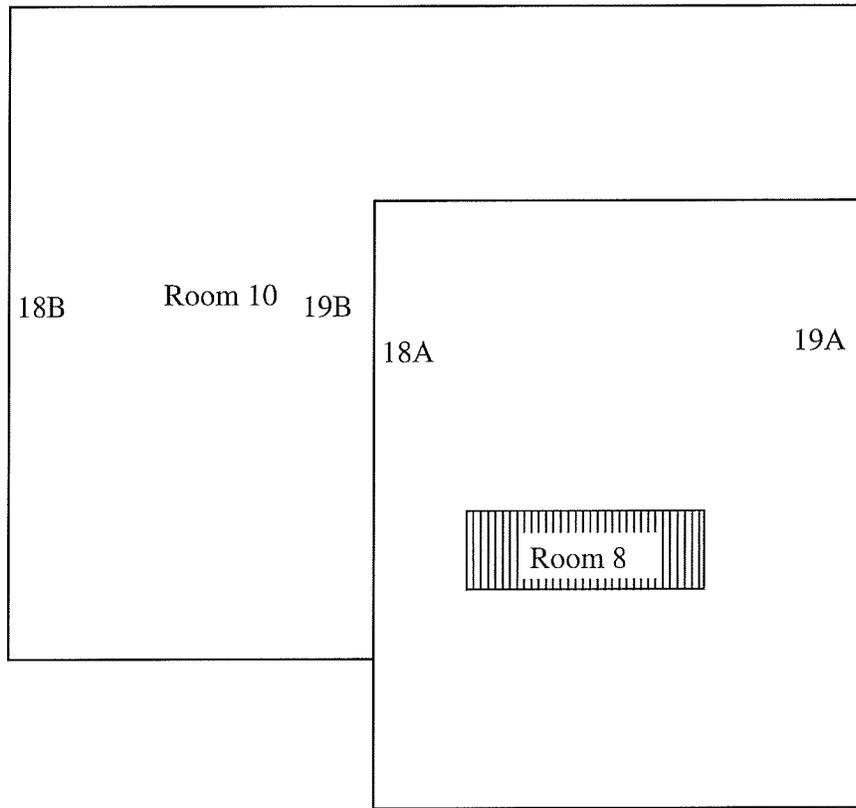
Basement

Please Note: This is a rough floor plan only. All items, (doorways, Windows, etc.) may not be included in this illustration. Also, room and component sizes are not drawn to scale.

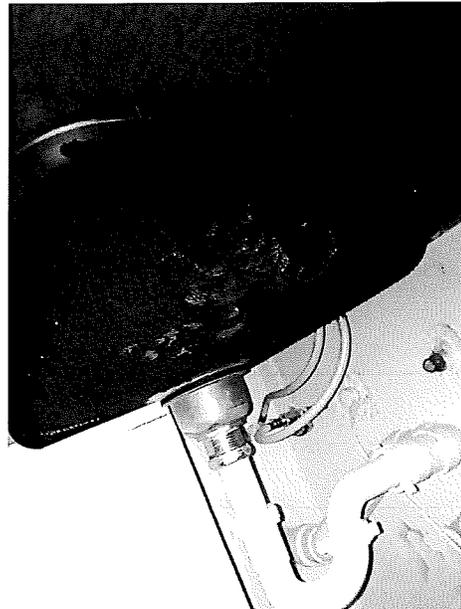
Sink Undercoat, brown

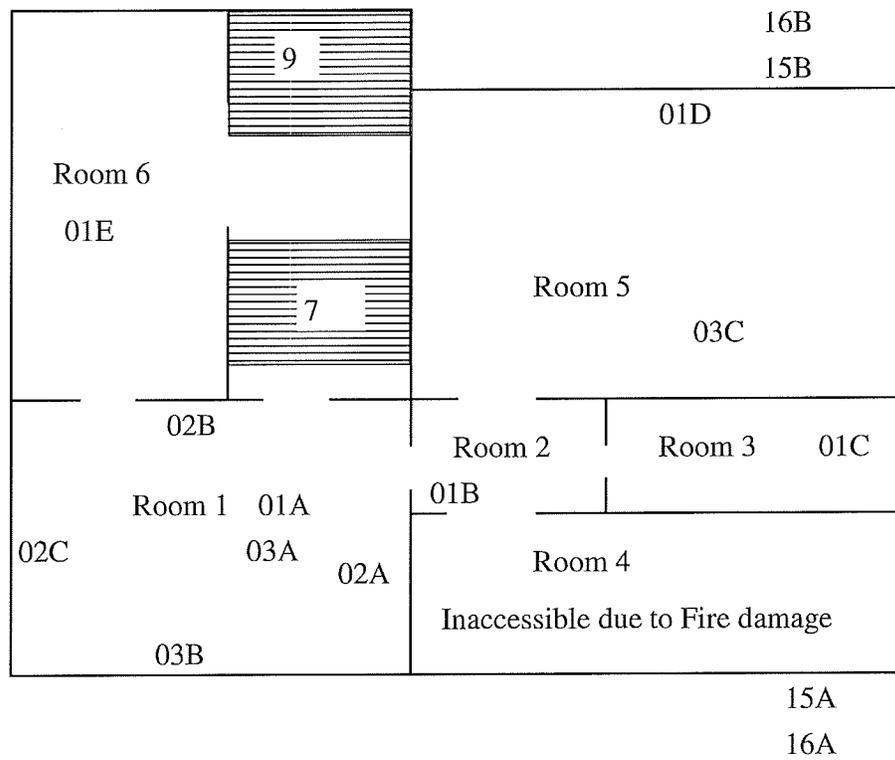
1st floor

Please Note: This is a rough floor plan only. All items, (doorways, Windows, etc.) may not be included in this illustration. Also, room and component sizes are not drawn to scale.

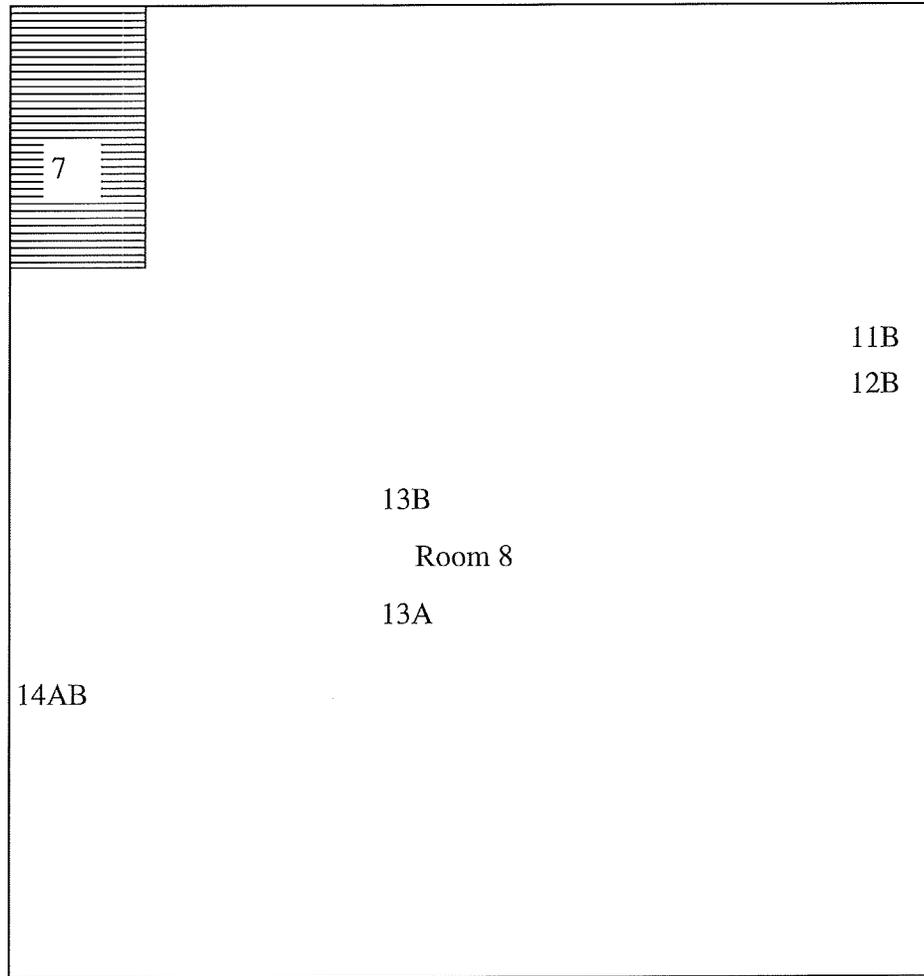
2nd floor

Please Note: This is a rough floor plan only. All items, (doorways, Windows, etc.) may not be included in this illustration. Also, room and component sizes are not drawn to scale.

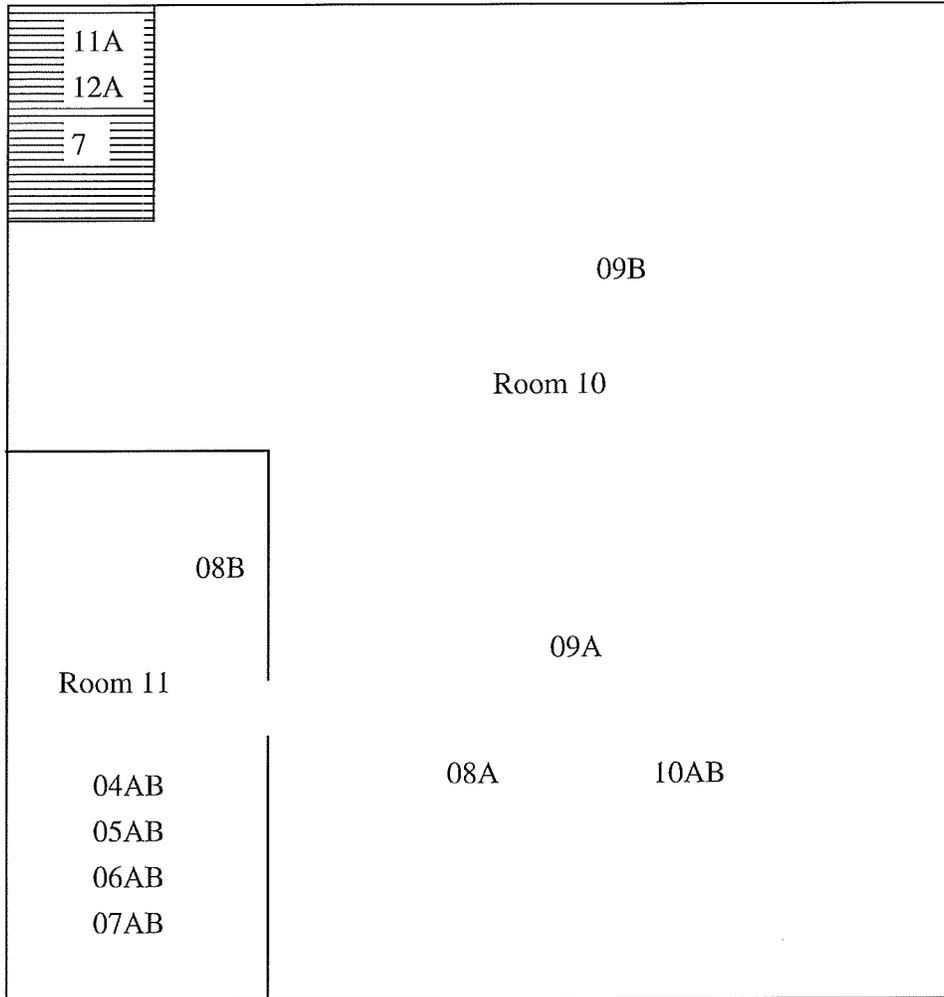
Basement

Please Note: This is a rough floor plan only. All items, (doorways, Windows, etc.) may not be included in this illustration. Also, room and component sizes are not drawn to scale.

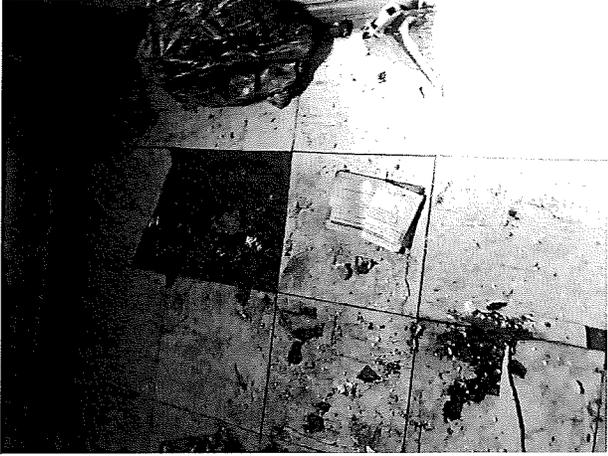
9X9 Tile, white

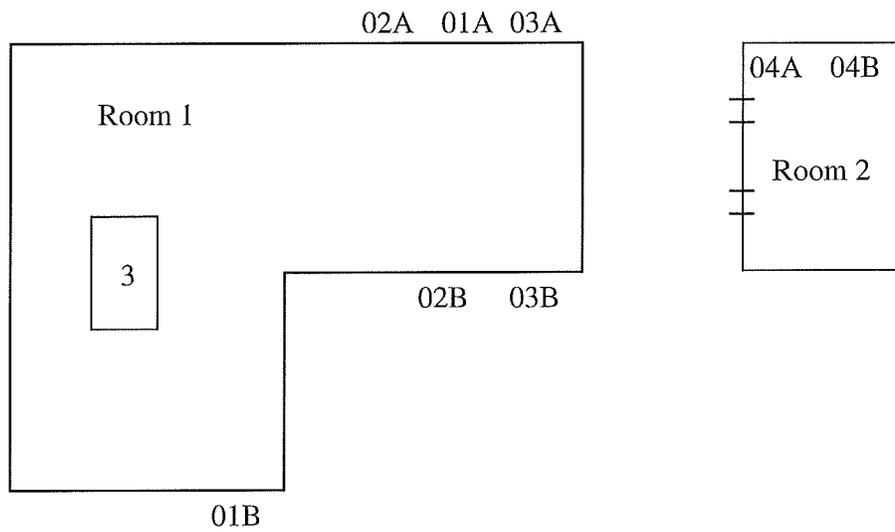
1st floor

Please Note: This is a rough floor plan only. All items, (doorways, Windows, etc.) may not be included in this illustration. Also, room and component sizes are not drawn to scale.

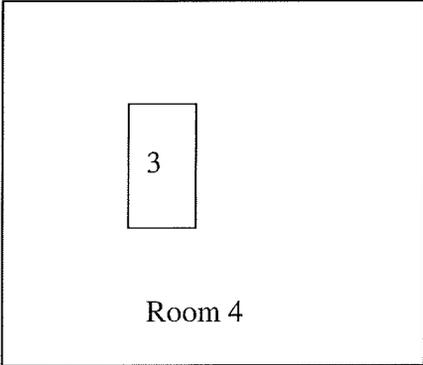
Basement

Please Note: This is a rough floor plan only. All items, (doorways, Windows, etc.) may not be included in this illustration. Also, room and component sizes are not drawn to scale.
