DATE: August 28, 2019
TO: Prospective Respondents
FROM: Amy Lucey, Contracts Administrator
SUBJECT: Addendum #2 to Invitation for Bids # 34798, S-96C Rehabilitation

**Subsurface Soil Exploration
Structure 96C Rehabilitation
Proposed Bypass Spillway
Indian River County, Florida**

Subject: Subsurface Soil Exploration
Structure 96C Rehabilitation
Proposed Bypass Spillway
Indian River County, Florida

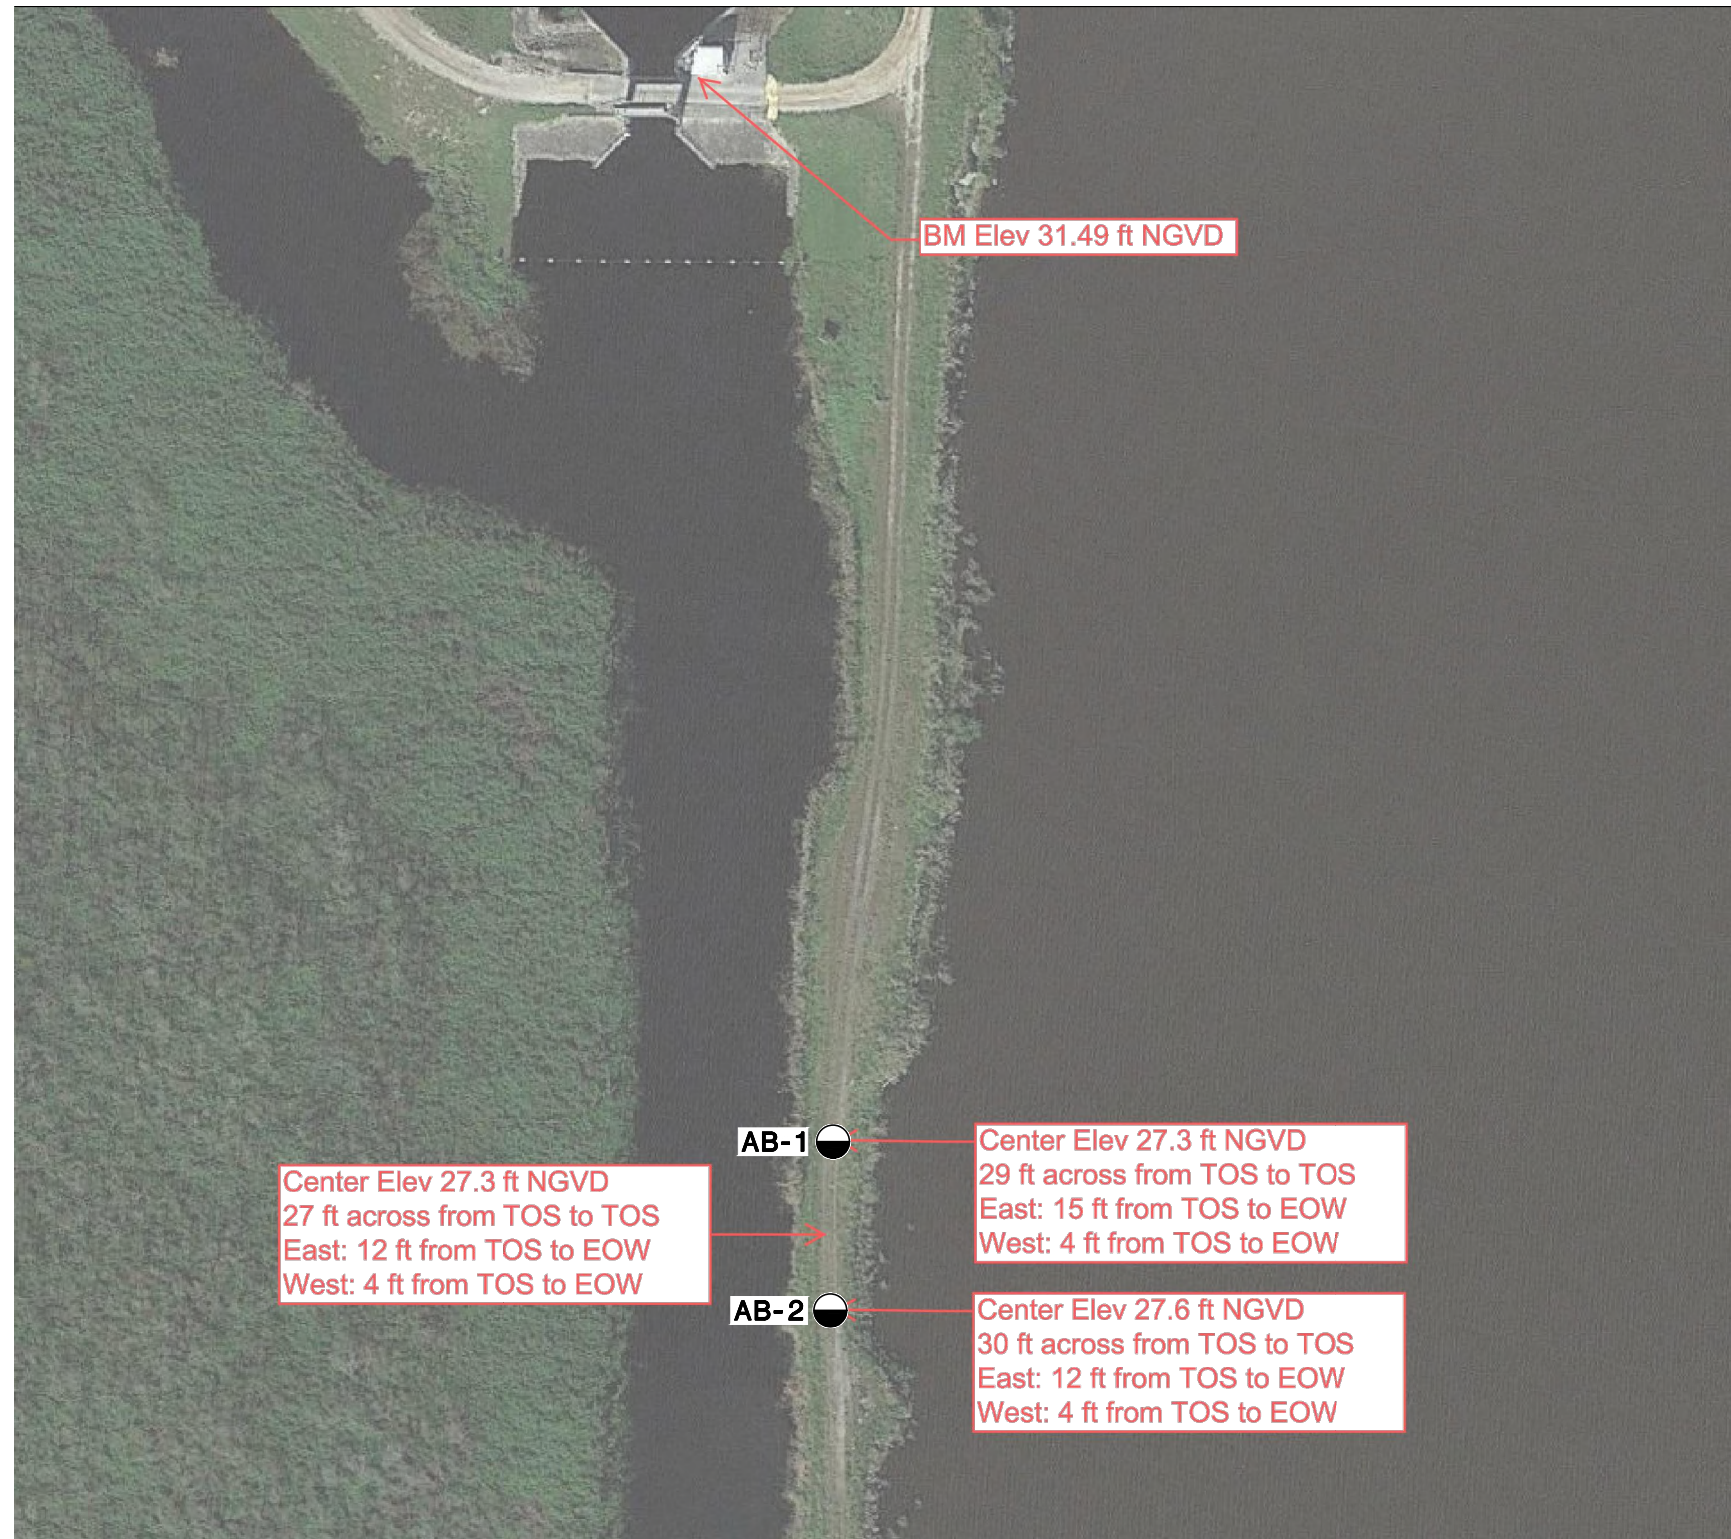
BORING LOCATION PLAN

The approximate locations of the borings are schematically illustrated on an aerial photograph provided by SJRWMD shown on Figure 2. These locations were staked in the field by others.

Center Elev 27.3 ft NGVD
 27 ft across from TOS to TOS
 East: 12 ft from TOS to EOW
 West: 4 ft from TOS to EOW

Center Elev 27.3 ft NGVD
 29 ft across from TOS to TOS
 East: 15 ft from TOS to EOW
 West: 4 ft from TOS to EOW

Center Elev 27.6 ft NGVD
 30 ft across from TOS to TOS
 East: 12 ft from TOS to EOW
 West: 4 ft from TOS to EOW

BM Elev 31.49 ft NGVD

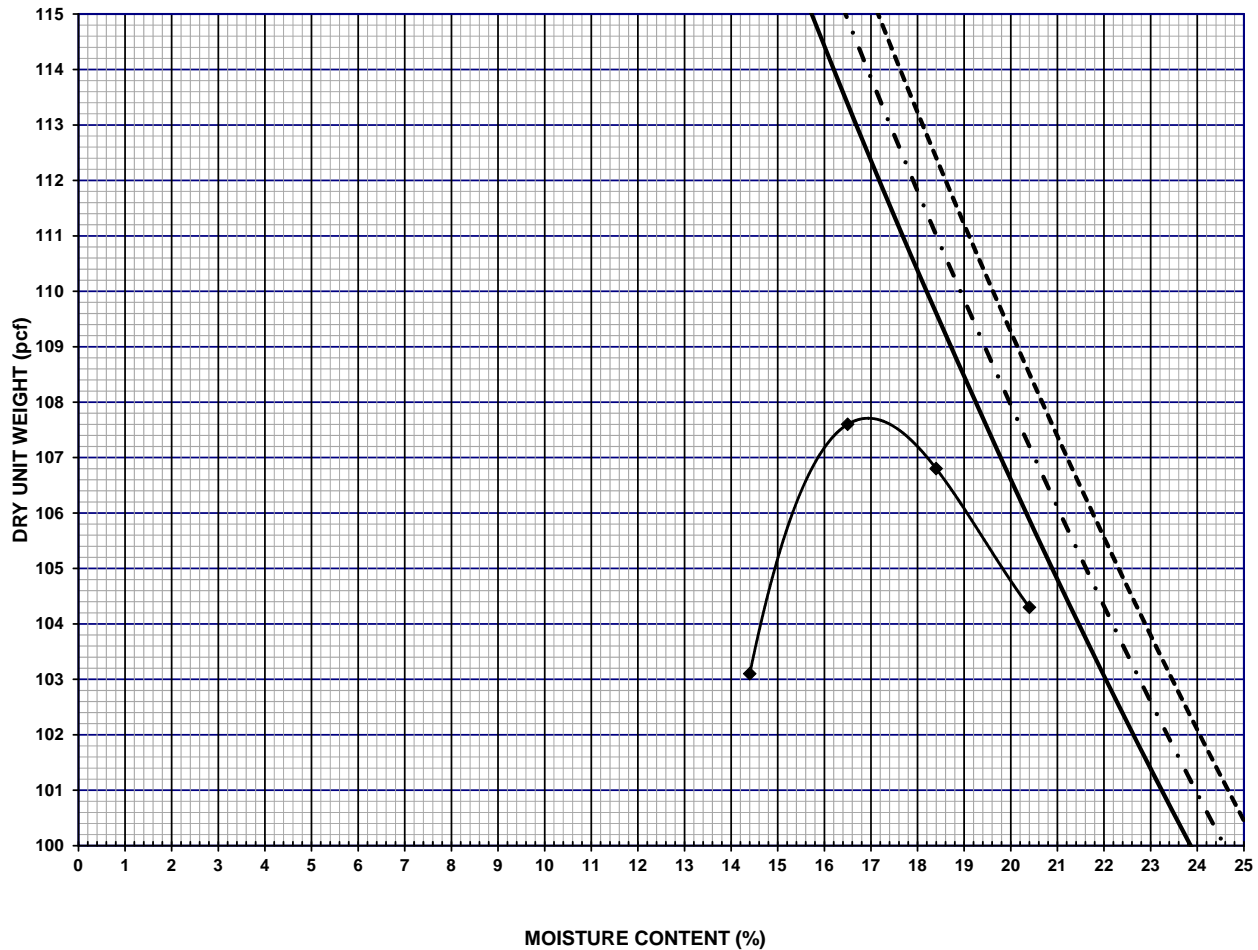
REPORT OF MOISTURE-DENSITY RELATIONSHIP

TEST RESULTS		
Maximum Dry Density (pcf)	Optimum Moisture Content (%)	Fines Passing #200 Sieve (%)
108.1	17.1	N/A

SAMPLE NUMBER: MP-1
 TEST METHOD: ASTM D-698
 SAMPLE DESCRIPTION: Green, gray and brown clay
 SAMPLE LOCATION: AB-1, 2 feet to 3 feet

In addition, we conducted 1 organic content test (ASTM D2974-87), 3 natural moisture content tests (ASTM D2216), 2 grain size analyses (ASTM D6913) and 3 percent fines analyses (ASTM D1140) on selected soil samples obtained from the borings. The results of these tests are presented adjacent to the sample depth on the boring profiles on Figure 3. A bulk sample for Standard Proctor testing was also obtained adjacent to Boring AB-1 from a depth range of 2 to 3 feet below ground surface. Results of the Standard Proctor test and the grain size analyses are presented in Appendix II.

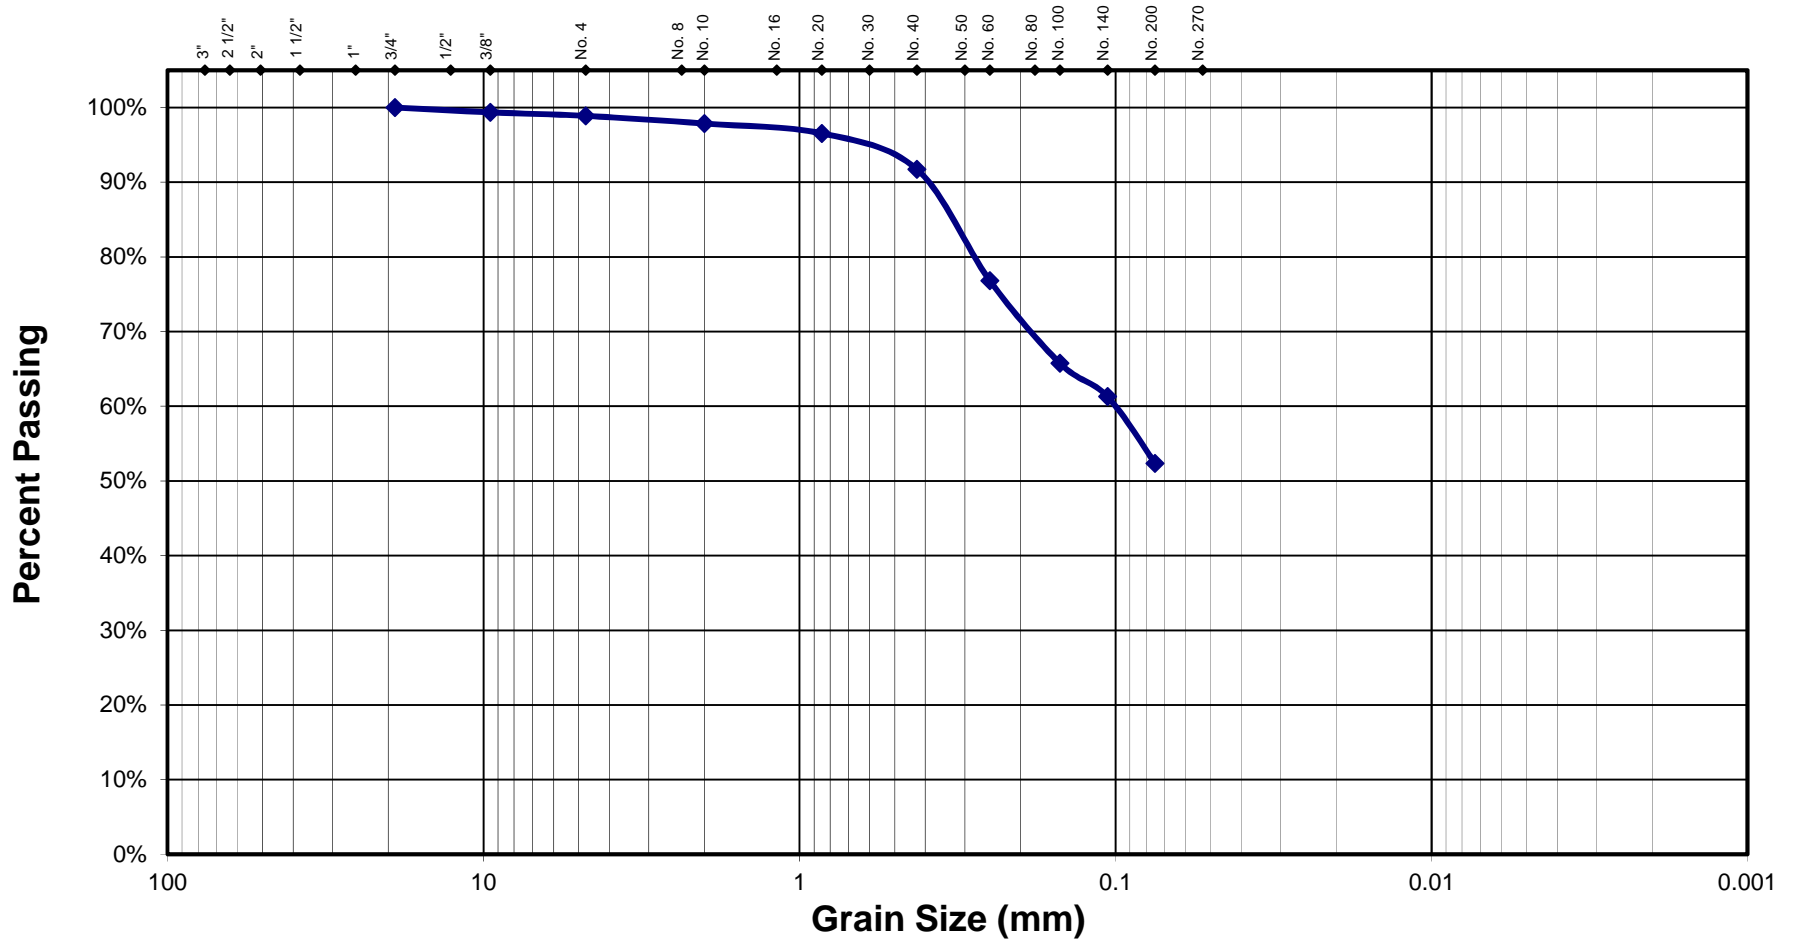
GRAIN SIZE DISTRIBUTION CURVE

Sample No.: 2 **Sample Location:** AB-1 (2-3')
Sample Description: CH - Gray Clay
Percent Passing No. 200 Sieve = 52.4% **LL:** Not Tested **PL:** Not Tested **PI:** Not Tested

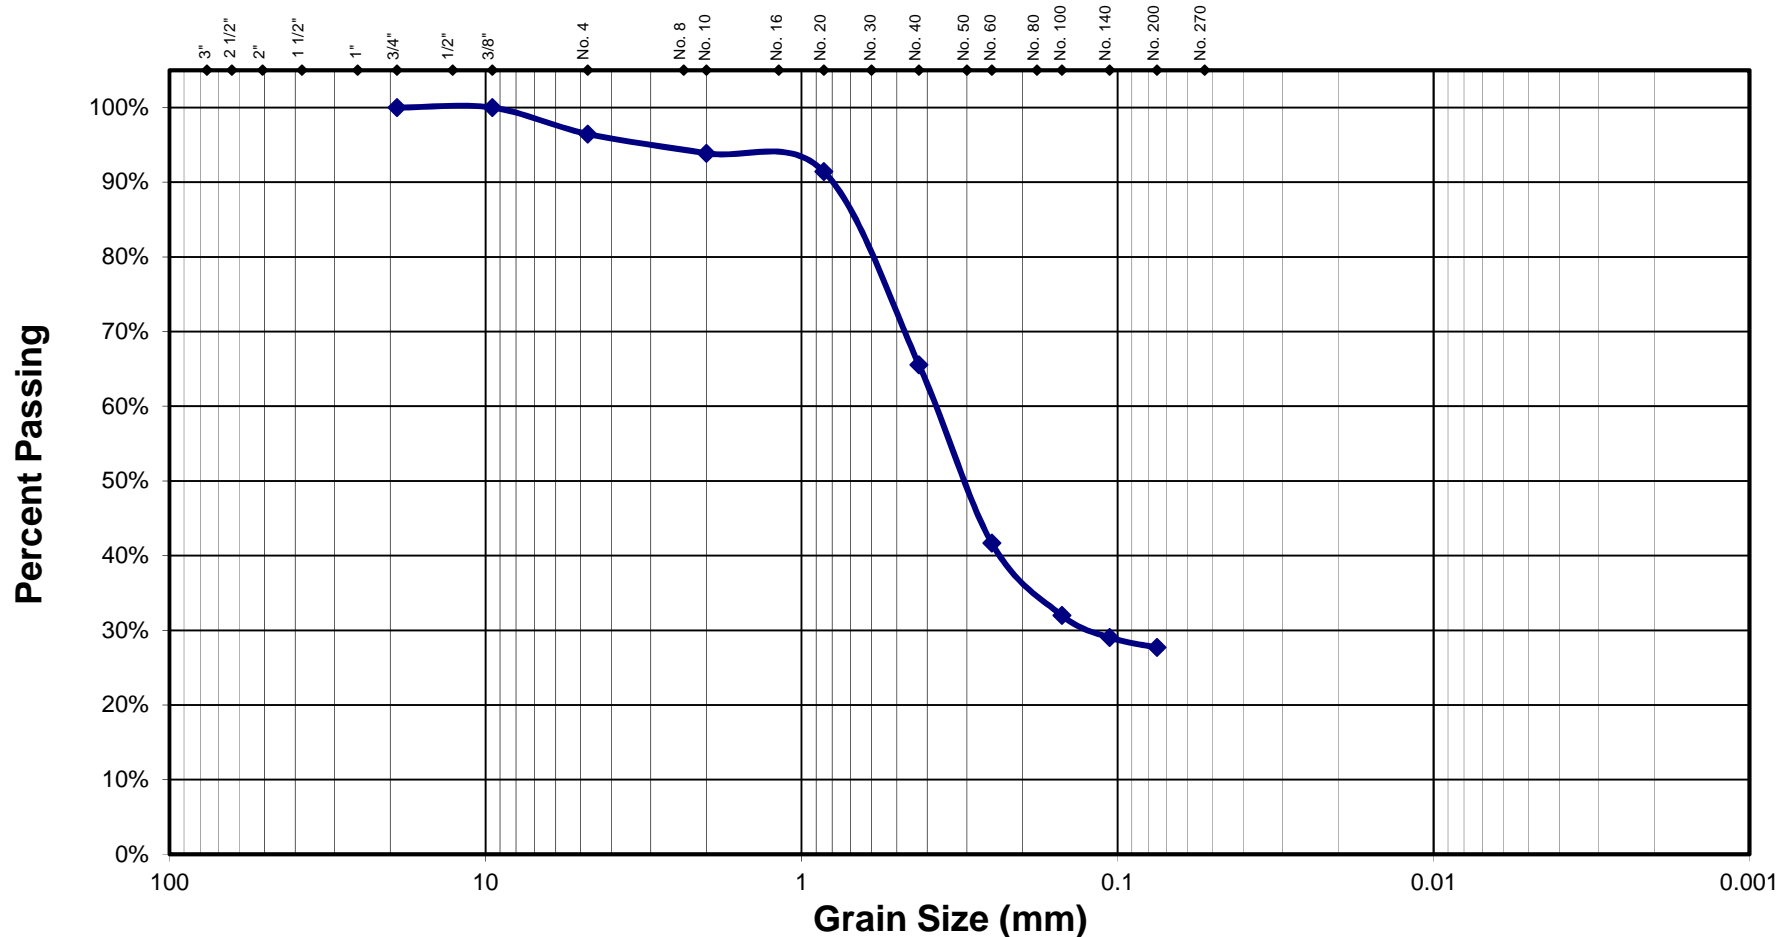
GRAIN SIZE DISTRIBUTION CURVE

Sample No.: W-8 **Sample Location:** AB-2 (2.5')
Sample Description: SC - Gray Clayey Fine Sand
Percent Passing No. 200 Sieve = 27.7% **LL:** Not Tested **PL:** Not Tested **PI:** Not Tested
