ADDENDUM NO. 1

Project Name: Jones Pier Residences Repairs for PO-04-FL-4283-PW-00796(0)

Subject: Structural Inspection – Historical Jones Pier Residence
7770 Jungle Trail
Vero Beach, Florida 32963
Engineer's Project Number: 18J021
IRC PO# 80385-00

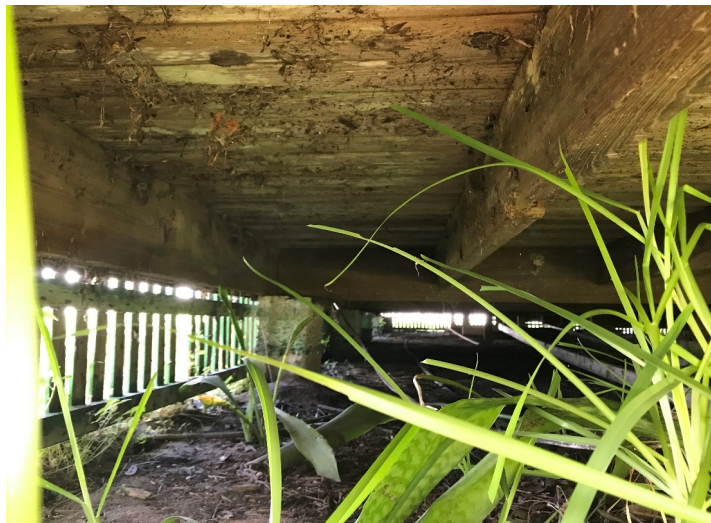
Picture showing difference in bearing height for joists and beams

- The difference in bearing height between the interior beams and perimeter beams will most likely require a combination of blocking and shims to accommodate the difference in bearing heights during the lifting operations.

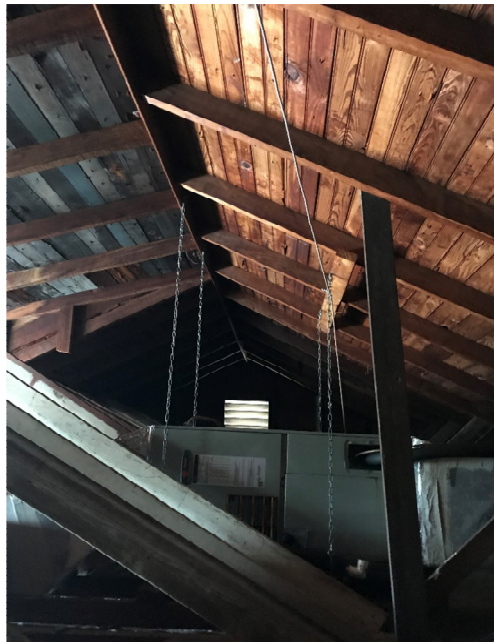
- The rafters have a diagonal and/or vertical chord near the middle of the span that connects to two interior walls that run north to south.
 - The bottom chord of the roof system was connected to the ceiling rafters with 2x4 blocks.

Picture showing rafters in attic with diagonal to wall below

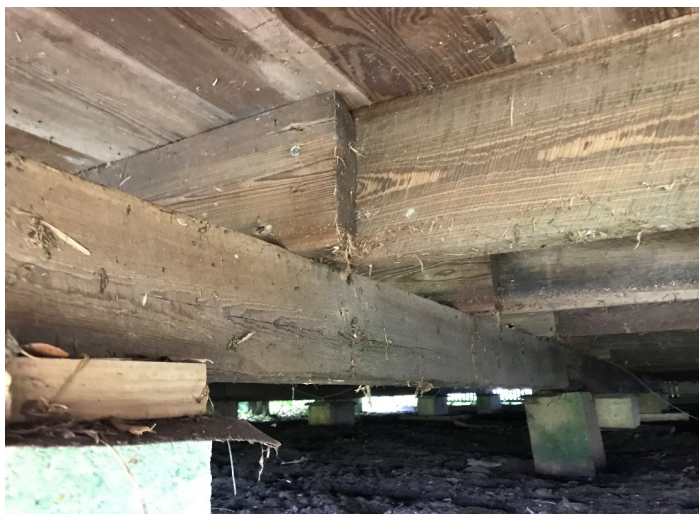
- The beam to beam connection over the CMU piers does not have a plate or splice connection. This may encourage movement if they are not braced and lifted properly.

Picture showing joists to beam connection and beam to beam scenario over CMU pier
