# Geotechnical Engineering Report

**Lubber Run Park Pedestrian Bridge  
Arlington, Arlington County, VA**

June 17, 2022

Terracon Project No. JD205321

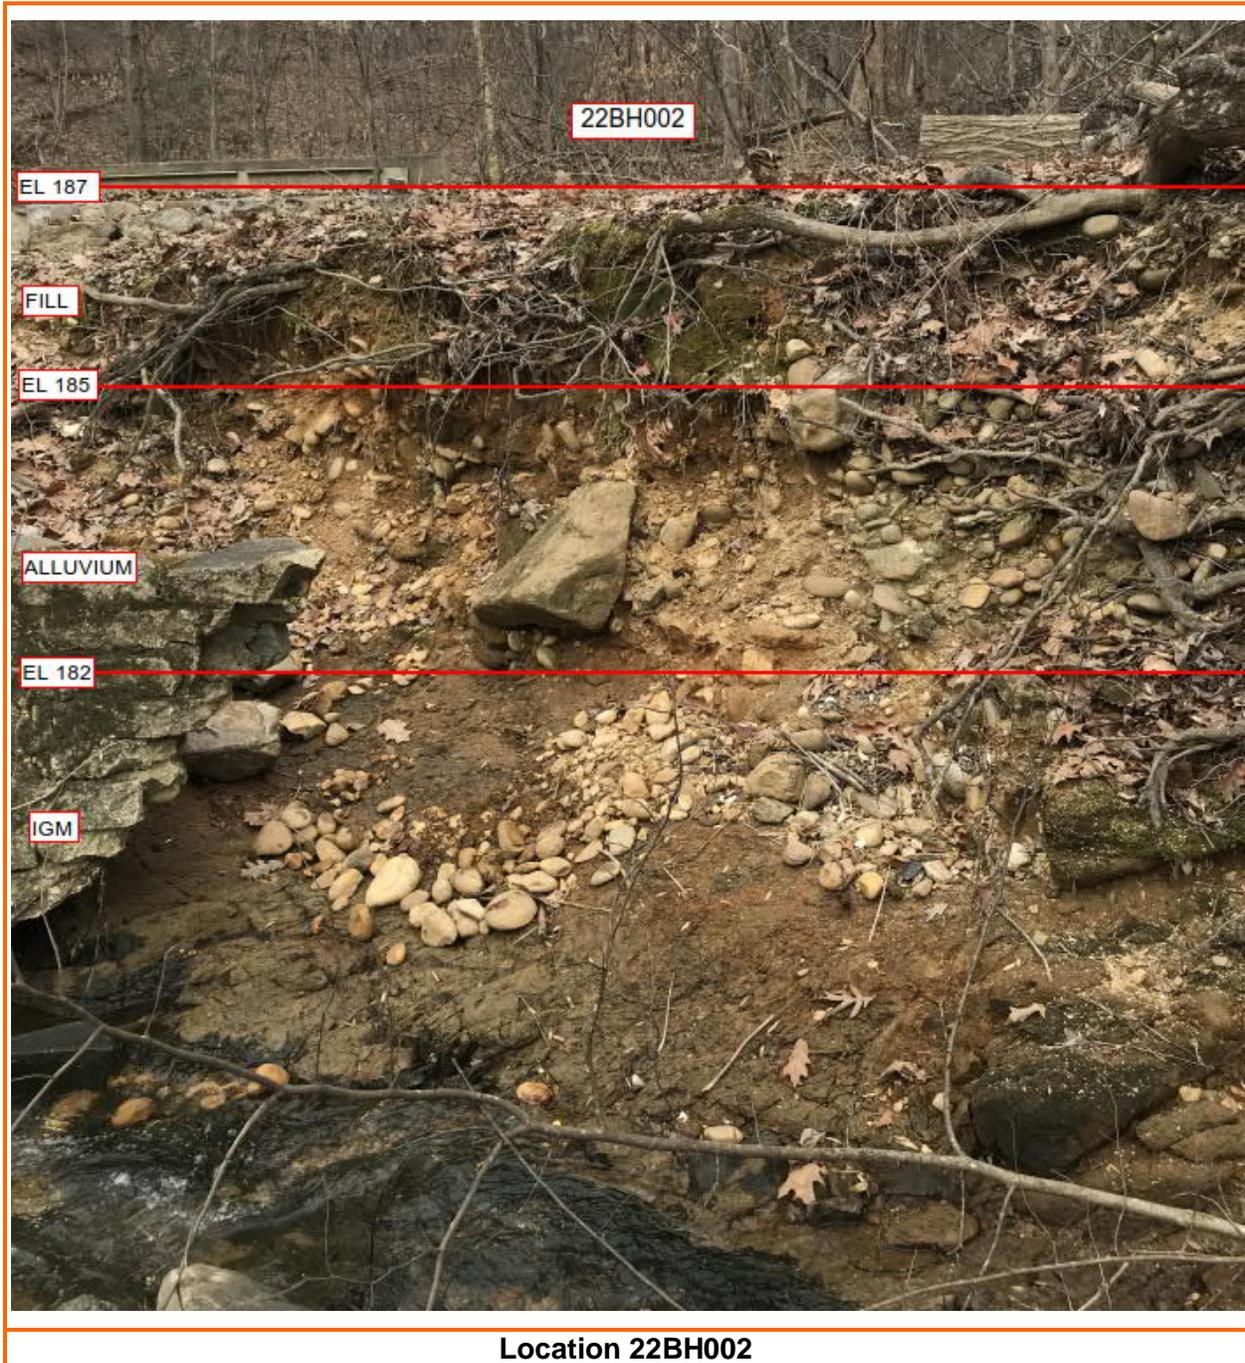
**PHOTOGRAPHY LOG**

A photo of the embankment cut with elevations and strata is provided in our [Photography Log](#).

The geotechnical engineering Scope of Services for this project included the advancement of one test boring to a depth of 18 feet below existing site grades. Due to the access issues, we could not drill at the west abutment. Therefore, we evaluated the subsurface profile based on the visual inspection of the soils around the embankment, see photography log.

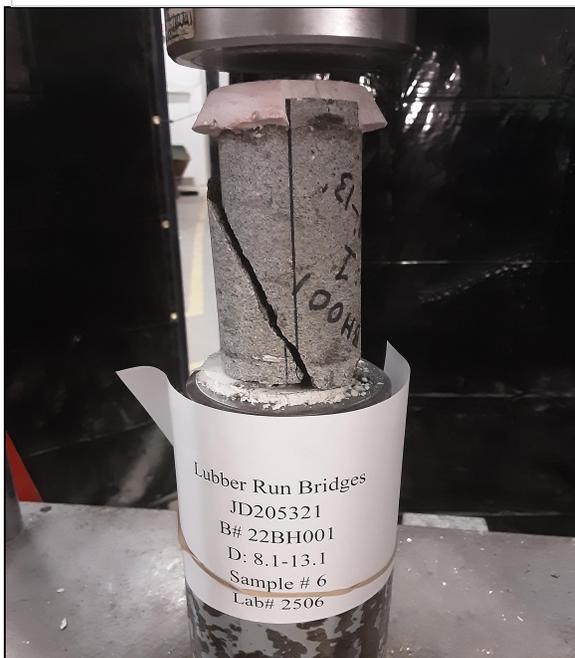
**SAMPLE LOCATION**

Site:	Lubber Run Park Pedestrian Bridge		
Description:	Mica Schist		
Boring:	22BH001	Depth (feet):	8.1-13.1

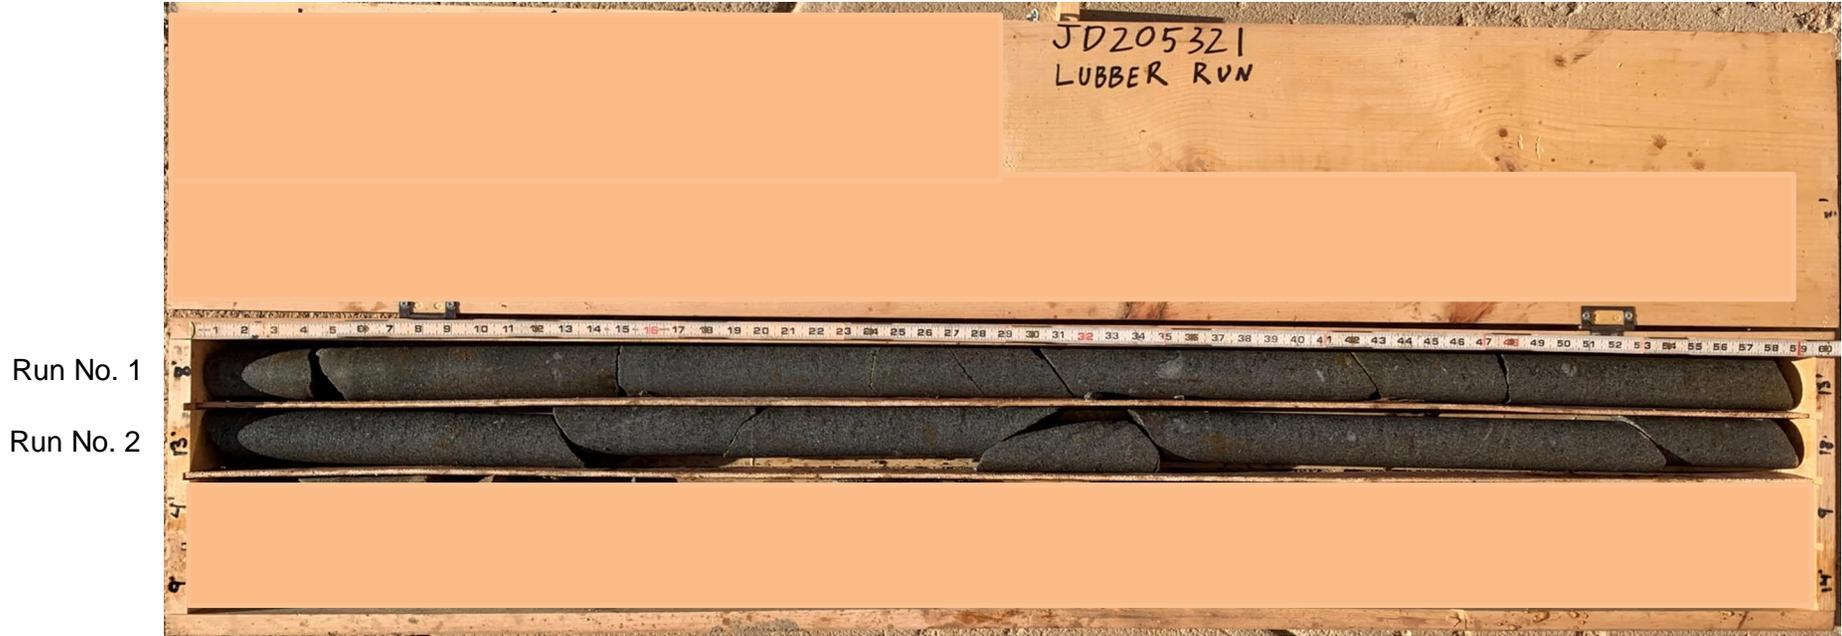
**ROCK CORE PHOTO LOG**

Run No. 1

Run No. 2
