Traffic Engineering Study

State Route 124 at State Route 60/Sam Freeman Road
Jackson County, Georgia

Date Prepared: June 8, 2018

ATKINS

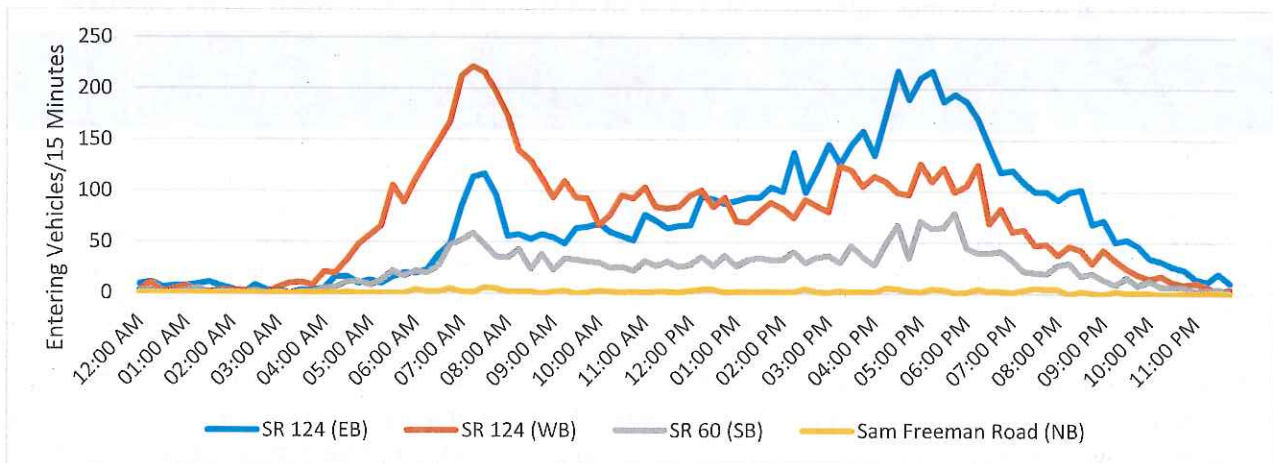
Figure 4. Entering Approach Volumes by Time of Day from 24-Hour Classification Count (April 2017)

SR 124 and SR 60 both exhibit typical AM and PM peak periods, with heavier volume flow westbound in the morning towards the nearest I-85 interchange. Similarly, in the evening the heaviest volume of traffic is eastbound away from the same I-85 interchange. The study intersection then observes a decrease in traffic to near minimal volumes overnight.

The AM peak hour occurs between 7:00 and 8:00 a.m. with a total approach volume of 1,454 vehicles per hour. The PM peak hour occurred between 5:00 and 6:00 p.m. with a total approach volume of 1,492 vehicles per hour. Overall, the SR 60 and SR 124 intersection served 15,813 daily vehicles during the 24-hour classification count, roughly 18 percent greater than the combined 2016 AADT values obtained from one SR 124 count station and the SR 60 count station. This disparity between the volumes can be attributed to the various neighborhoods and other side streets that would add vehicular traffic. The approach with the greatest volume of traffic was the westbound approach on SR 124 with 6,855 vehicles across the day. **Figure 4** summarizes the 24-hour classification count by time of day for each approach of the study intersection.

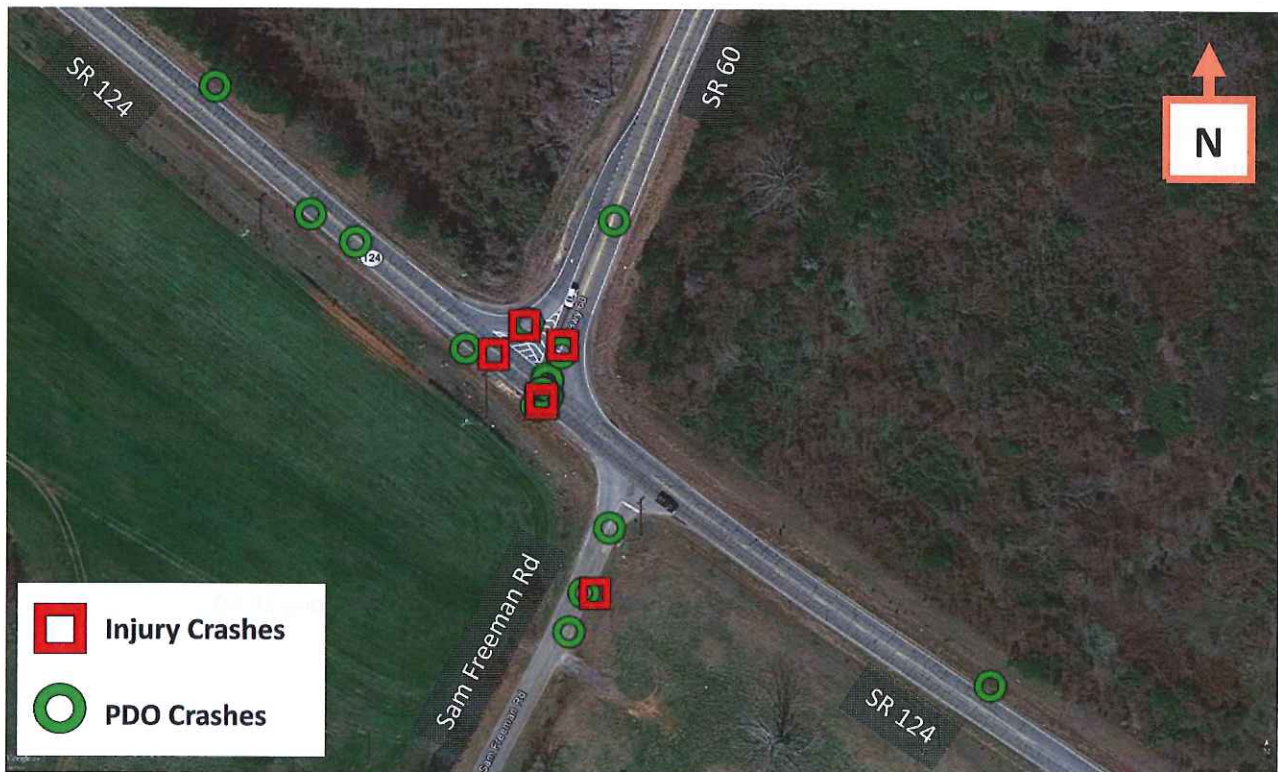
Figure 5. Location of Traffic Crashes, SR 124 at SR 60

In total, 40 crashes occurred at the study intersection during the five-year study period, including nine injury crashes resulting in one severe injury. There were no fatal crashes or non-motorized collisions during the five-year study period. **Figure 5** shows the locations for each of these crashes.

The higher value for the crash rates (0.30 for injury crashes and 1.35 for total crashes) can be attributed primarily to the large number of rear ends and single vehicle crashes, which each made up 35 percent of the total crashes. The higher percentage of rear ends can be attributed to how the SR 124 mainline is lacking any turning lanes. However, the higher percentage of single vehicle crashes is unusual. When exploring the crash data, multiple reasons were found as the underlying cause for these single vehicle crashes; among them, speed seemed to be the most common factor. A collision diagram for the subject intersection is provided in **Appendix C** of this report.

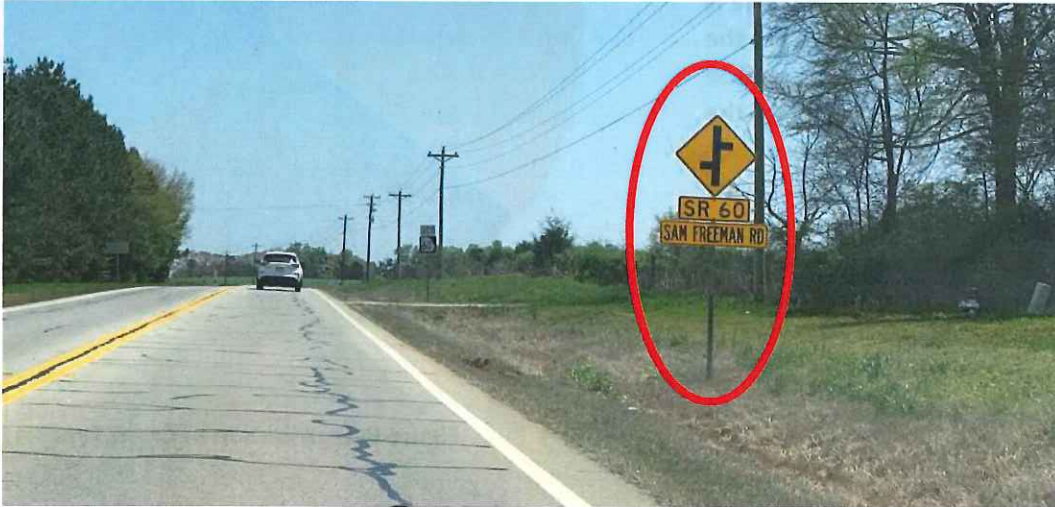
Figure 7. Eastbound SR 124 approaching SR 60

- An offset intersection ahead (W2-7L) sign along SR 124 for the eastbound approach (**Figure 7**).

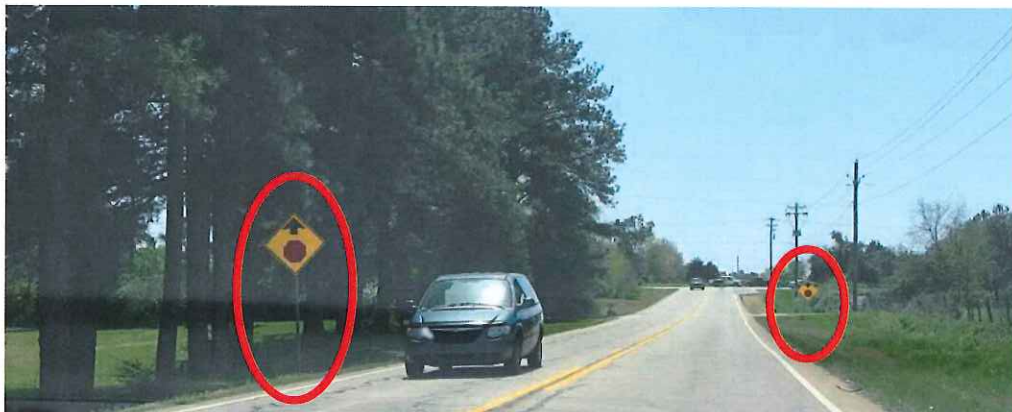
Figure 8. Southbound SR 60 approaching SR 124

- Stop-sign ahead warning signs (W3-1a) along the southbound approach on SR 60 (**Figure 8**) as well as the northbound approach on Sam Freeman Road.

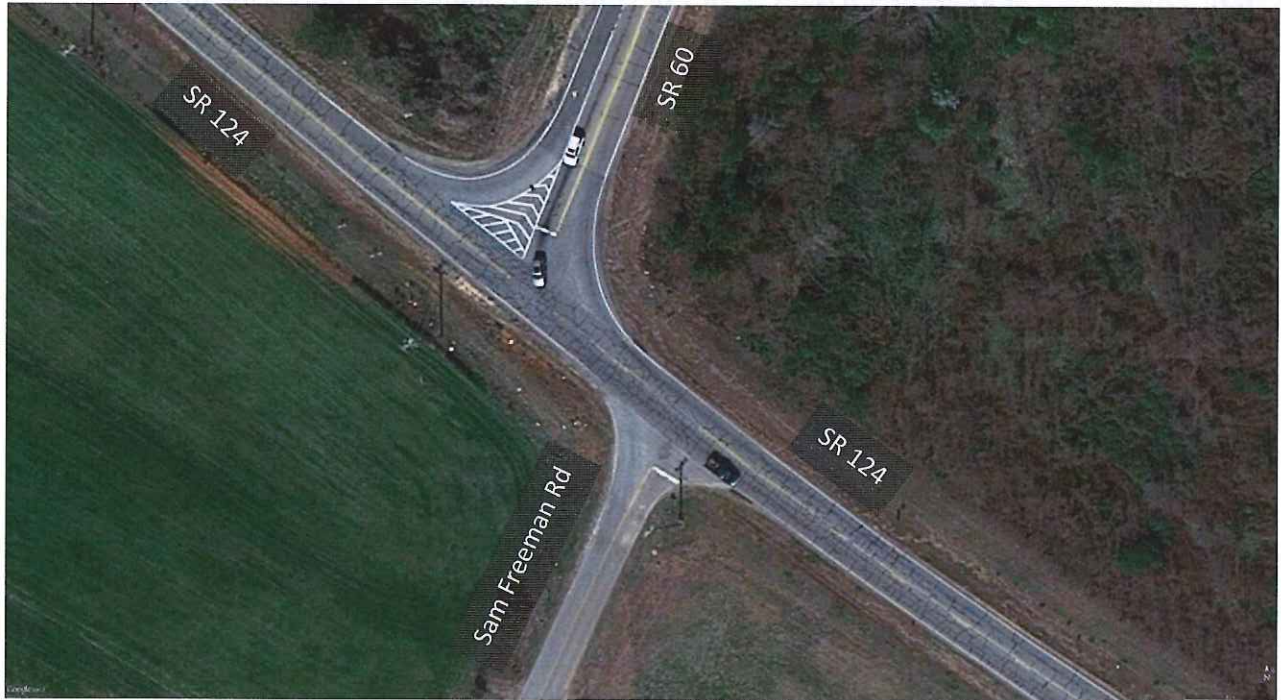
Figure 10. Intersection Orientation

While it has been stated that the SR 60 and Sam Freeman Road intersections with SR 124 are their own T-intersections, they are close enough to act as one intersection. This means that vehicles from the SR 60 and Sam Freeman Road intersections provide conflict points with one another that do not occur with standard offset T-pair intersections. For these minor approaches this will raise additional questions by drivers over right-of-way, which can also lead to creating movements that other drivers did not expect.

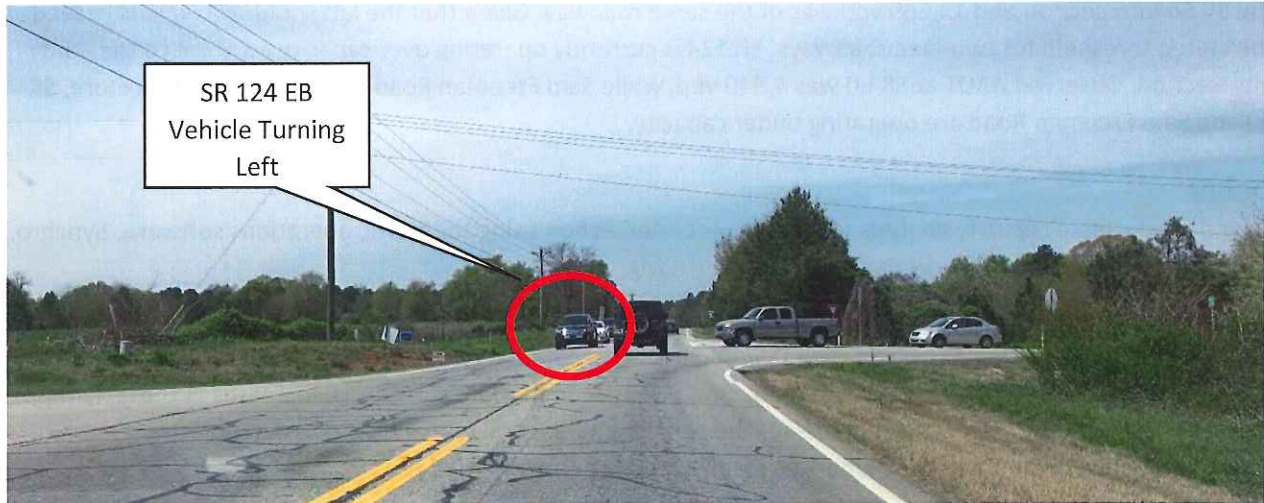
Figure 12. Vehicle Turning Left on SR 124

Within the subject intersection 50 percent (7 of the 14) of the rear-end crashes that occurred were on SR 124 and related to vehicles slowing down or stopping to make a turn onto SR 60 or Sam Freeman Road. These rear ends could have otherwise been avoided had the vehicles making the turning movement been provided their own exclusive turning lanes outside of the through lanes on SR 124.

The installation of left-turn and right-turn lanes can help reduce the number of rear ends occurring on SR 124. This will provide these turning movements with their own independent lane away from the through lanes on SR 124 and can also help to clarify to other drivers the intended movement of these vehicles for driver awareness.
