## MEMORANDUM

To: Clell Ford, Lakes Manager HCPNR  
From: Richard Jones, PE  
Re: IMWID – Phase II – Fill Assessment  
Date: February 15, 2016  
C: Brian Roy

*Fill Assessment Memorandum  
Highlands County BOCC*

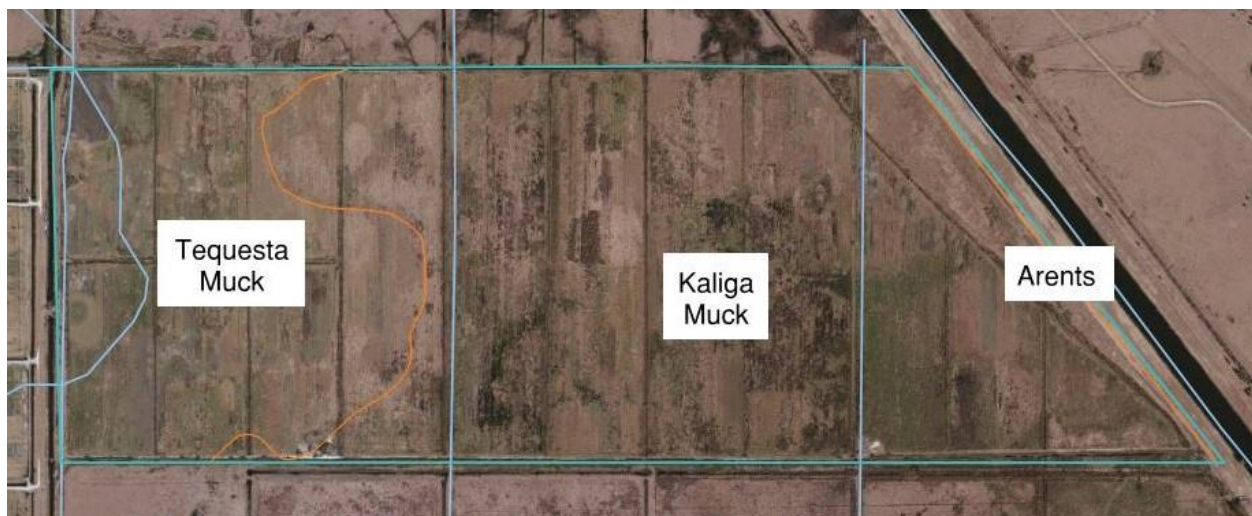
**Figure 1 - NRCS Soil Map**

The NRCS soil map for the impoundment site is shown in **Figure 1**. It indicates that there are two predominate soils types on the site: Tequesta Muck and Kaliga Muck. Arents refers to highly sloping land, which, in this case, is the existing C-41A spoil berm. Kaliga occupies approximately 70% of the property and Tequesta 30%. The official U.S. Government description for each is as follows:

- Kaliga Muck – very deep, very poorly drained, slow permeable soils. Moderately thick deposits of sapric material with underlying loamy and clayey materials. The high organic and muck soil layer is normally 0 to 26 inches deep.
- Tequesta Muck – very deep, very poorly drained, slow permeable soils. Formed in stratified marine sandy and loamy sediments. The high organic and muck soil layer is normally 0 to 12 inches deep with steaks down to 25 inches deep.

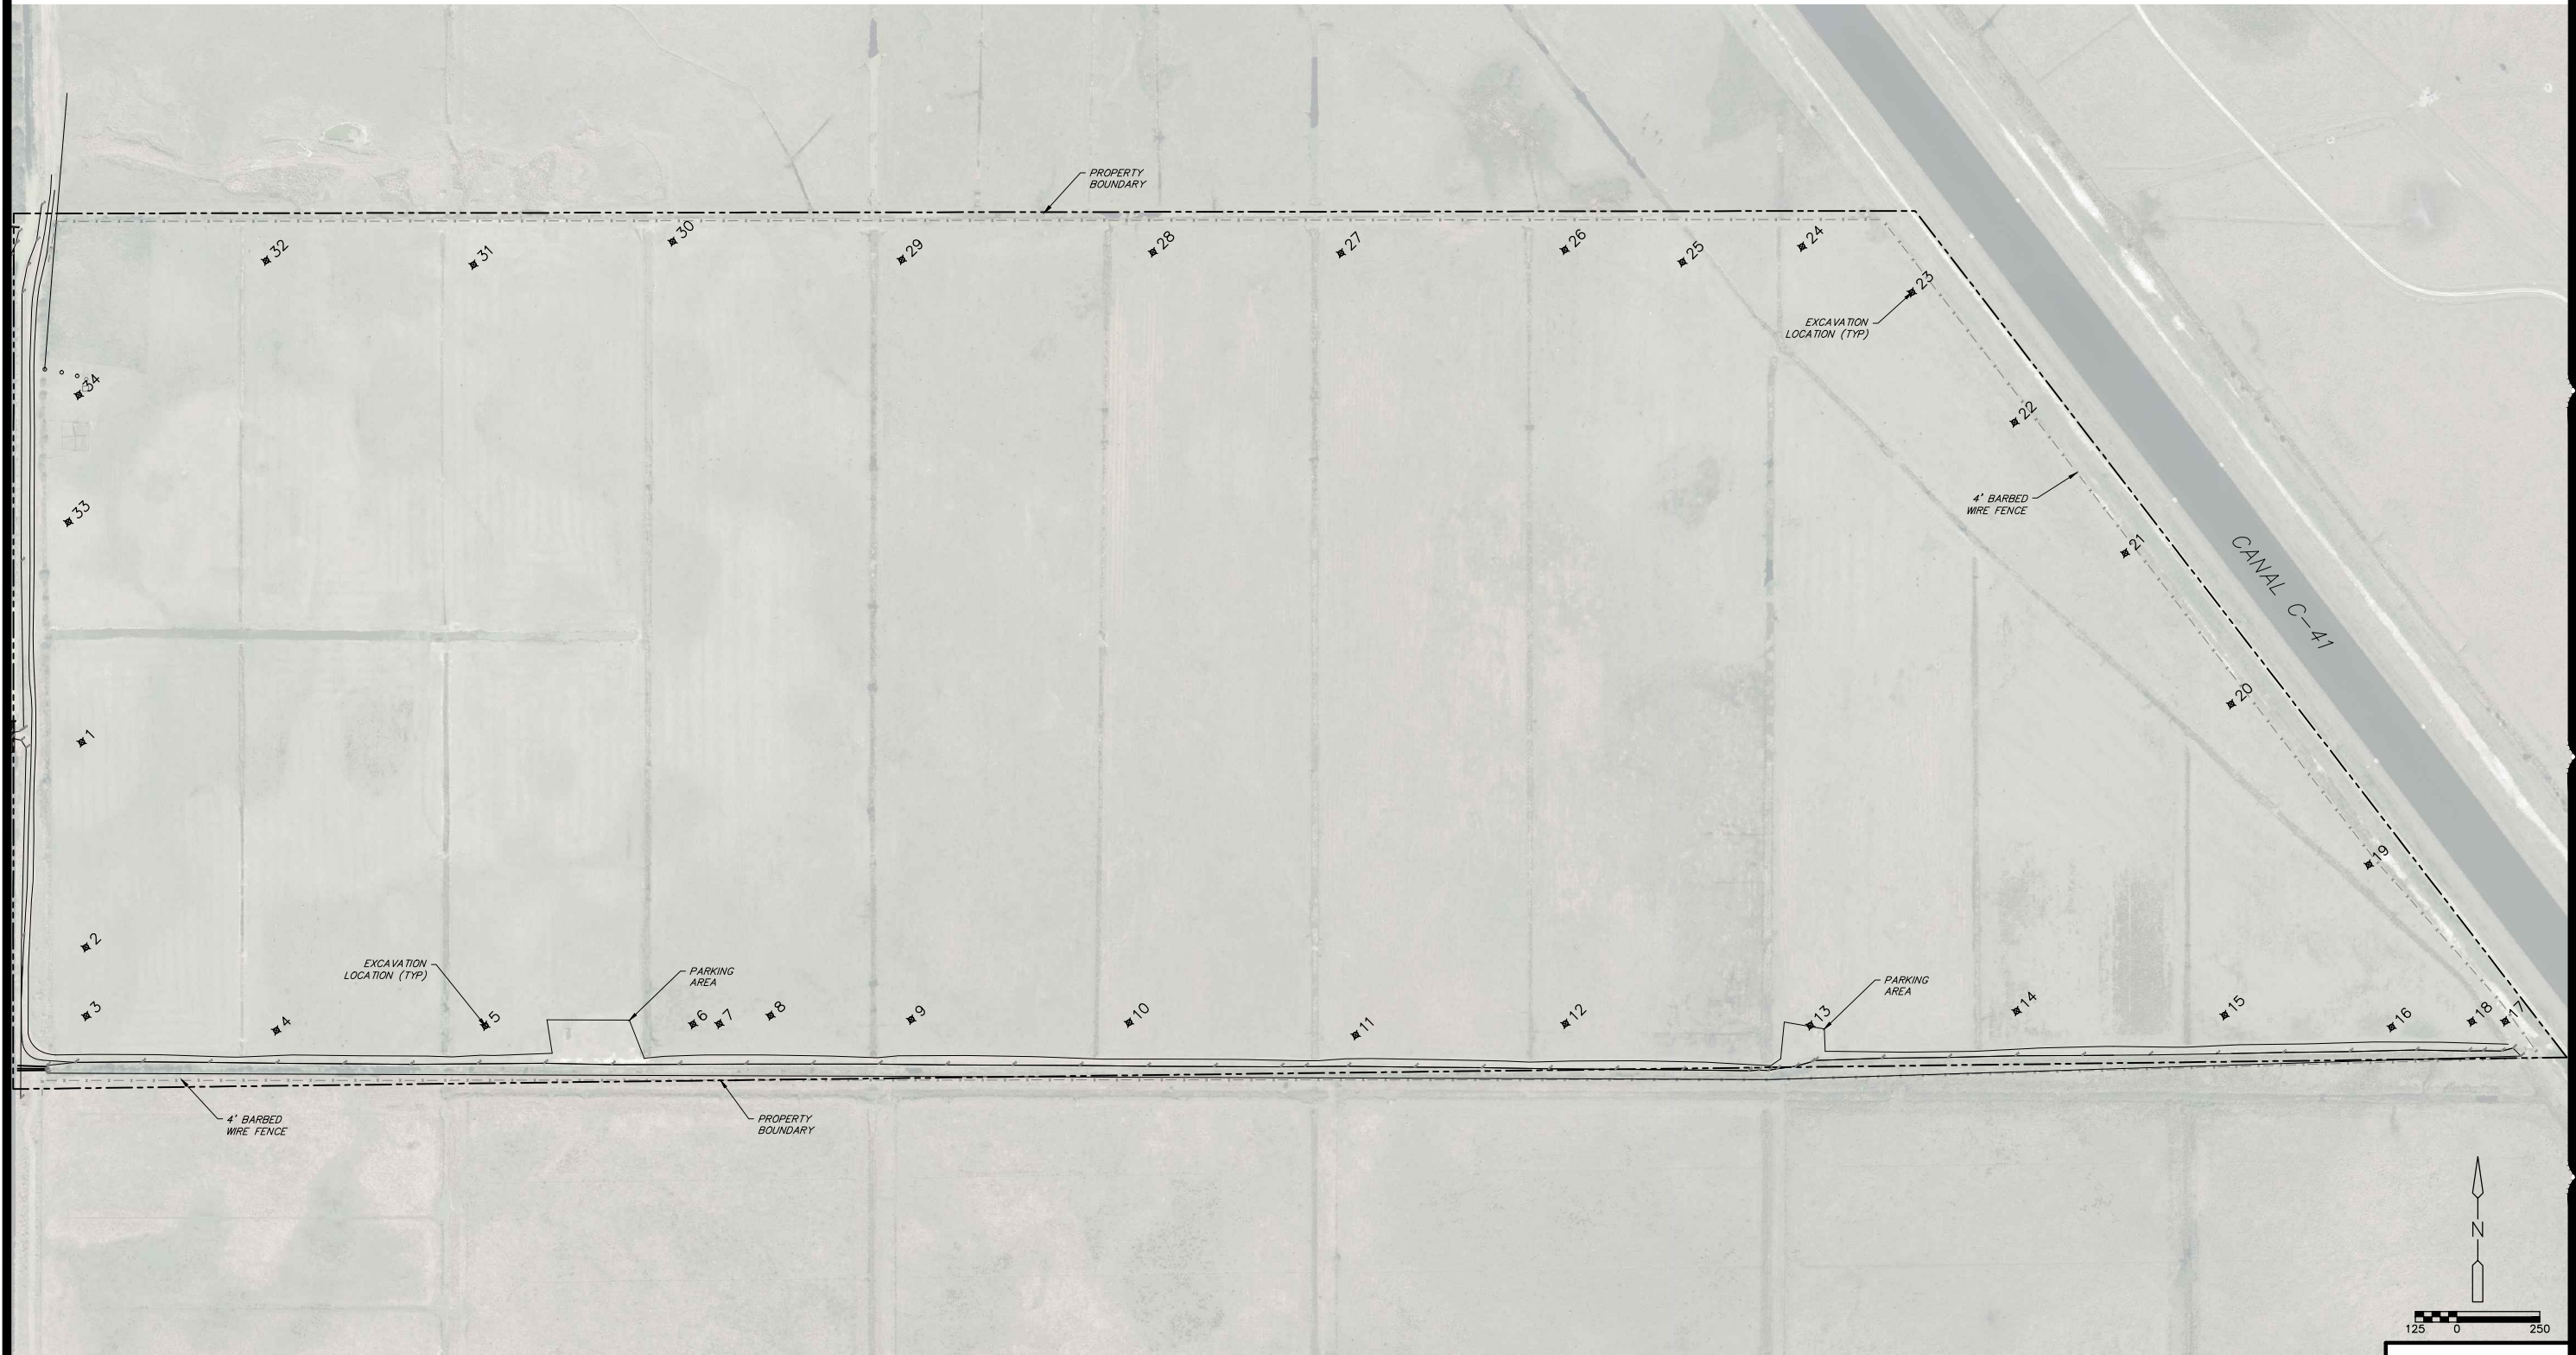
SHEET  
 G-3

the approximate location of the proposed impoundment berm and evenly spaced 600 feet apart, where possible. The holes were dug to a depth of at least 4 feet, conditions permitting, photographed, and the engineer's observations recorded. The location of each test hole was recorded by GPS and plotted by AutoCAD on an aerial map for future reference. **Table 1** provides a summary of the data collected for each site. The figure in **Appendix A** shows the location of the excavations on the property. **Appendix B** contains the photographs of each test hole.

CIVIL  
 SOIL EXCAVATION SITES

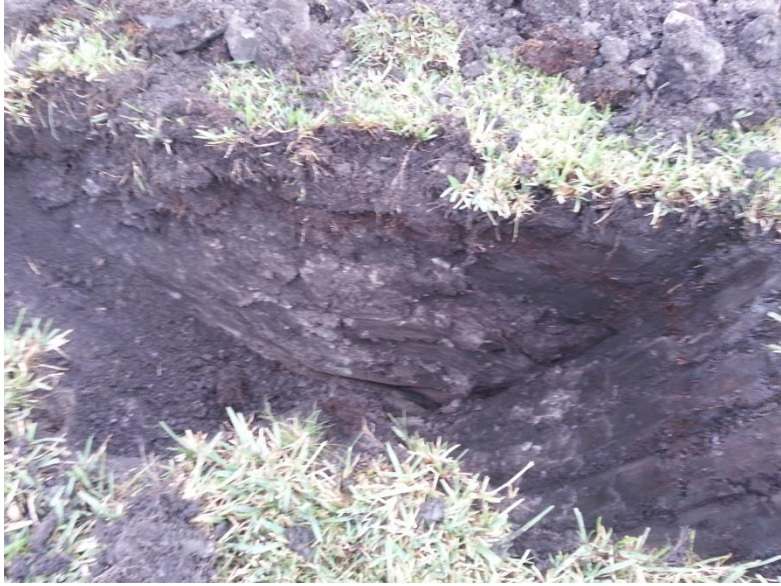
Picture Location: Site 1a

Site #	North			West			Picture IDs	Comments & Observations
	deg	min	sec	deg	min	sec		
1	27	17	2.17	81	14	2.04	Site 1a, 1b	0"-16" Organic Topsoil, 16"-48" Fine Sand w/ Cohesion
2	27	16	56.05	81	14	1.89	none	0"-16" Organic Topsoil, 16"-30" Organic, 30"-84" Marl/Clay
3	27	16	54	81	14	1.87	Site 3a, 3b	0"-16" Organic Topsoil, 16"-24" Light Sand, 24"-40" Fibrous Organic, 40"-60" Dark Sand
4	27	16	53.58	81	13	55.52	Site 4a, 4b	0"-16" Organic Topsoil, 16"-60" Fine Sand w/ Cohesion
5	27	16	53.73	81	13	48.54	Site 5a, 5b	0"-16" Organic Topsoil, 16"-32" Brown Sand, 32"-84", Fine Sand w/ Cohesion
6	27	16	53.79	81	13	41.6	Site 6a, 6b	0"-24" Organic Topsoil, 24"-72" Fine Sand w/ Cohesion
7	27	16	53.8	81	13	40.72	Site 7a, 7b	0"-16" Organic Topsoil, 16"-32" Light Sand, 32"-72" Fine Sand w/ Cohesion
8	27	16	54.05	81	13	39.01	Site 8a, 8b	0"-16" Organic Topsoil, 16"-22" Light Sand, 22"-36" Fine Sand w/ Cohesion
9	27	16	53.94	81	13	34.31	Site 9a, 9b	0"-16" Organic Topsoil, 16"-32" Light Sand, 32"-62" Fine Sand w/ Cohesion

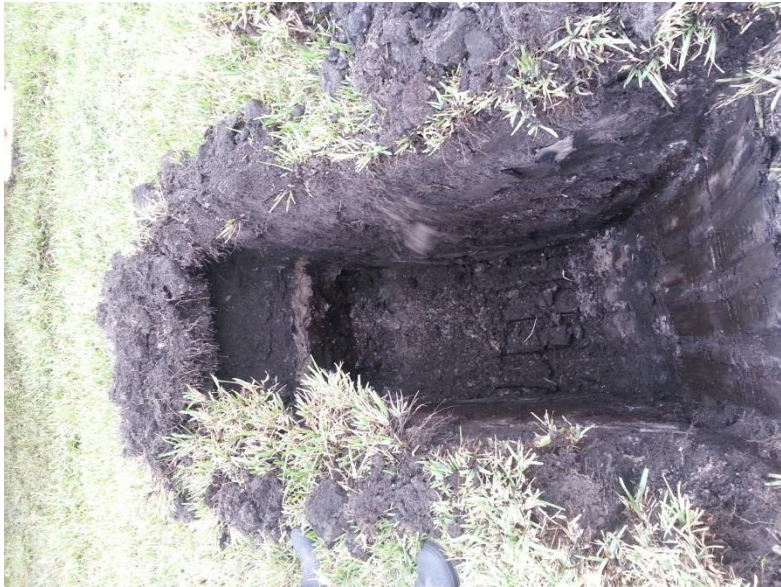
Picture Location: Site 3a

NRCS soil map. The west and south sides appeared to have the most significant muck layers, but the depth was inconsistent. The deepest muck layers were found in Sites 11-14, 18, 19, and 21, though none exceeded 30 inches. The east and north sides of the property had a surprisingly thin organic topsoil layer. Only excavation Site 2 had organic soils deeper than 4 feet, where the tractor type backhoe could not find a suitable subsoil layer. This is partially due to the high water table conditions at the location. However, the soil conditions at Site 2 seemed to be an anomaly, limited to a small area; Site 3 was only 200 feet away and had sandy subsoil only 16 inches below ground level.

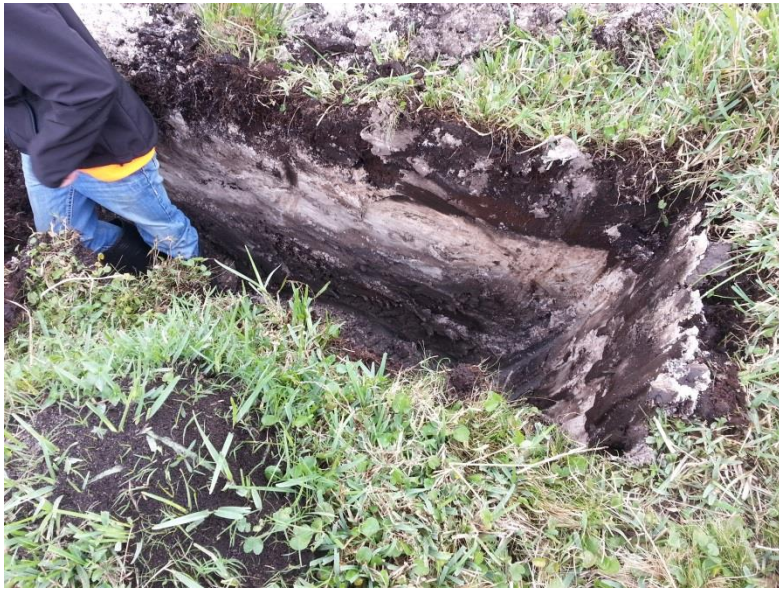
Picture Location: Site 10a

10	27	16	53.86	81	13	27.03	Site 10a, 10b, 10c	0"-16" Organic Topsoil, 16"-28" Light Sand, 28"-48" Fine Sand w/ Cohesion
11	27	16	53.5	81	13	19.46	Site 11a, 11b	0"-21" Organic Topsoil, 21"-32" Dark Sand, 32"-62" Fine Sand w/ Cohesion
12	27	16	53.85	81	13	12.45	Site 12a, 12b	0"-24" Organic Topsoil, 24"-48" Fine Sand w/ Cohesion
13	27	16	53.81	81	13	4.27	Site 13a, 13b, 13c	0"-30" Organic Topsoil, 30"-57" Fine Sand w/ Cohesion
14	27	16	54.25	81	12	57.38	Site 14a, 14b, 14c	0"-27" Organic Topsoil, 27"-36" Dark Sand, 36"-72" Fine Sand w/ Cohesion
15	27	16	54.14	81	12	50.43	Site 15a, 15b	0"-10" Organic Topsoil, 10"-36" Dark Sand
16	27	16	53.79	81	12	44.85	Site 16a	0"-12" Organic Topsoil, 12"-32" Light Sand, 32"-48" Dark Sand
17	27	16	53.85	81	12	41.4	Site 17a, 17b	0"-12" Organic Topsoil, 12"-36" Light Sand, 36"-48" Dark Sand
18	27	16	53.96	81	12	42.17	Site 18a, 18b	0"-20" Organic Topsoil, 20"-28" Light Sand, 28"-48" Dark Sand

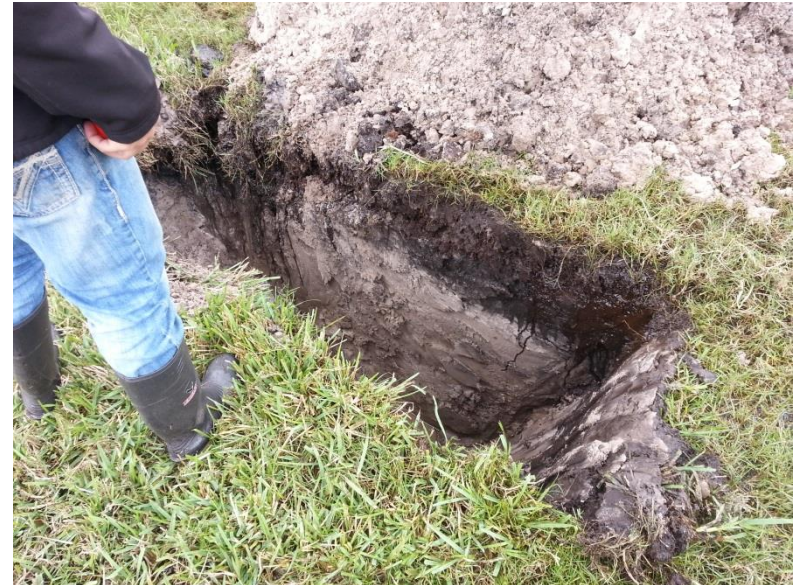
Picture Location: Site 19a

Site #	North			West			Picture IDs	Comments & Observations
	deg	min	sec	deg	min	sec		
19	27	16	58.64	81	12	45.62	Site 19a, 19b	0"-20" Organic Topsoil, 20"-28" Light Sand, 28"-48" Dark Sand
20	27	17	3.42	81	12	50.23	Site 20a, 20b	0"-9" Organic Topsoil, 9"-48" Grey Sand
21	27	17	7.92	81	12	53.78	Site 21a, 21b	0"-20" Organic Topsoil, 20"-28" Light Sand, 28"-48" Dark Sand
22	27	17	11.82	81	12	57.48	Site 22a, 22b	0"-6" Organic Topsoil, 6"-22" Light Sand, 22"-48" Grey Sand w/ Some Blue Color
23	27	17	15.69	81	13	0.92	Site 23a, 23b	0"-8" Organic Topsoil, 8"-48" Brown Sand
24	27	17	17.05	81	13	4.59	Site 24a, 24b	0"-6" Organic Topsoil, 6"-26" Brown Sand, 26"-34" Light Sand, 34"-48" Grey Sand w/ Some Blue Color
25	27	17	16.58	81	13	8.59	Site 25a, 25b	0"-6" Organic Topsoil, 6"-40" Brown Sand, 40"-48" Grey Sand w/ Some Blue Color
26	27	17	16.94	81	13	12.52	Site 26a, 26b	0"-8" Organic Topsoil, 8"-58" Brown Sand

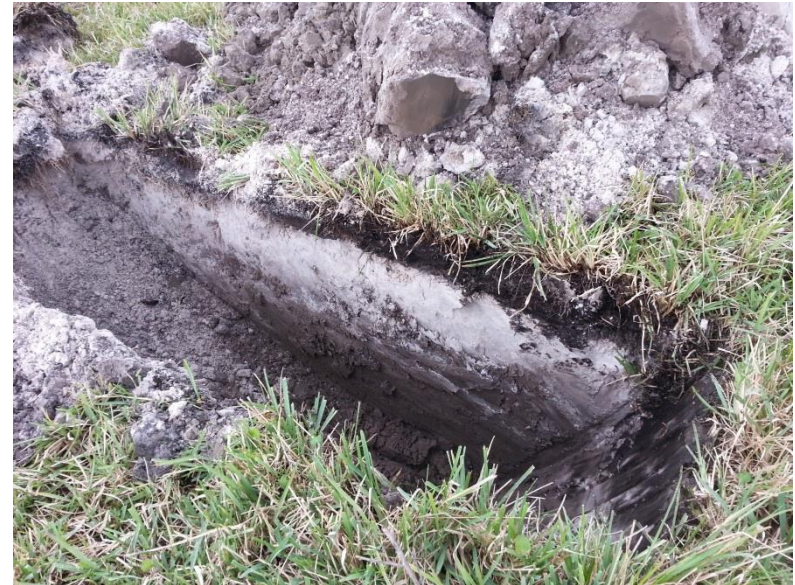
Picture Location: Site 27a

27	27	17	16.83	81	13	20	Site 27a, 27b	0"-8" Organic Topsoil, 8"-20" Light Sand, 20"-48" Brown Sand
28	27	17	16.85	81	13	26.28	Site 28a, 28b	0"-12" Organic Topsoil, 12"-24" Light Sand, 24"-48" Brown Sand w/ Cohesion
29	27	17	16.61	81	13	34.67	Site 29a, 29b, 29c	0"-6" Organic Topsoil, 6"-30" Light Sand, 30"-48" Brown Sand w/ Cohesion
30	27	17	17.14	81	13	42.33	Site 30a, 30b	0"-9" Organic Topsoil, 9"-29" Grey Sand w/ Some Blue Color, 29"-42" Coarse Sand w/ Shell, 42"-60" Grey Sand w/ Some Blue Color
31	27	17	16.44	81	13	48.98	Site 31a, 31b	0"-6" Organic Topsoil, 6"-51" Coarse Sand w/ Shell
32	27	17	16.55	81	13	55.91	Site 32a, 32b	0"-26" Organic Topsoil, 26"-56" Brown Sand
33	27	17	8.74	81	14	2.5	Site 33a, 33b	0"-6" Organic Topsoil, 6"-48" Brown Sand
34	27	17	12.53	81	14	2.16	Site 34a, 34b, 34c	Site was obviously filled in the past, 0"-16" Sandy Fill Dirt, 16"-26" Brown Sand w/ Cohesion, 26"-46" Dark Organic Soil, 46"-68" Brown Sand w/ Cohesion
