ADDENDUM No. 1

South Chickamauga Greenway Connector Project
Contract Number: T-15-032
Chattanooga Department of Transportation

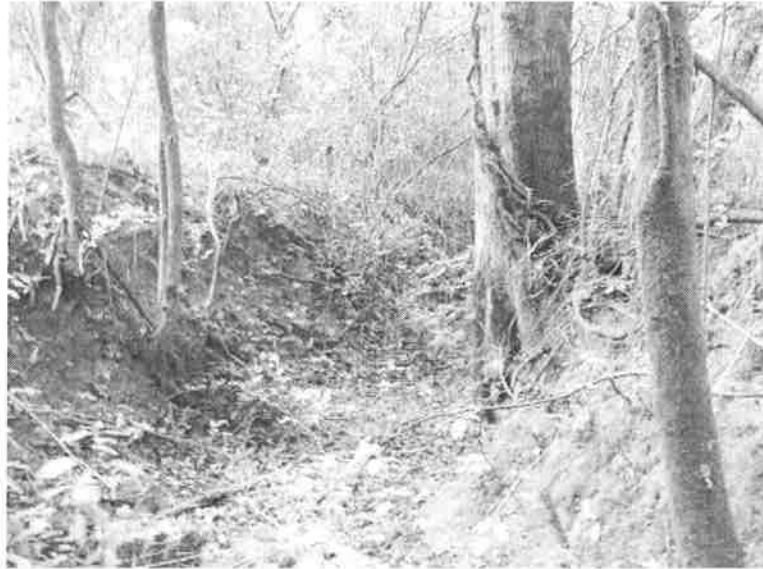
1	Location / Orientation	S1, looking south and downstream	Photographer: KLS	Date: 6/3/2016
	Remarks	View of WWC / Ephemeral Stream labeled S1.

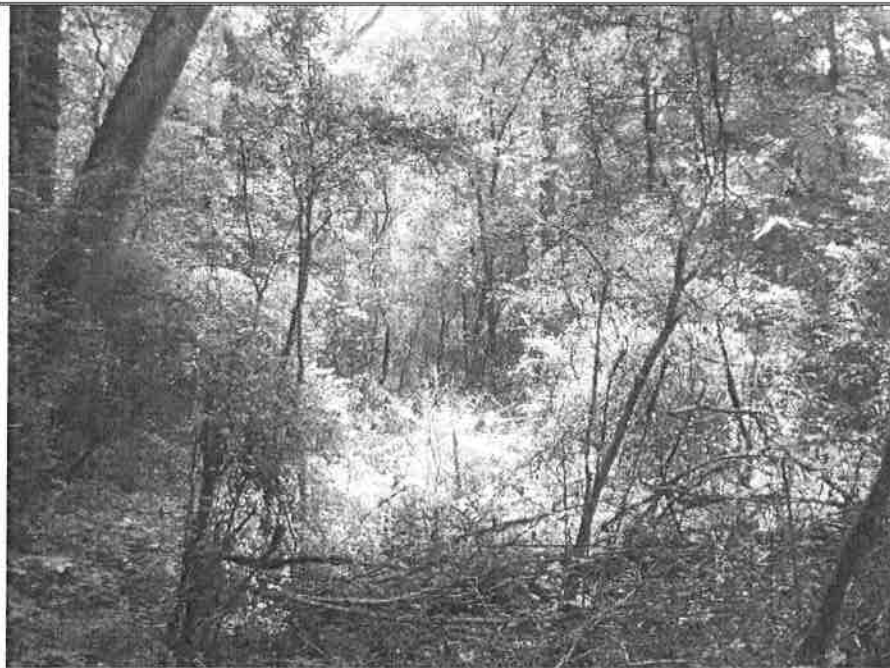
2	Location / Orientation	In the western portion, facing east	Photographer: KLS	Date: 6/3/2016
	Remarks	Typical view of proposed trail corridor

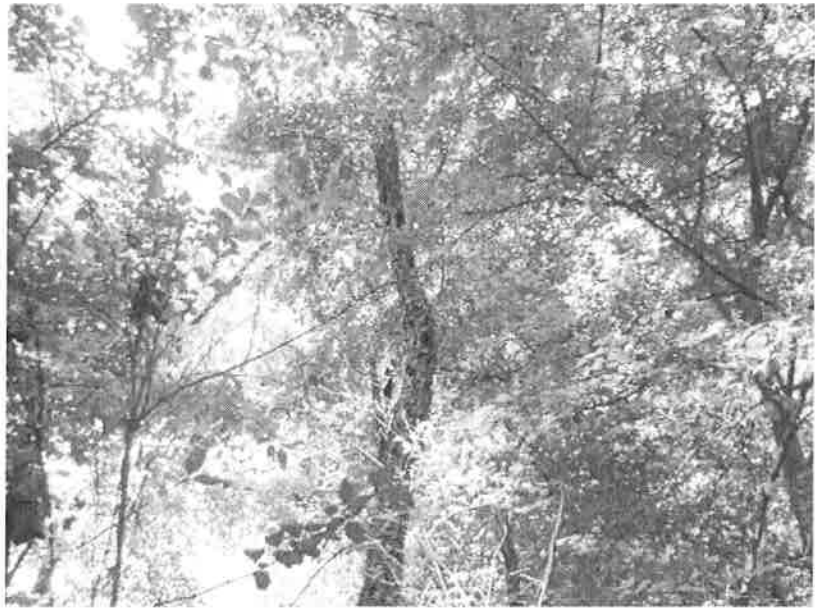
Date: 6/3/2016
		Photographer: KLS
3	Location / Orientation	Potential bat habitat designated BH-5
	Remarks	View of typical snag observed within reviewed corridor

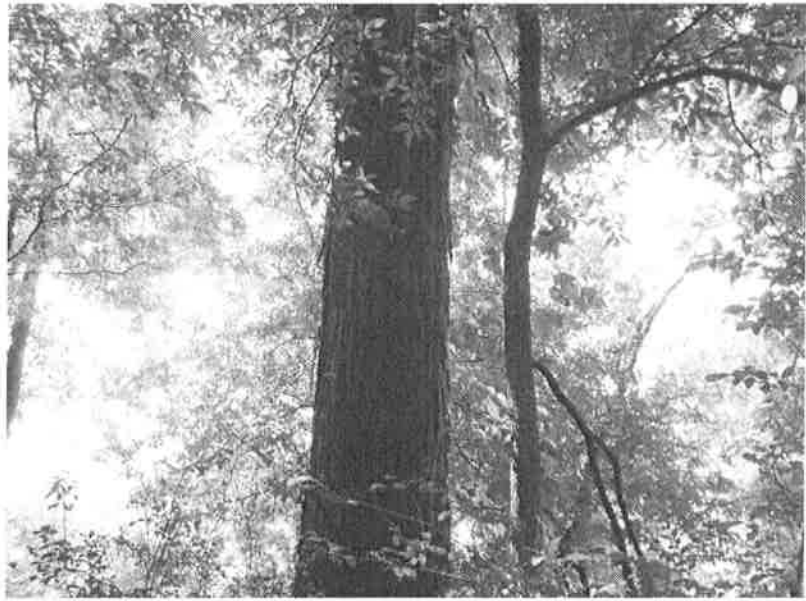
Date: 6/3/2016
		Photographer: KLS
4	Location / Orientation	Potential bat habitat designated BH-8
	Remarks	View of a large shagbark hickory observed within reviewed corridor.

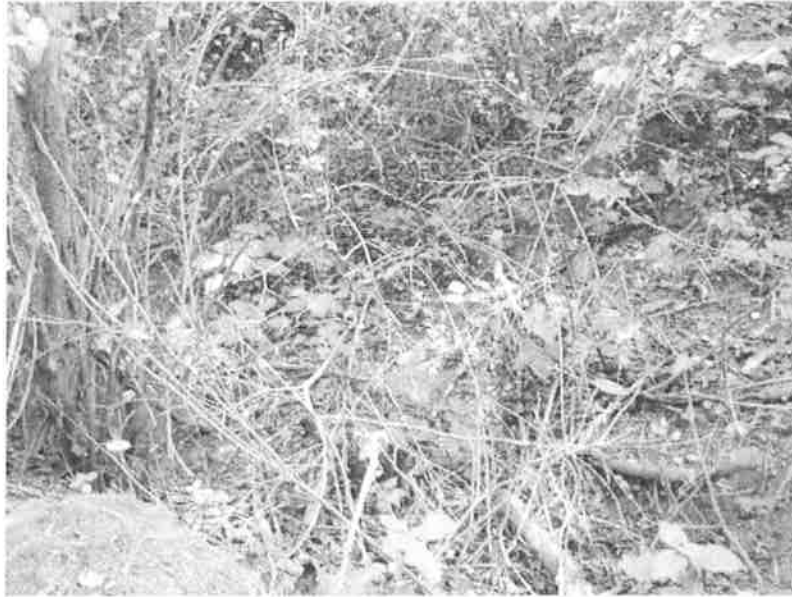
5	Location / Orientation	S2, looking northeast and upstream	Photographer: KLS Date: 6/3/2016
	Remarks	View of WWC / Upland Drainage feature labeled S2.

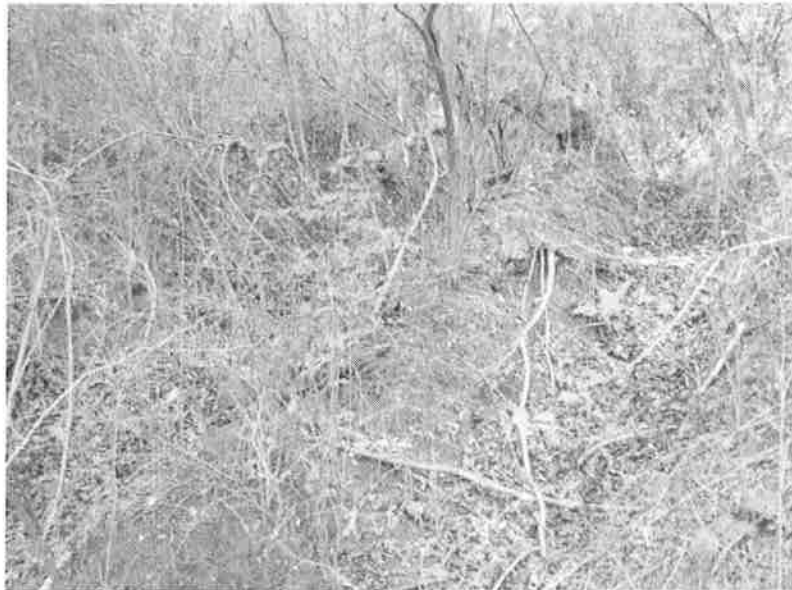
6	Location / Orientation	S3, looking northeast and upstream	Photographer: KLS Date: 6/3/2016
	Remarks	View of WWC / Upland Drainage feature labeled S3 (A&B).

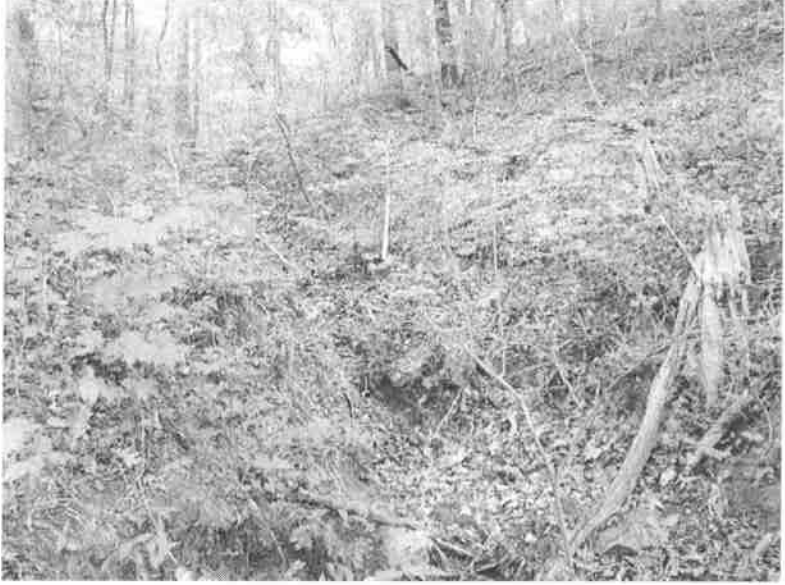
7	Location / Orientation	S4, looking northwest and upstream
	Remarks	View of WWC / Upland Drainage feature labeled S4.

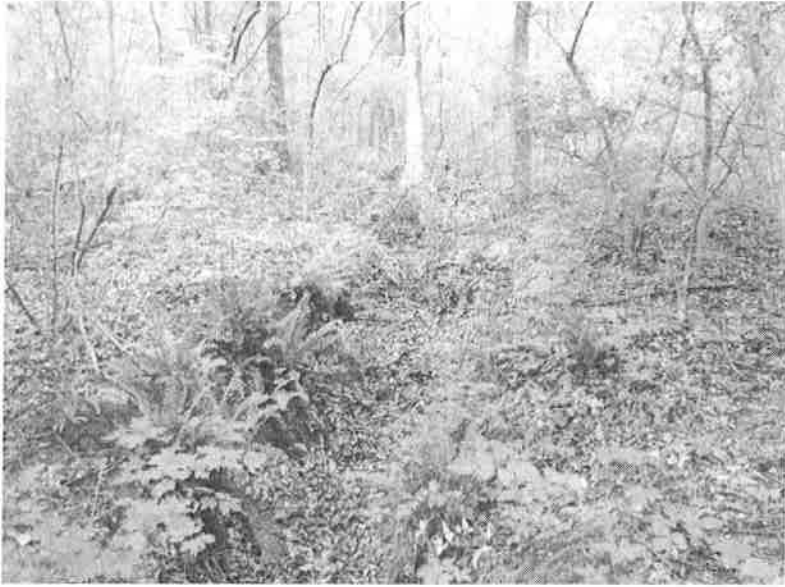
8	Location / Orientation	S5, looking northeast and upstream
	Remarks	View of WWC / Upland Drainage feature labeled S5.
