ADDENDUM #1

2018 Beaufort County Roads Resurfacing IFB #020818E

J - 22171

MCCRACKEN CIRCLE DRAINAGE IMPROVEMENTS

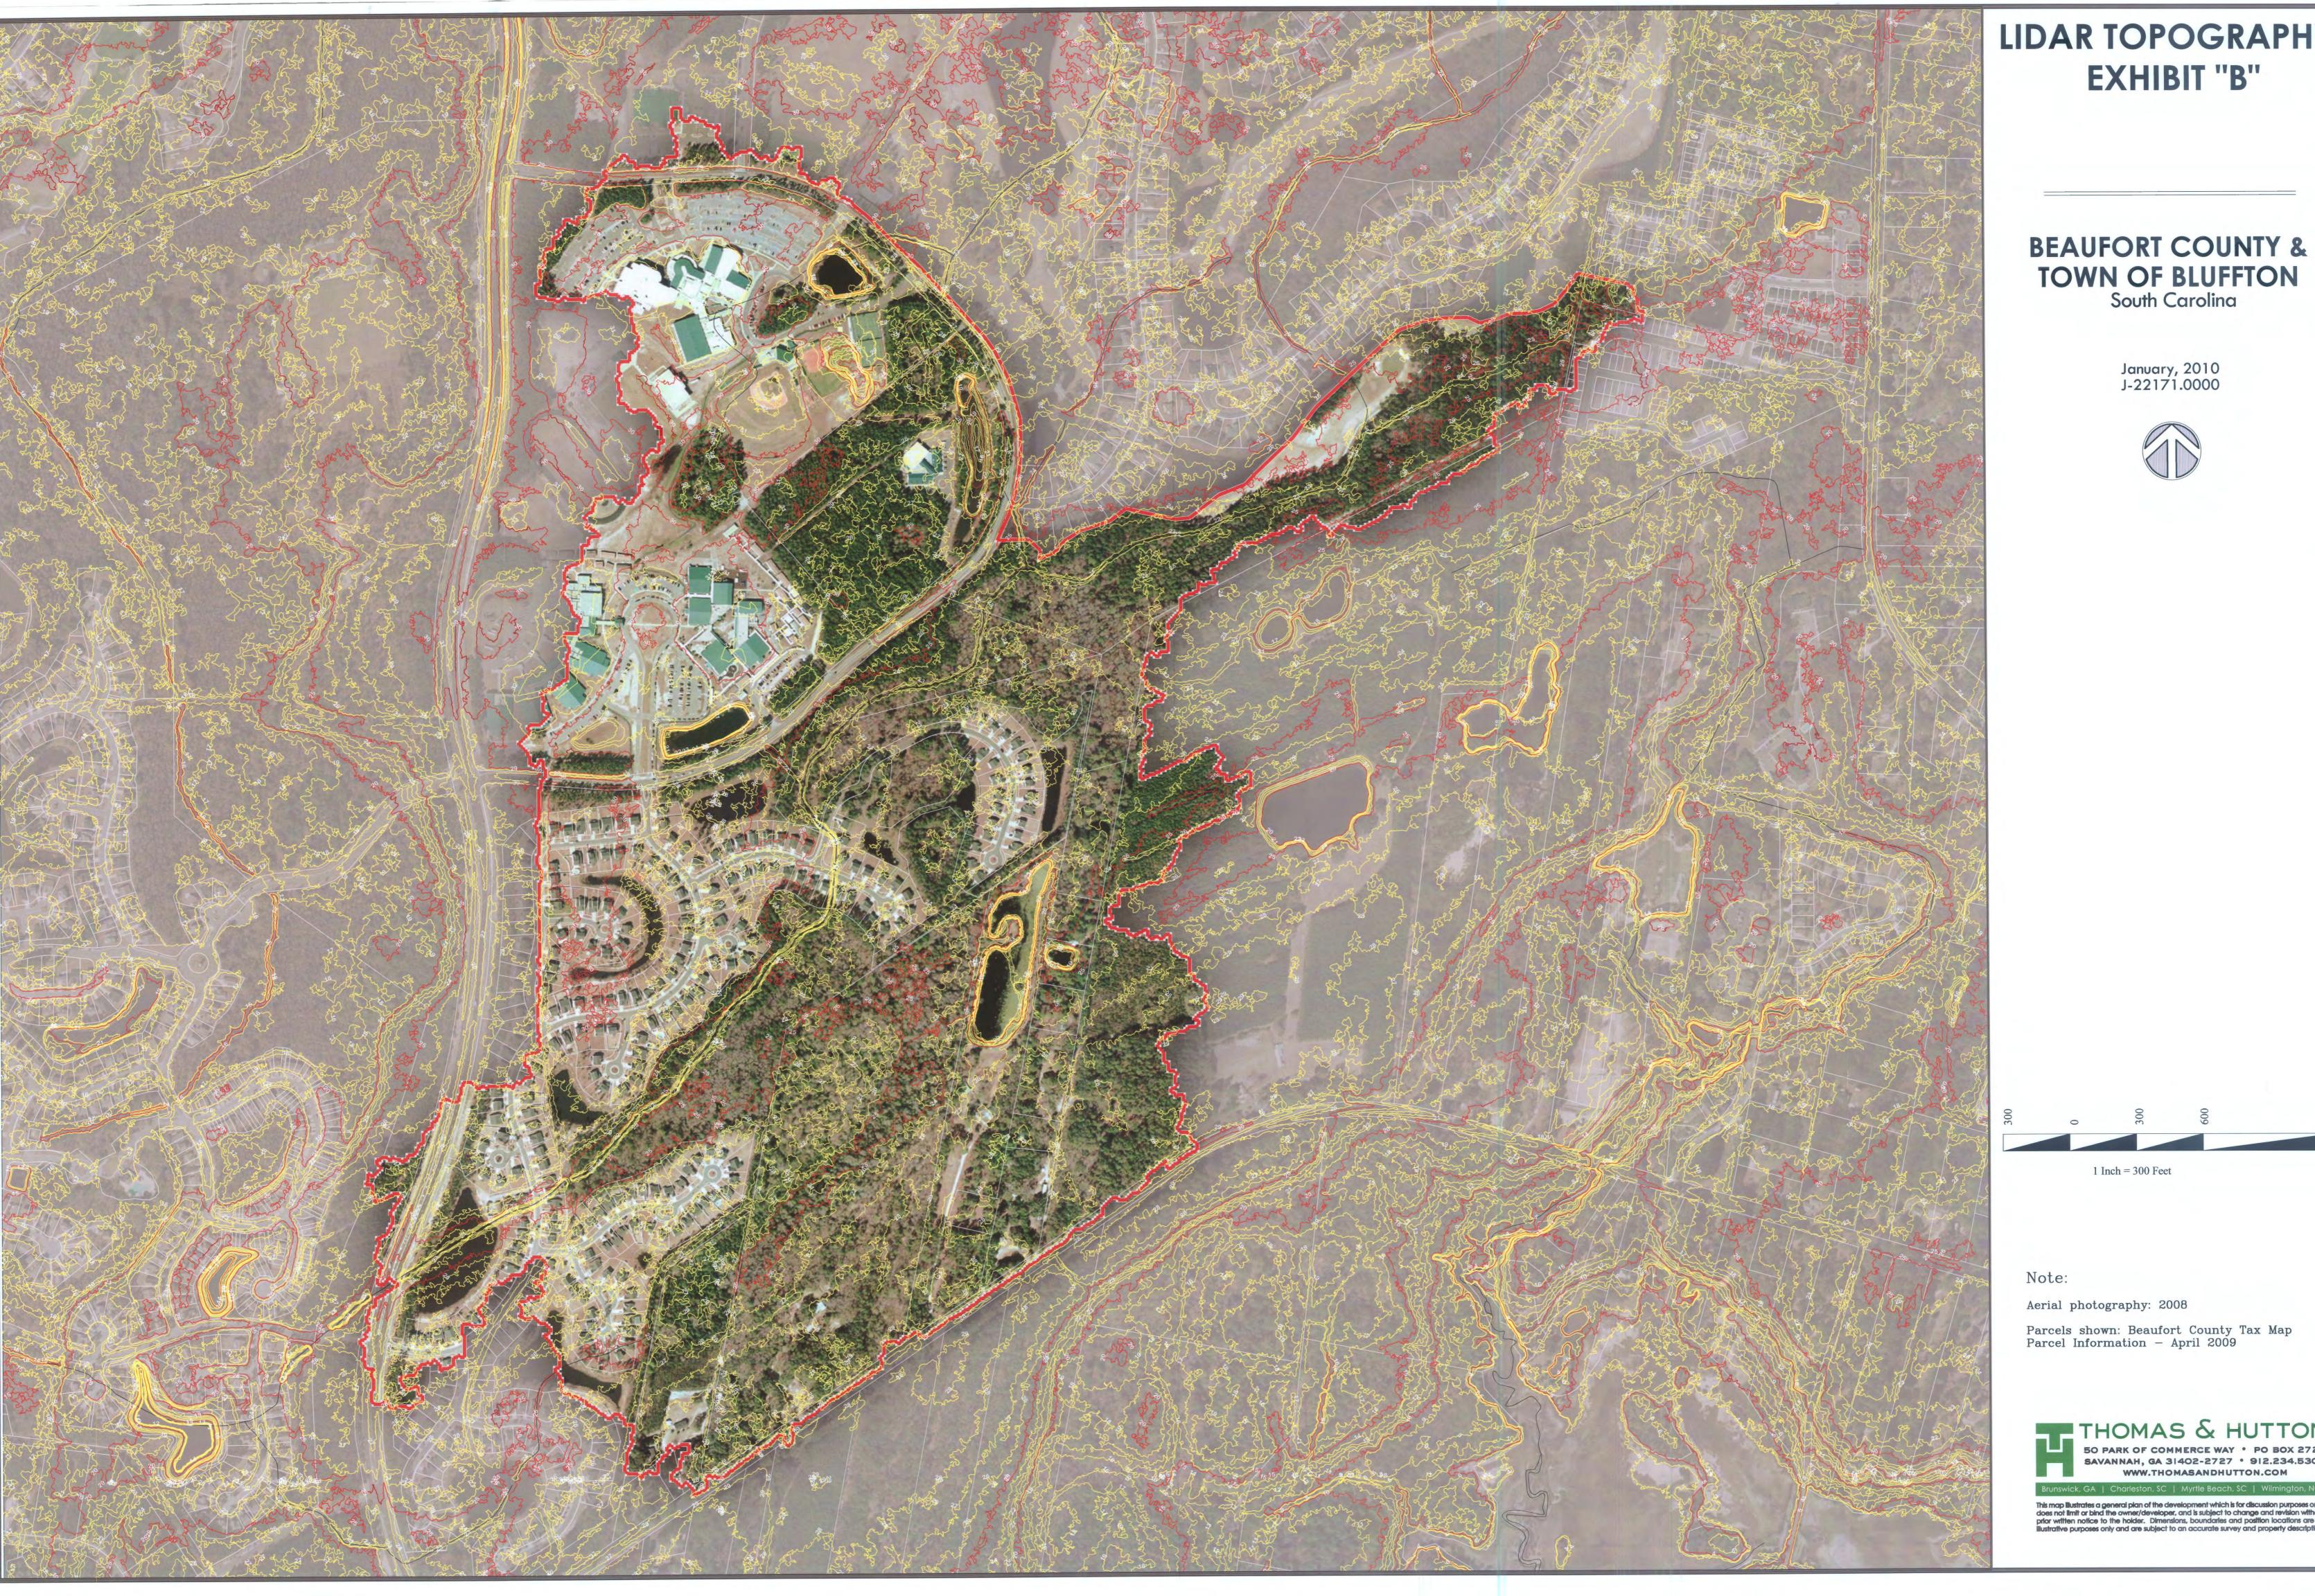
LIDAR TOPOGRAPHY **EXHIBIT "B"**

MCCRACKEN CIRCLE LIDAR TOPOGRAPHY

The Pinecrest and Pine Ridge models were merged and modified to only include hydraulic input of significance relating to the flooding problem on McCracken Circle. The watershed delineation needed to be modified to represent actual build out conditions as development in this area has impacted watershed boundaries since the completion of these two communities. The watershed was delineated with the use of a hydrologically enforced Digital Elevation Model (DEM), produced from lidar and record drawing information regarding stormwater flow patterns in the area. The preparation of a hydrological enforcement refers to adding features such as culverts, ditches, and canals to the DEM so that flow-networks depicting drainage patterns will be accurately defined.

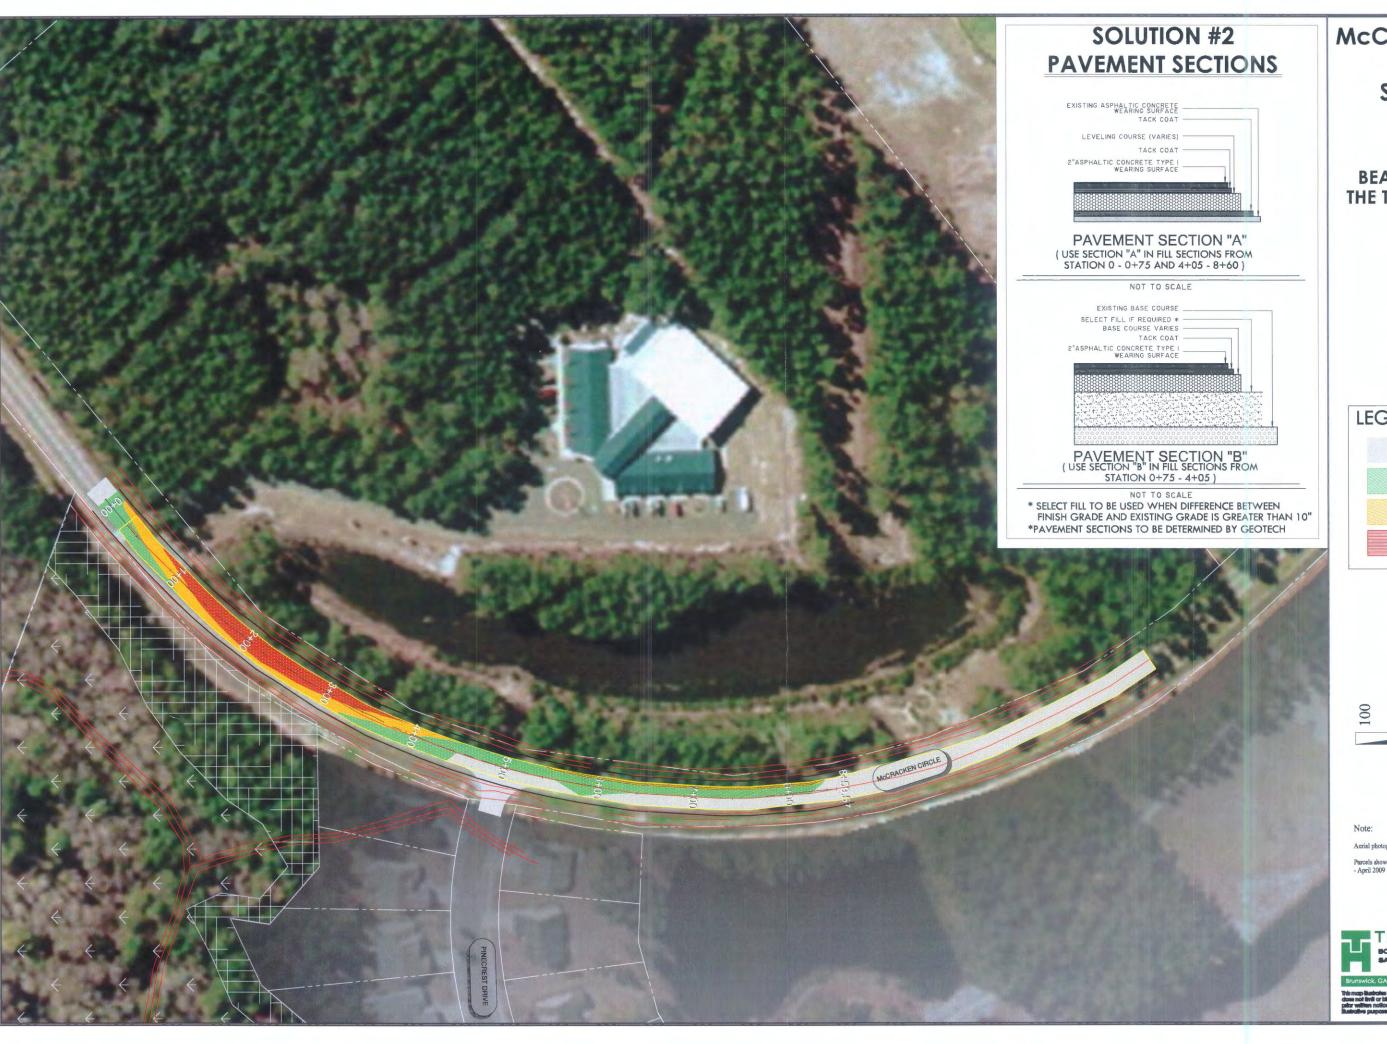
McCRACKEN CIRCLE **EXHIBIT "D" SOLUTION #2**

MCCRACKEN CIRCLE SOLUTION #2

Based on the information and results of each of the steps listed above, the most viable solution to correct the flooding issues at McCracken Circle is to raise the elevations of the road to a level where it will remain dry during the 25 year / 24 hour storm event. The amount the road needs to be raised is represented on the attached exhibit. This study only looked at the area of McCracken circle adjacent to the entrance of Pinecrest. Beaufort County and the Town of Bluffton may also want to consider other areas of concern as well. We did not observe any other areas of flooding during our site visits. We recommend observing the roadway immediately following a significant rain event to determine if there are other areas of concern that need to be addressed during the design, permitting and construction for the improvements. As mentioned, we have prepared an exhibit to illustrate the estimated elevations of the roadway improvements. We have included as an attachment an Engineers opinion of cost of Probable Construction Cost for the required improvements, as well as, estimates for the required design, permitting and construction observation costs associated with the improvements.

The proposed solution shown on the attached exhibit includes two types of pavement sections. Section A will be used in areas where the grade difference between proposed and existing ground is less than approximately six to ten inches. Section A includes tacking the existing asphalt, placing leveling course to the required elevation and then applying a two inch surface

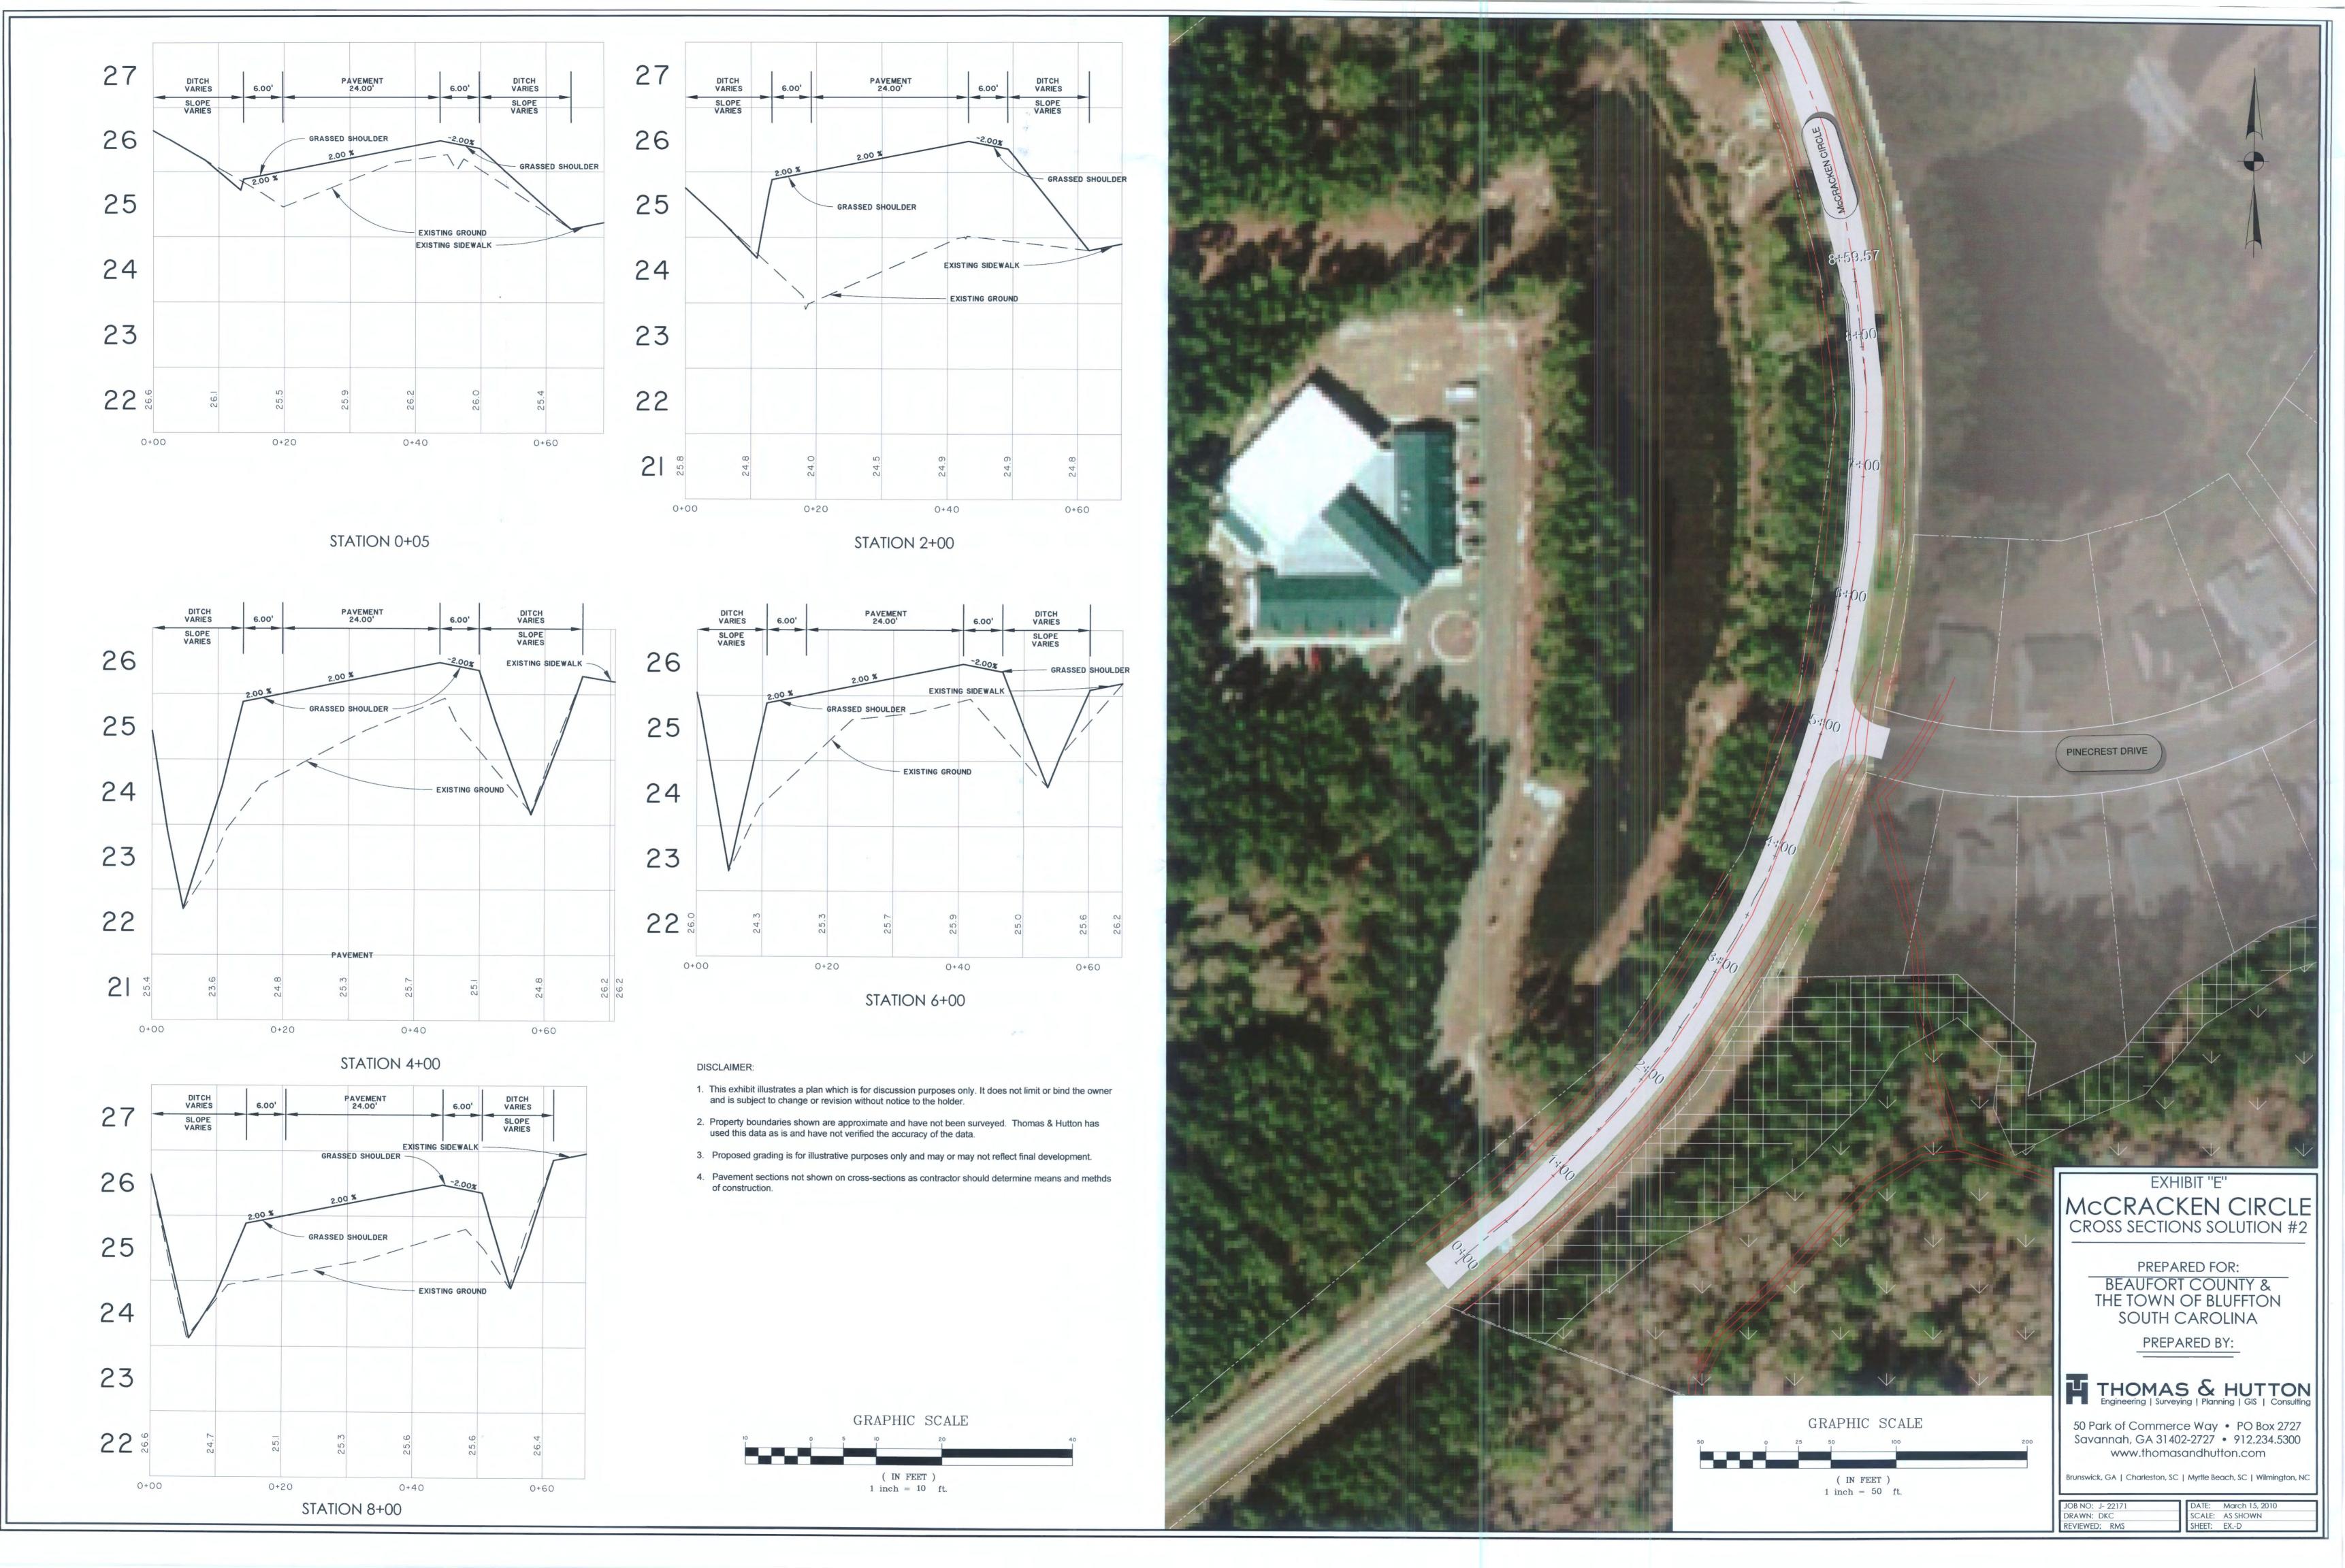
EXHIBIT E

McCracken Circle Cross Sections Solution #2

course. Section B will be used areas where the grade difference is greater than approximately six to ten inches. Section B will include removing the existing pavement, adding fill material to create the subgrade, followed by a rock base and surface course. The thickness of the select fill and rock base course will depend on the finished grade elevations compared to existing. Specific means of construction should be further evaluated when design plans are prepared to ensure the most cost effective solution. In addition to the improvements to the roadway, Beaufort County may also want to consider adding material to the roadside swales to limit the amount of water standing within them. Currently, portions of the roadside swales are below the normal water of the pond and therefore hold water at all times. This has been considered in the cost estimate but is not a necessity.
