**ADDENDUM NO. 5**

**ALTERATIONS & ADDITIONS TO:  
POLICE ANNEX TRAINING CENTER  
MARKET COMMON**

Myrtle Beach, South Carolina  
January 24, 2020

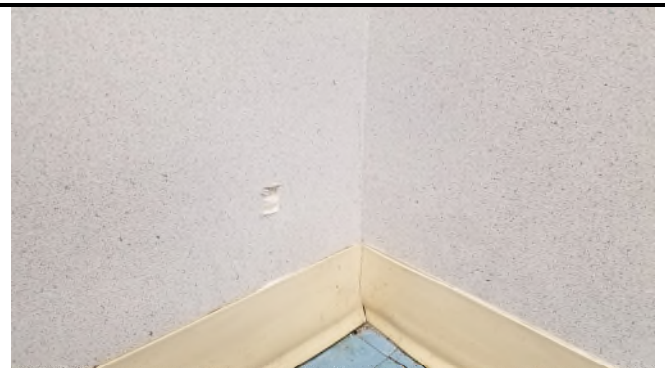
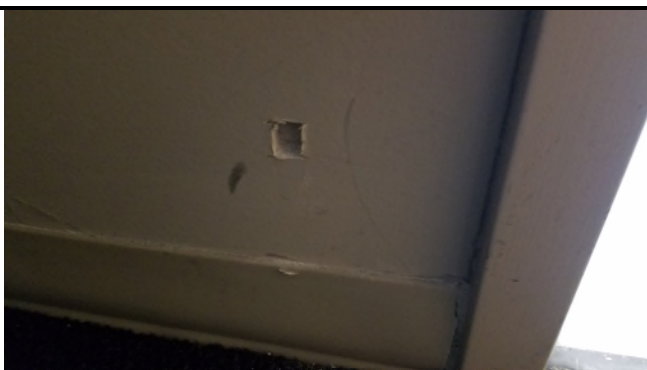
Picture 10 – \*HA20 Sheetrock Walls

Picture 11 – \*HA20 Sheetrock Walls

Picture 12 – \*HA20 Sheetrock Walls

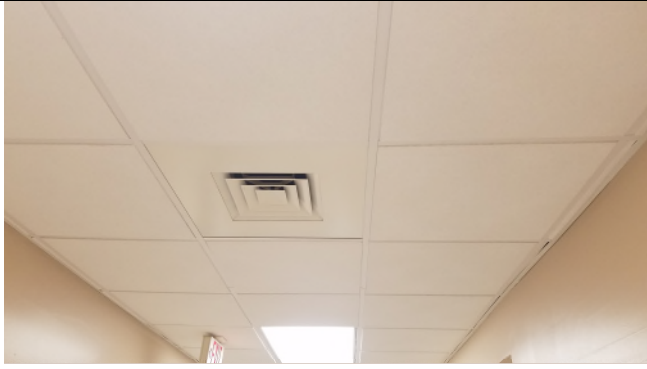
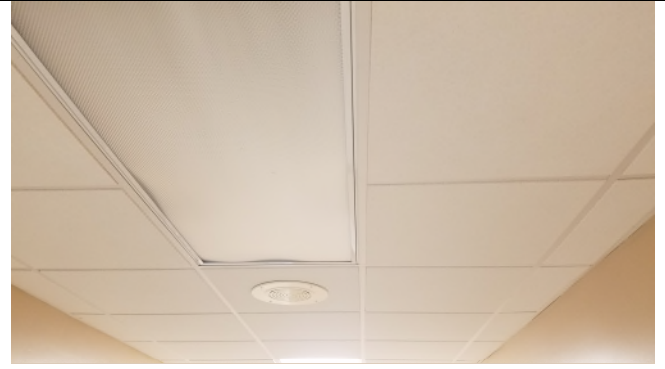
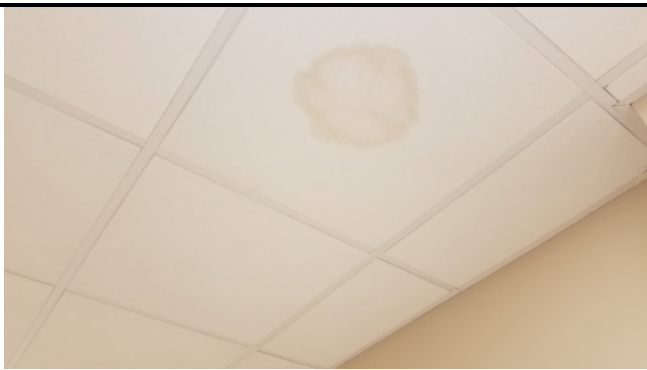
Picture 13 – \*HA30 2x2 Textured Ceiling Tiles

Picture 14 – \*HA30 2x2 Textured Ceiling Tiles

Picture 15 – \*HA30 2x2 Textured Ceiling Tiles

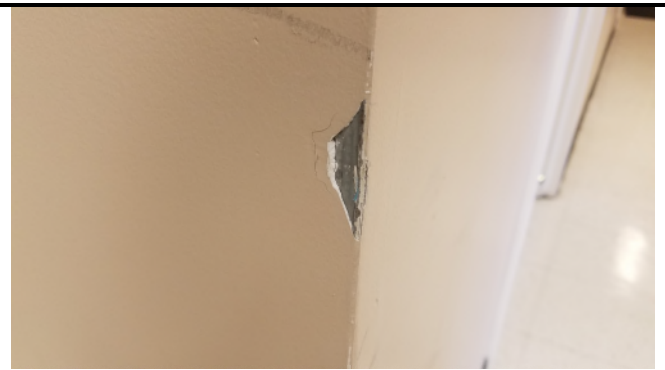
Picture 16 – \*HA40 Joint Compound

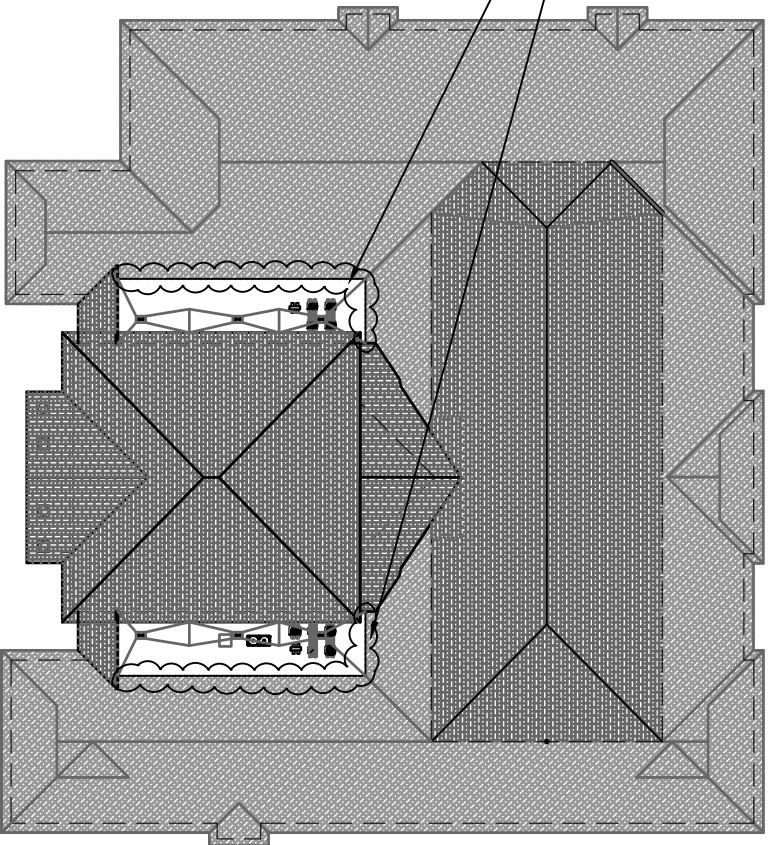
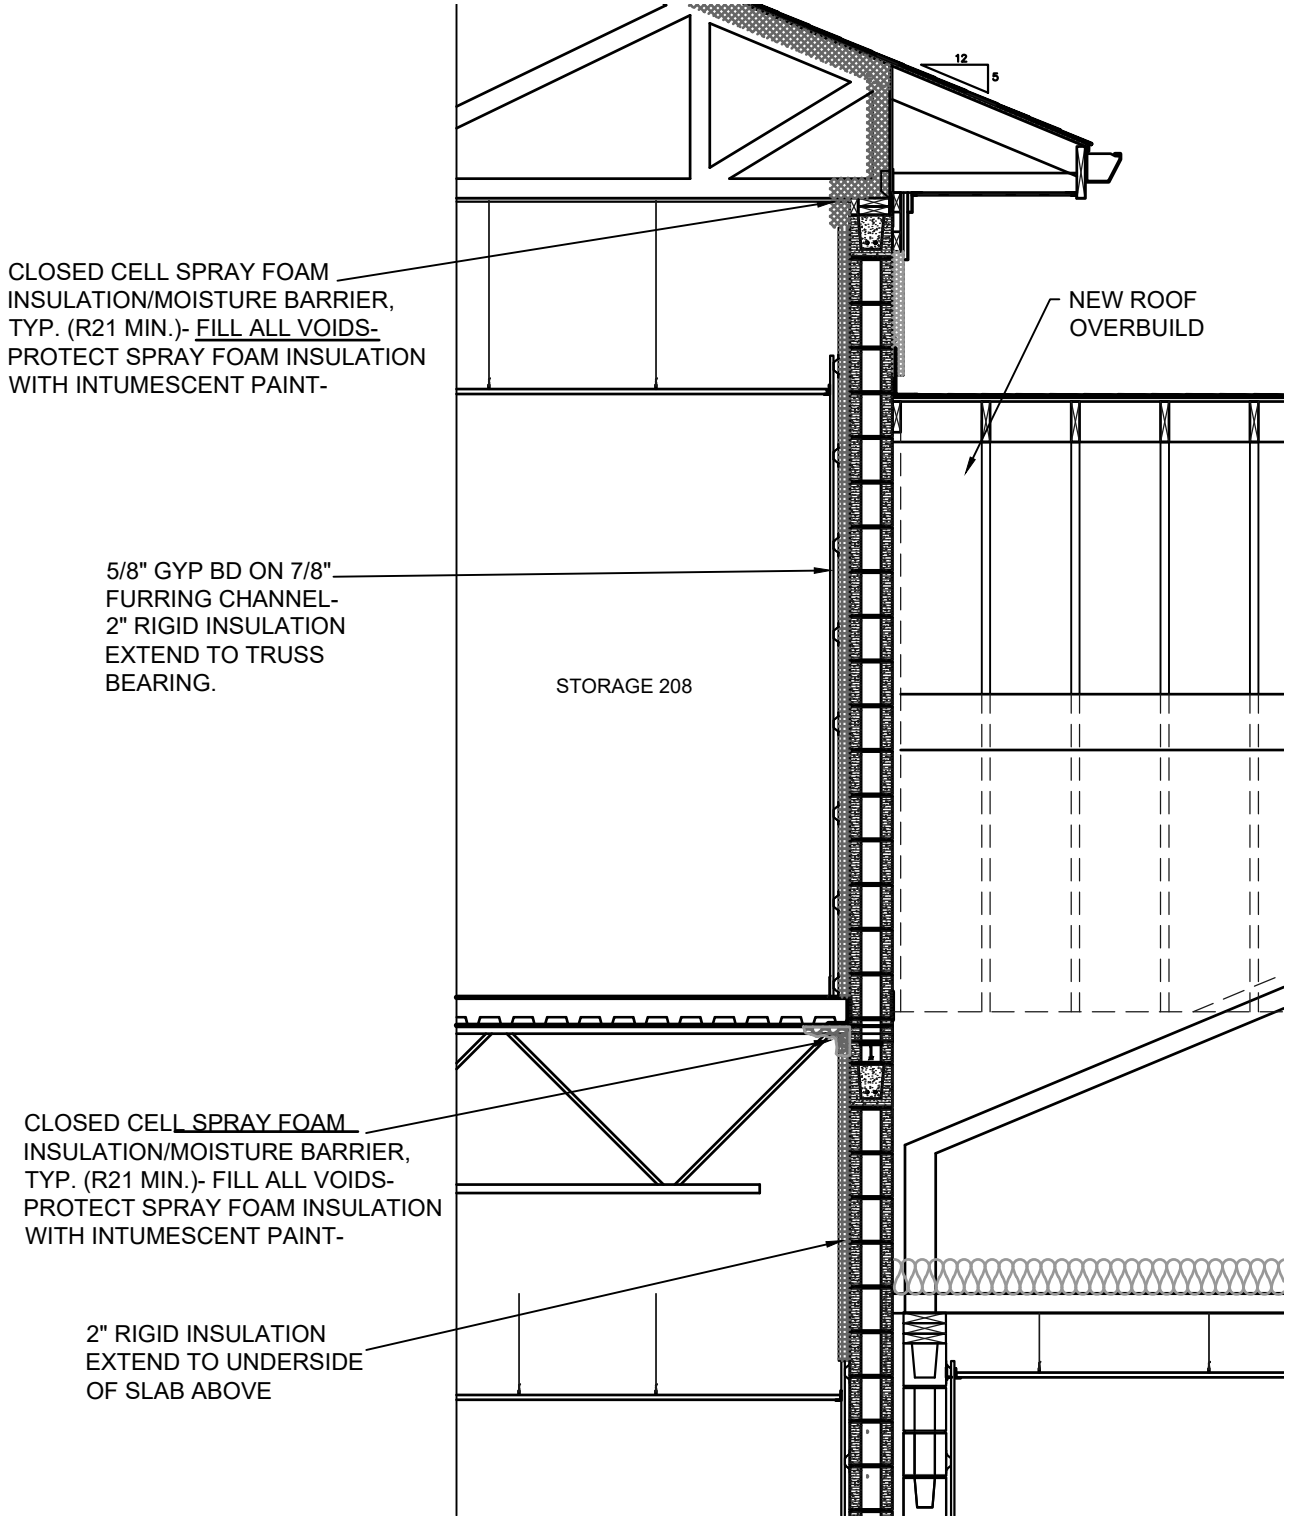
CLOSED CELL SPRAY FOAM INSULATION/MOISTURE BARRIER, TYP. (R21 MIN.)- FILL ALL VOIDS- PROTECT SPRAY FOAM INSULATION WITH INTUMESCENT PAINT-

NEW ROOF OVERBUILD

2. SHEET A7.0 – WALL SECTIONS
  - A. Contractor’s attention is directed to Detail 1/7.0. Contractor is advised to revise per Bulletin Drawing B5 (attached herewith) consisting of 1 page dated 1/24/2020 for thermal barrier.

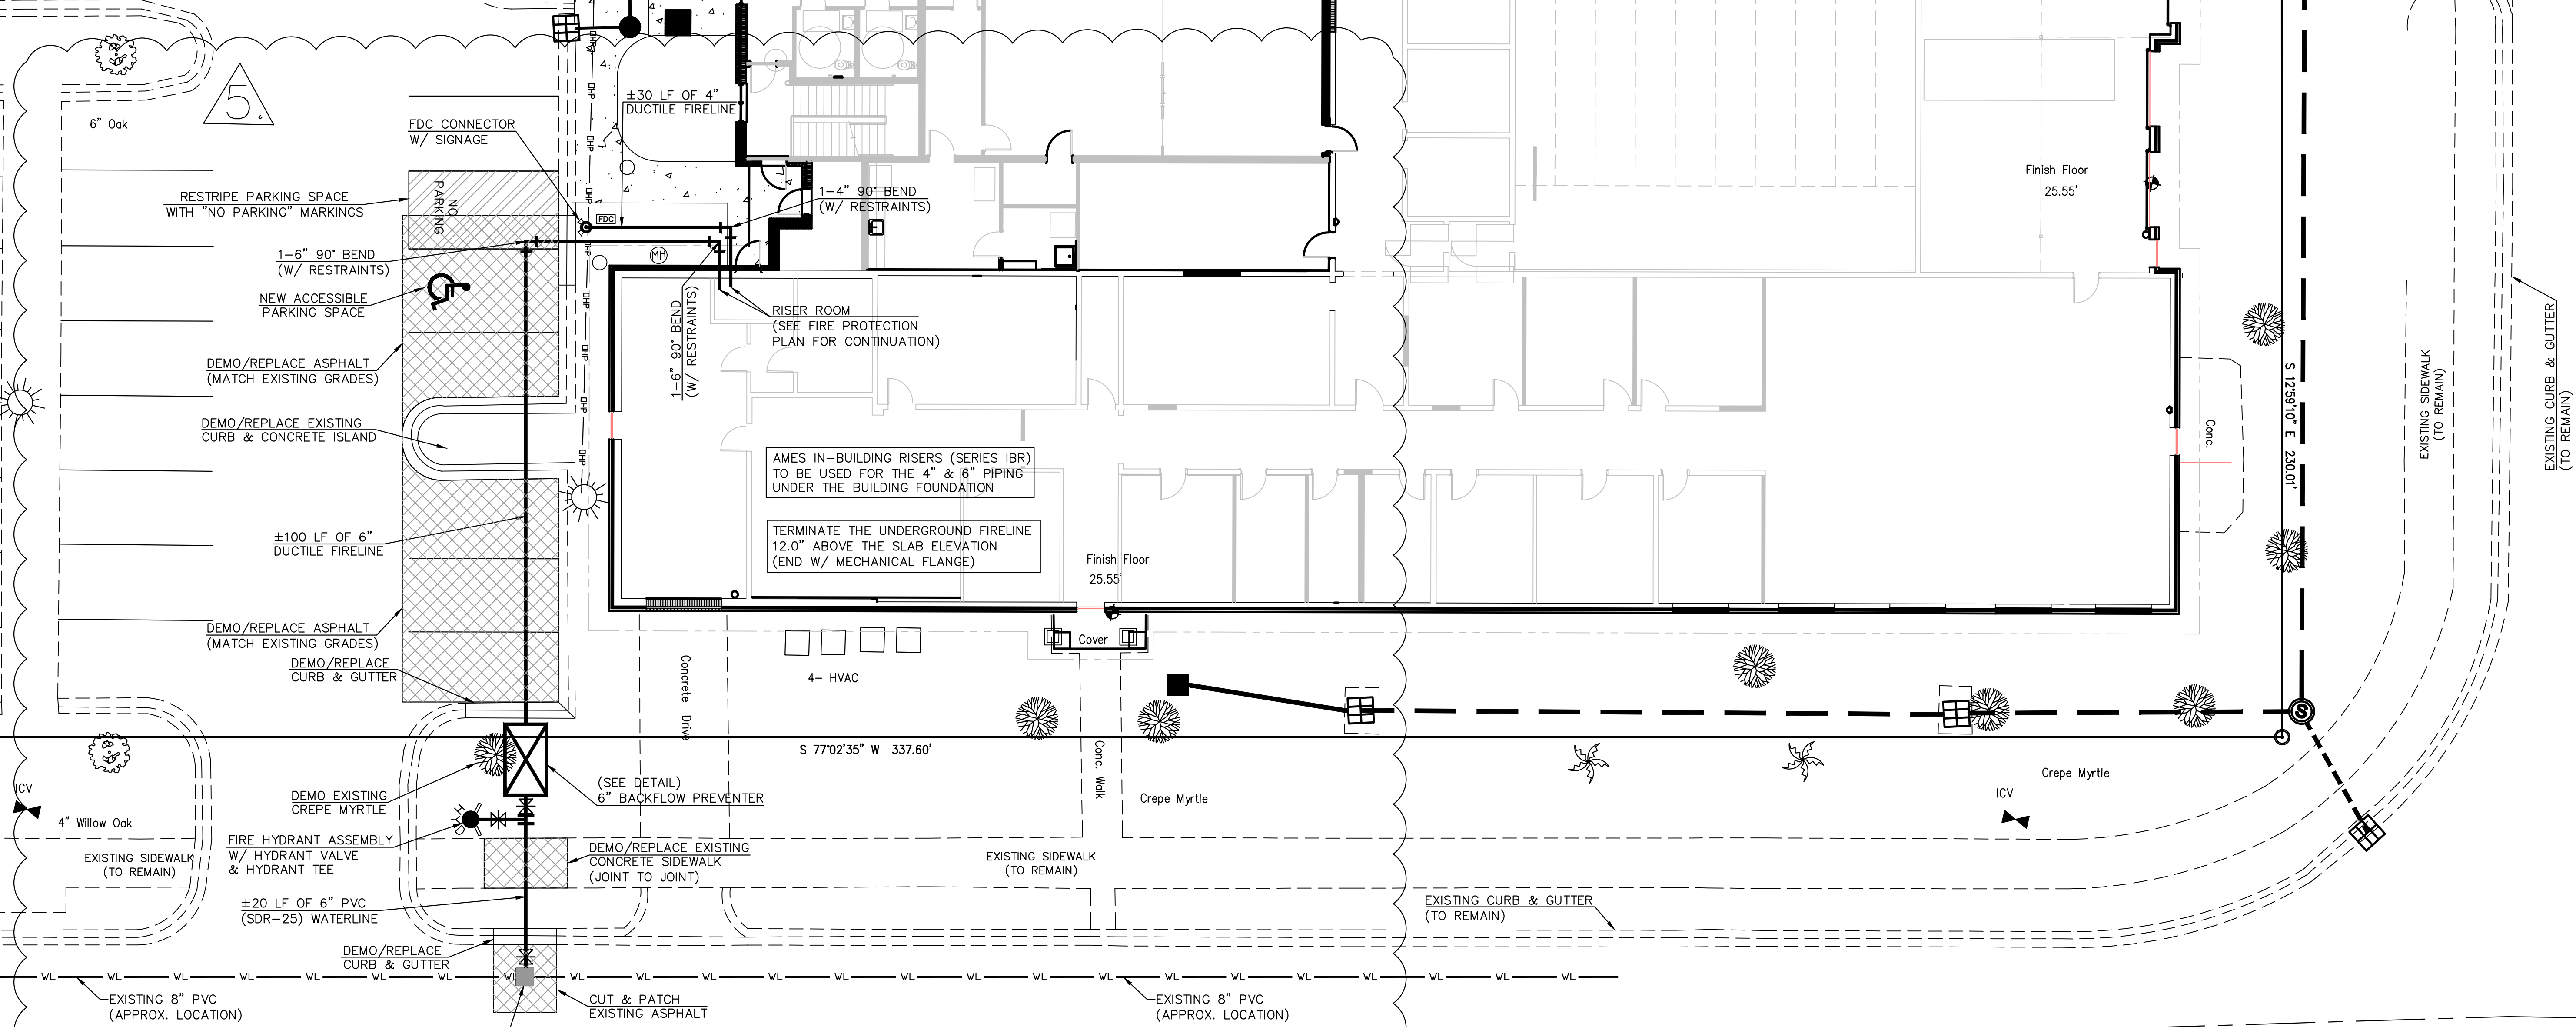
NOTE:  
CONTRACTOR TO VERIFY LOCATION, DEPTH,  
& SIZE OF EXISTING UTILITIES PRIOR TO  
INSTALLATION OF THE NEW FIRELINE

- A11. *Add new 8" x 6" tap (to be coordinated with the City of Myrtle Beach). Add 25 LF of a 6" pvc waterline, 1 new fire hydrant and a 6" backflow preventer (WATTS 709DDC) in a concrete vault. Add 100 LF of ductile iron fireline. Add 4" ductile iron fireline and an FDC connection. AMES Riser to be used for the piping under the building. There will be minor demolition and replacing of asphalt and curbing in order to install the new fireline. See attached revised drawings C5 and C6.*

3. SHEET C5 – FIRELINE PLAN
  - A. Contractor’s attention is directed to SHEET C5 – FIRELINE PLAN. Contractor is advised to insert SHEET C5 – FIRELINE PLAN (attached herewith), consisting on 1 page and dated 1/24/2020.
