CANADA RD SEWER REPAIR

RENAISSANCE GROUP, INC.
 9700 VILLAGE CIRCLE, SUITE 100
 LAKELAND, TN 38002
 (901) 332-5533 VOICE (901) 332-5534 FAX EMAIL: @RGROUP.BIZ

DEPARTMENT OF ENGINEERING
EXISTING CONDITIONS
 LAKELAND, TENNESSEE

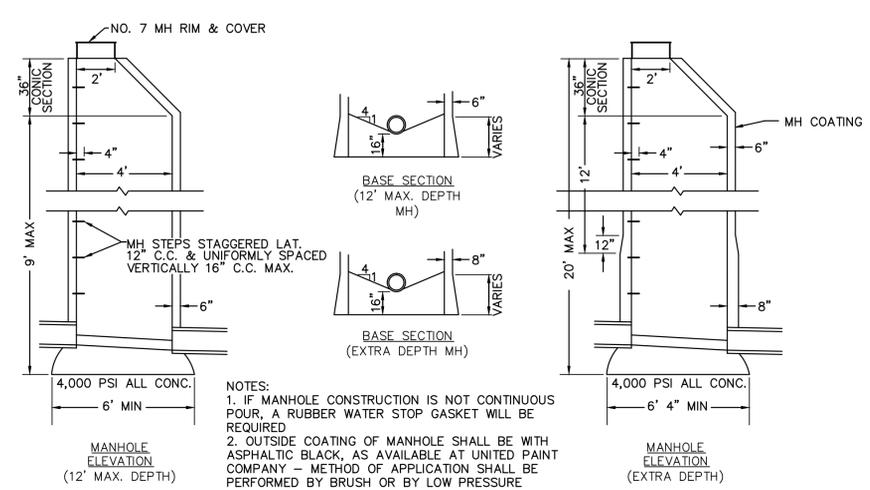
SANITARY MANHOLE STRUCTURE

NOTES:
 1. IF MANHOLE CONSTRUCTION IS NOT CONTINUOUS POUR, A RUBBER WATER STOP GASKET WILL BE REQUIRED.
 2. OUTSIDE COATING OF MANHOLE SHALL BE WITH ASPHALTIC BLACK, AS AVAILABLE AT UNITED PAINT COMPANY - METHOD OF APPLICATION SHALL BE PERFORMED BY BRUSH OR BY LOW PRESSURE SPRAYER

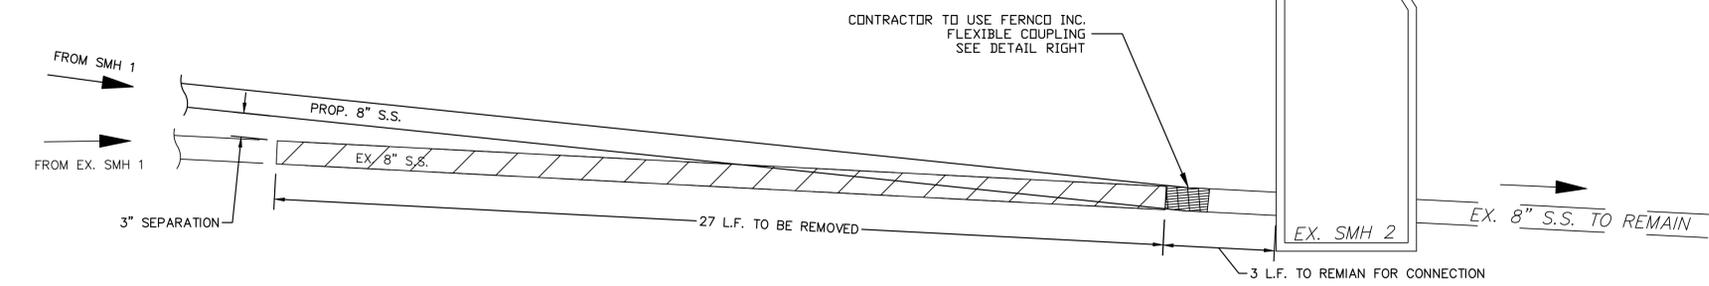
PROPOSED SEWER CONNECTION

DETAIL NOTES:
 1. CUT EX. SANITARY SEWER LINE 3 L.F. UPSTREAM FROM EX. SMH 2
 2. REMOVE 27 L.F. OF EXISTING 8" SANITARY SEWER
 3. CONNECT PROPOSED 8" S.S. LINE TO EX. 8" S.S. LINE USING FERRO INC. FLEXIBLE COUPLING
