SUBJECT: Addendum No. 1 – Hockey Netting System

Re: Roof Framing Evaluation for Rigging Loads
Knoxville Coliseum Roof Framing Evaluation and Scoreboard Relocation
Knoxville, Tennessee
CWE Project No. 2009145.00

The purpose of this letter is to convey and summarize the results of our structural evaluation of the roof framing over the coliseum area and to provide you with updated recommendations for the safe application of rigging loads for future events.

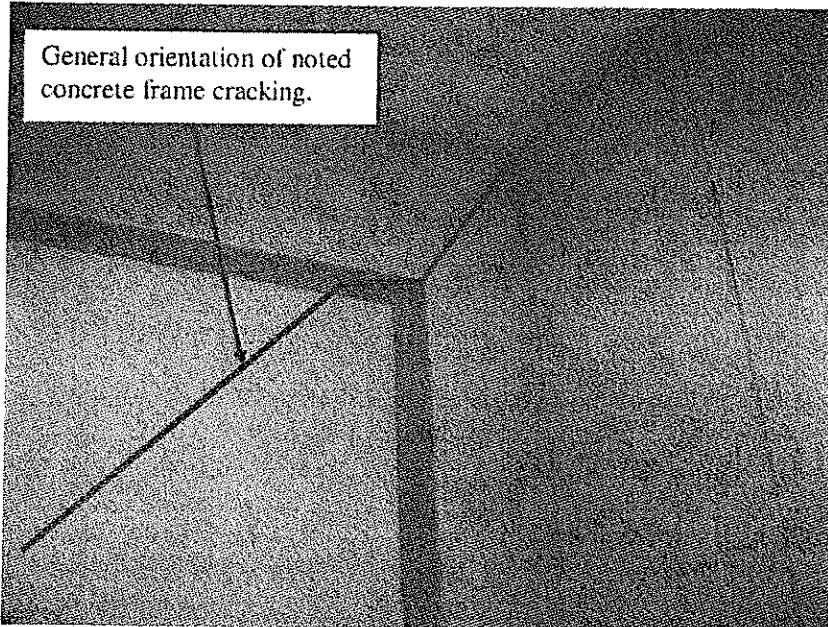
During our initial walk-thru, it was noted that the cantilever concrete frames which support the steel arch section of the roof had visible cracking as seen in photos 1 and 2. The exact extent of the cracking was partially masked by the painting conducted a few years ago. These cracks appear to have been present for a relatively long period of time. Coliseum personnel were not aware of their existence, and painting contractors had not brought it to their attention. These cracks appear to be fairly tight with no evidence of recent significant movement. However, given their critical location within primary framing members that possess no redundancy, we recommend that these cracks be closely monitored. We are available to assist in the development of a system and schedule for the monitoring and recording of any movements. We recommend cracks be monitored for a minimum period of a year. Readings should be recorded on a monthly cycle, after the application of rigging loads from each significant event/show, and during each significant snow occurrence. If significant movement occurs, these cracks should be further evaluated. Alternatively, CWE can provide the monitoring of cracks on an hourly rate or negotiated basis.

Photo 1 – Sample Sketch of Concrete Frame Cracking at Fixed end of Cantilever
(actual cracks have been painted over and are not visible in this photo)

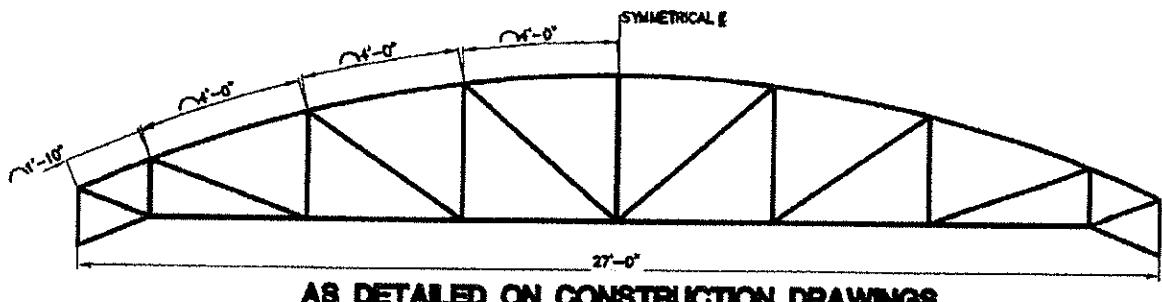
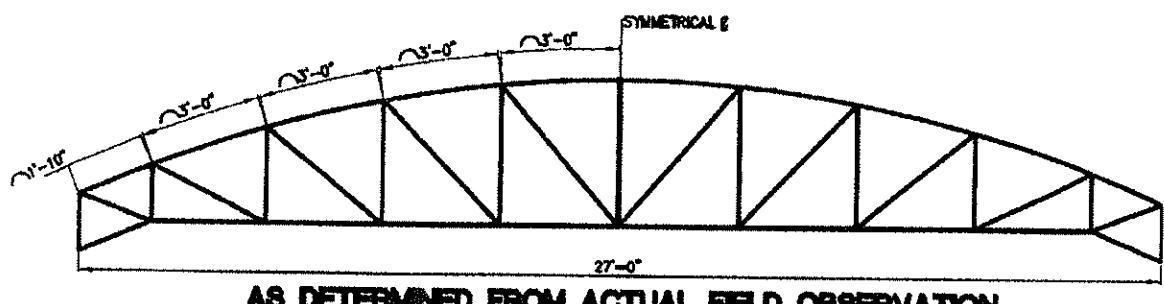
INTERMEDIATE TRUSS PROFILE

were randomly verified with that shown on the original structural construction drawings. A significant deviation in the web member layout of the conventional steel trusses was observed and noted. Refer to the attached Intermediate Truss Profile sketch depicting the observed deviation. Our computer analysis model was adjusted accordingly, and based on our results, it is our opinion that the actual layout does not adversely affect the intended structural performance of these trusses.

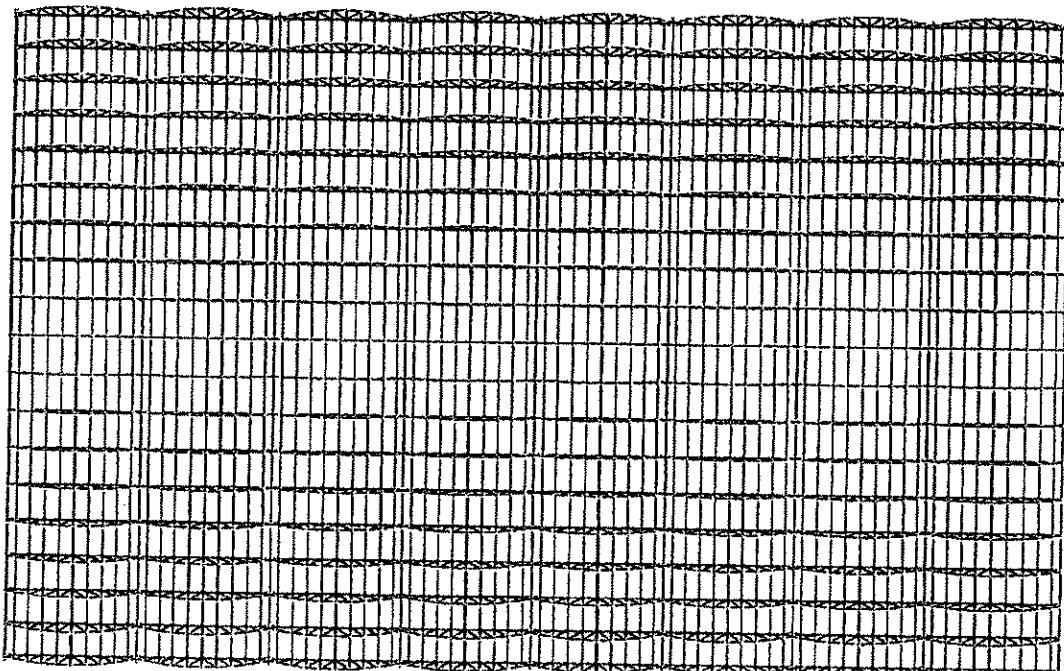
As previously noted, a computer model of the steel framing system was generated to aid in the analysis of multiple scenarios for applied rigging loads and their effects on the structural system. A few screenshots of the analytical computer model have been included for your reference. During our review of the structural construction documents, we were unable to confirm the required material specification used for the design and construction of the steel portion of the roof framing system. Therefore, in our analysis model we have assumed the ultimate and yield strengths of the steel members to be 60,000 psi and 33,000 psi, respectively. This assumption was based on the wide use of material specification ASTM A7 for structural steel buildings from the late 1930's until the early 1960's. We also conducted a quick review of the critical section of the concrete frames, located in the cantilever roof beam at the face of the concrete column, supporting each side of the arches.

Top View of Computer Model

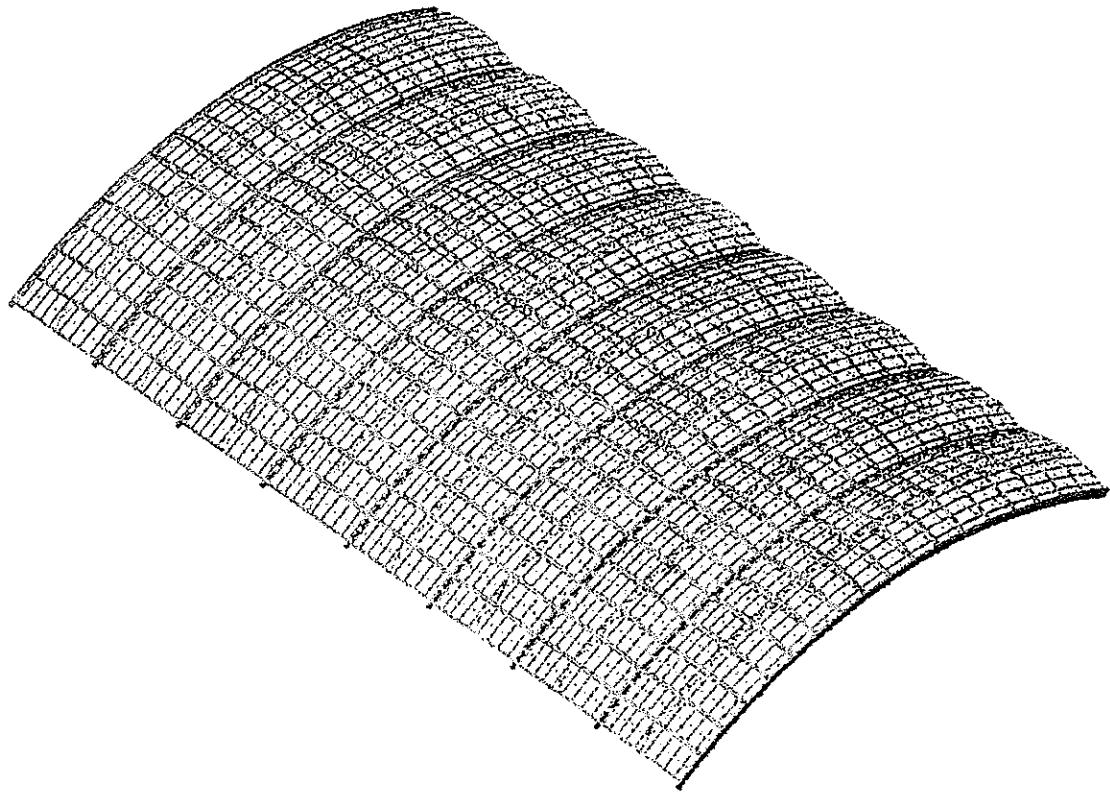
Rendered Isometric View of Eight Bay Model

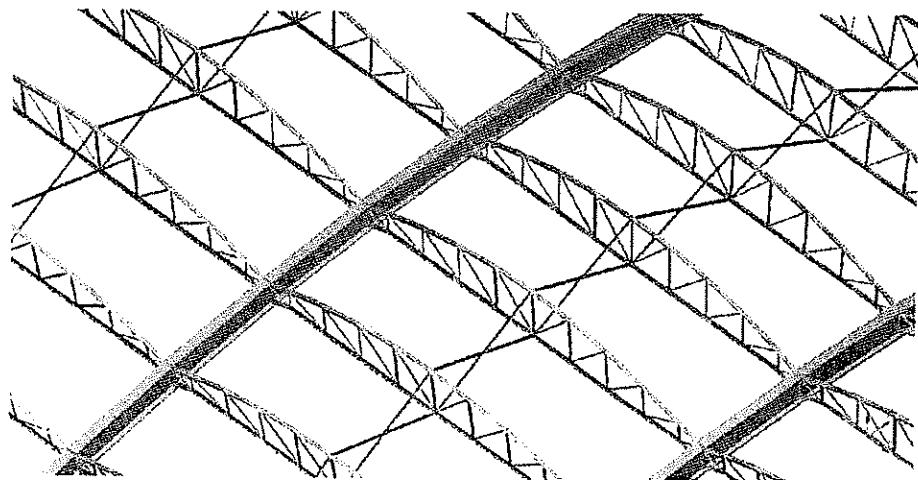
Rendered Isometric View Close-Up of Eight Bay Model
(Roof Deck & 'Bulb-T Purlins Not Shown for Clarity)

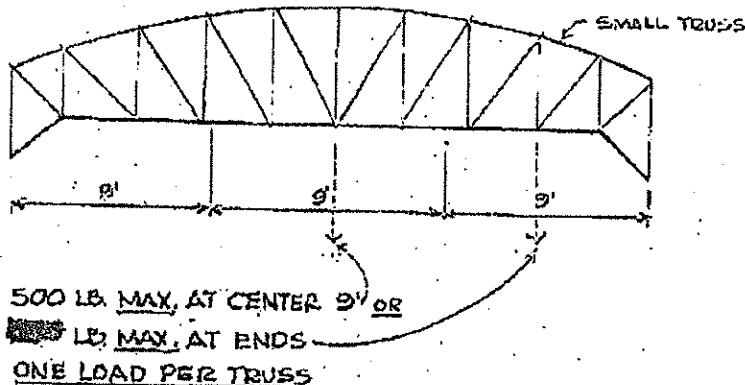
ATTACHMENT #1
PREVIOUS RIGGING GUIDELINES

1500 LB. MAX. EACH LOAD
AT LEAST 8' BETWEEN LOADS
(1500 LB. INCLUDES LOADS FROM TRUSSES)

DO NOT SUSPEND LOADS FROM ROOF DURING SNOW, RAIN OR HIGH WIND

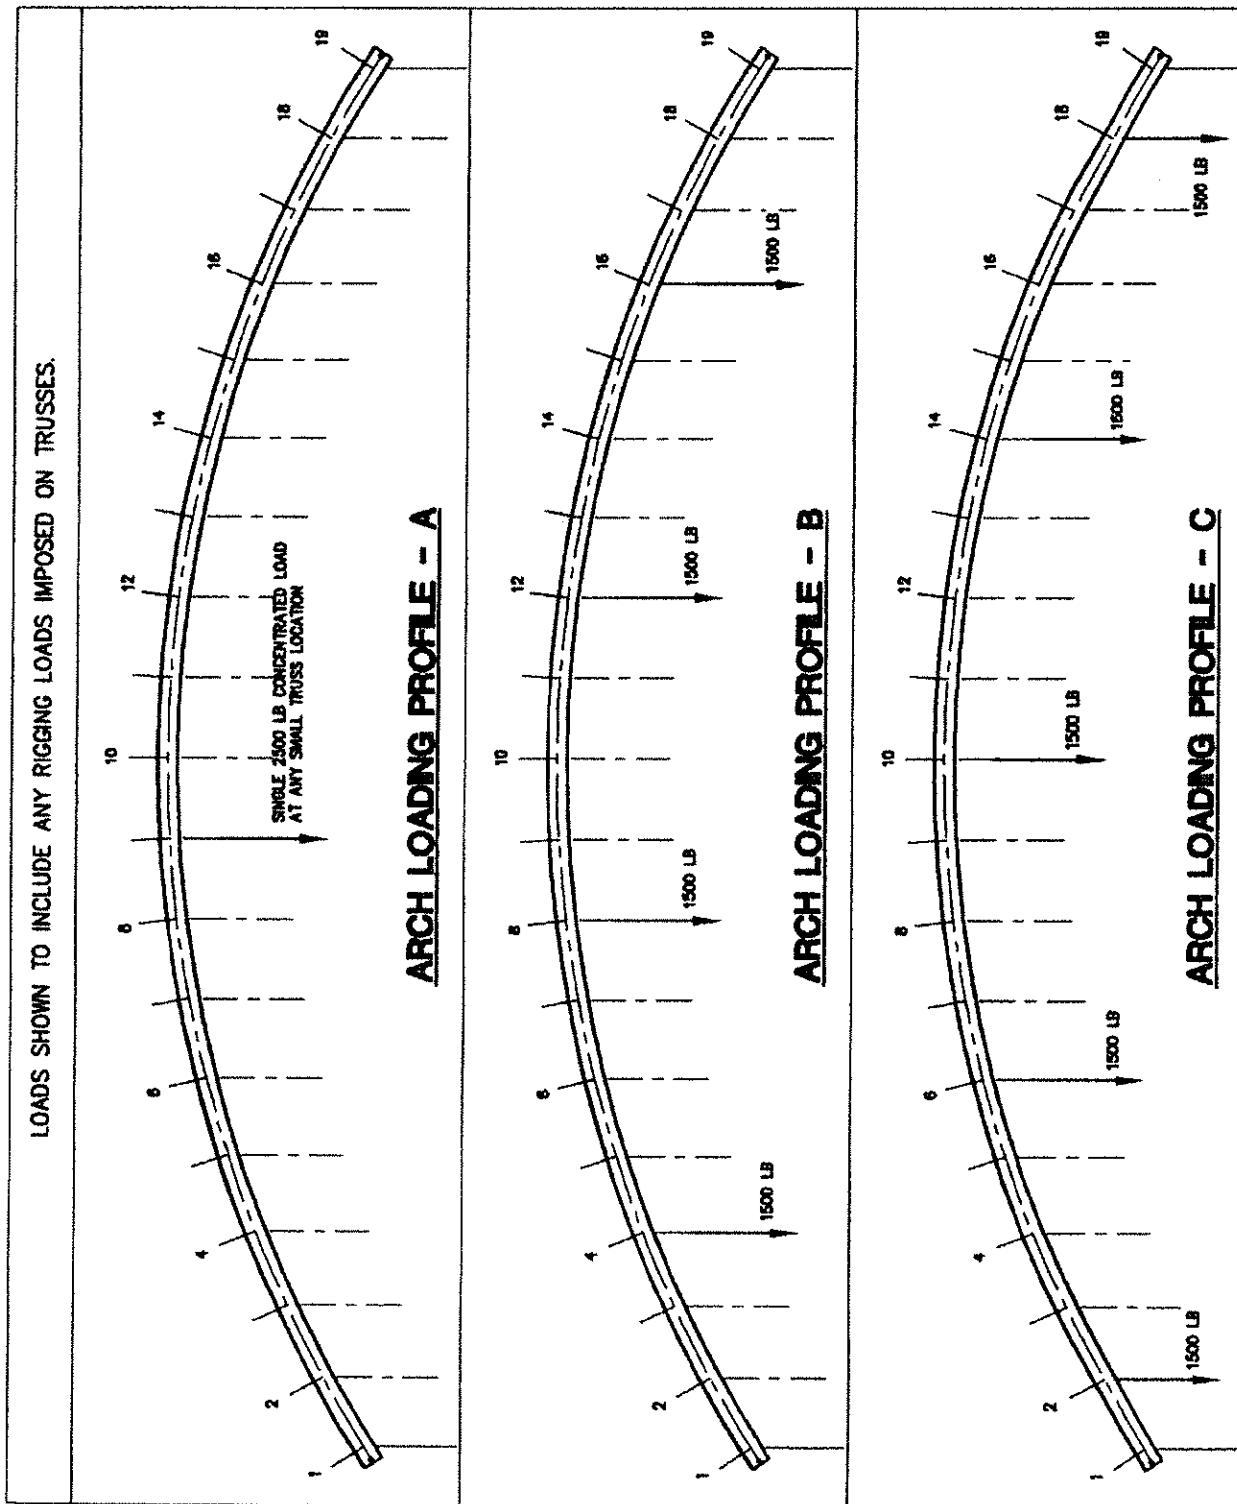
PROJECT Knoxville Civic Coliseum NO. 2008145.00
COMPUTED BY MRR DATE 11/30/11 CHECKED BY DATE
SUBJECT Allowable Steel Arch Loading Profiles SHT 9 OF 11

As a starting point for our rigging load evaluation, we used information provided by a rigging contractor commonly used by the facility and Attachment #1. Based on multiple trial analyses using different rigging load configurations, we have provided updated guidelines for the safe application of rigging loads. Please refer to the Arch Loading Profiles noted for a depiction of these guidelines.

- A single suspended load of up to 2500lb applied directly to the arch at one small truss location.
 - "Arch Loading Profile - A".
- Four or five suspended loads of no more than 1500lb applied directly to the arch at every fourth small truss location.
 - "Arch Loading Profile - B" OR
 - "Arch Loading Profile - C".
- Multiple suspended loads of no more than 800lb applied directly to the arch at every other small truss location.
 - "Arch Loading Profile - D"

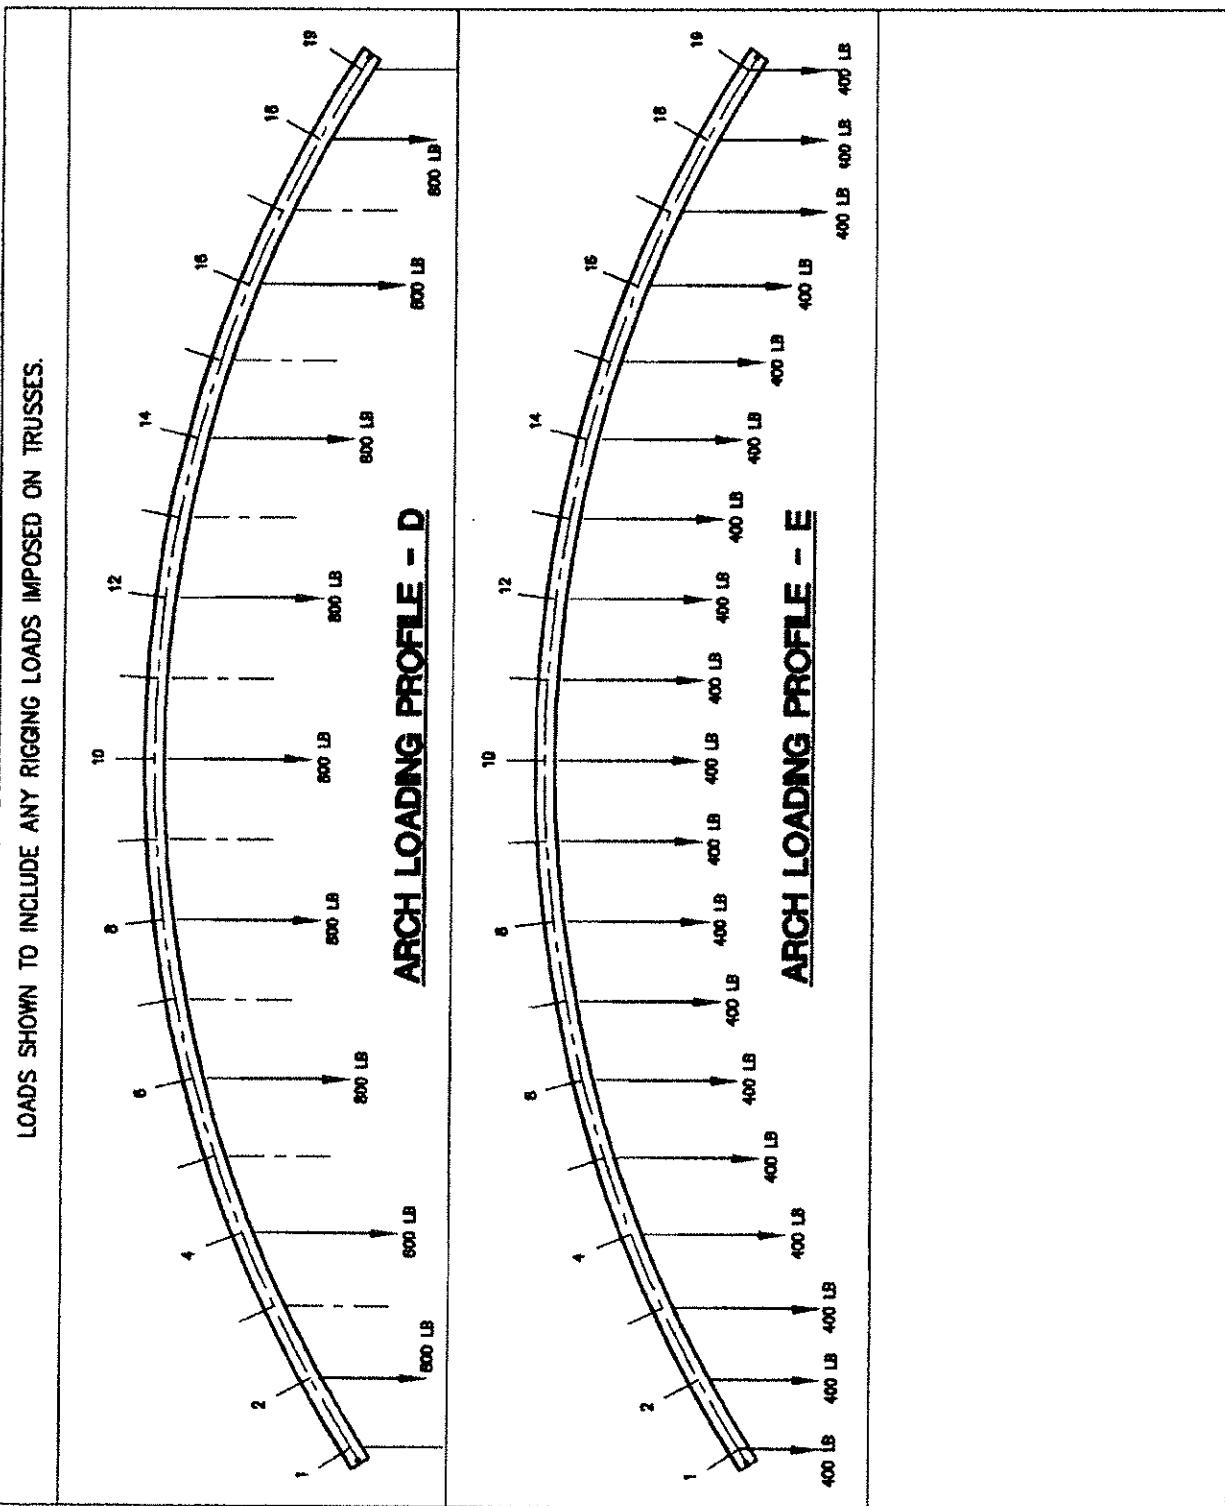
PROJECT Knoxville Civic Coliseum NO. 2009145.00
COMPUTED BY MRR DATE 11/30/11 CHECKED BY DATE
SUBJECT Allowable Steel Arch Loading Profiles SHT 10 OF 11

- Multiple suspended loads of no more than 400lb applied directly to the arch at every small truss location.
 - "Arch Loading Profile - E"

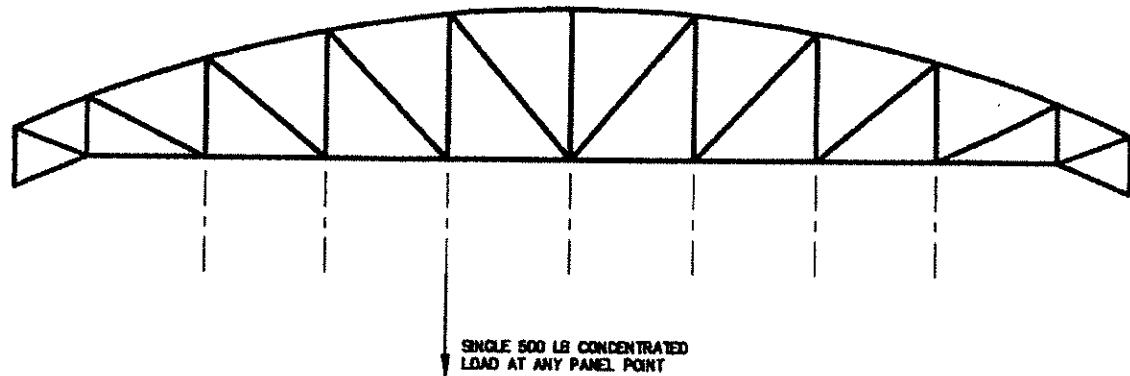
ROOF TRUSS LOADING PROFILE - F

For the typical roof trusses, a maximum single load of 500 lb may be applied at any panel point. Do not hang loads greater than 6" away from panel points that would produce bending in the bottom chords. Refer to Roof Truss Loading Profile - F attached.

DO NOT APPLY CONCENTRATED LOADS BETWEEN PANEL POINTS THAT WILL PRODUCE BENDING OF TRUSS CHORDS.
