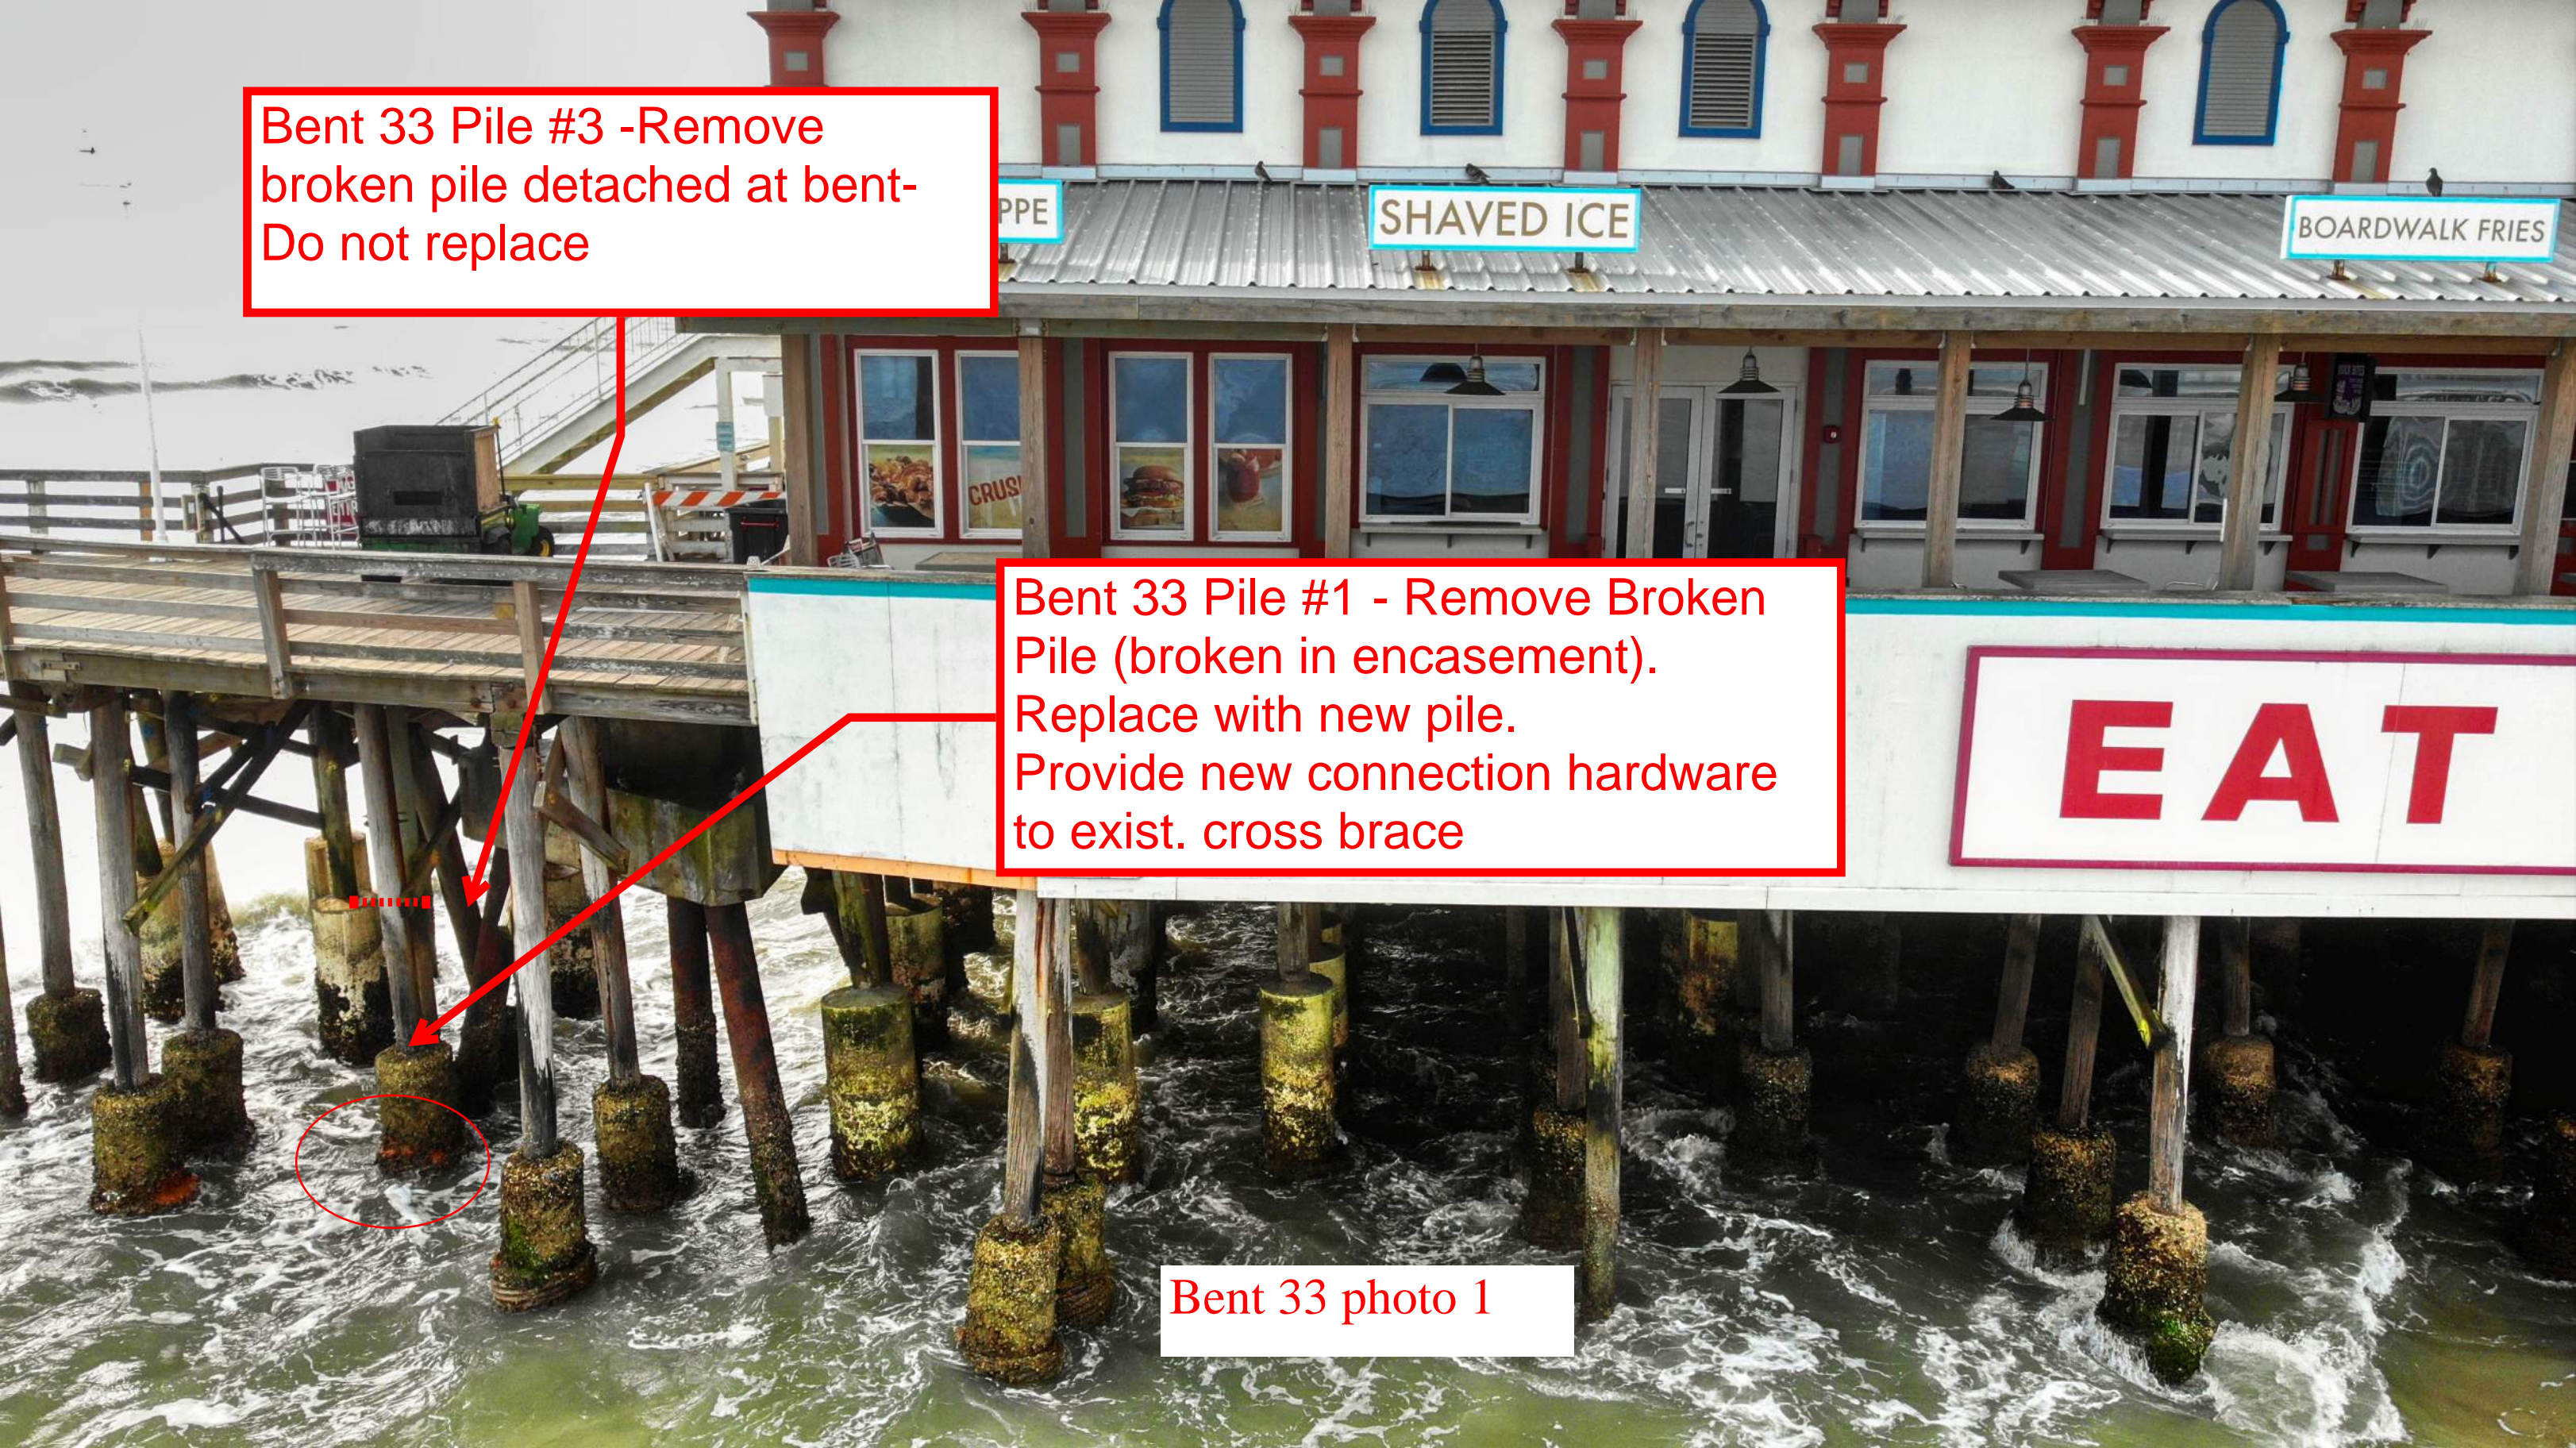
Bent 33 photo 1

Bent 33 Pile #3 -Remove
broken pile detached at bent-
Do not replace

Bent 33 Pile #1 - Remove Broken
Pile (broken in encasement).
Replace with new pile.
Provide new connection hardware
to exist. cross brace

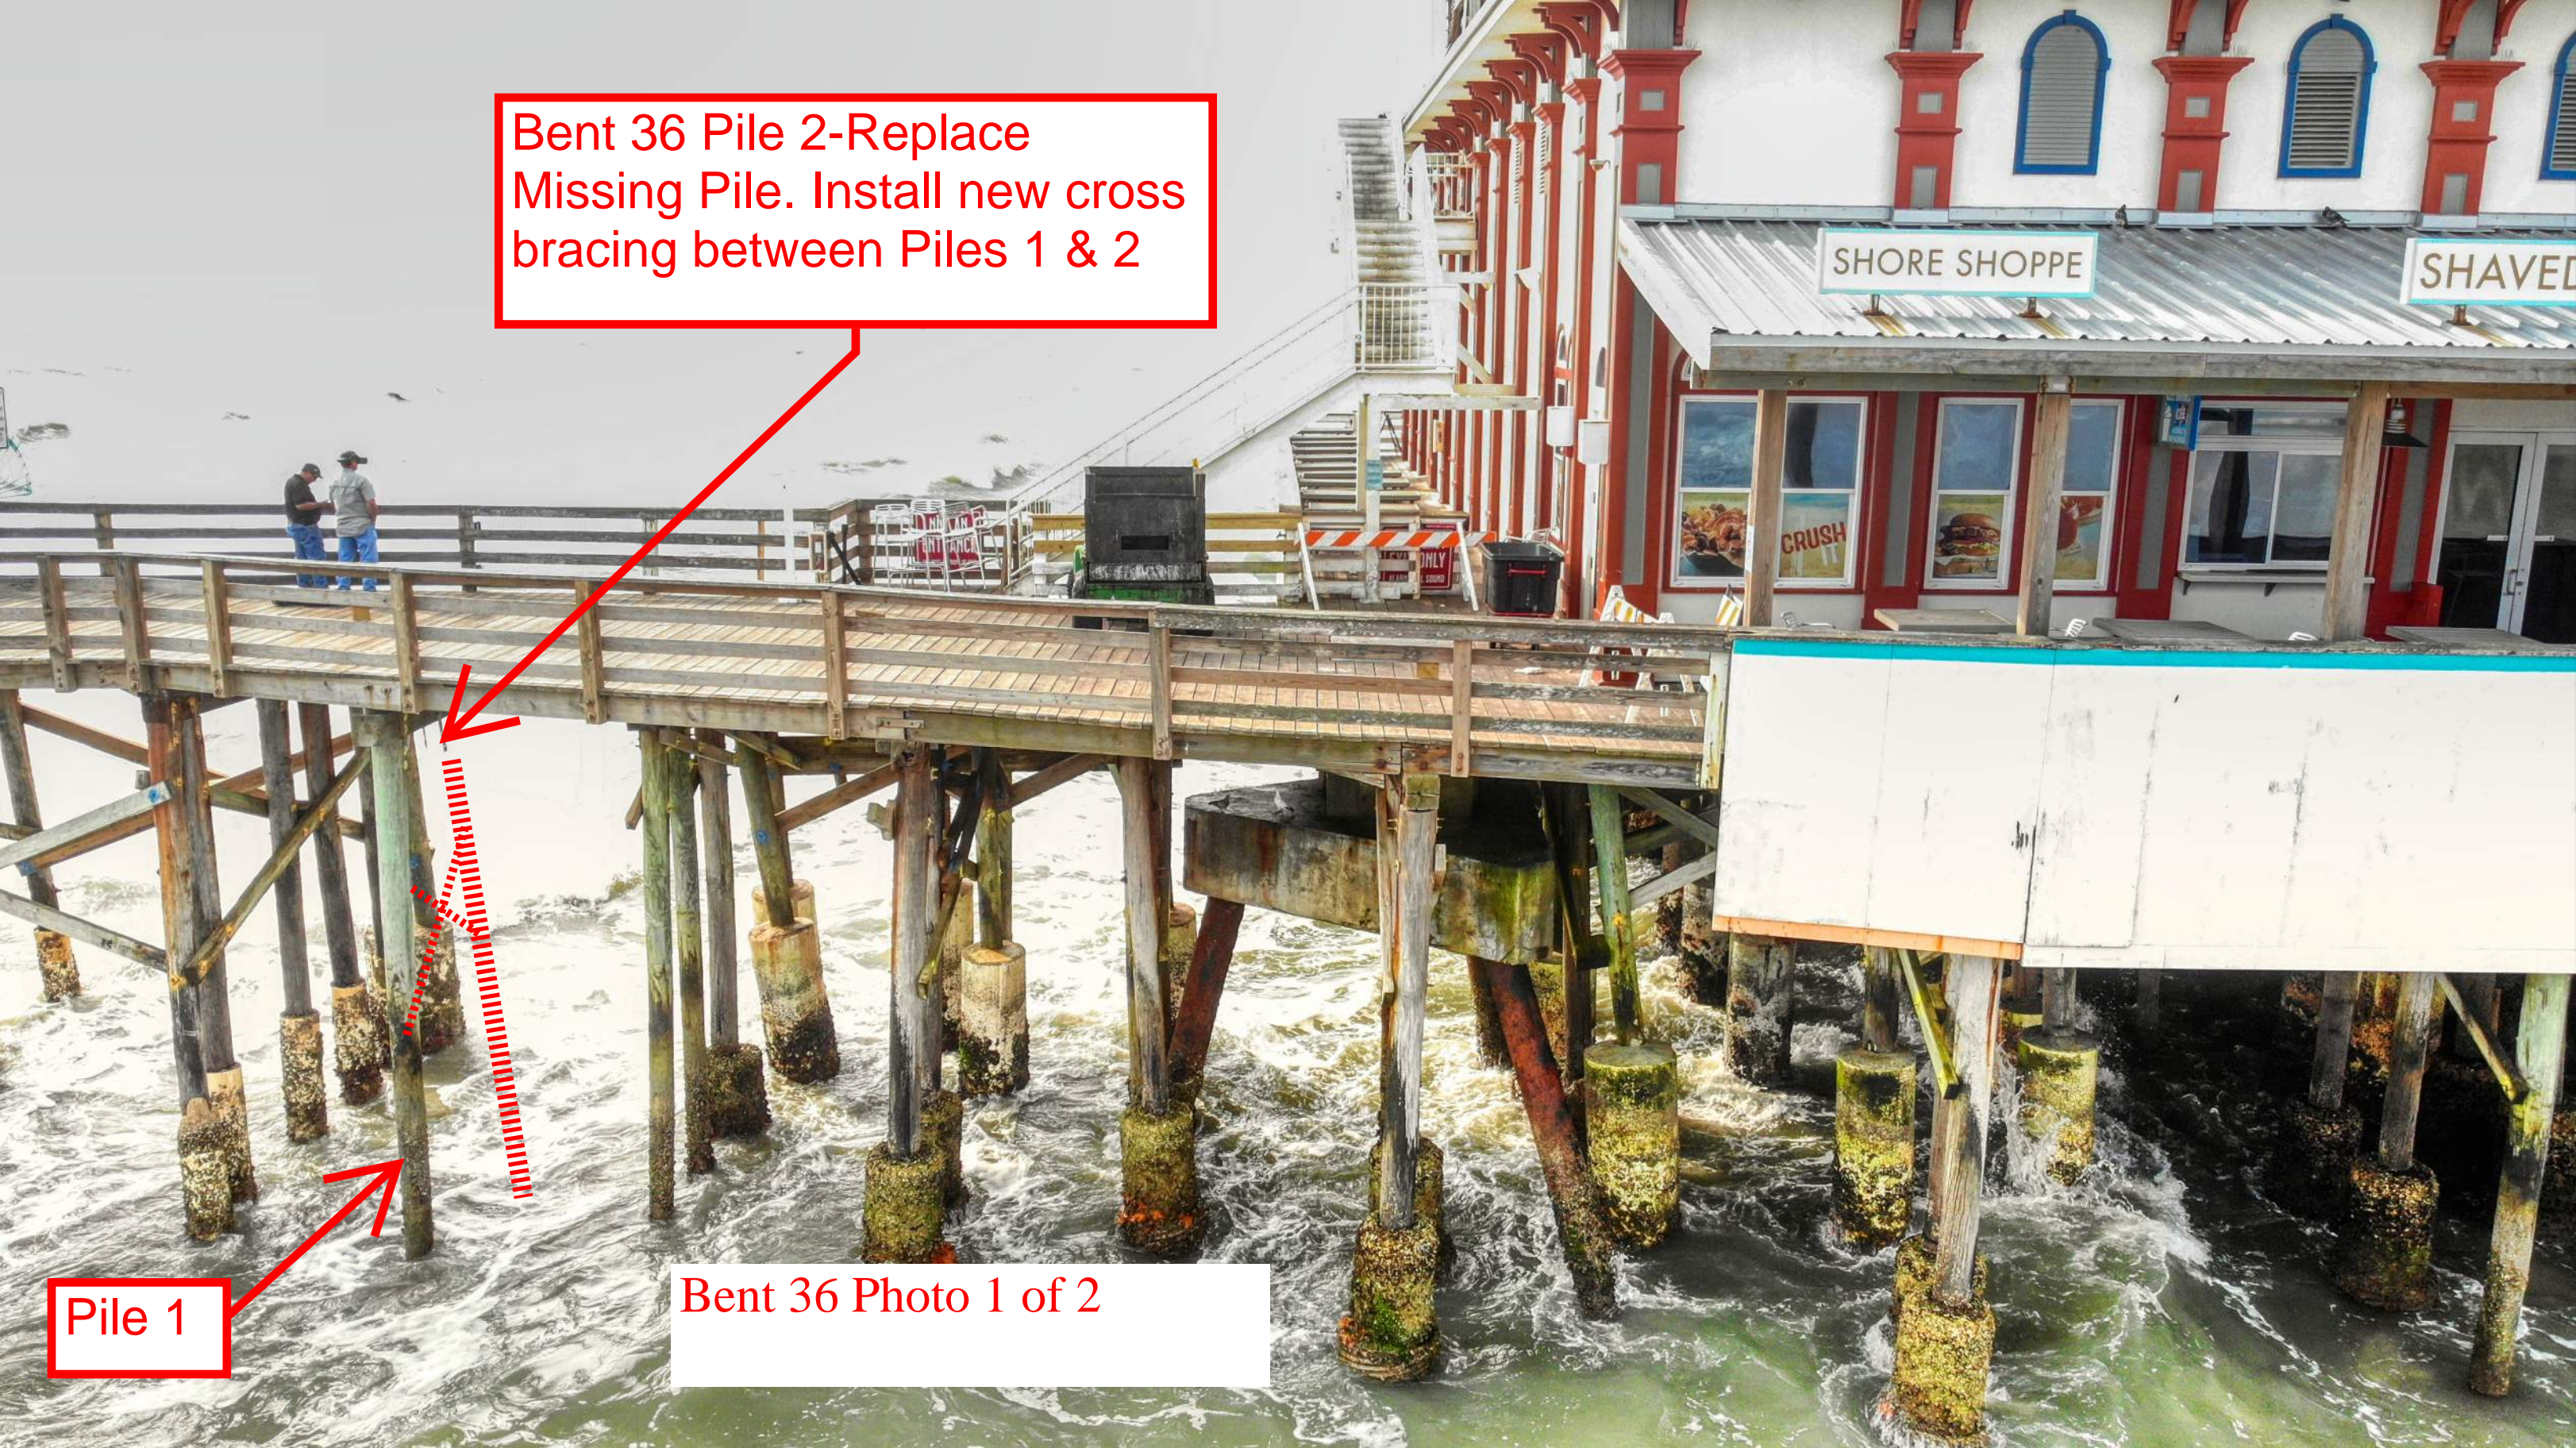
Bent 36 Photo 1 of 2

Bent 36 Pile 2-Replace
Missing Pile. Install new cross
bracing between Piles 1 & 2

Pile 1

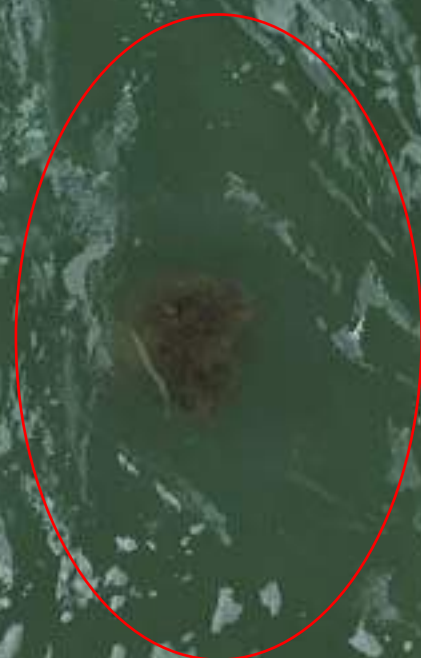
Bent 36 Photo 2/2

Pile stub
Bent 36
-pile #2
location

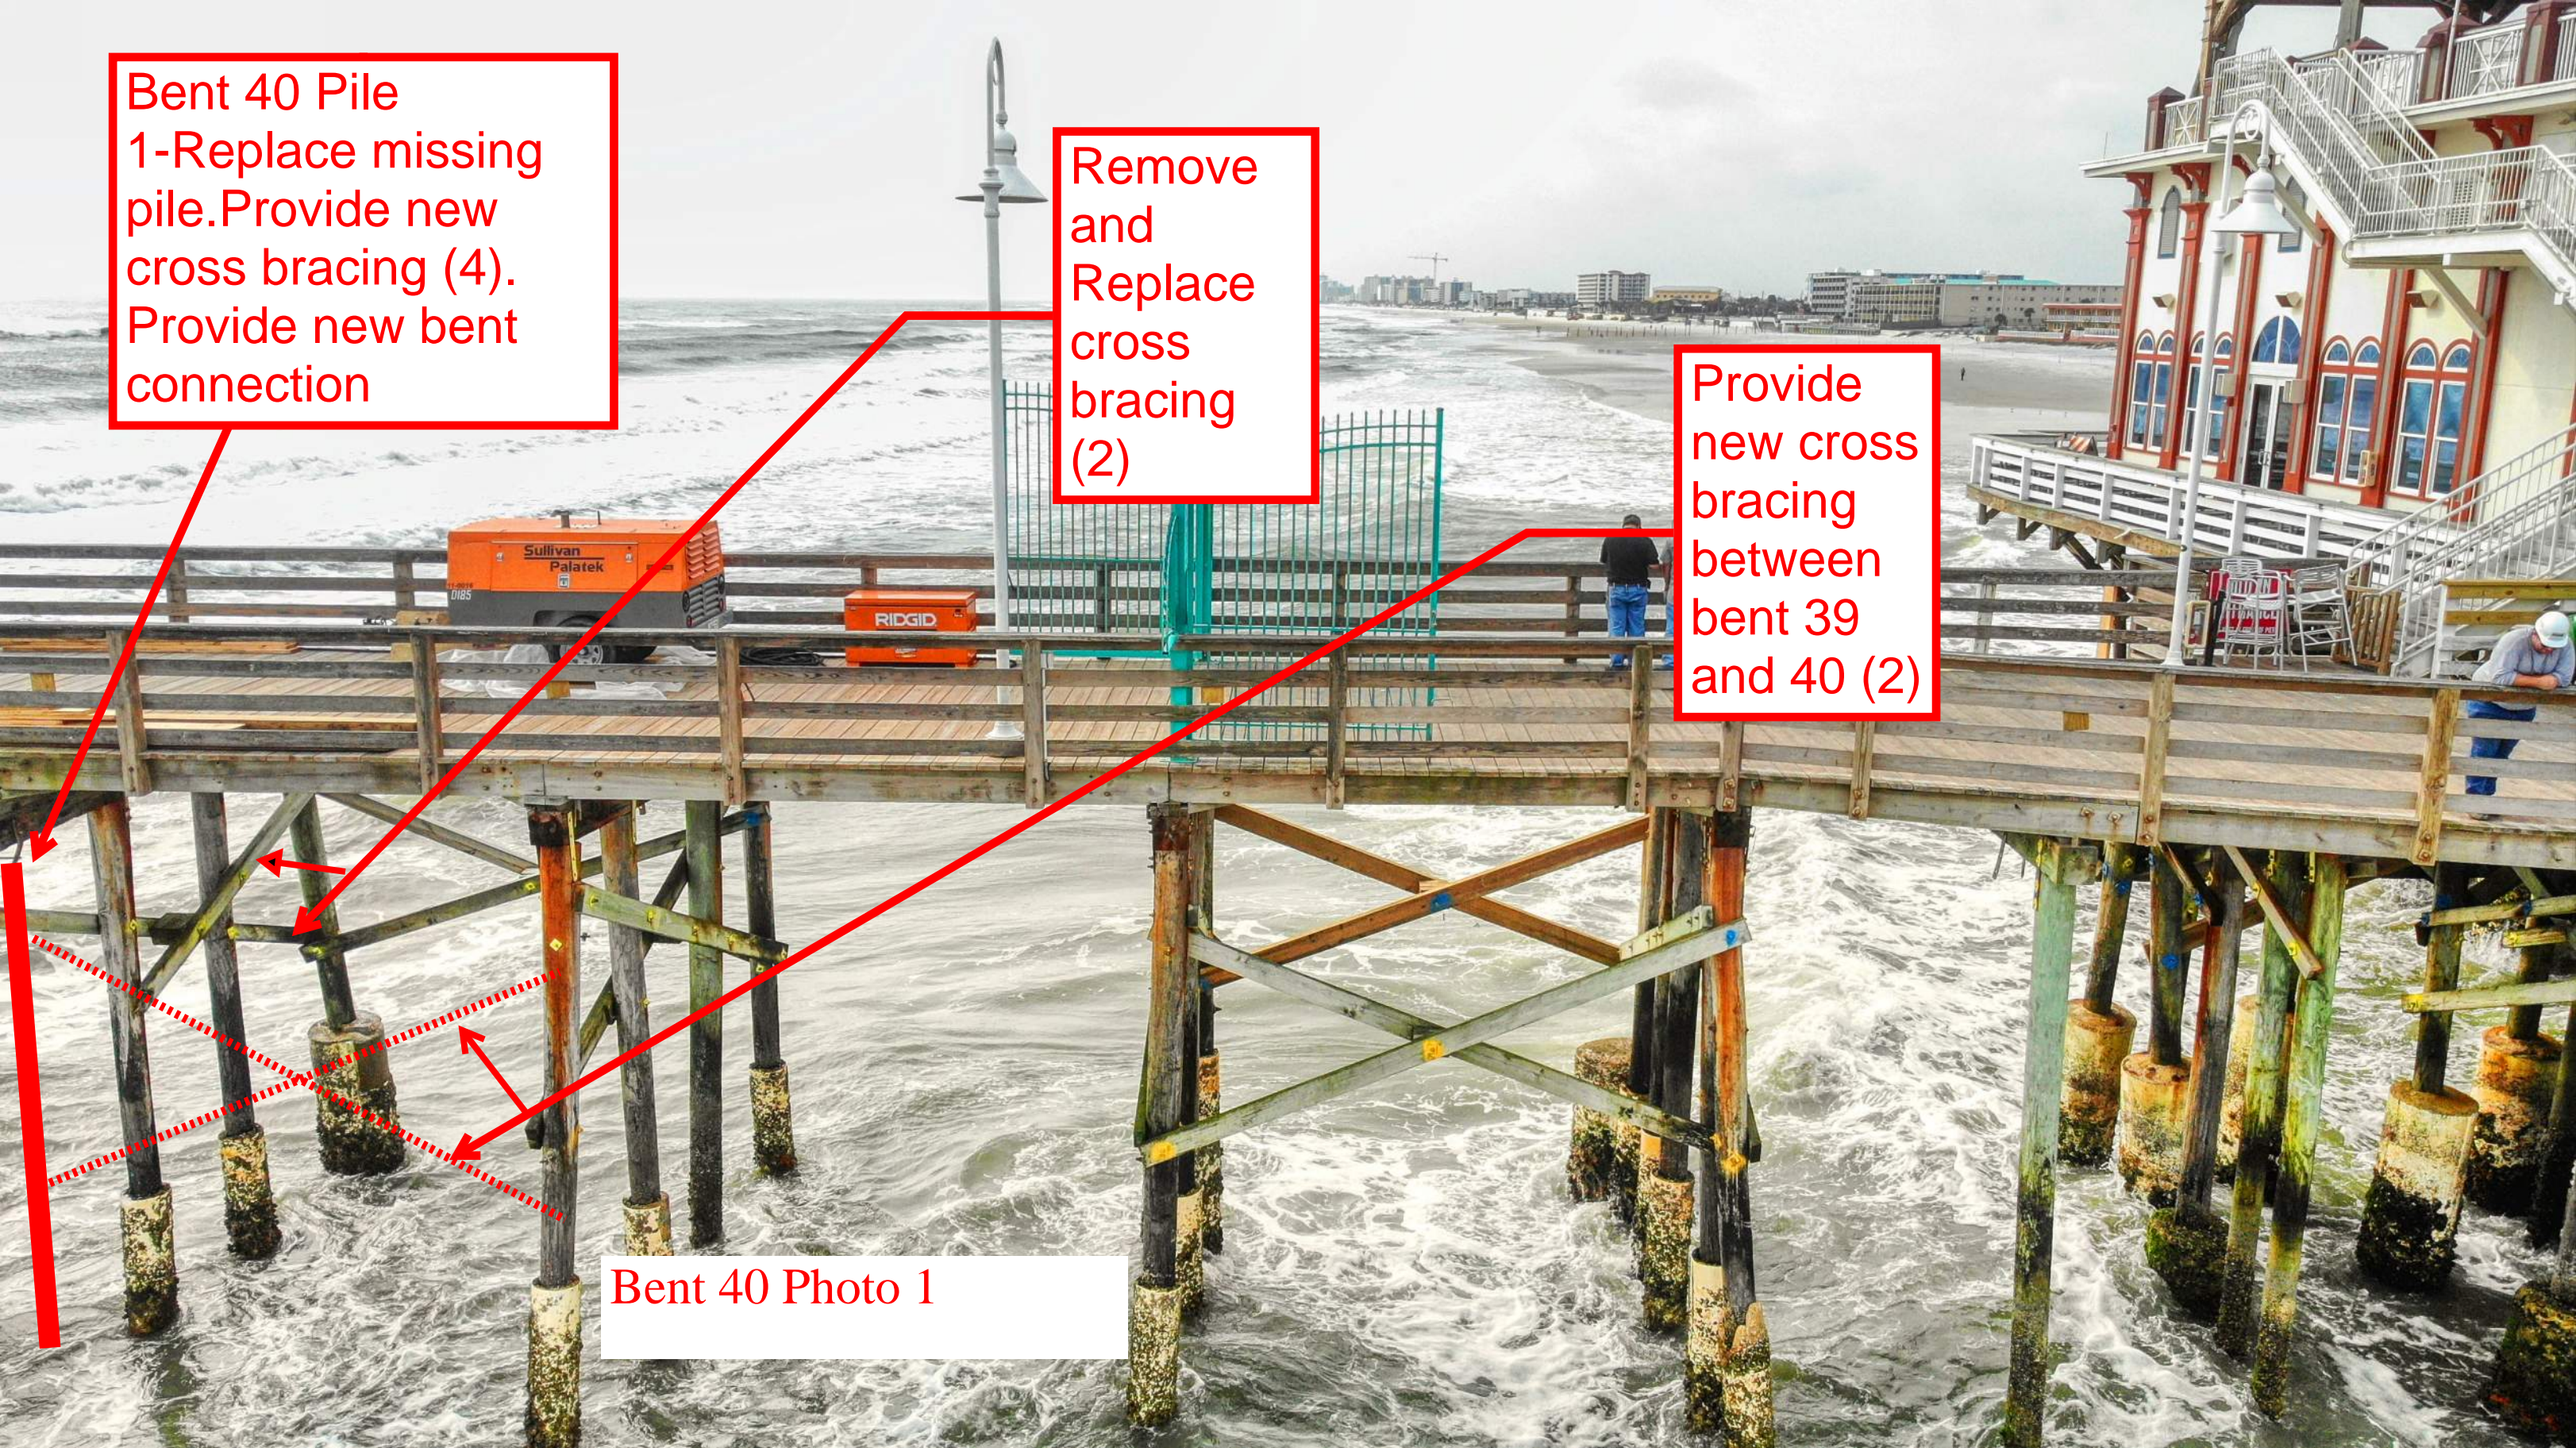
Bent 40 Photo 1

Bent 40 Pile
1-Replace missing
pile. Provide new
cross bracing (4).
Provide new bent
connection

Remove
and
Replace
cross
bracing
(2)

Provide
new cross
bracing
between
bent 39
and 40 (2)

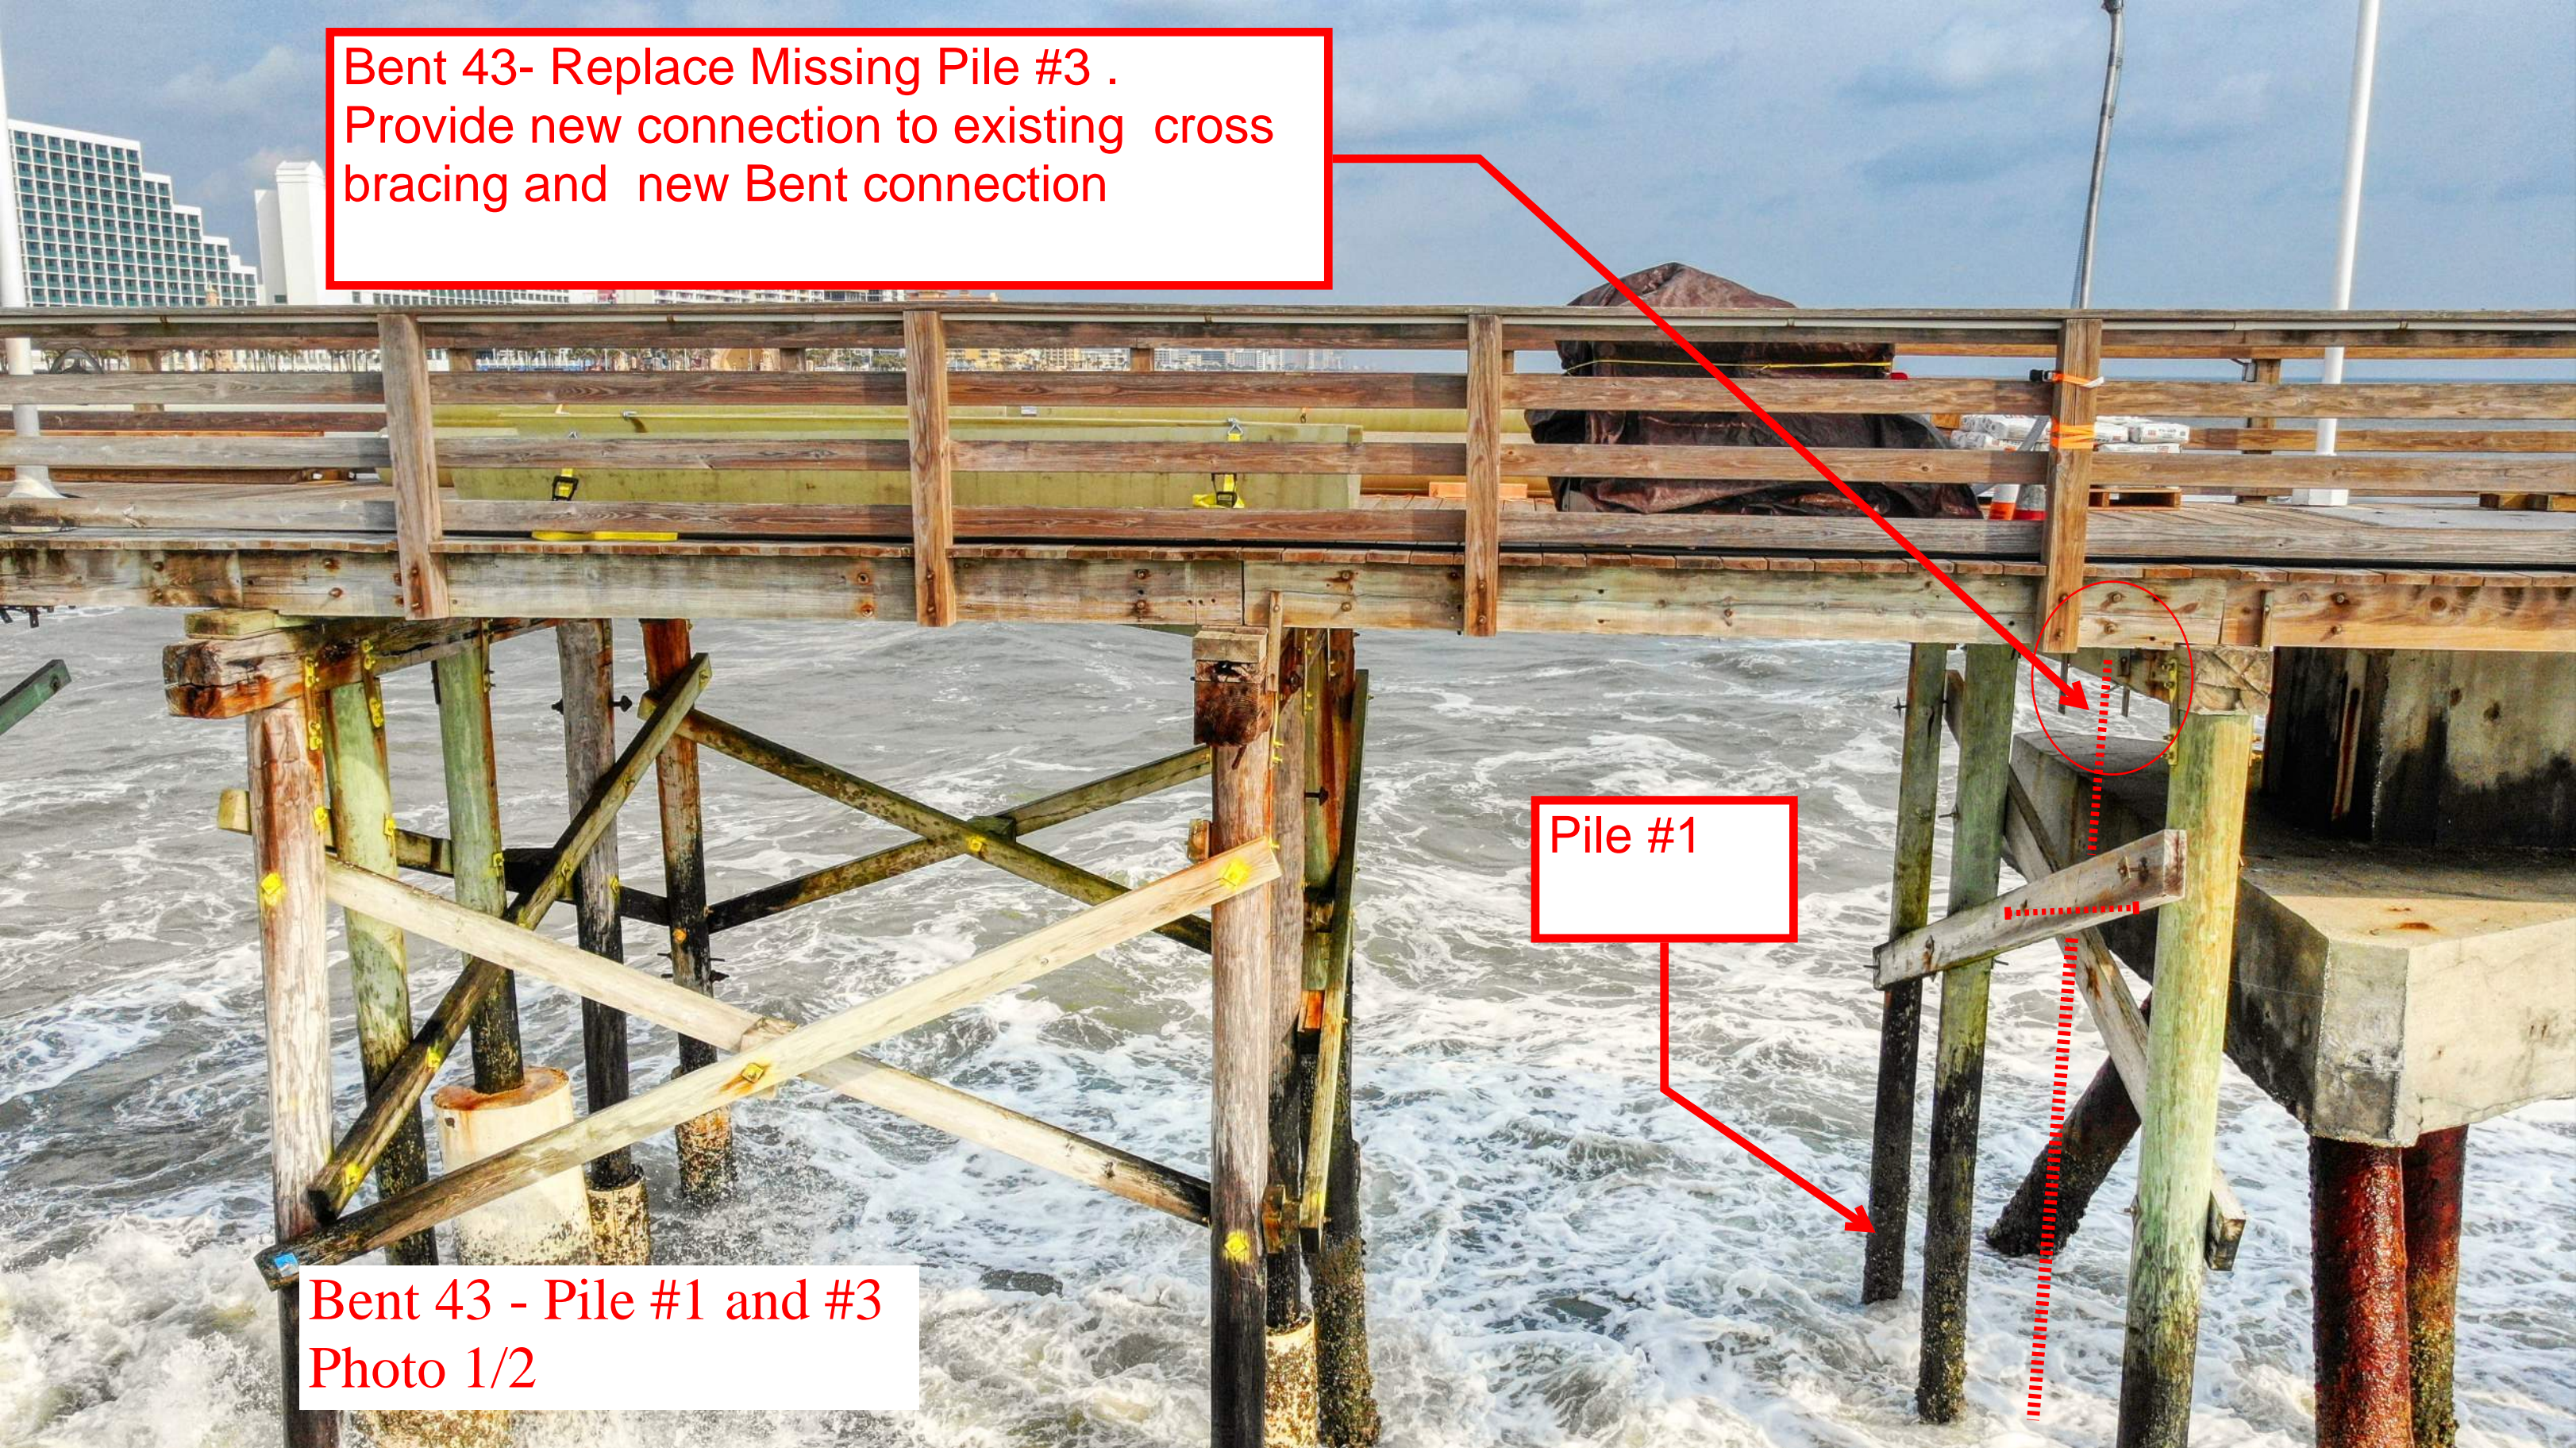
Bent 43 - Pile #1 and #3
Photo 1/2

Bent 43- Replace Missing Pile #3 .
Provide new connection to existing cross
bracing and new Bent connection

Pile #1

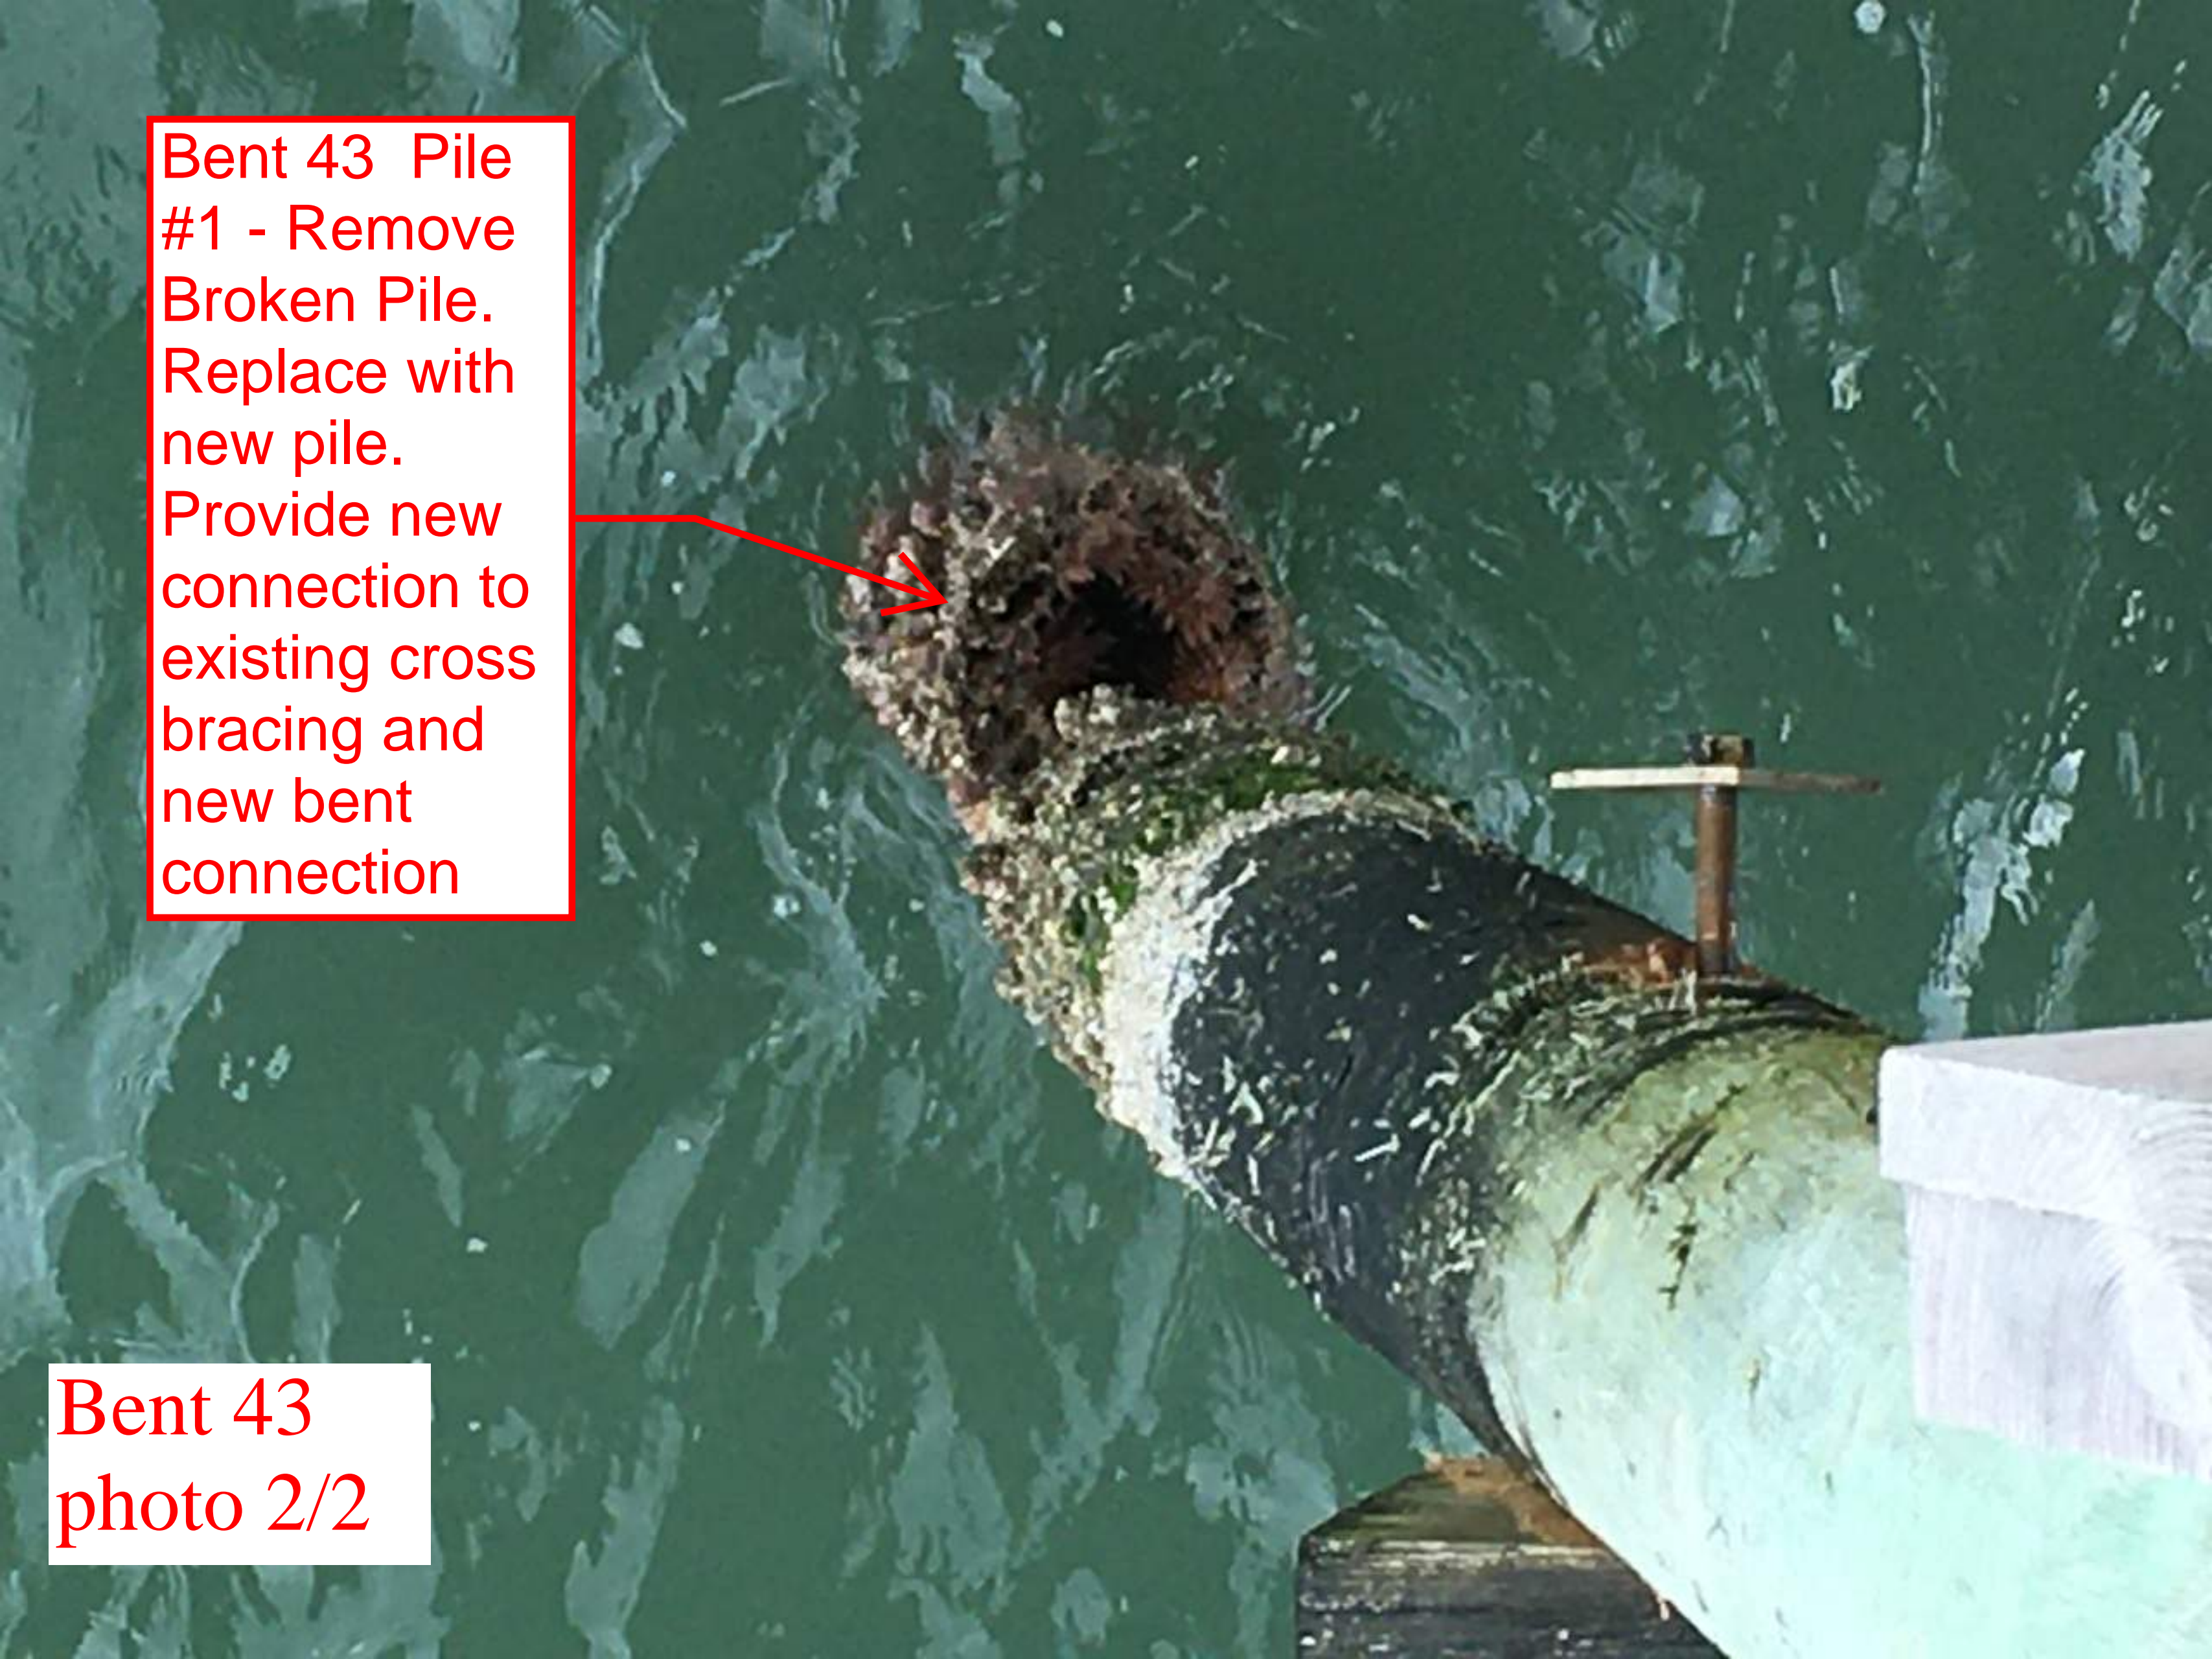
Bent 43
photo 2/2

Bent 43 Pile
#1 - Remove
Broken Pile.
Replace with
new pile.
Provide new
connection to
existing cross
bracing and
new bent
connection

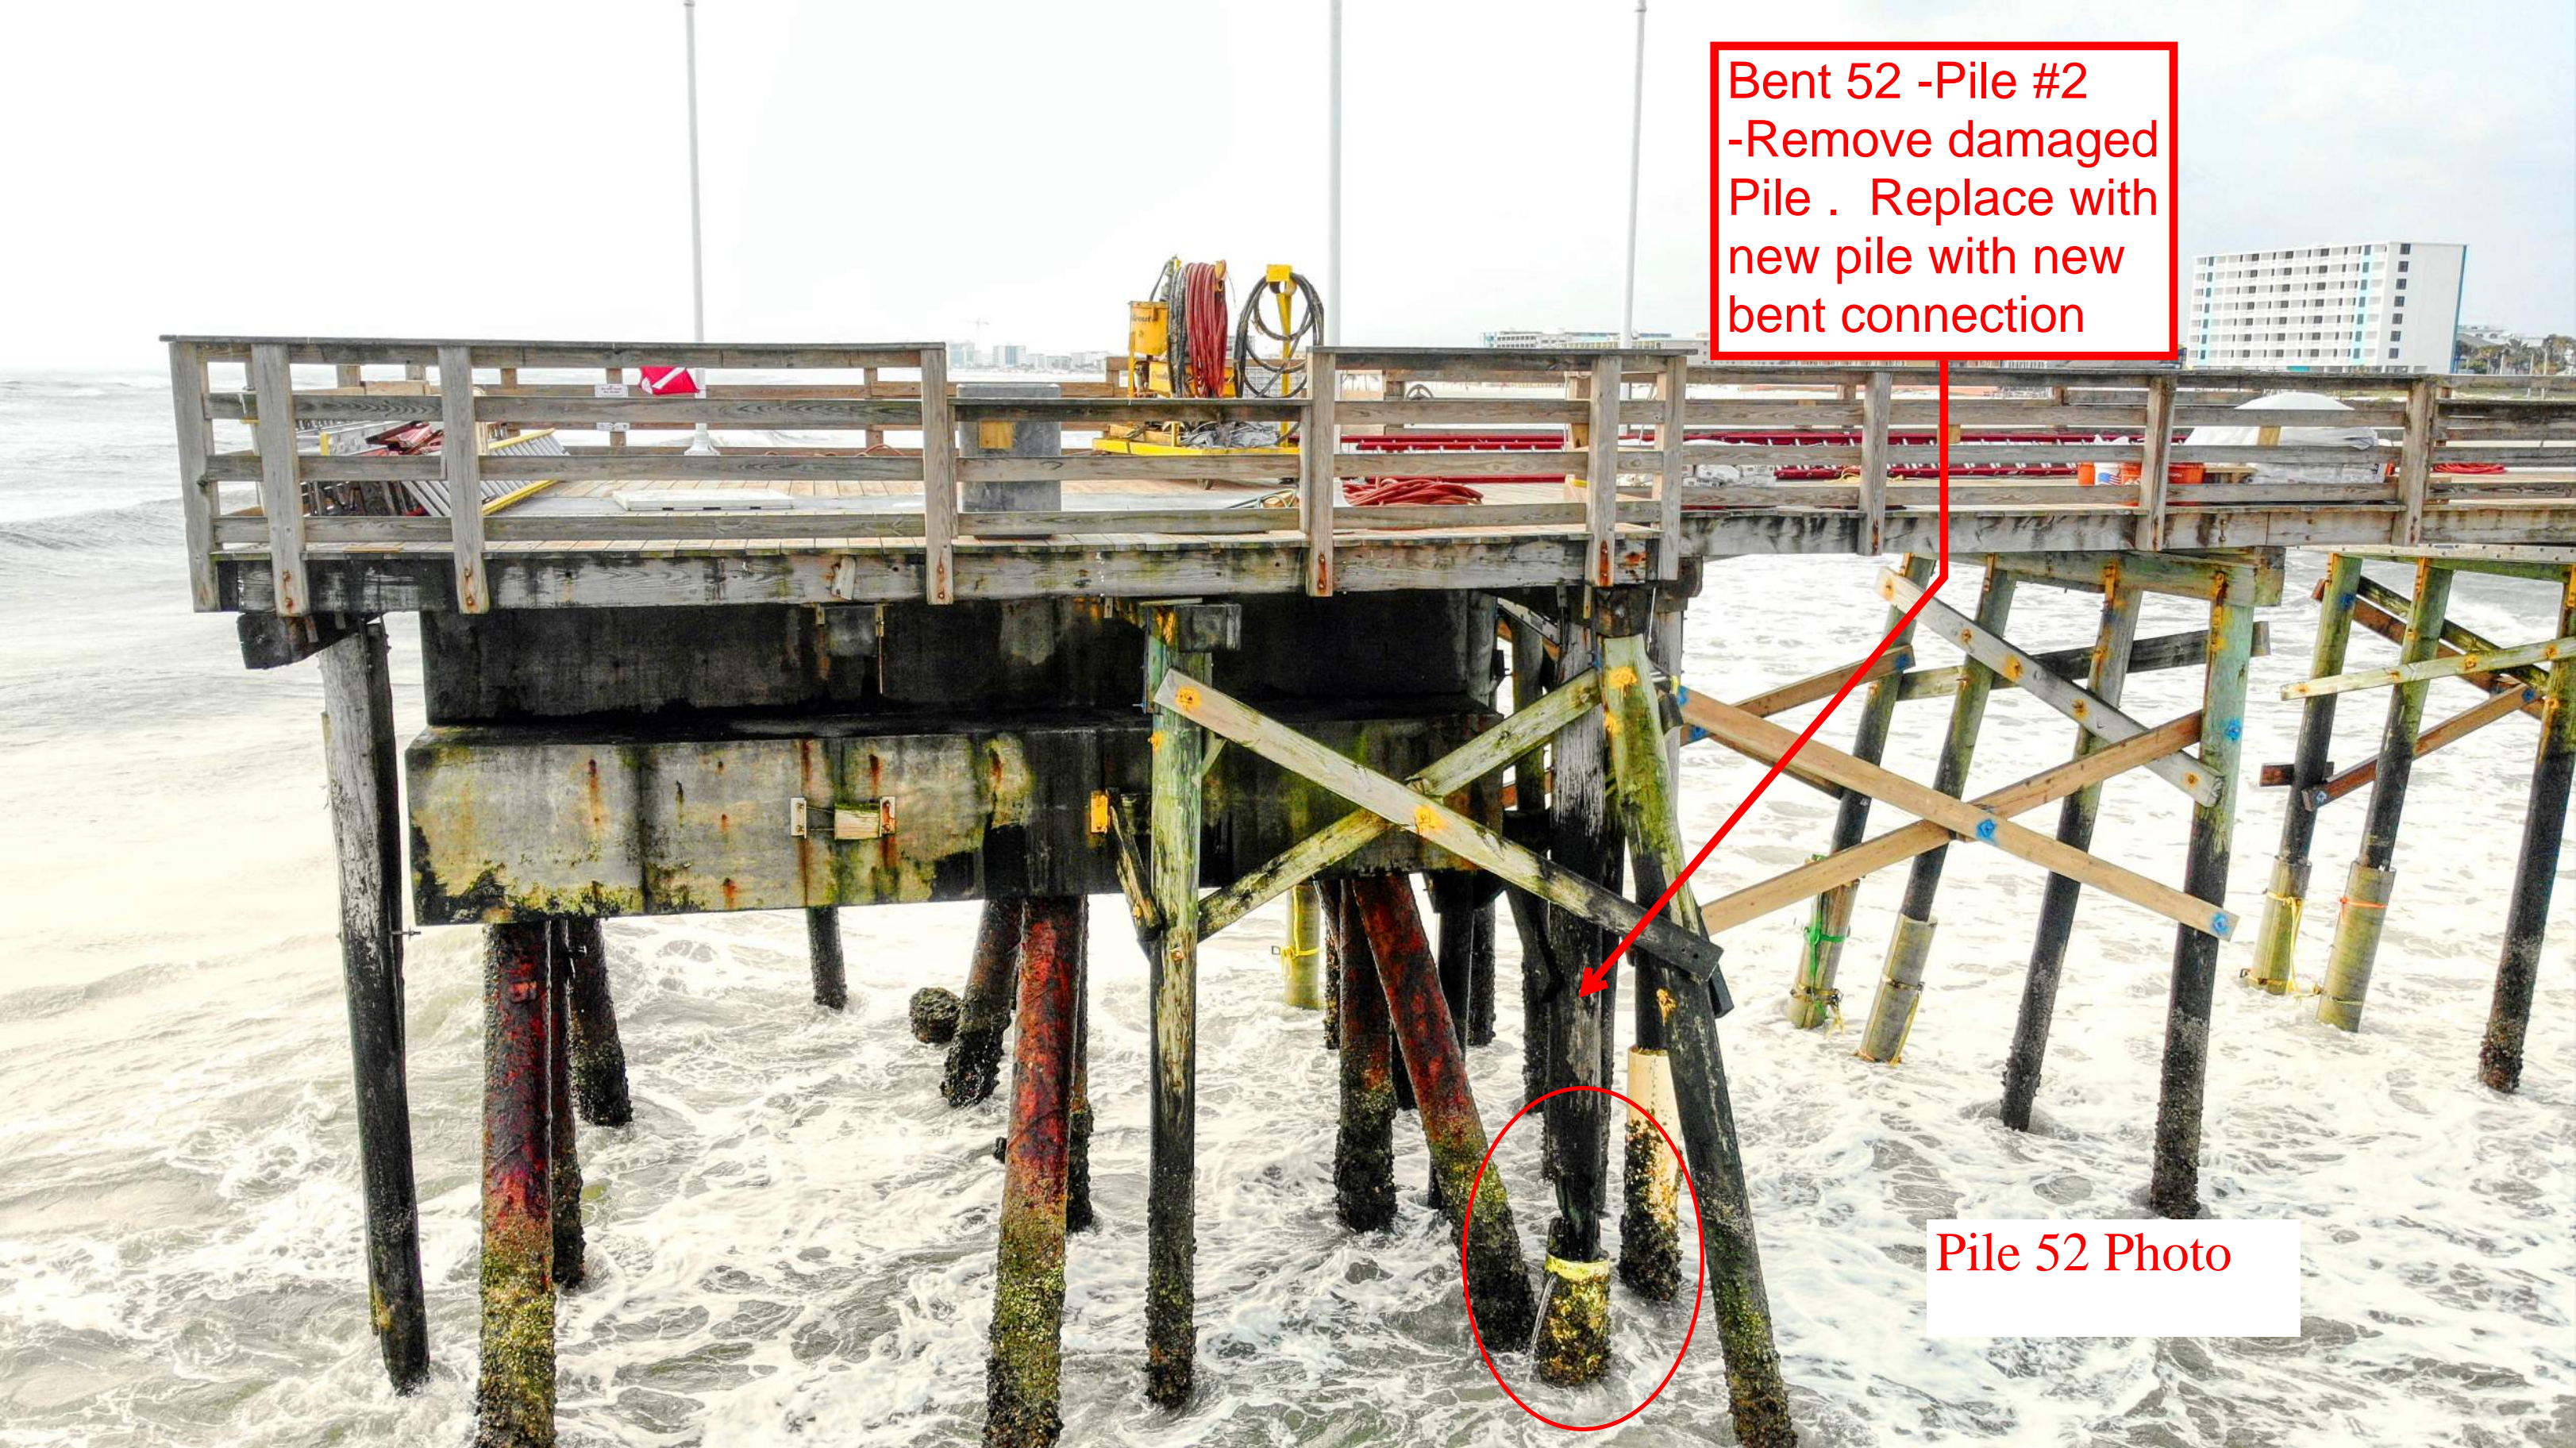
Pile 52 Photo

Bent 52 -Pile #2
-Remove damaged
Pile . Replace with
new pile with new
bent connection
