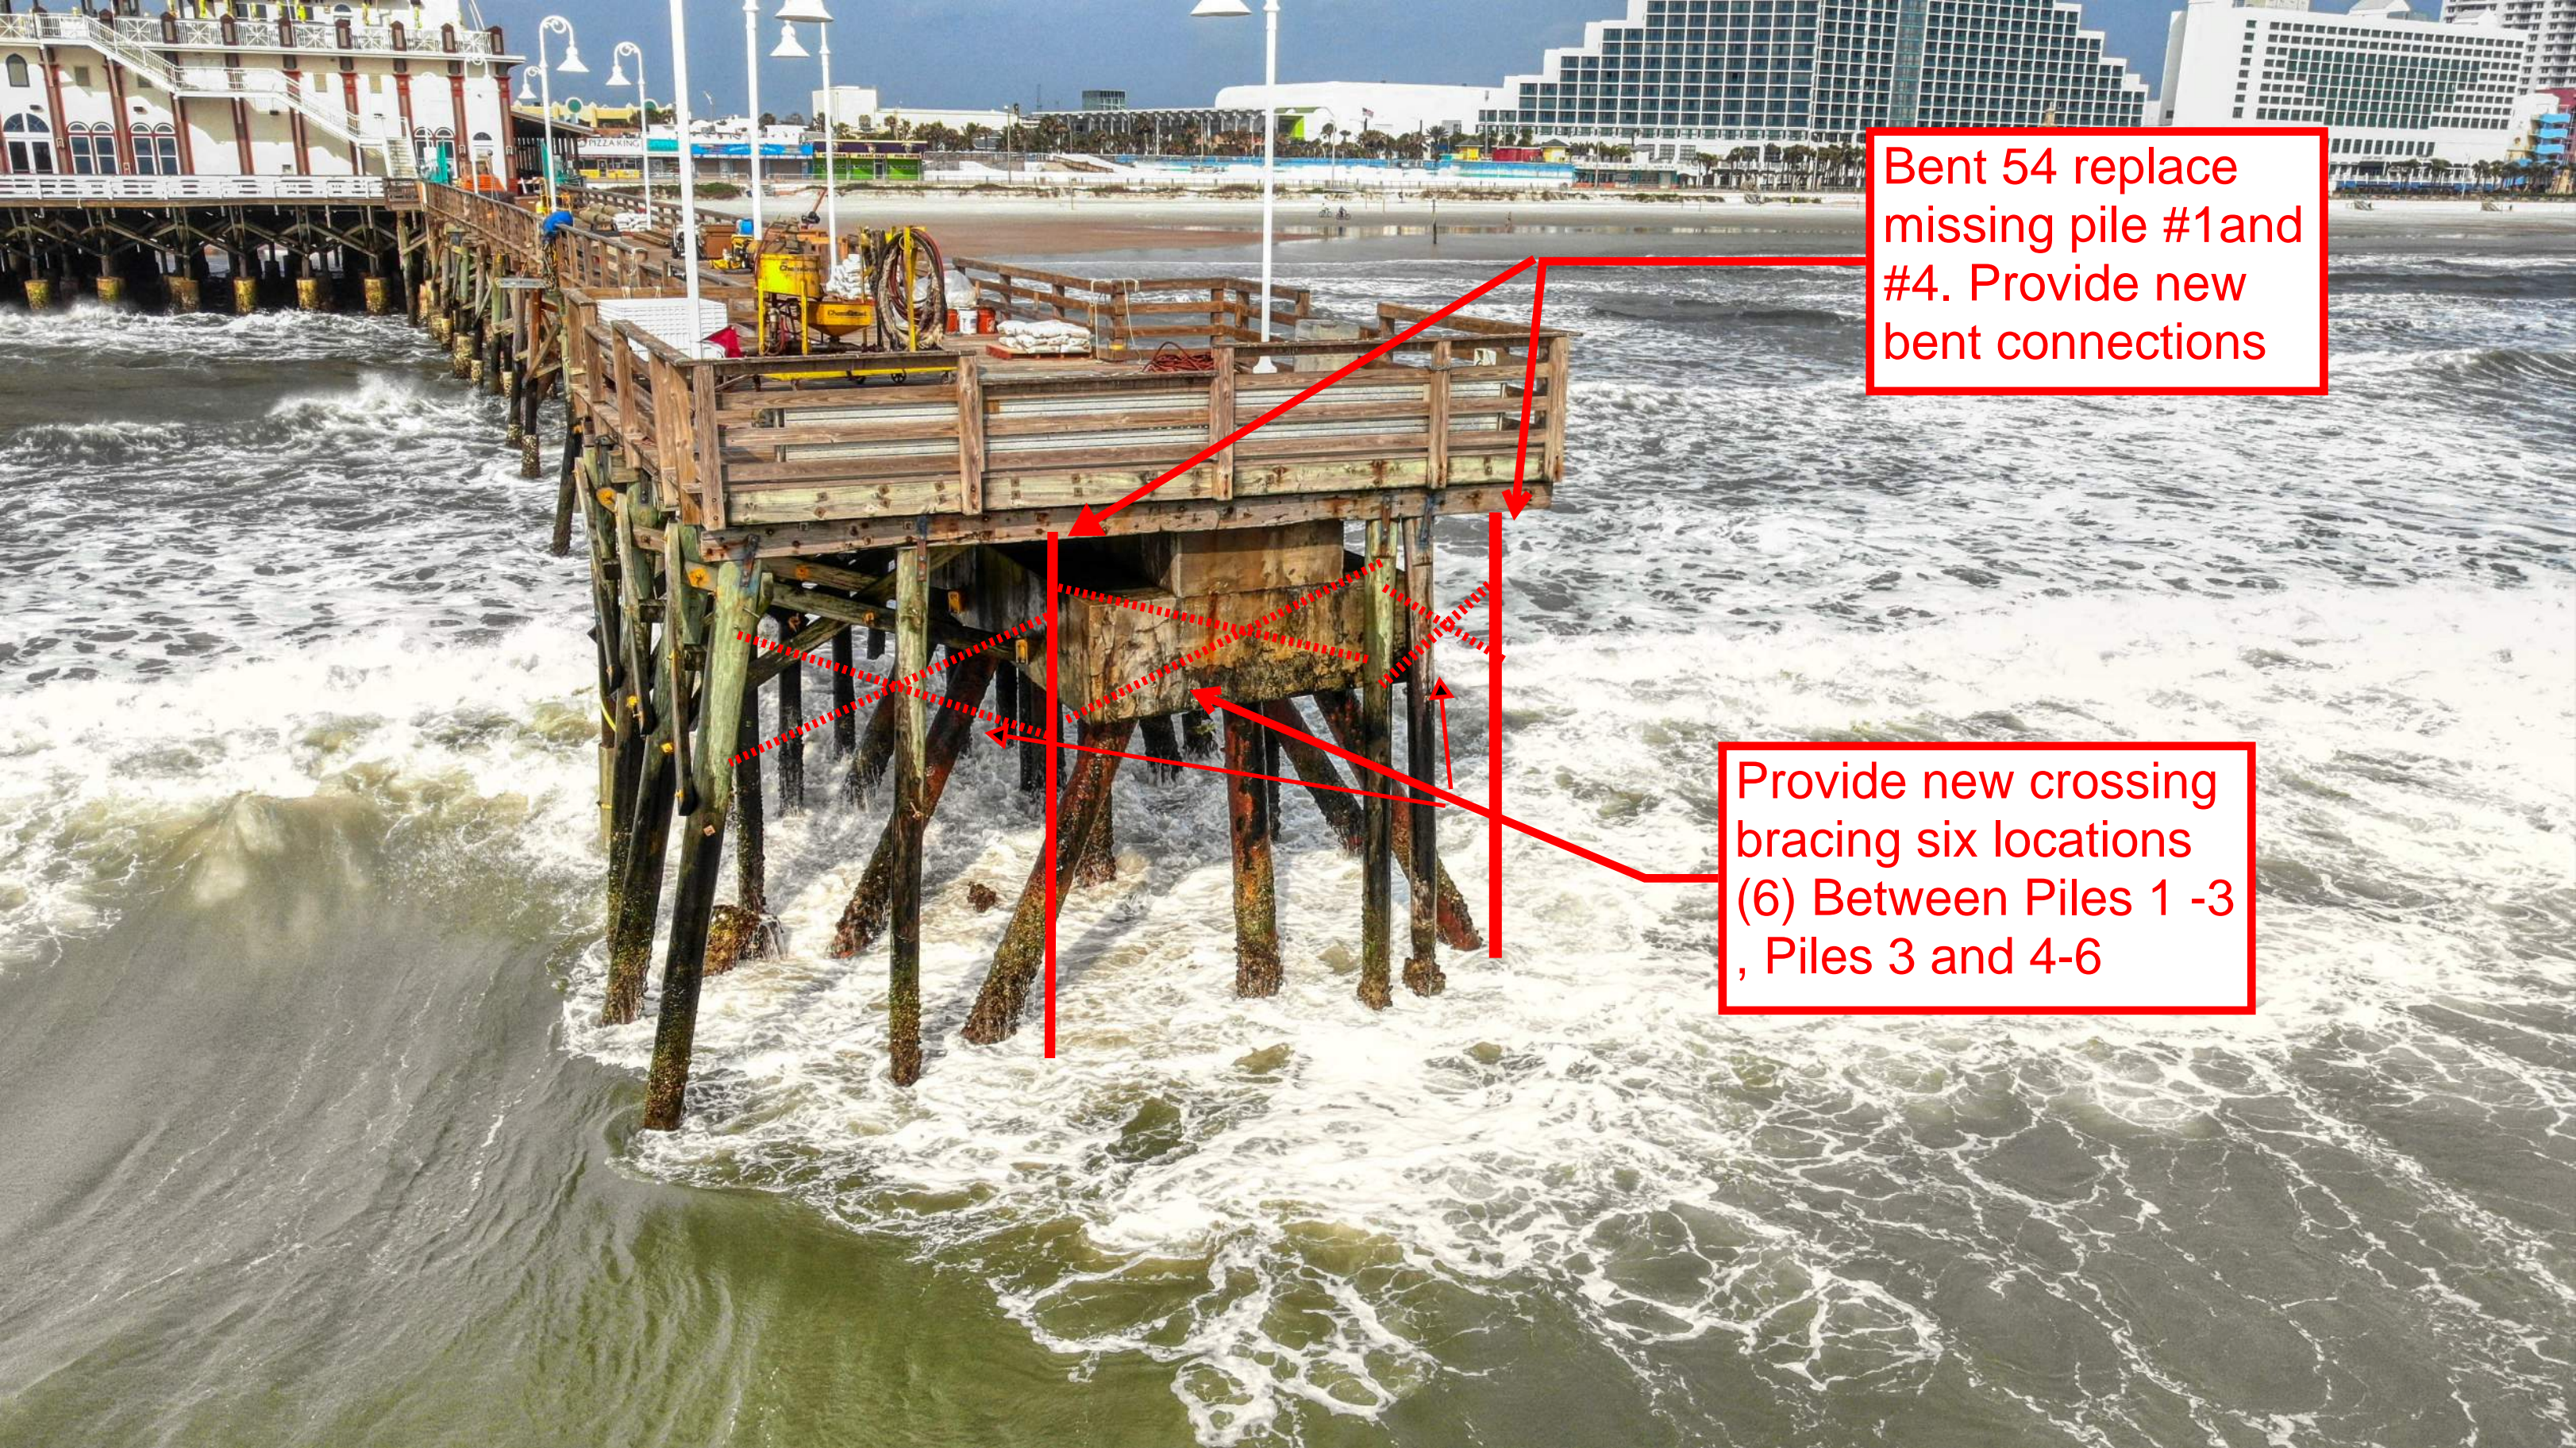
Bent 54 replace missing pile #1 and #4. Provide new bent connections

Provide new crossing bracing six locations (6) Between Piles 1 -3 , Piles 3 and 4-6
