# Geotechnical Evaluation

## McDowell Recharge Basins Improvements

12100 McDowell Road  
Avondale, Arizona

August 2, 2019 | Project No. 606042002

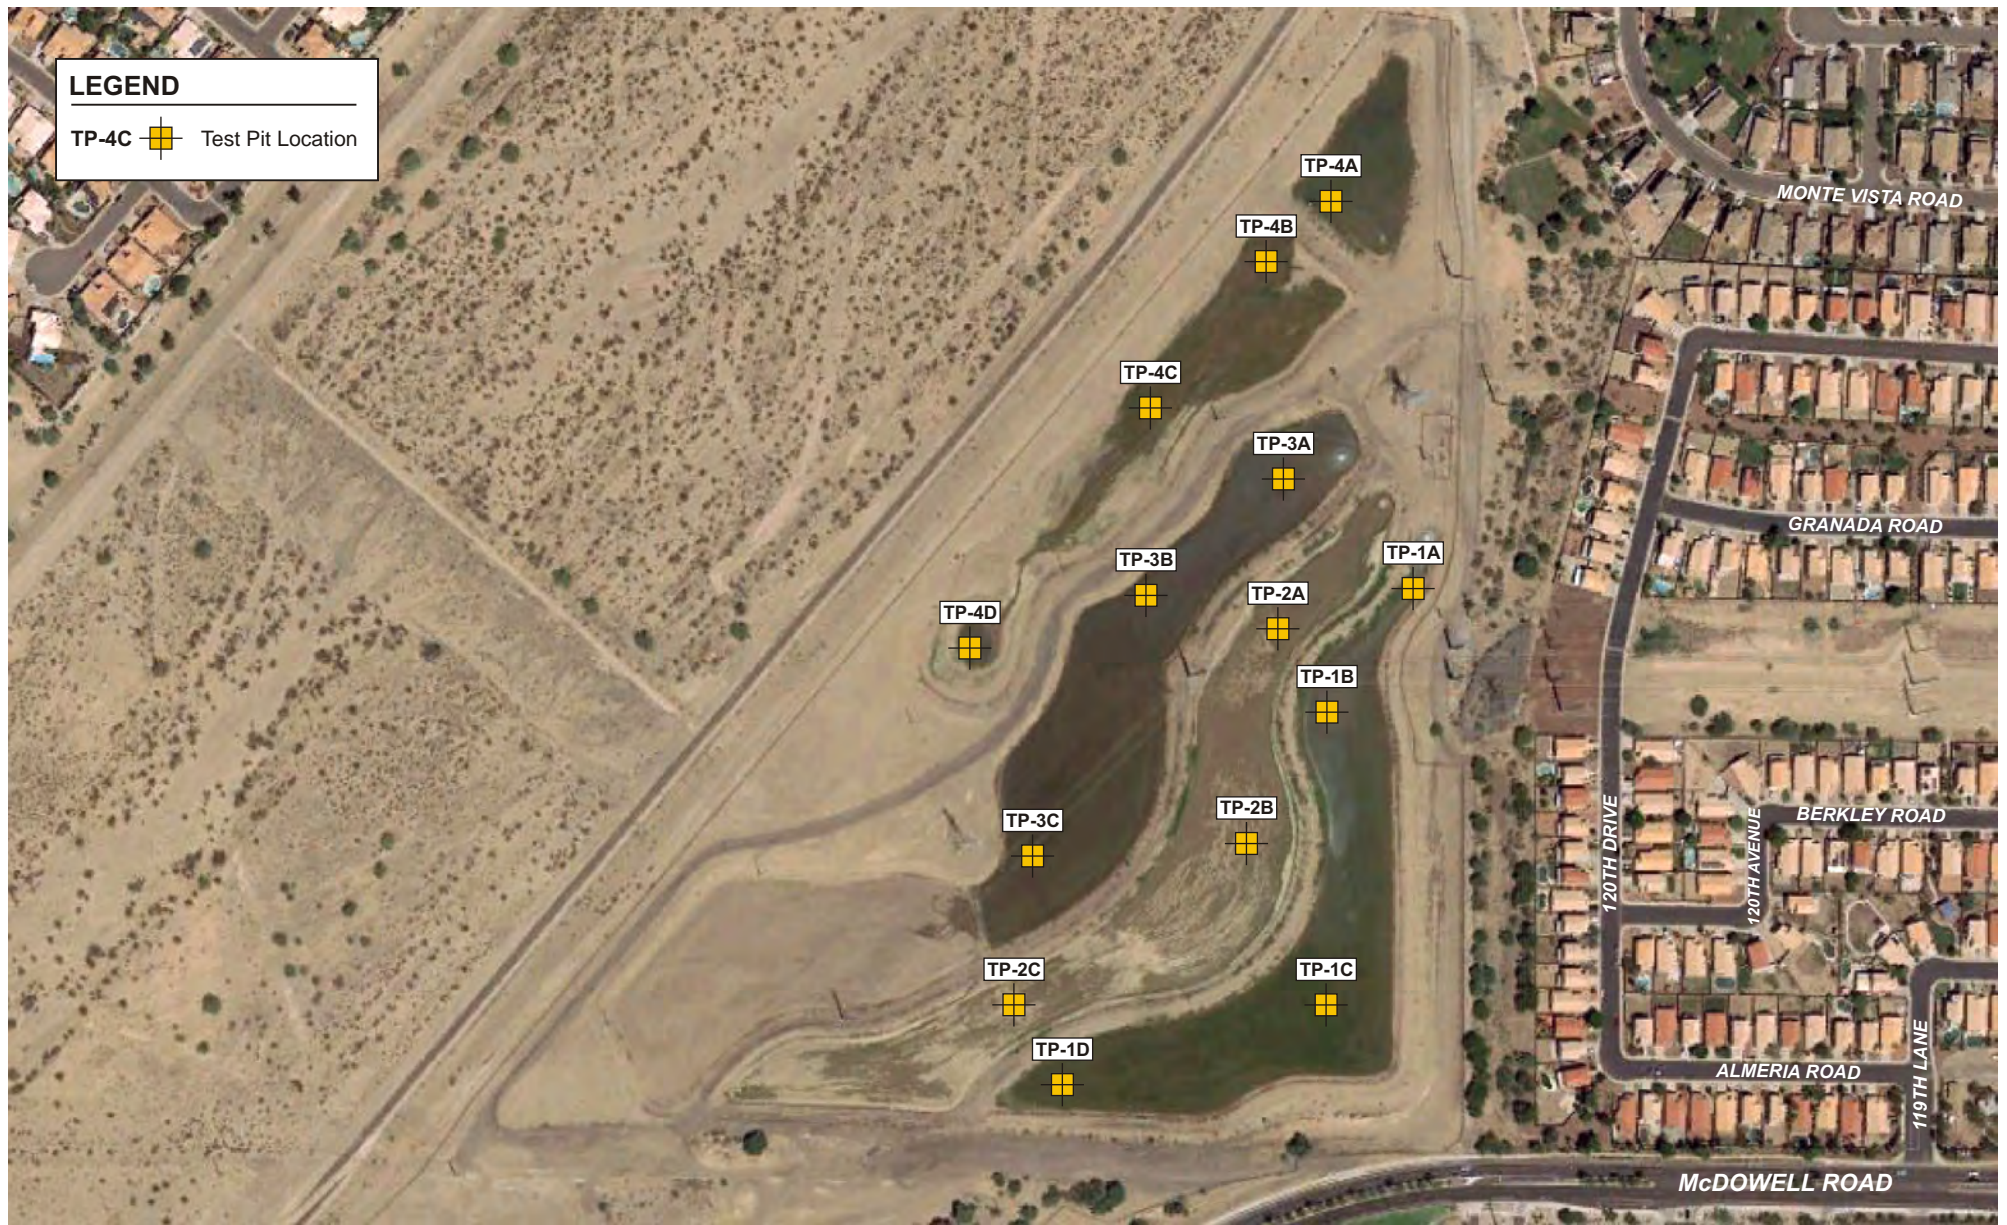
TP-4C

Test Pit Location

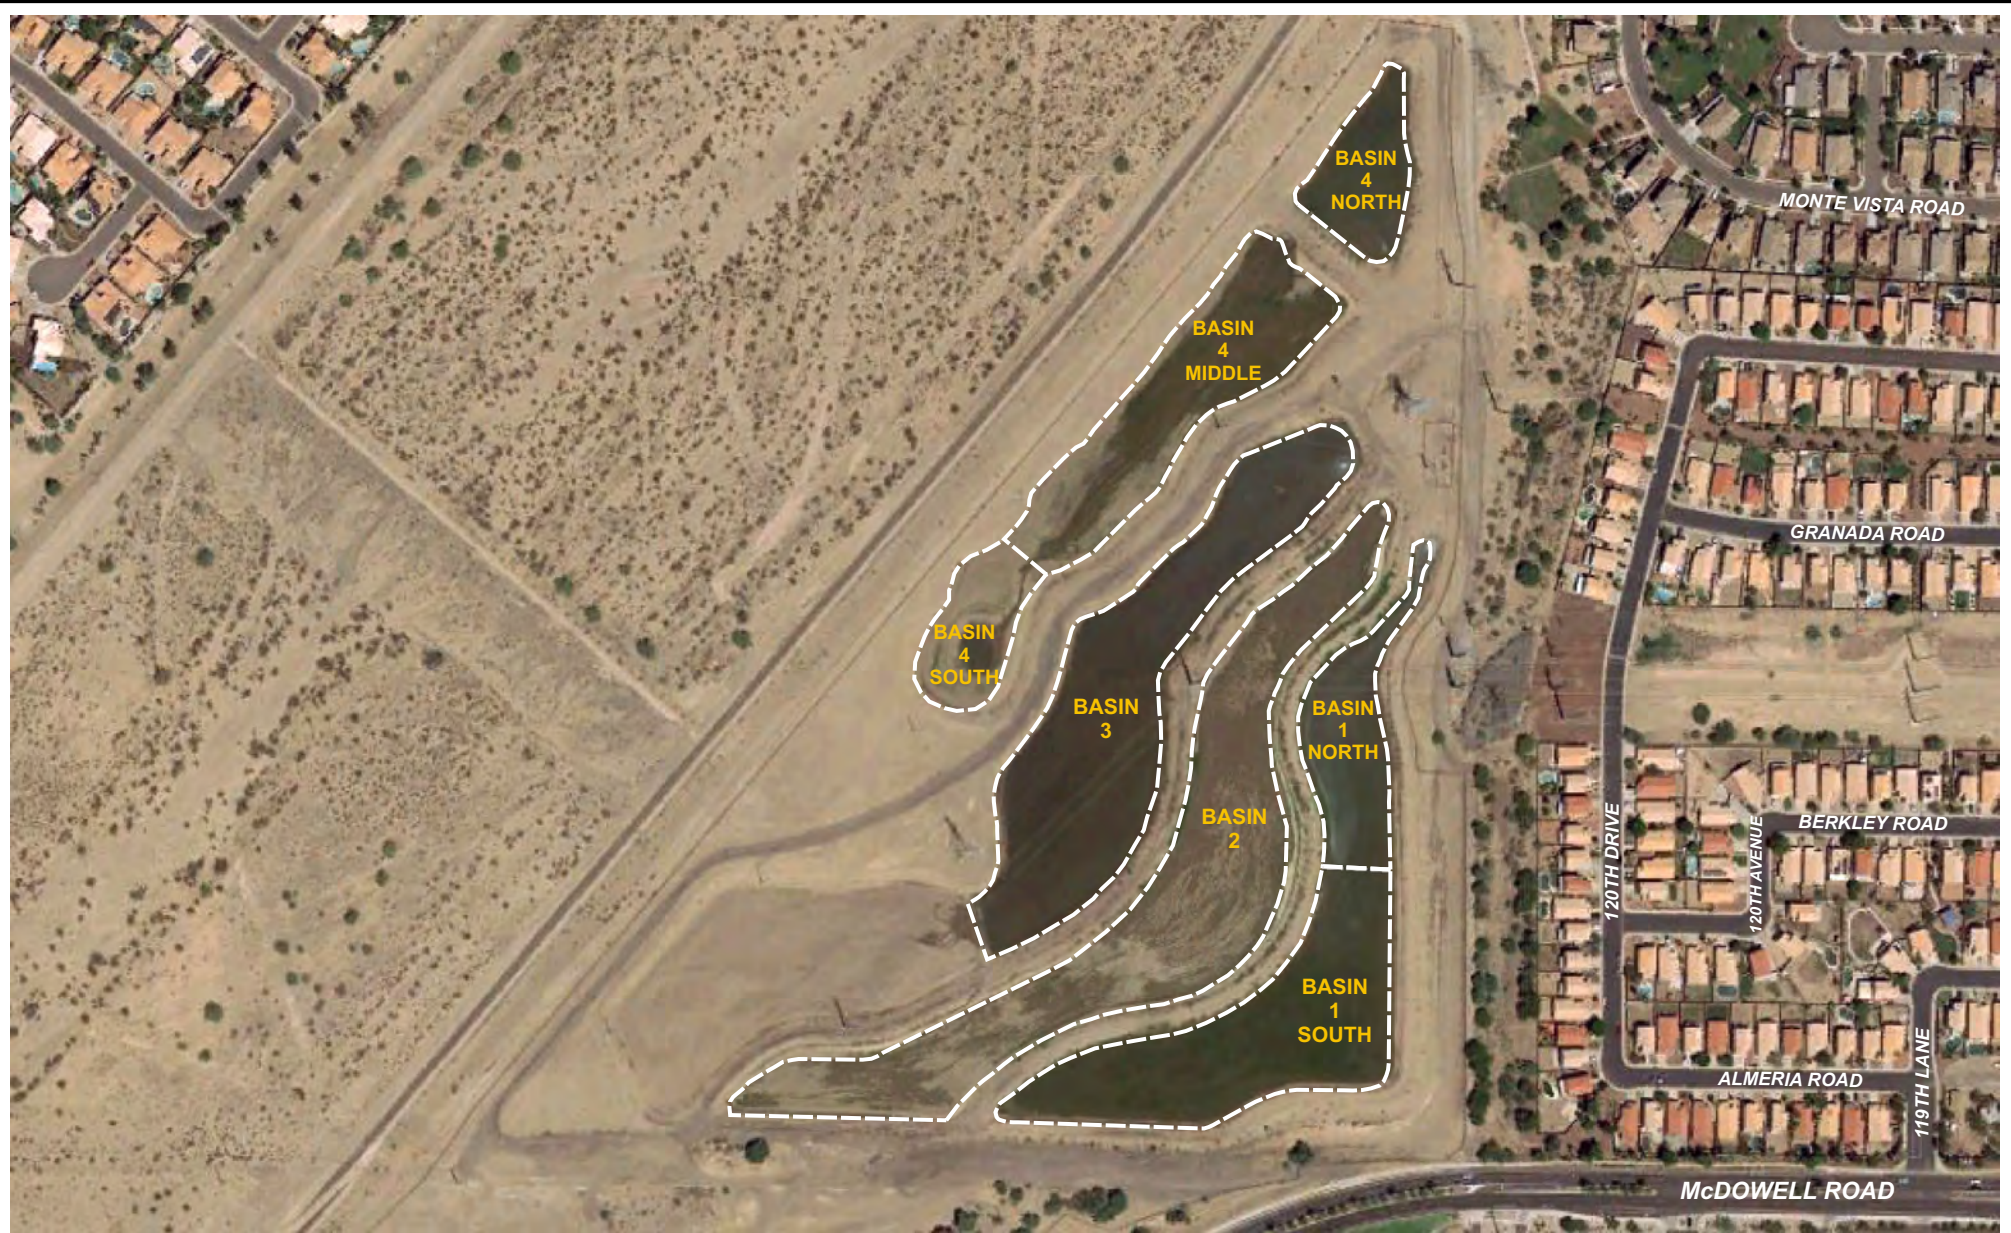
**FIGURE 3**

Basins 1 and 4 were divided in to sub-boundaries based on varying thickness of sediment encountered in our test pits. Basin sediment removal boundaries as well as recommended removal depths are presented on Figure 3. Table 3 presents the estimated areas, recommended removal depths and estimated volume of sediment removal. The estimated volume of sediment to be removed was based on estimated surface areas of the basin and the recommended thicknesses removed.

**SEDIMENT REMOVAL BOUNDARIES**

<b>Location</b>	<b>Area, ft<sup>2</sup></b>	<b>Recommended Removal Depth, ft</b>	<b>Estimated Sediment Removal Volume, yd<sup>3</sup></b>
Basin-1North	55,392	1.5	3,078
Basin-1South	139,689	0.5	2,587
Basin-2	223,253	0.5	4,135
Basin-3	186,389	0.5	3,451
Basin-4North	40,913	2.0	3,031
Basin-4Middle	113,513	1.0	4,204
Basin-4South	39,752	1.5	2,209

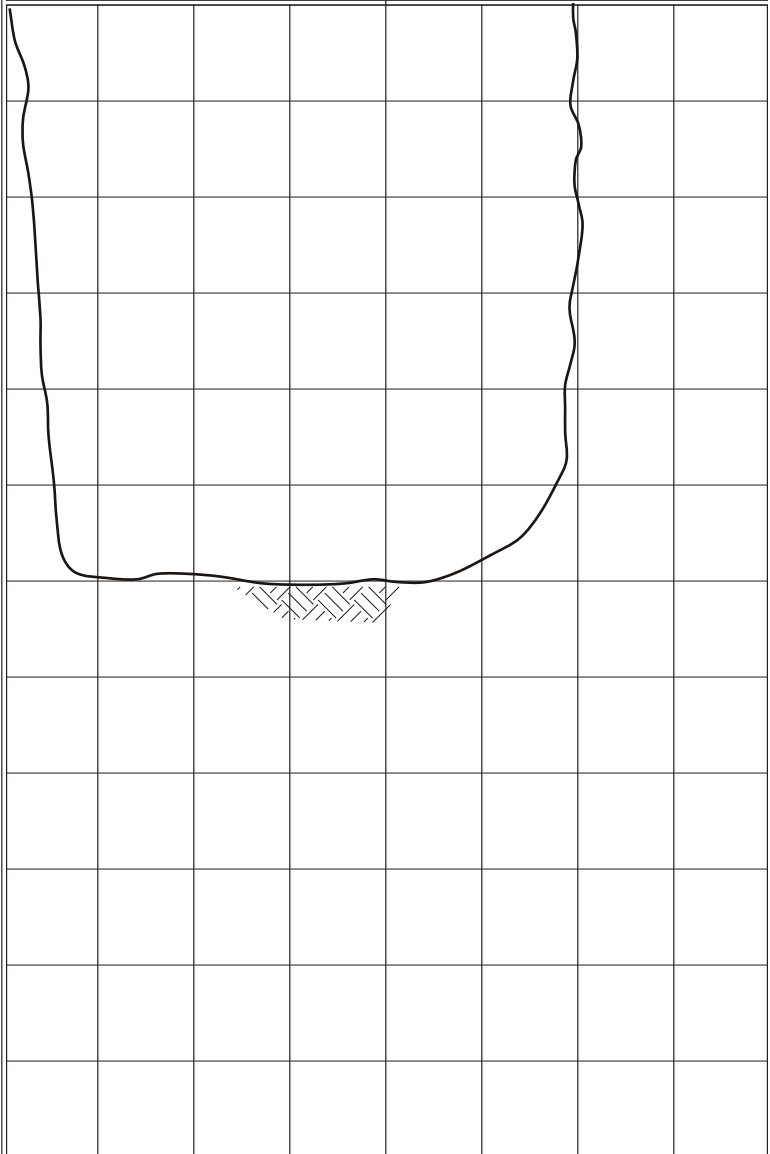
LOCATION BASIN 1 (SEE FIGURE 2)

SEDIMENT:  
Brown, dry, medium dense, clayey SAND.

ALLUVIUM:  
Brown, moist, medium dense, silty SAND; trace gravel.

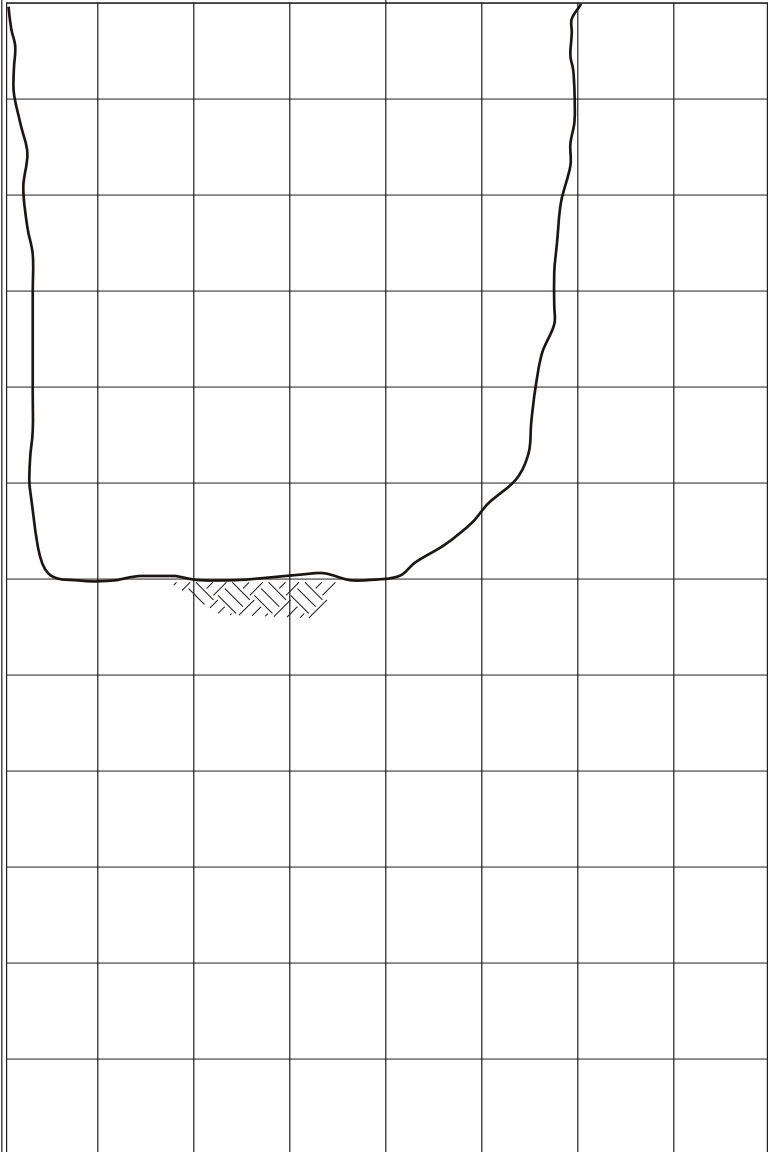
DATE EXCAVATED 6/25/19 TEST PIT NO. TP-1B  
GROUND ELEVATION 983' ± (MSL) LOGGED BY DM  
METHOD OF EXCAVATION CASE 560 SUPER N BACKHOE  
LOCATION BASIN 1 (SEE FIGURE 2)

SEDIMENT:  
Brown, dry, medium dense, sandy lean CLAY; trace gravel.

ALLUVIUM:  
Brown, moist, medium dense, silty SAND; few gravel.

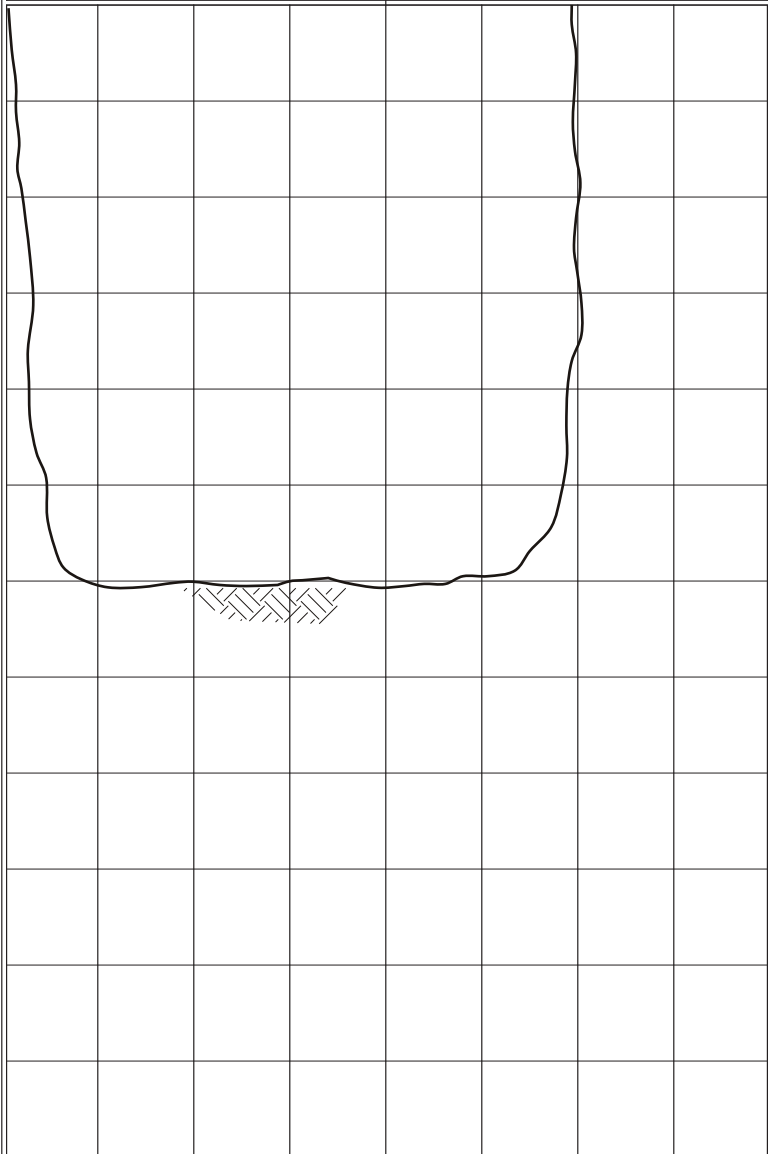
DATE EXCAVATED 6/25/19 TEST PIT NO. TP-1C  
GROUND ELEVATION 981' ± (MSL) LOGGED BY DM  
METHOD OF EXCAVATION CASE 560 SUPER N BACKHOE  
LOCATION BASIN 1 (SEE FIGURE 2)

SEDIMENT:  
Brown, dry, loose, clayey SAND.  
ALLUVIUM:  
Brown, moist, medium dense, poorly graded SAND; few gravel; cobbles and possible boulders.

Brown, moist, medium dense, silty SAND; few gravel; cobbles and possible boulders.

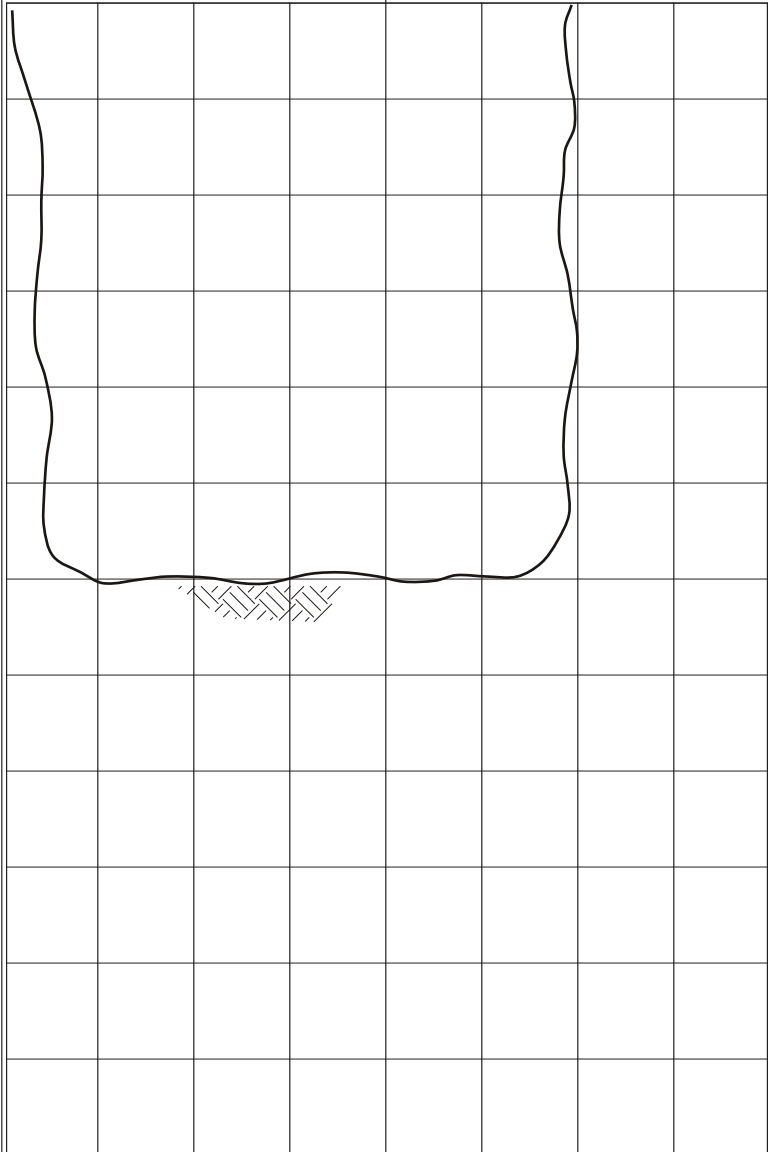
DATE EXCAVATED 6/25/19 TEST PIT NO. TP-1D  
GROUND ELEVATION 981' ± (MSL) LOGGED BY DM  
METHOD OF EXCAVATION CASE 560 SUPER N BACKHOE  
LOCATION BASIN 1 (SEE FIGURE 2)

**SEDIMENT:**  
Brown, dry, medium dense, clayey SAND.

**ALLUVIUM:**  
Brown, moist, medium dense, silty SAND; few gravel; cobbles and possible boulders.

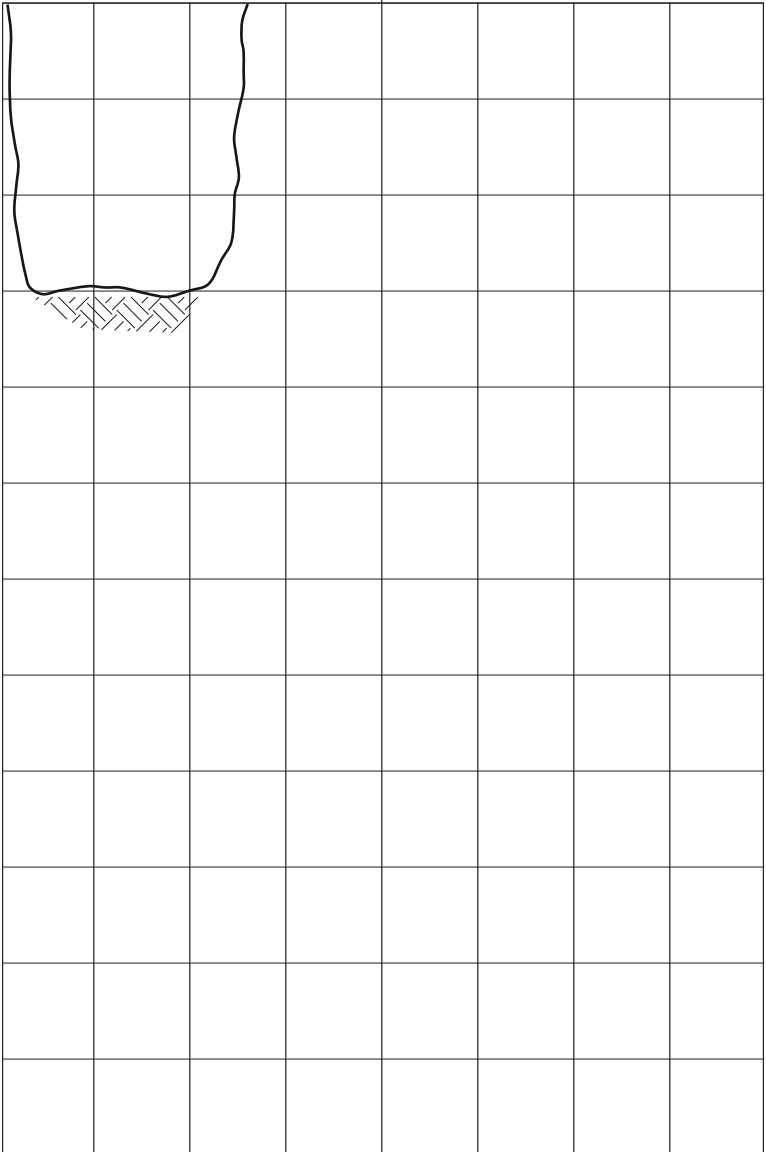
DATE EXCAVATED 7/10/19 TEST PIT NO. TP-2A  
GROUND ELEVATION 981' ± (MSL) LOGGED BY DM  
METHOD OF EXCAVATION CASE 560 SUPER N BACKHOE  
LOCATION BASIN 2 (SEE FIGURE 2)

SC  
SEDIMENT:  
Brown, dry, loose, clayey SAND.

SM  
ALLUVIUM:  
Brown, moist, medium dense, silty SAND; trace gravel.

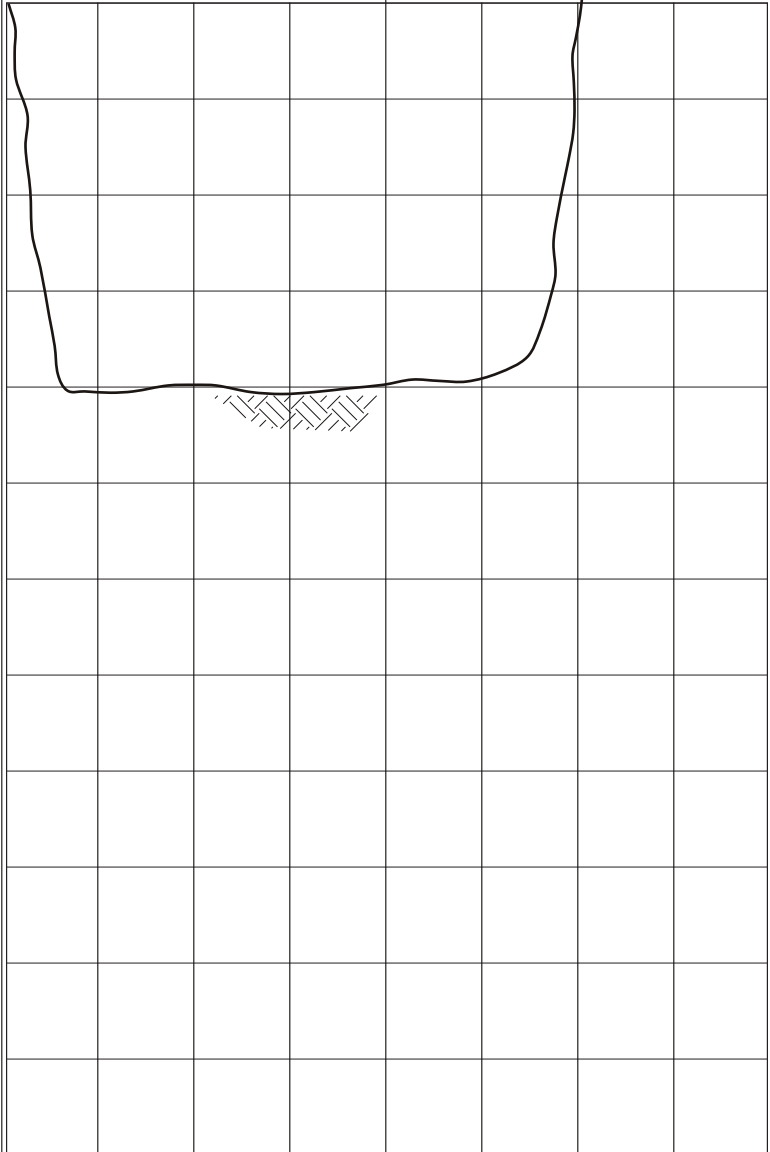
DATE EXCAVATED 7/2/19 TEST PIT NO. TP-3A  
GROUND ELEVATION 982' ± (MSL) LOGGED BY DM  
METHOD OF EXCAVATION CASE 560 SUPER N BACKHOE  
LOCATION BASIN 3 (SEE FIGURE 2)

SEDIMENT:  
Brown, moist, medium dense, clayey SAND; trace gravel.

ALLUVIUM:  
Brown, moist, medium dense, silty SAND.

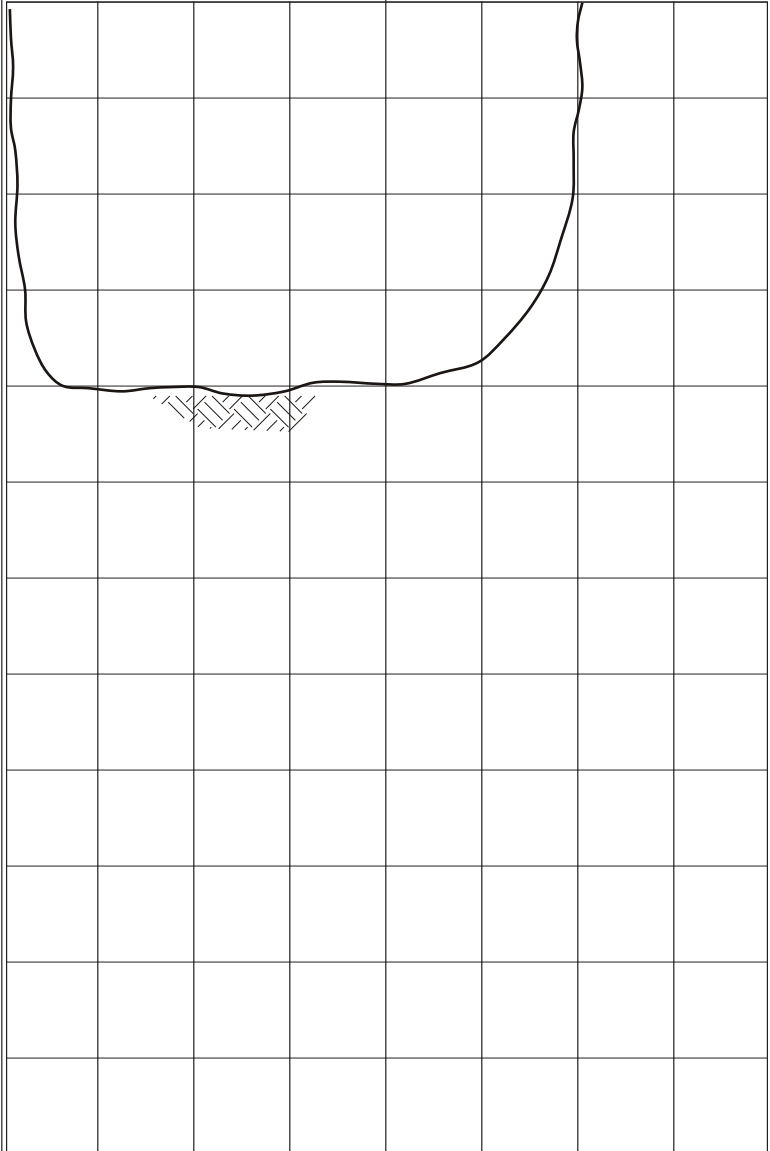
DATE EXCAVATED 7/2/19 TEST PIT NO. TP-3B  
GROUND ELEVATION 982' ± (MSL) LOGGED BY DM  
METHOD OF EXCAVATION CASE 560 SUPER N BACKHOE  
LOCATION BASIN 3 (SEE FIGURE 2)

**SEDIMENT:**  
Brown, dry, medium dense, clayey SAND.

**ALLUVIUM:**  
Brown, moist, medium dense, poorly graded GRAVEL with sand; trace silt; cobbles and possible boulders.

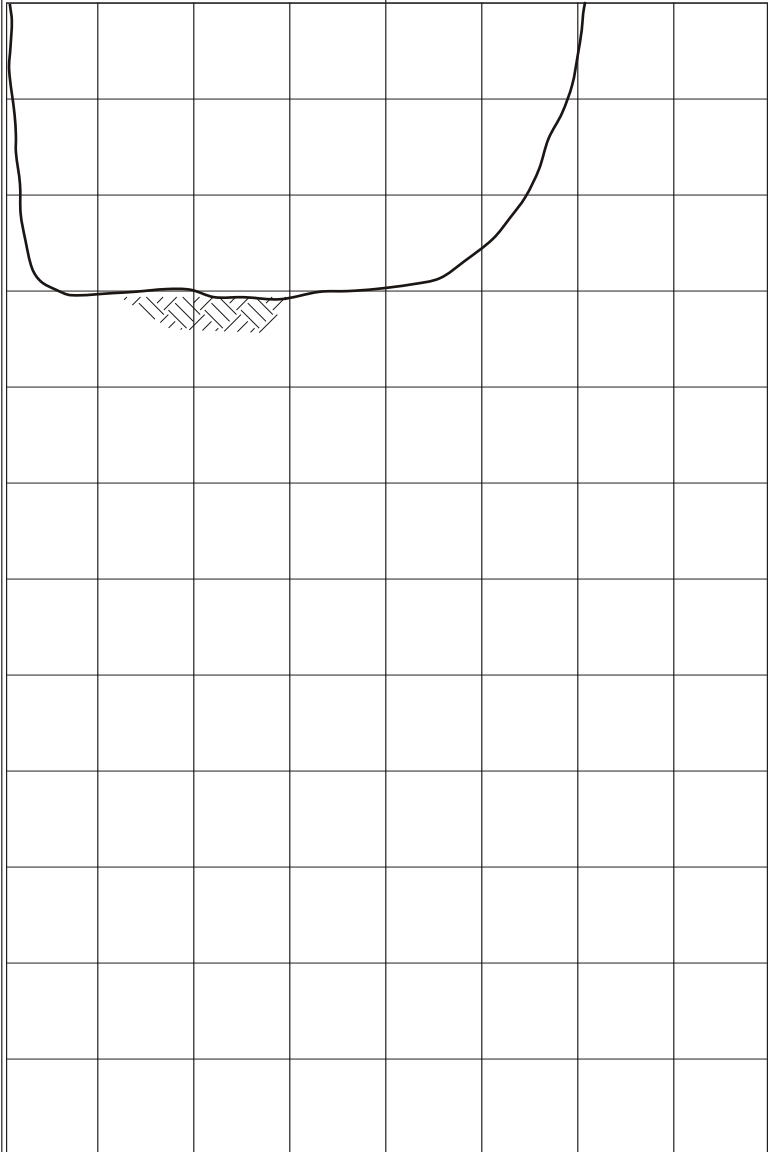
DATE EXCAVATED 7/2/19 TEST PIT NO. TP-3C  
GROUND ELEVATION 981' ± (MSL) LOGGED BY DM  
METHOD OF EXCAVATION CASE 560 SUPER N BACKHOE  
LOCATION BASIN 3 (SEE FIGURE 2)

SEDIMENT:  
Brown, dry, loose, clayey SAND.  
ALLUVIUM:  
Brown, moist, medium dense, silty SAND; trace gravel.

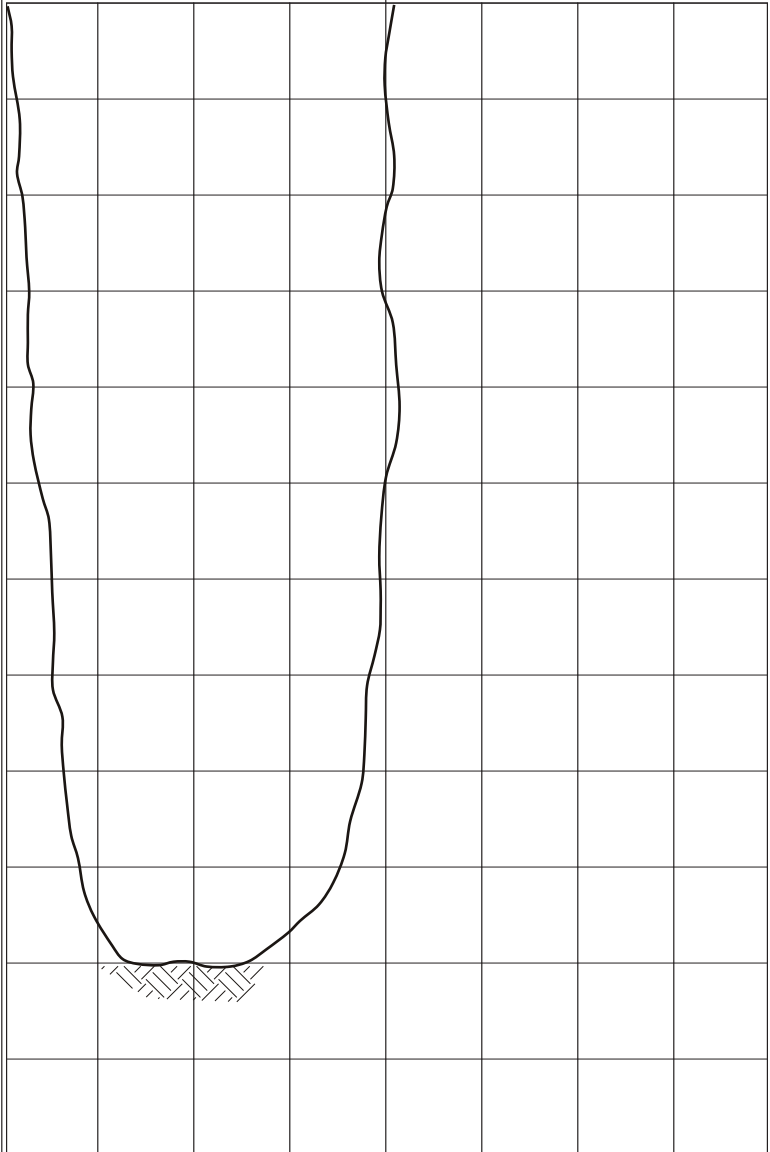
DATE EXCAVATED 6/25/19 TEST PIT NO. TP-4A  
GROUND ELEVATION 983' ± (MSL) LOGGED BY DM  
METHOD OF EXCAVATION CASE 560 SUPER N BACKHOE  
LOCATION BASIN 4 (SEE FIGURE 2)

SEDIMENT:  
Brown, dry, medium dense, clayey SAND; trace gravel.

ALLUVIUM:  
Brown, moist, medium dense, silty SAND; few gravel.

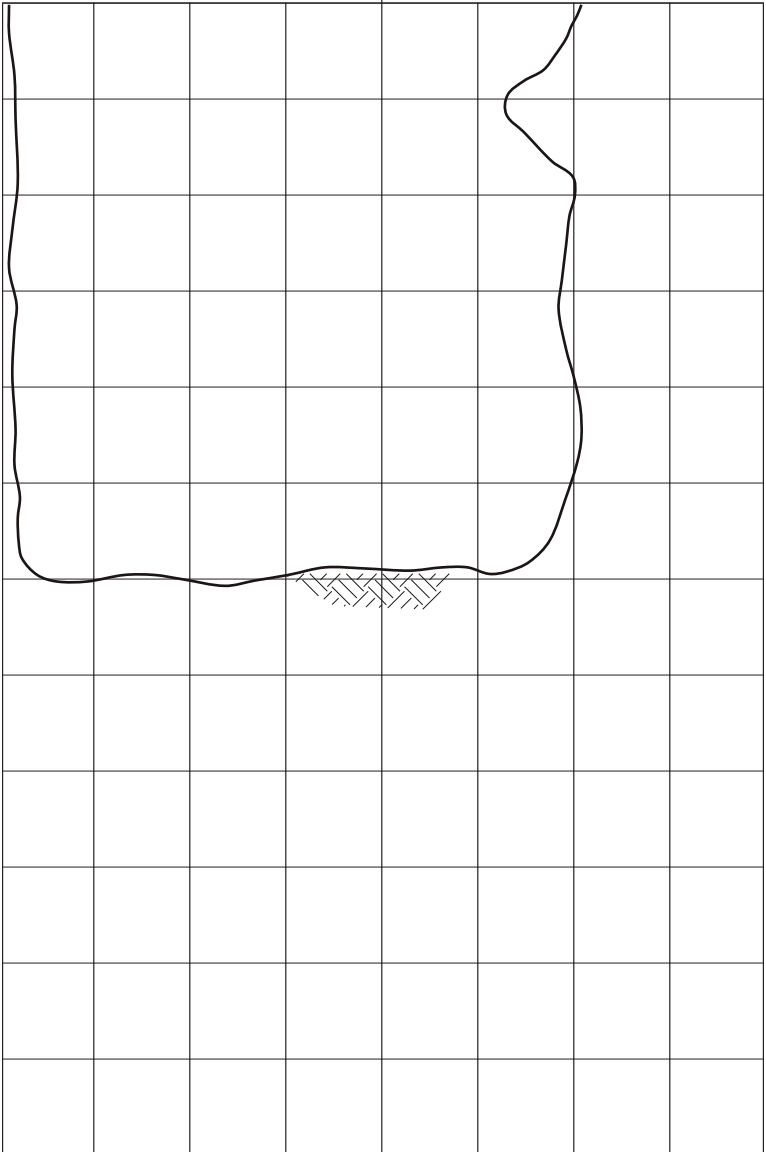
DATE EXCAVATED 6/25/19 TEST PIT NO. TP-4D  
GROUND ELEVATION 980' ± (MSL) LOGGED BY DM  
METHOD OF EXCAVATION CASE 560 SUPER N BACKHOE  
LOCATION BASIN 3 (SEE FIGURE 2)

SEDIMENT:  
Brown, dry, medium dense, clayey SAND.

ALLUVIUM:  
Brown, moist, medium dense, silty SAND; trace gravel; cobbles and possible boulders.

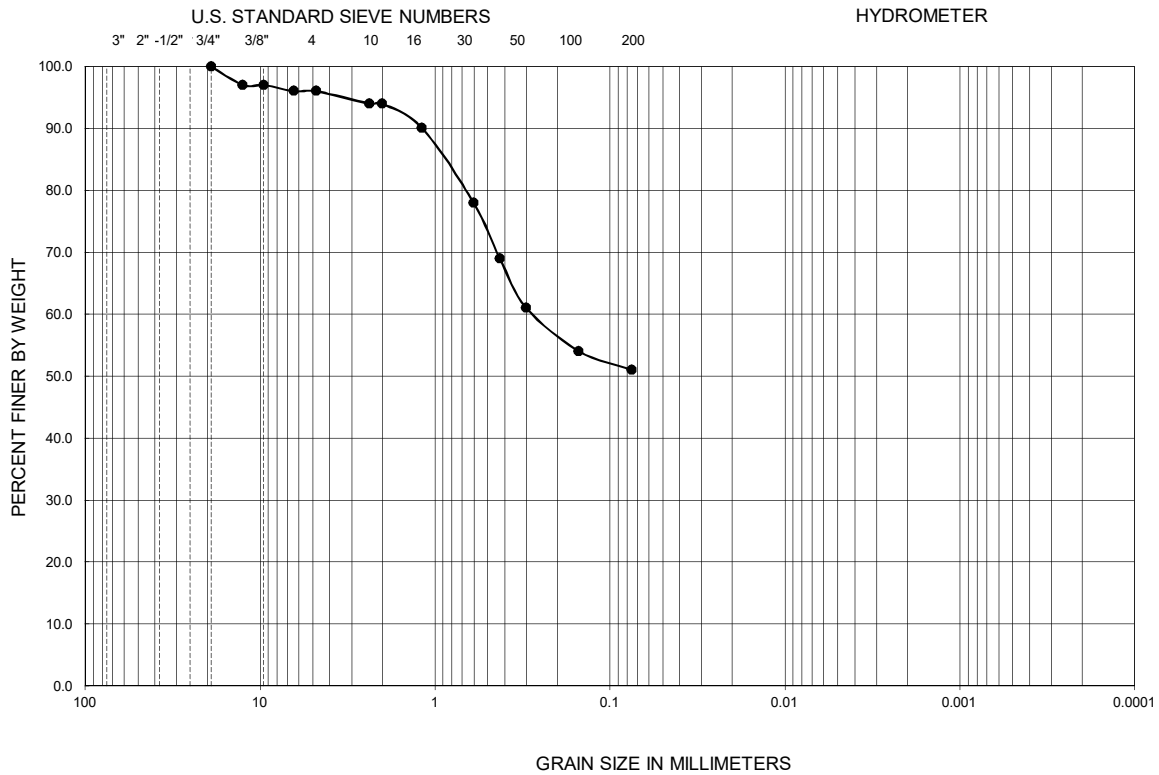
Symbol	Sample Location	Depth (ft)	Liquid Limit	Plastic Limit	Plasticity Index	D <sub>10</sub>	D <sub>30</sub>	D <sub>60</sub>	C <sub>u</sub>	C <sub>c</sub>	Passing No. 200 (percent)	USCS
●	TP-1B	0.0-1.4	32	16	16	--	--	0.28	--	--	51.0	CL

PERFORMED IN GENERAL ACCORDANCE WITH ASTM C136 / D422

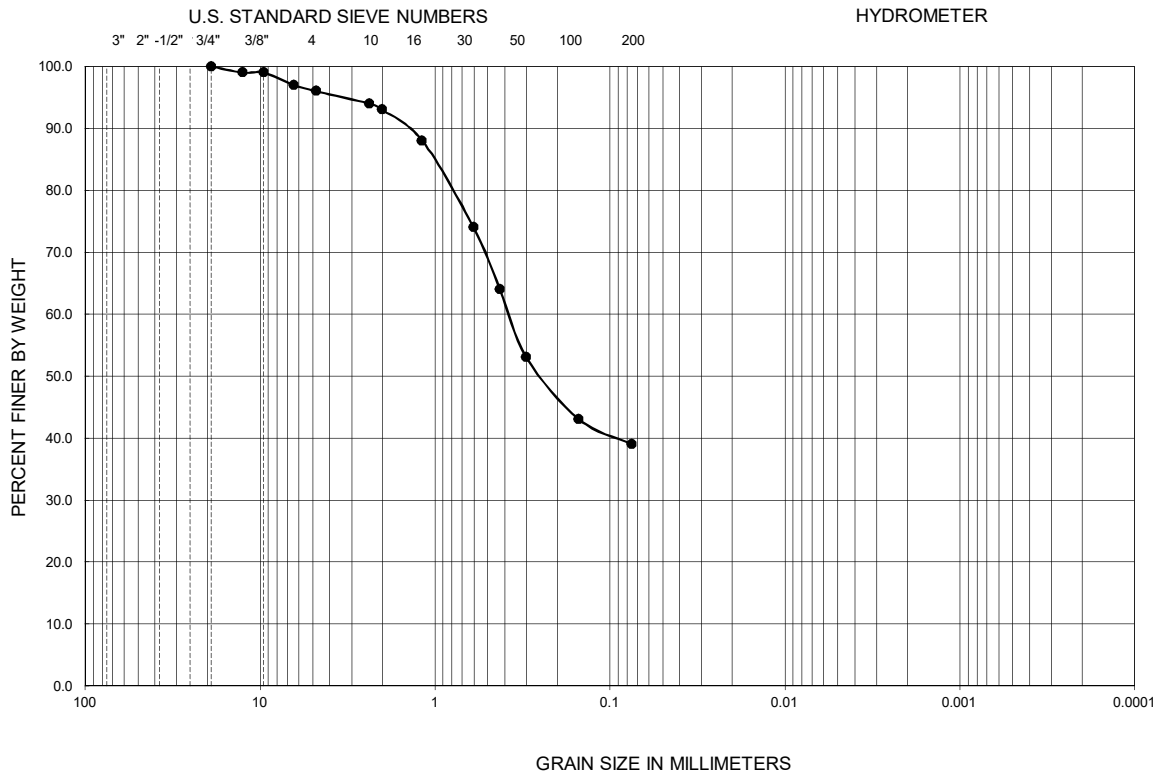
FIGURE B-3

Symbol	Sample Location	Depth (ft)	Liquid Limit	Plastic Limit	Plasticity Index	D <sub>10</sub>	D <sub>30</sub>	D <sub>60</sub>	C <sub>u</sub>	C <sub>c</sub>	Passing No. 200 (percent)	USCS
●	TP-2A	0.0-0.5	33	17	16	--	--	0.38	--	--	39.0	SC

PERFORMED IN GENERAL ACCORDANCE WITH ASTM C136 / D422

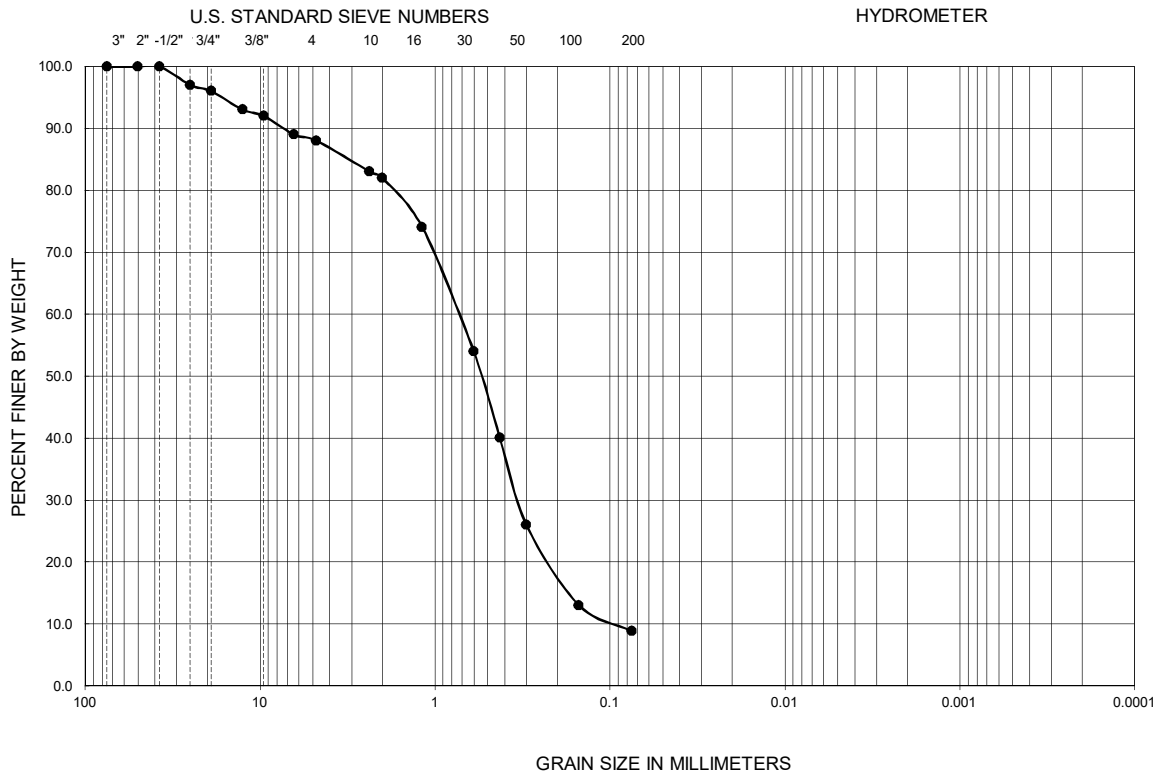
Symbol	Sample Location	Depth (ft)	Liquid Limit	Plastic Limit	Plasticity Index	D <sub>10</sub>	D <sub>30</sub>	D <sub>60</sub>	C <sub>u</sub>	C <sub>c</sub>	Passing No. 200 (percent)	USCS
●	TP-2B	0.1-3.0	--	--	NP	0.090	0.337	0.72	8.0	1.7	8.8	SW-SM

PERFORMED IN GENERAL ACCORDANCE WITH ASTM C136 / D422

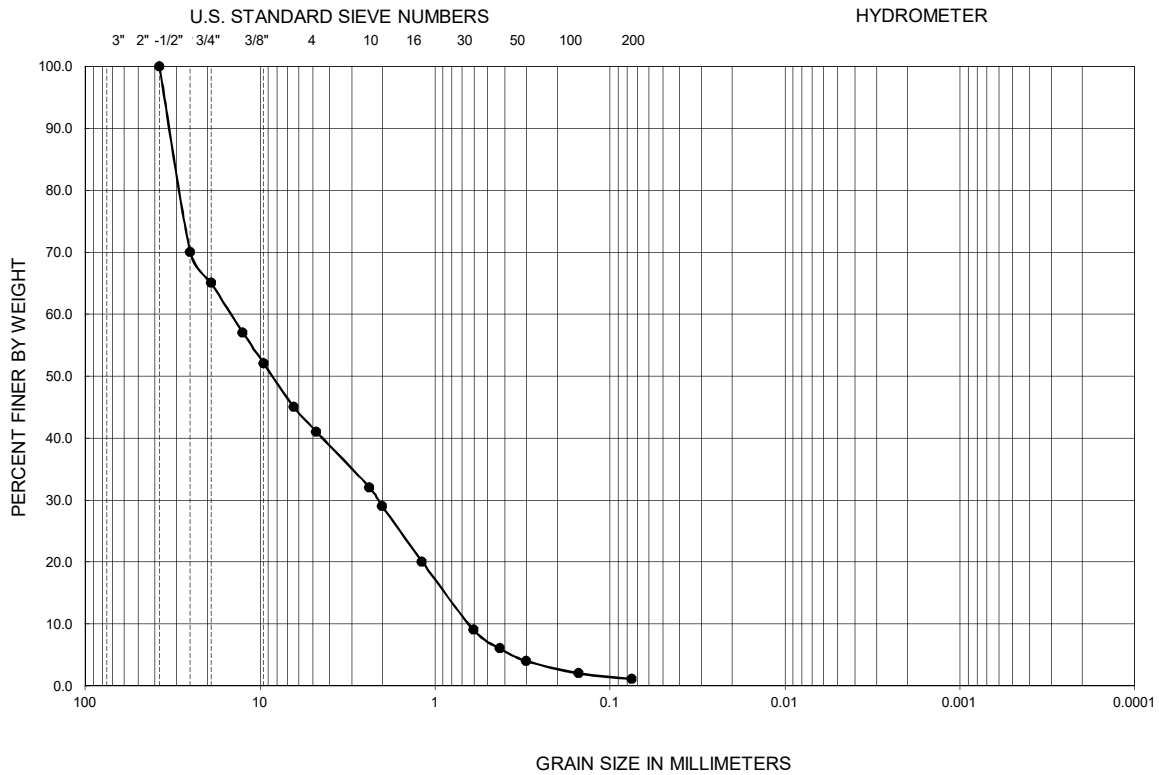
Symbol	Sample Location	Depth (ft)	Liquid Limit	Plastic Limit	Plasticity Index	D <sub>10</sub>	D <sub>30</sub>	D <sub>60</sub>	C <sub>u</sub>	C <sub>c</sub>	Passing No. 200 (percent)	USCS
●	TP-3B	0.2-3.0	--	--	NP	0.623	2.126	14.79	23.7	0.5	1.1	GP

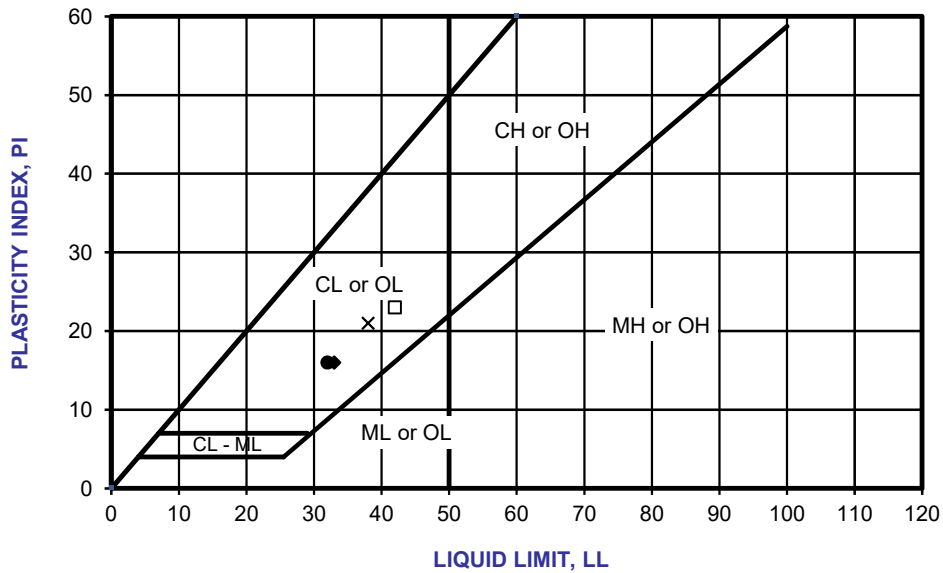
FIGURE B-9

SYMBOL	LOCATION	DEPTH (ft)	LIQUID LIMIT	PLASTIC LIMIT	PLASTICITY INDEX	USCS CLASSIFICATION (Fraction Finer Than No. 40 Sieve)	USCS
●	TP-1B	0.0-1.4	32	16	16	CL	CL
■	TP-1C	2.0-3.0	-	-	NP	ML	SM
◆	TP-2A	0.0-0.5	33	17	16	CL	SC
○	TP-2B	0.1-3.0	-	-	NP	ML	SW-SM
□	TP-3A	0.0-0.5	42	19	23	CL	SC
△	TB-3B	0.2-3.0	-	-	NP	ML	GP
X	TP-4A	0.0-0.5	38	17	21	CL	SC
+	TP-4C	0.4-3.0	-	-	NP	ML	SM

PERFORMED IN GENERAL ACCORDANCE WITH ASTM D 4318

Atterberg limits Tests were performed on selected representative fine-grained soil samples to evaluate the liquid limit, plastic limit, and plasticity index in general accordance with ASTM D4318. These test results were utilized to evaluate the soil classification in accordance with the USCS. The test results and classifications are shown on Figure B-9.
