## TECHNICAL MEMORANDUM

Project Number:  
0034.011.002

Subject: Merritt College Horticulture Complex Percolation testing

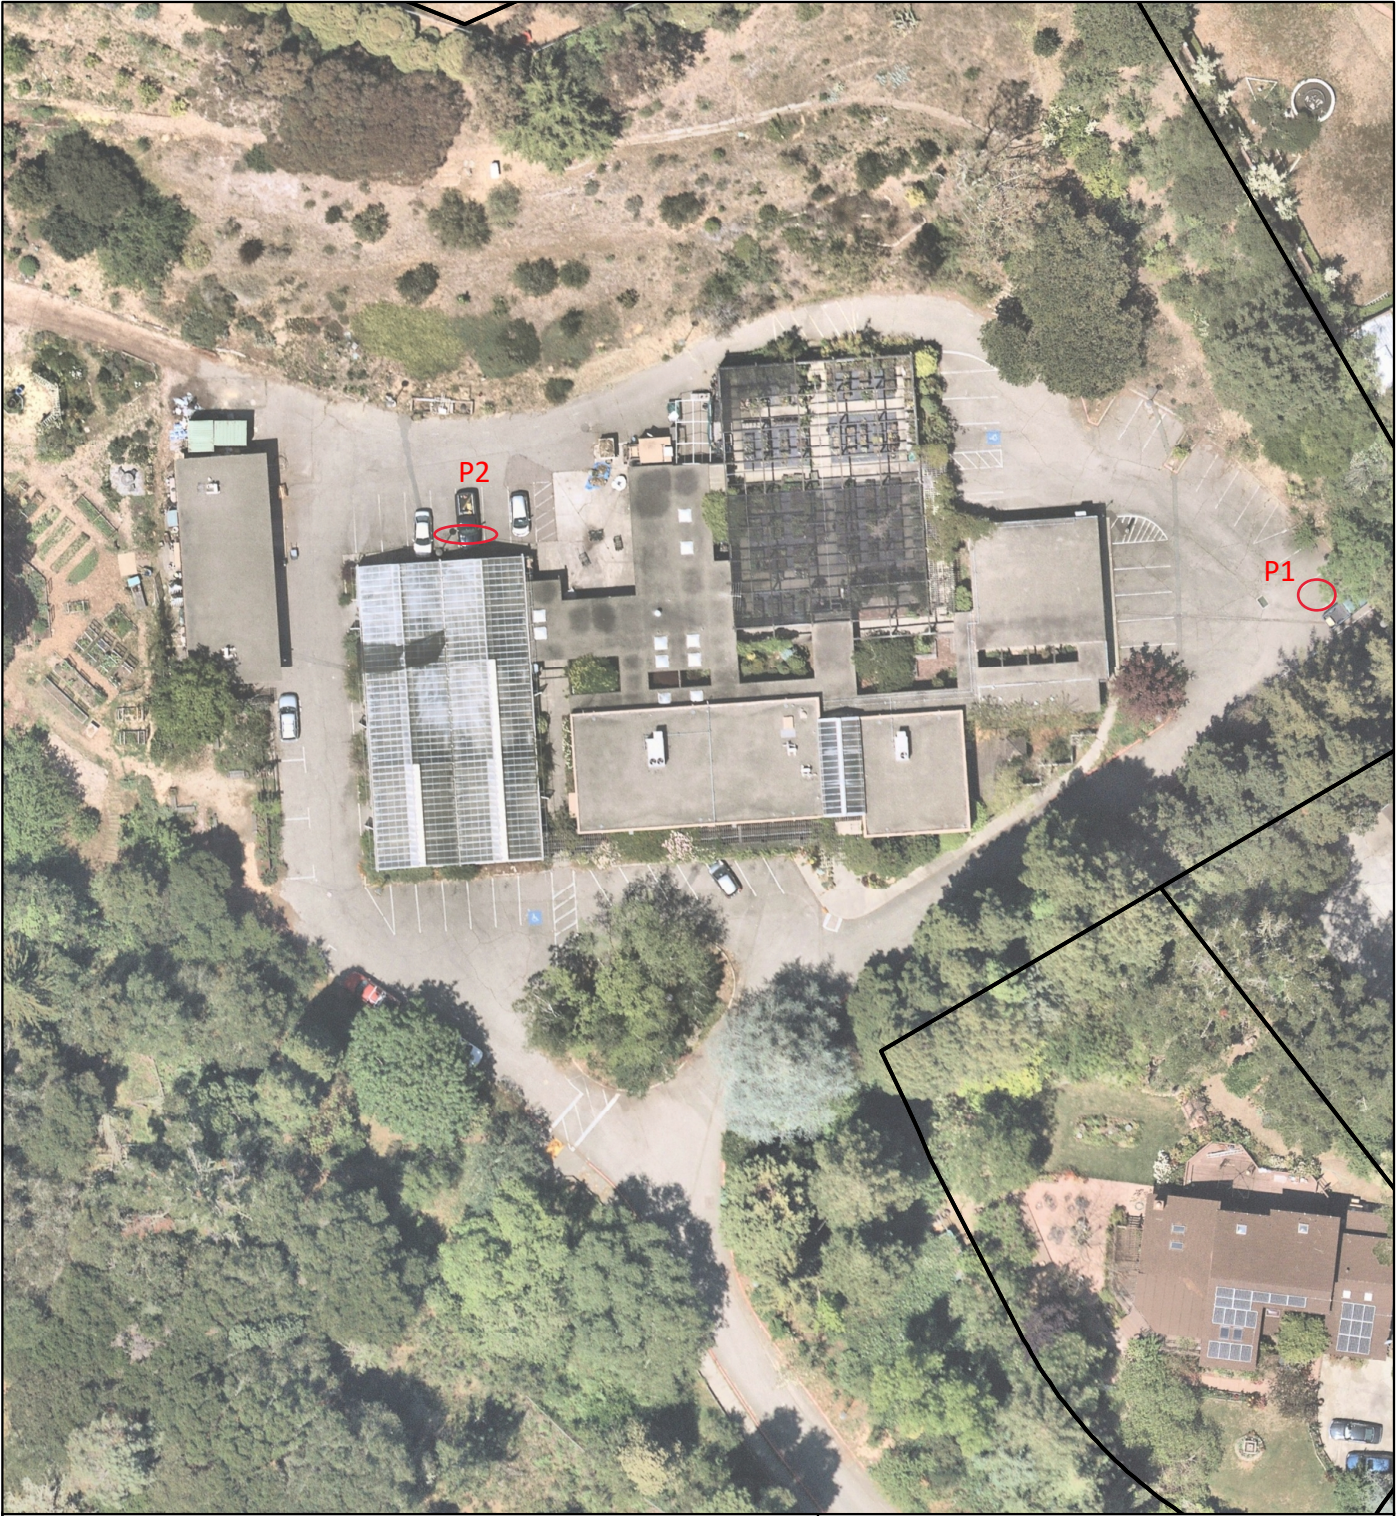
**FIGURE 2**

**Site Map**

PROJECT: Merritt College Percolation Testing  
12500 Campus Drive, Oakland, CA

Figure 2 – Proposed Percolation Testing Areas

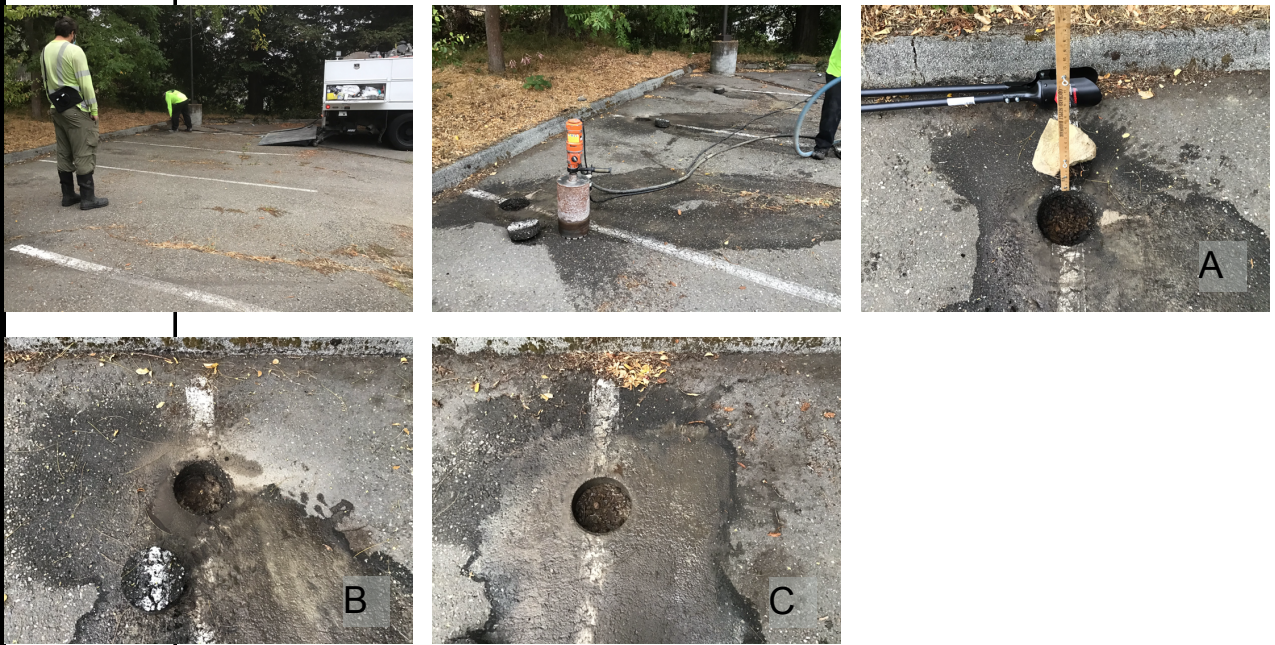
<b>Date:</b> 08.27.20		<b>Day of the Week:</b> Thursday		<b>Logged by:</b> EKela Autry	
<b>Project Name:</b> Merritt Hort Center			<b>Project Number:</b> 0034.011.0001		
<b>Site Location / Address:</b> 12500 Campus Drive, Oakland CA					
<b>Weather Conditions:</b> Overcast			<b>Start Time:</b> 0700		<b>Stop Time:</b> 1600
<b>Personnel present on site:</b> Justin (Del Secco), Kristen S. (TEI), EKela A. (TEI), Ryan G. (TEI)					
Time	Notes				
0700	<p>On site. Safety tailgate, photo taken by Ryan to confirm.</p> <p>Coring for P1 begins in east corner of parking lot. Cores are about 3" thick.</p>

<p>Soil is compact and tough. Holes labeled A-C from north to south.</p>

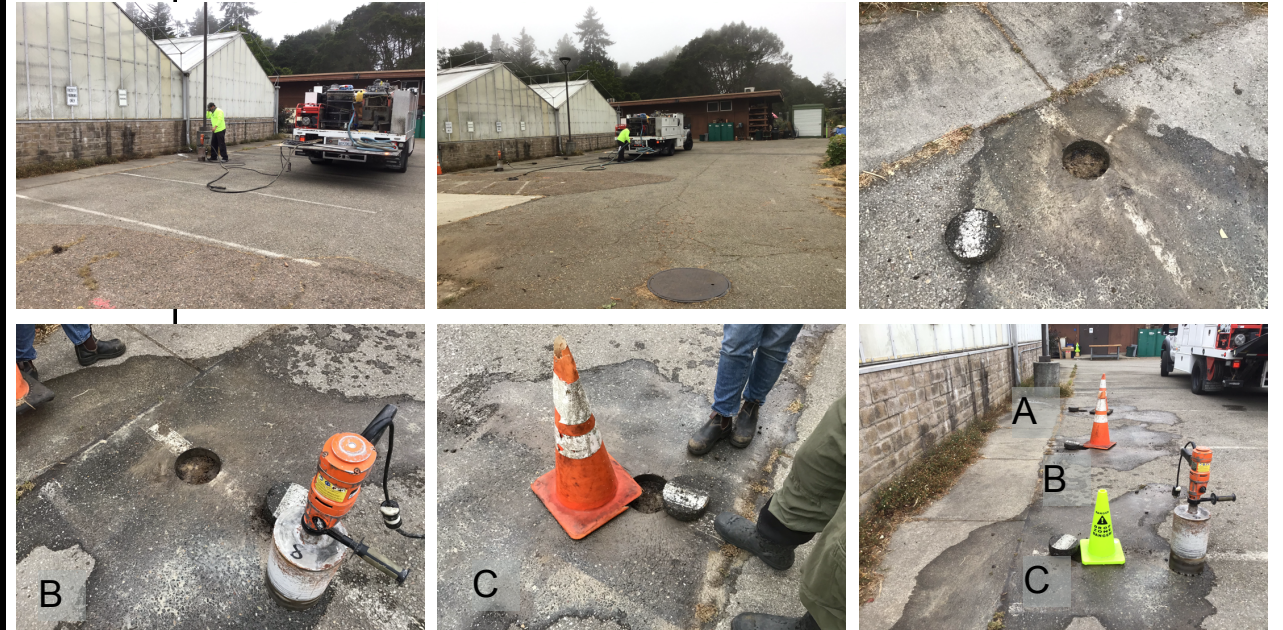
Time	Notes
0751	Coring begins for P2 on north side of building, a couple feet north of greenhouse structure. Holes sub-labeled A-C from west to east.

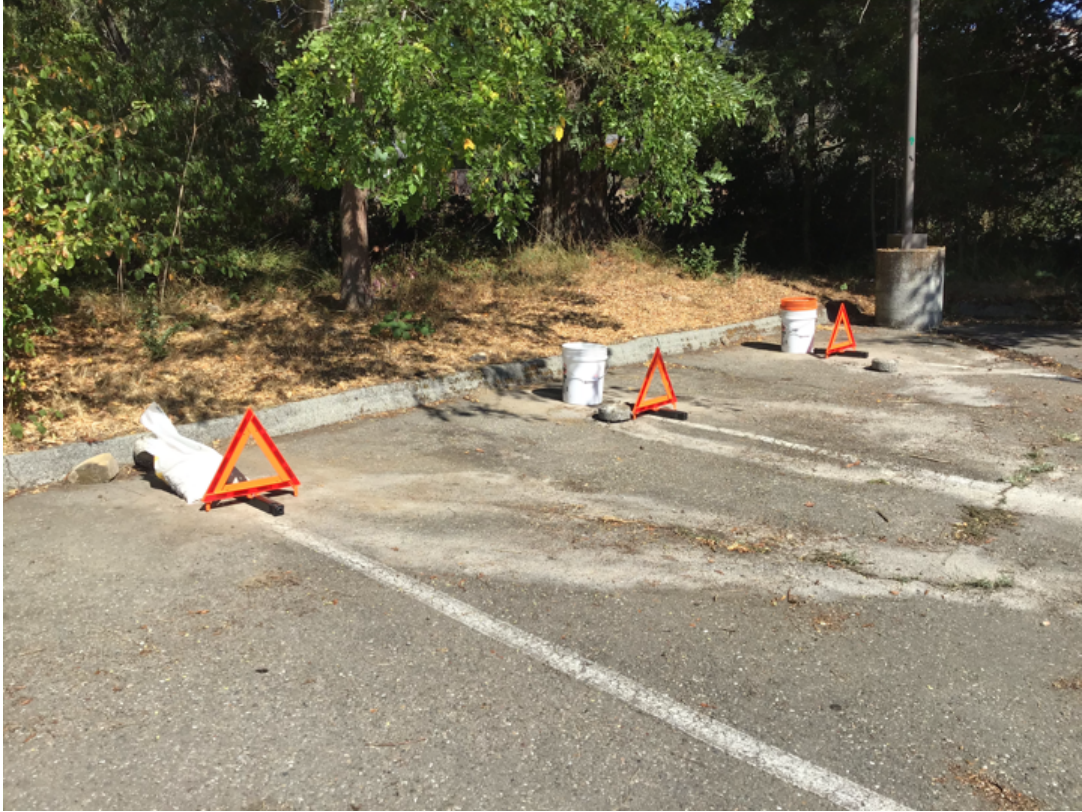
Time	Notes
1120-1535	<p>Soaking period begins. Every 30 minutes the holes at P1 and P2 are measured from the ground surface to the top of the water to see how far the water has fallen from 6" bgs. The results of this 4 hour soaking periods can be viewed on the following page.</p> <p>Start times            Perc 1A: 1120            Perc 1B: 1125            Perc 1C: 1130</p> <p>Perc 2C: 1140            Perc 2B: 1142            Perc 2A: 1144</p>
1600

<p>All holes covered at the end of the day and cones and triangles left in front of them. Offsite.</p>
