# **Erskine Environmental Consulting**

Subject: Geologic Evaluation for Naturally Occurring Asbestos  
Child Development Center Site  
Merritt College Campus, Oakland, CA

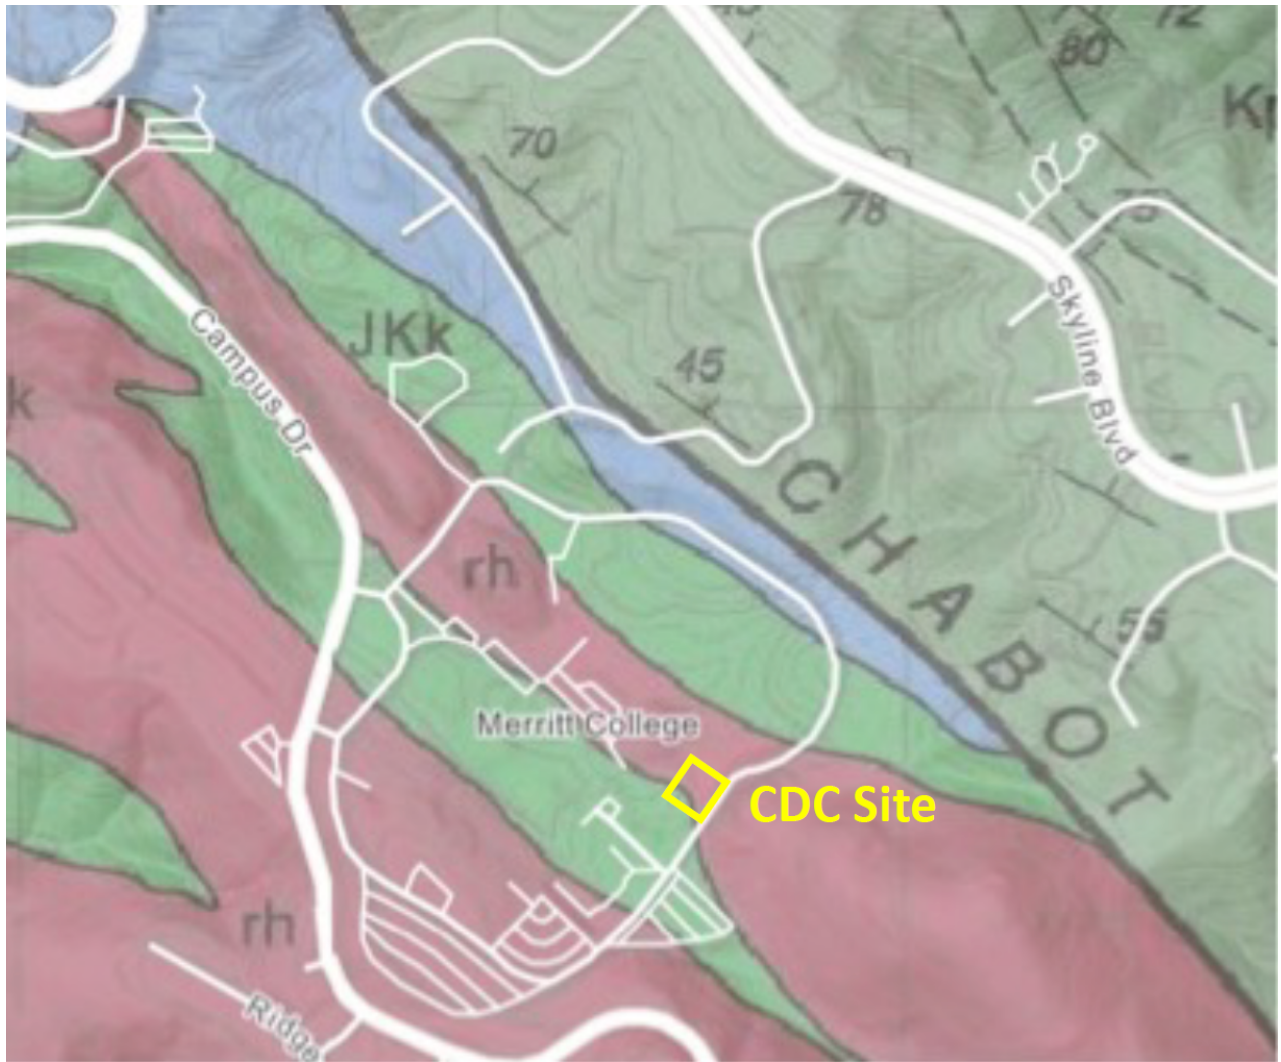
Figure 3: Geologic map showing the CDC site being underlain by rhyolite and possibly Knoxville Formation shale. From Dibblee and Minch, 2005.

A search of the USGS database produced two geologic maps depicting the geologic units that underlie the subject site. The most recently published map by Dibblee and Minch (2005) depicts serpentinite (an ultramafic rock unit where asbestos is ubiquitous) approximately 900 feet northeast of the CDC site (Figure 3). On this map, the site where construction will occur is underlain by rhyolite of the Coast Range Ophiolite Complex and possibly shale of the Knoxville formation. Rhyolite and shale are considered by the California Geological Survey (CGS) as having a low potential for asbestos to be present (asbestos is not likely to be present). The earlier map published by Graymer (2000) depicts the site to be underlain by quartz keratophyre, a volcanic rock of intermediate composition (Figure 4). This lithology also is considered to have a low potential to contain asbestos.

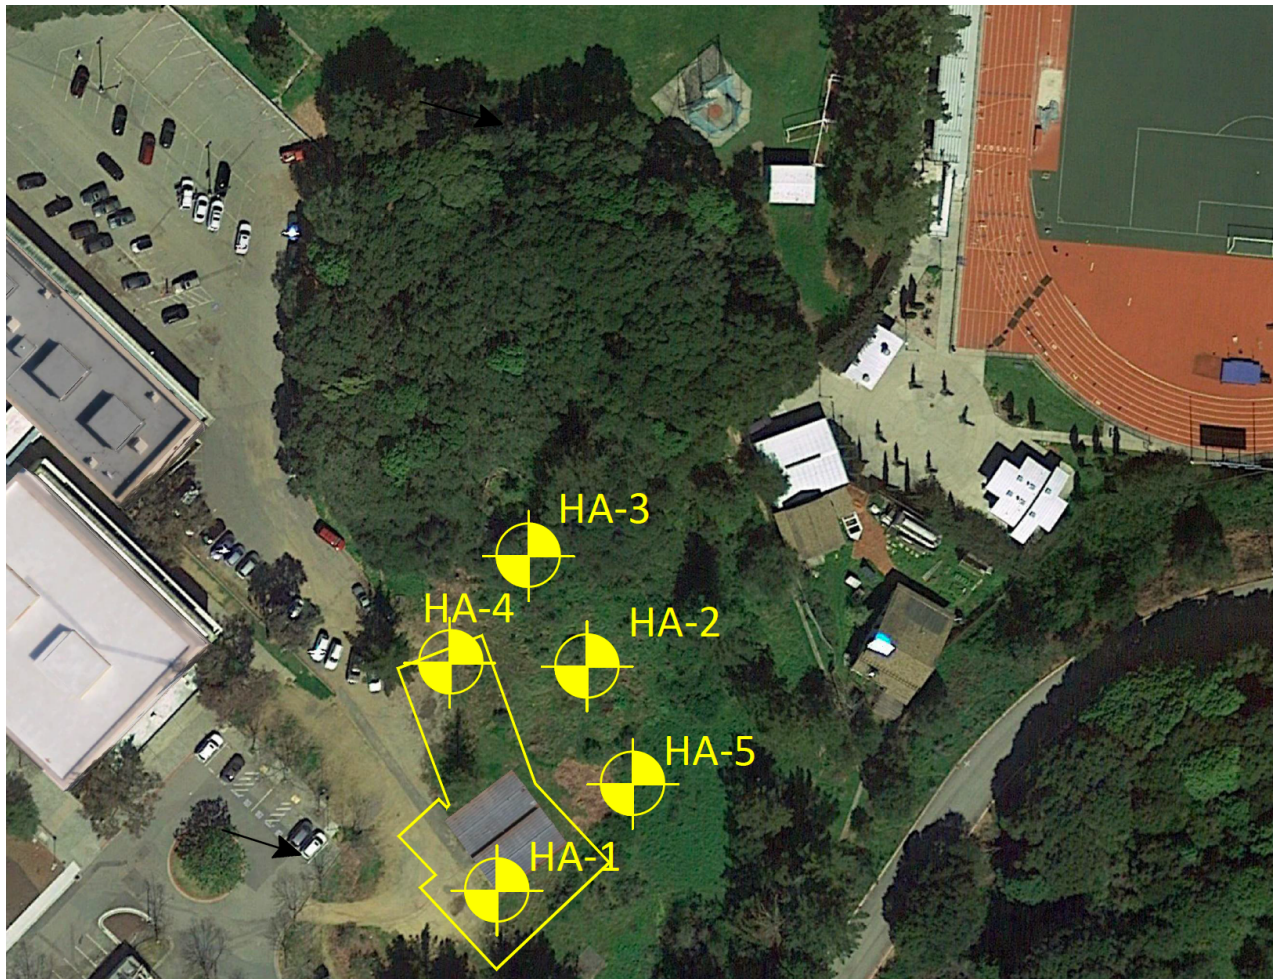
Figure 5: Location of the five borings advanced by Terraphase (2019) during the geotechnical investigation.

In 2019, Terraphase Engineering Inc. conducted a Geotechnical Design and Geological Hazards Evaluation which included five borings (Terraphase, 2019). The location of the five borings advanced by Terraphase is shown in Figure 5.

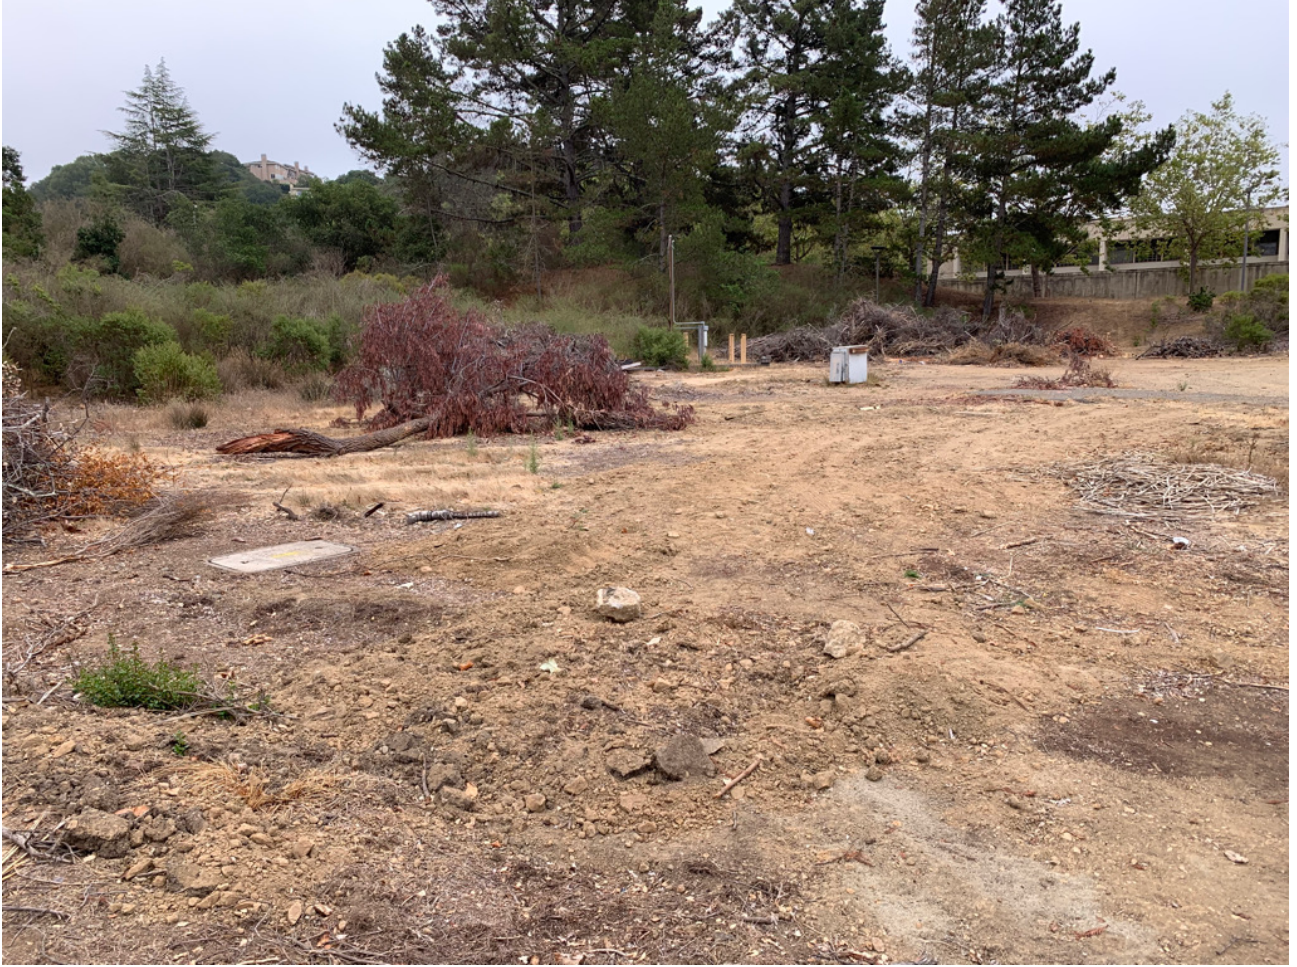
Figure 6: Photograph of the CDC site at the time of the geologic evaluation.

The site was clear of buildings and structures, and much of the site had been cleared of vegetation (Figure 6). Gravel sized clasts of rhyolite were present across the site and on the surrounding slopes (Figure 7). Ten potholes were advanced using a breaking bar and post hole digger to ascertain the lithology of the rock units that underlie the site. Hard rhyolite was

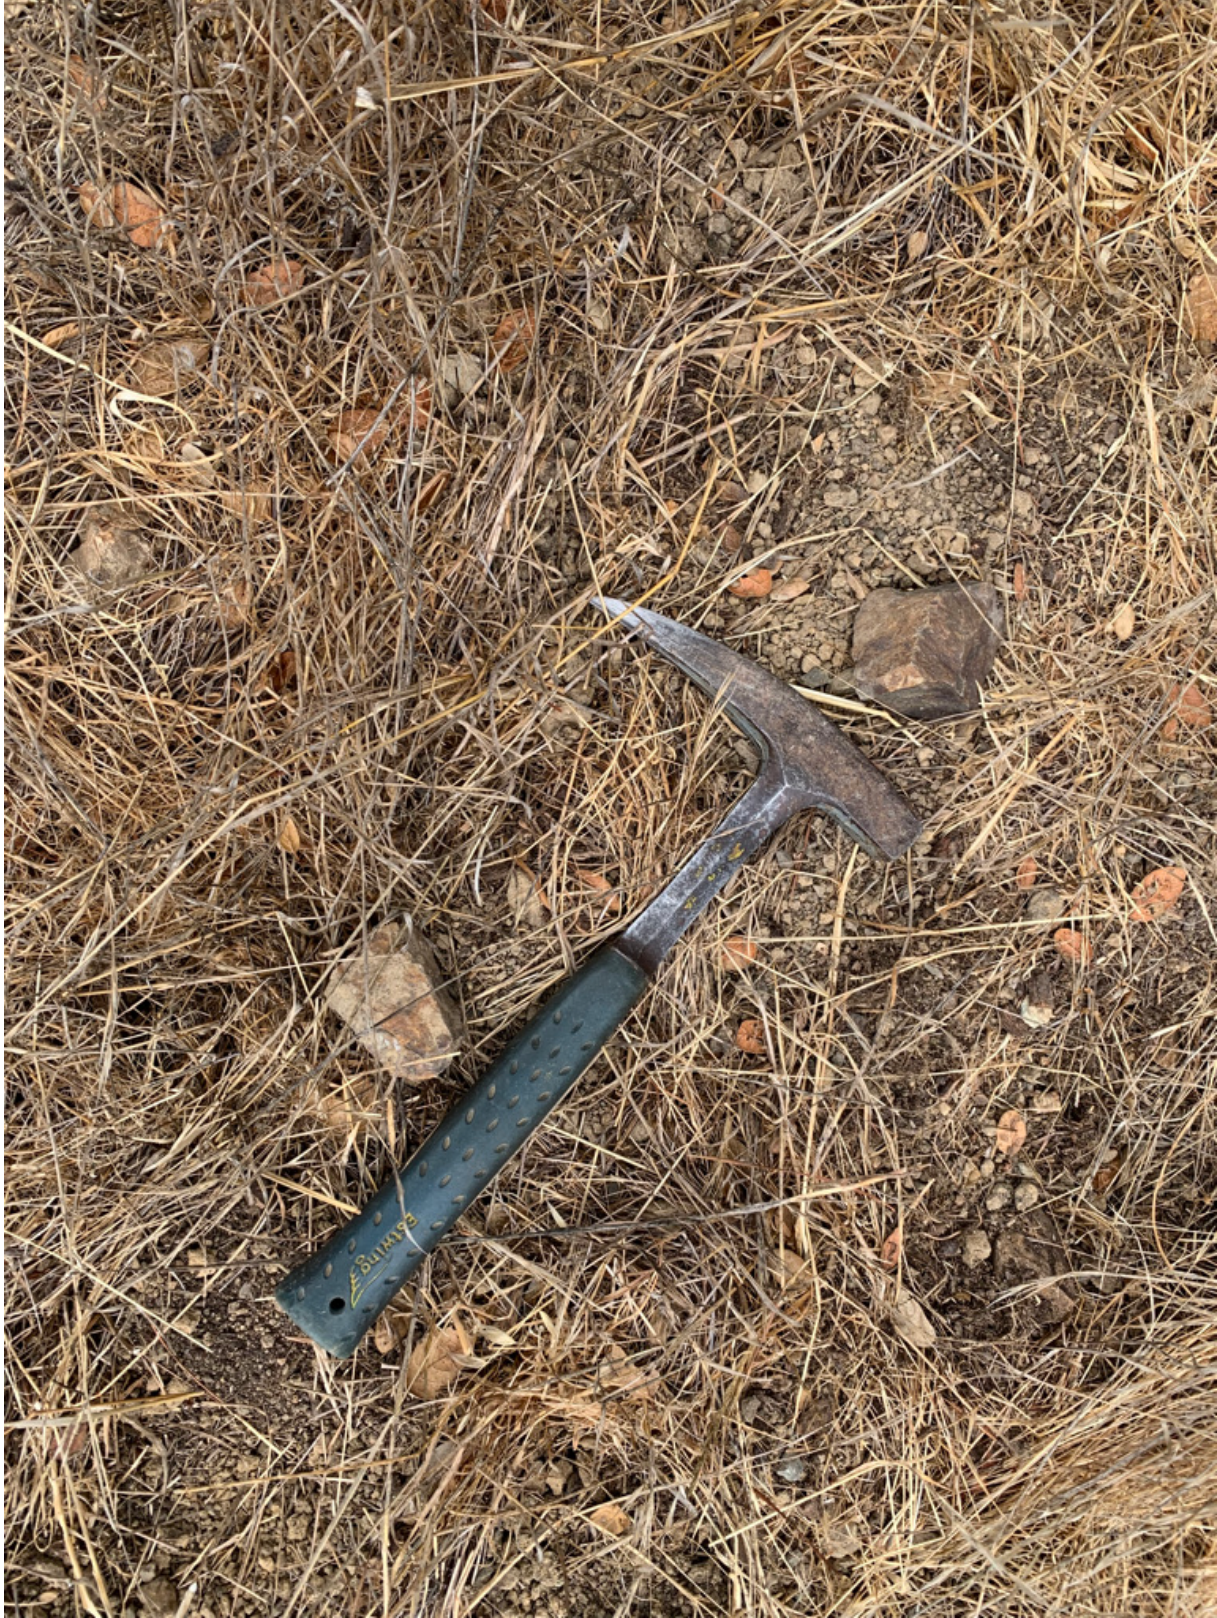
Figure 7: Detail showing clasts of rhyolite occupying the CDC site.

encountered in each of the potholes, confirming the depiction on the geologic maps and observations by Terraphase that the site is underlain by rhyolite. Serpentinite was not observed at the site.

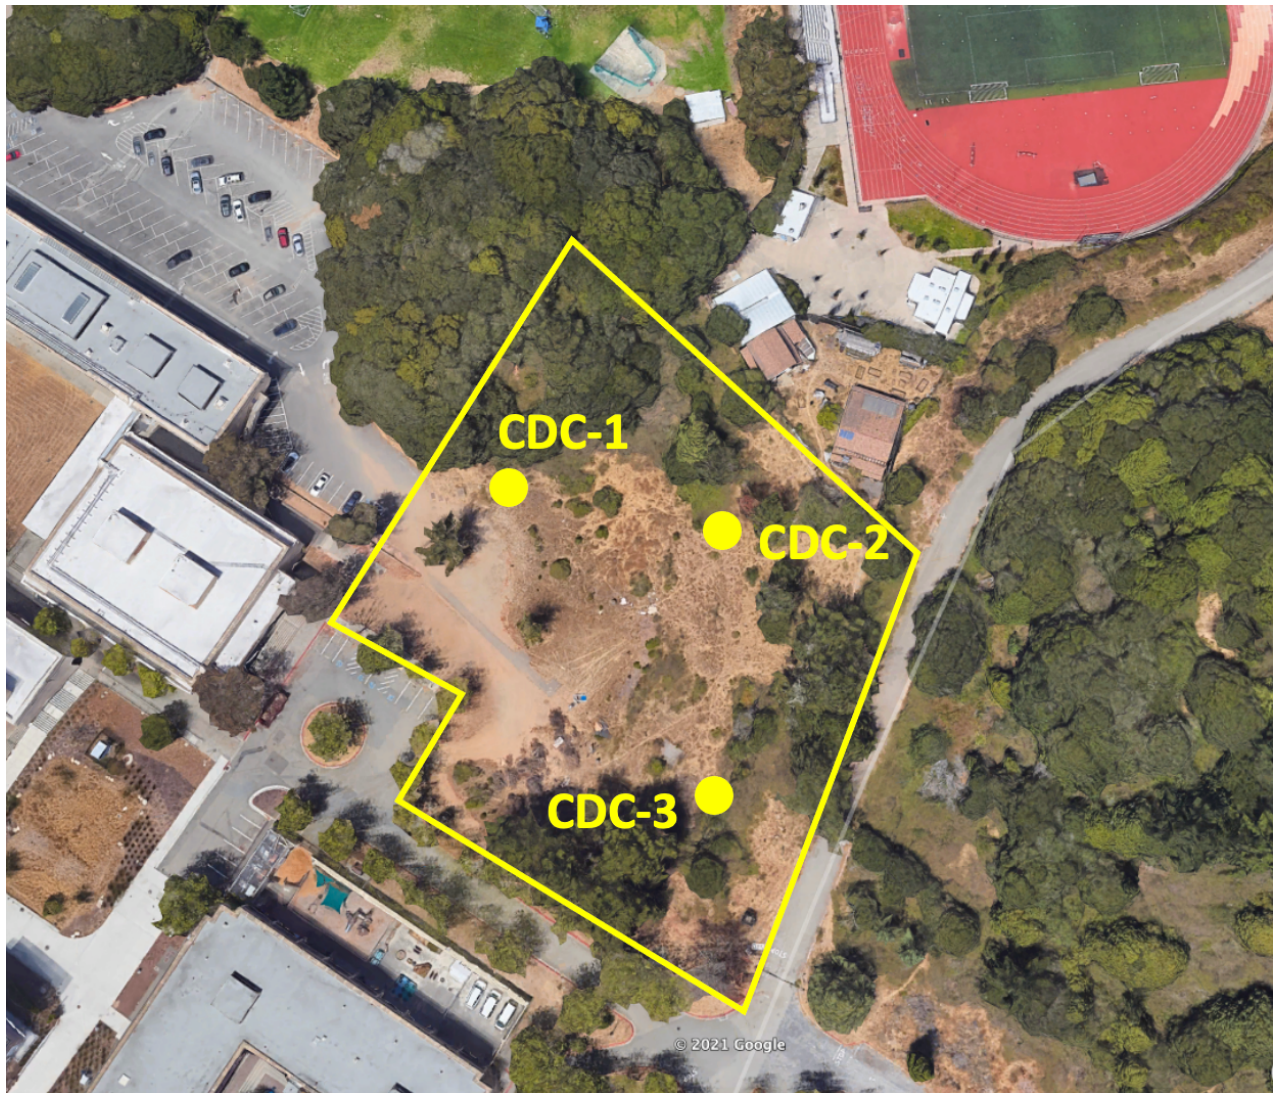
Figure 8: Location of soil borings for the sampling of soil for asbestos.

Three samples consisting of 20-point aliquots were collected within the area that will be disturbed during construction (Figure 8). The three samples, consisting of rhyolite, were representative of the rock that occupies the site as indicated by clasts on the surface and observed within the ten potholes.
