Attachment M
SITE DRAWINGS AND CAMERA LOCATIONS

GRIFFIN GARDENS APARTMENTS

4881 Griffin Road Davie, FL 33314

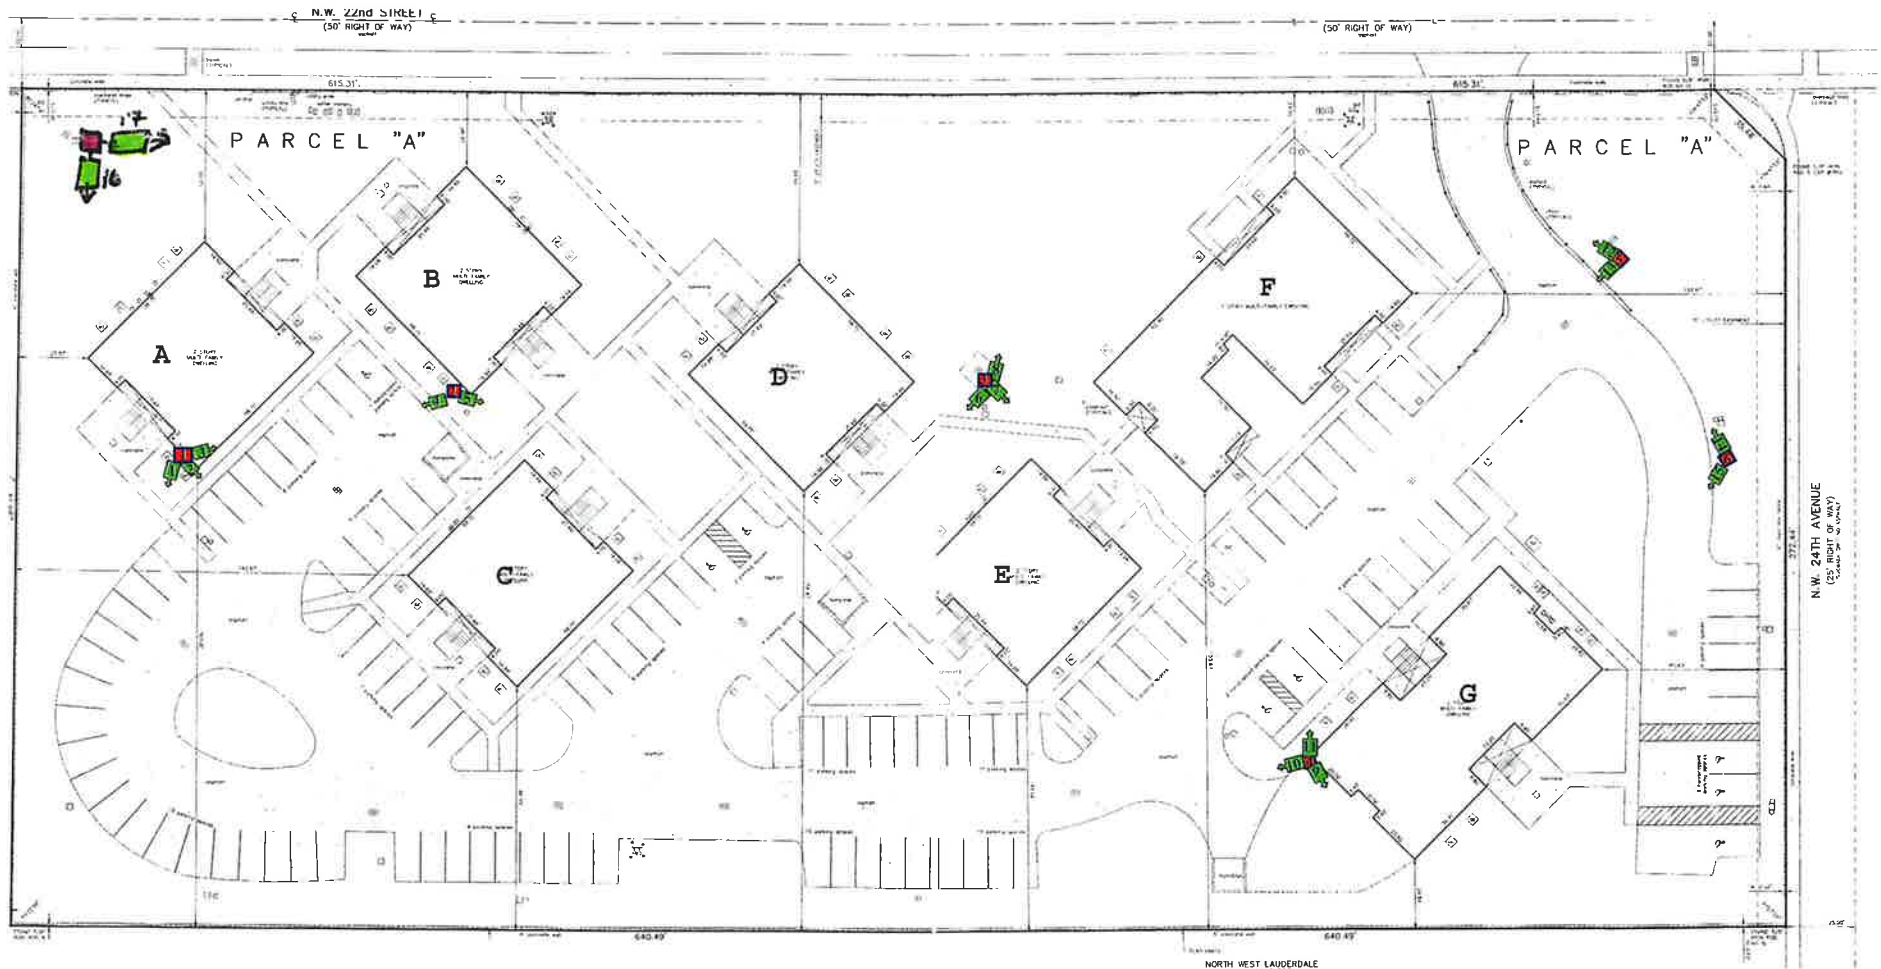
EVERGLADE HEIGHTS APARTMENTS 2400 NW 22ND STREET FT. LAUDERDAL FL. 33311

Auburn Gardens and Roosevelt Heights
Fed to Everglade Heights

- 1 NVR 24 T
- 17   5MP 2.8mm Fixed Lens Camera
- 7   Transmitters
- 9 Pole Mounts
- 8 Wall Mounts
- UPS Power Supply

1. 2.8mm fixed lens, wall mounted bullet camera located at South corner of building A Facing South.
2. 2.8mm fixed lens, wall mounted bullet camera located at South corner of building A Facing SE.

3. 2.8mm fixed lens, wall mounted bullet camera located at South corner of building A Facing NE.
4. 2.8mm fixed lens, wall mounted bullet camera located at South corner of building B facing SW.

5. 2.8mm fixed lens, wall mounted bullet camera located at South corner of building facing SE.
6. 2.8mm fixed lens, pole mounted bullet camera between buildings D, E, and F facing SW.

7. 2.8mm fixed lens, pole mounted bullet camera located between buildings D, E, and F facing SE.
8. 2.8mm fixed lens, pole mounted bullet camera located between buildings D, E, and F facing NE.

9. 2.8mm fixed lens, wall mounted bullet camera located at North corner of building facing North
10. 2.8mm fixed lens, wall mounted bullet camera located at North corner of building facing West.

11. 2.8mm fixed lens, wall mounted bullet camera located at North corner of building facing SE.
12. 2.8mm fixed lens, pole mounted bullet camera located on NW 24th Ave facing NW toward property entrance.

13. 2.8mm fixed lens, pole mounted bullet camera located on NW 24th Ave facing the drive between building E, F, and G
14. 2.8mm fixed lens, pole mounted bullet camera located on NW 24th Ave facing North toward property entrance

15. 2.8mm fixed lens, pole mounted bullet camera located on NW 24th Ave facing SW
16. 2.8 mm fixed pole mounted bullet camera located on NW 22nd Ave. facing SW and SE

17. 2.88mm Fixed pole mounted bullet camera located on NW 22 Ave. Facing SW and SE

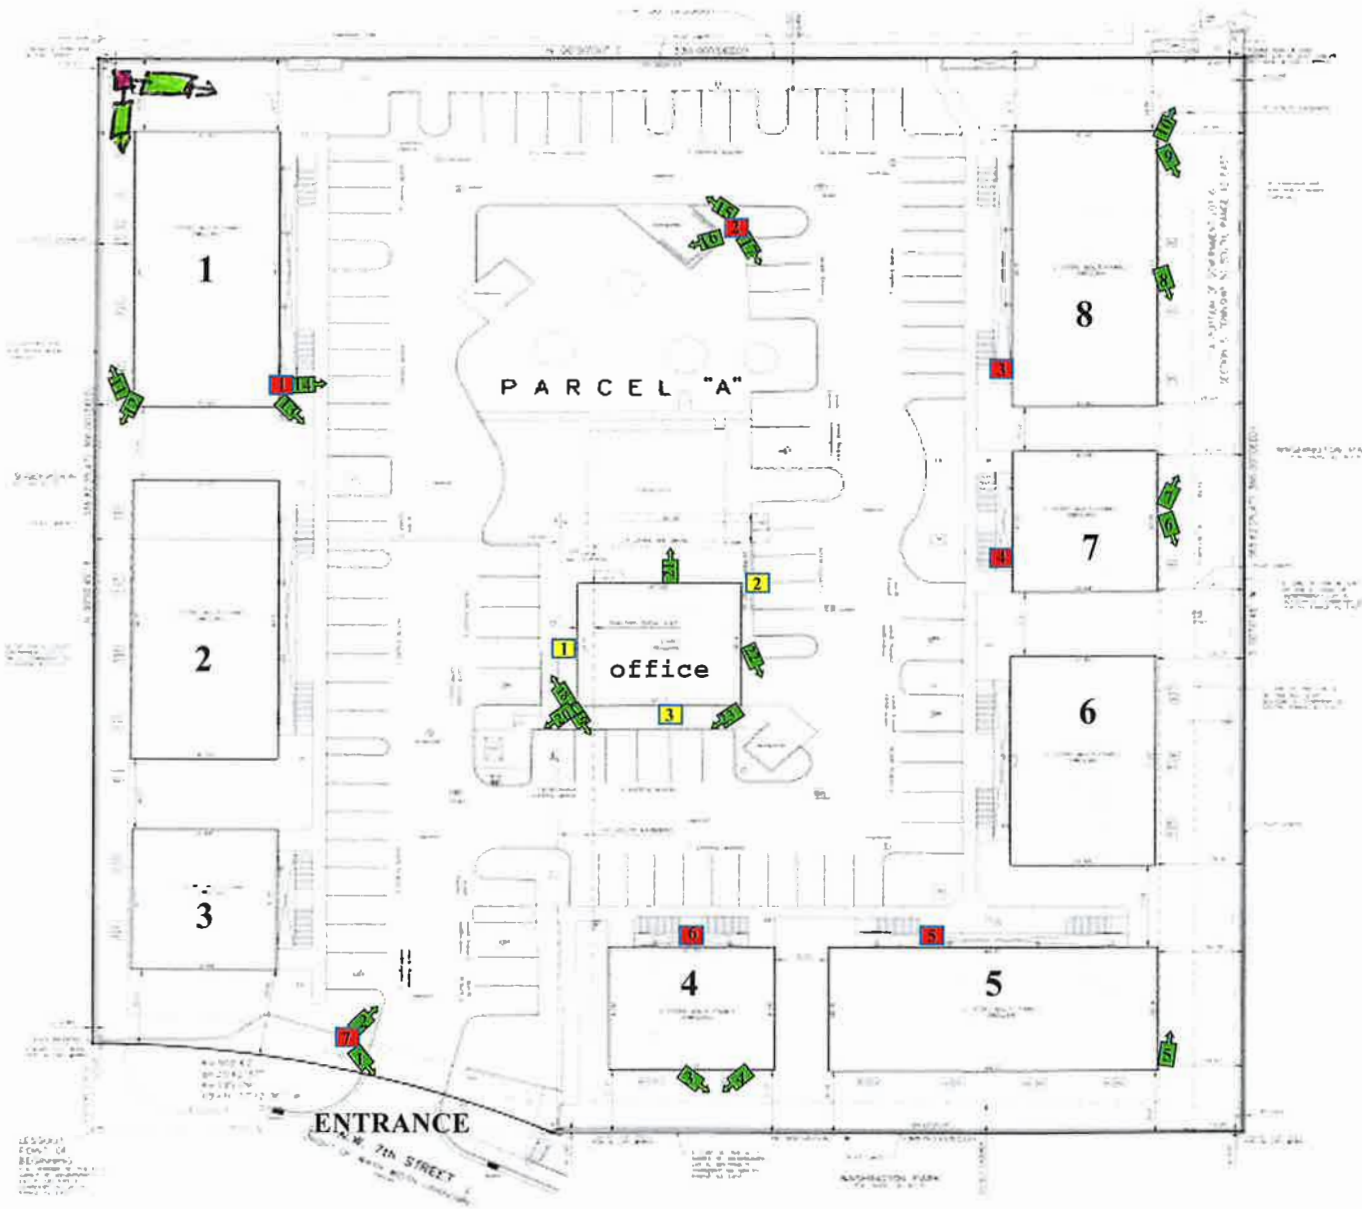
**MEYERS ESTATES
2411 NW 7TH STREET
FT. LAUDERDALE FL 33311**

- 1 NVR 24 T
- 23   SMP Fixed 2.8mm Lens
- 8   Transmitters
- 7 High Power AC1200 Dual-Band Outdoor Bridge
- 3   Receivers
- 7 POE Switches
- 5 Pole Mounts
- 18 Wall Mounts

1. 2.8mm fixed lens, pole mounted bullet camera located at entrance facing SE.
2. 2.8mm fixed lens, pole mounted bullet camera located at entrance facing NE.

3. 2.8mm fixed lens, wall mounted bullet camera located on South elevation of building 4 facing SE
4. 2.8mm fixed lens, wall mounted bullet camera located on South elevation of building 4 facing SW

5. 2.8mm fixed lens, wall mounted bullet camera located on East elevation of building 5 facing North
6. 2.8mm fixed lens, wall mounted bullet camera located on East elevation of building 7 facing South

7. 2.8mm fixed lens, wall mounted bullet camera located on East elevation of building 7 facing North
8. 2.8mm fixed lens, wall mounted bullet camera located on East elevation of building 8 facing South

9. 2.8mm fixed lens, wall mounted bullet camera located on East elevation of building 8 facing South
10. 2.8mm fixed lens, wall mounted bullet camera located on East elevation of building 8 facing North

11. 2.8mm fixed lens, wall mounted bullet camera located on West elevation of building 1 facing North
12. 2.8mm fixed lens, wall mounted bullet camera located on West elevation of building 1 facing South

13. 2.8mm fixed lens, pole mounted bullet camera located on East elevation of building 1 facing SE
14. 2.8mm fixed lens, pole mounted bullet camera located on East elevation of building 1 facing East

15. 2.8mm fixed lens, pole mounted bullet camera located at NE end of parking lot facing NW
16. 2.8mm fixed lens, wall mounted bullet camera located at NE end of parking lot facing SW

17. 2.8mm fixed lens, wall mounted bullet camera located at NE end of parking lot facing SE
18. 2.8mm fixed lens, wall mounted bullet camera located at SW corner of office facing NW

19. 2.8mm fixed lens, wall mounted bullet camera located at SW corner of office facing SE
20. 2.8mm fixed lens, wall mounted bullet camera located at SW corner of office facing SW

21. 2.8mm fixed lens, wall mounted bullet camera located at North elevation of office facing North
22. 2.8mm fixed lens, wall mounted bullet camera located at East elevation of office facing SE

23. 2.8mm fixed lens, wall mounted bullet camera located at SW corner of office facing SW
24. Reposition cameras, 10, 11, and 12
