Subject: Pre-demolition Hazardous Materials Survey Report
1151 Sevier Avenue and 1209 Island Home Avenue, Knoxville, Tennessee
Sevier Avenue Streetscape Project

**HAZARDOUS MATERIALS SURVEY REPORT
FOR THE
TWO FORMER RESIDENTIAL STRUCTURES
1151 SEVIER AVENUE AND 1209 ISLAND HOME AVENUE
KNOXVILLE, TENNESSEE**

**Two Former Residential Structures
1151 Sevier Avenue and 1209 Island Home Avenue, Knoxville, Tennessee
City of Knoxville Sevier Avenue Streetscape Project**

QE2 Task No. 501588

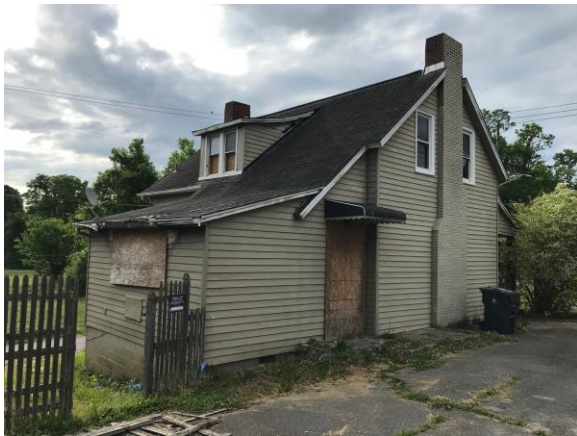
West side, burned rear bedroom addition

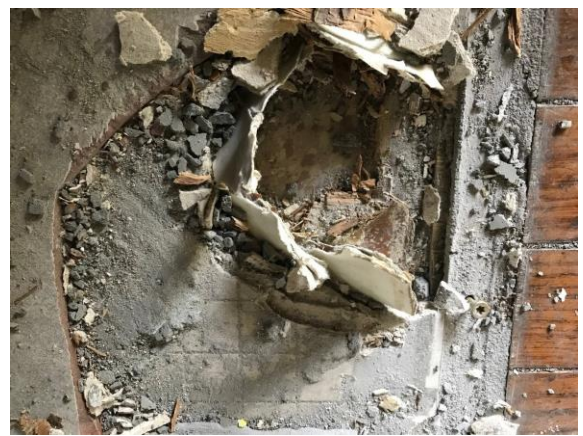
In the house at 1151 Sevier Avenue, one type of VFT (1151-3, tan & brown) and one type of vinyl sheet flooring (1151-4, brown 6-in brick patterned) were confirmed as ACMs. No asbestos was detected in the associated mastics. The ACM VFT and vinyl are layers in the same space in the Kitchen. Both layers are under ceramic tile, backer board, and non-ACM white vinyl sheet flooring. The VFT is also under plywood. Both layers are potentially under kitchen cabinetry. No other materials in Building 1 were confirmed as ACMs.

ACM VFT & vinyl under ceramic tile in Kitchen

The presence of Category I non-friable ACM (VFT and vinyl sheet flooring) was confirmed at both houses during the survey. Category II non-friable ACM (Transite panels) were confirmed at 1209 Island Home Avenue. Non-friable materials are not considered to be regulated ACM (RACM) unless they have become friable or are expected to become friable through being subjected to breaking, sanding, grinding, cutting, or abrading during demolition, renovation, or maintenance activities. Future demolition of the structures could render them friable. Locations of confirmed ACM are provided for the two structures in Tables 3 and 4.

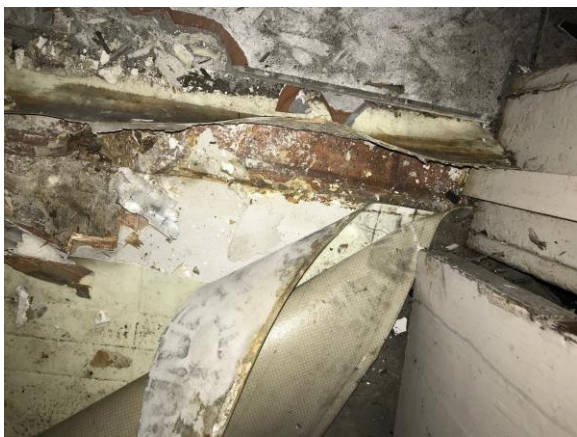
Brown patterned vinyl sheet floor in Kitchen

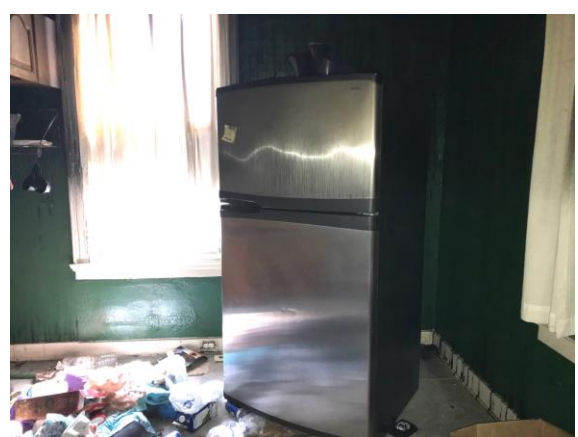
Refrigerator in 1151 Sevier Kitchen

The house at 1151 Sevier Avenue includes a refrigerator that could potentially contain ODSs. Other cooling equipment like HVAC units have been removed from the site. Federal law prohibits the open discharge of ODSs to the atmosphere during maintenance or disposal. Under 40 CFR Part 82, the EPA issued a Final Rule (May 14, 1993) promulgating regulations under Section 608 of the Clean Air Act that establish a recycling program for ozone-depleting refrigerants recovered during the servicing and disposal of air-conditioning or refrigeration equipment. Together with the prohibition (effective July 1, 1992) on venting during servicing, repair, and disposal of Class I and Class II substances, these regulations are intended to reduce emissions of ODSs to the environment. The regulations require that ODSs contained “in bulk” (i.e., with refrigerant charge intact) in appliances/equipment be removed prior to disposal. Section 608 contains requirements concerning the safe disposal of Class I and Class II substances. If the equipment contains ODSs with the charge intact, then trained technicians must safely recover the ODSs. According to the EPA regulations, the last entity in the disposal chain must either remove the refrigerant or obtain verification that refrigerant has been removed previously. The regulations note that refrigerant lines cannot simply be cut before disposal as this is a violation of the statute and the regulations prohibiting venting of ODSs to the environment.

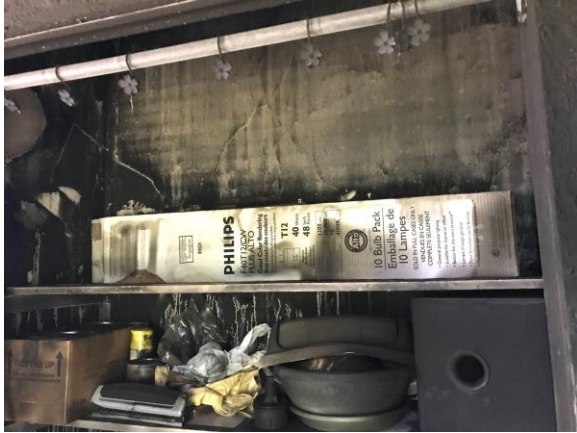
1151 Sevier – fluorescent light bulbs, household containers of cleaners

Detailed visual assessments identified the presence of mercury-containing equipment including light bulbs and appliances or equipment potentially containing thermostats. Mercury-containing wastes and articles that are generated by households and commercial and industrial facilities are in most cases considered hazardous waste and must be managed properly. Mercury-containing wastes are regulated by TDEC under Standards for Universal Waste Management (Per TDEC Rule 1200-1-11-.12 and equivalent Federal regulations). Any removed mercury-containing equipment should be handled as a hazardous waste and are subject to the EPA Land Disposal Restriction Regulations. Any mercury-containing equipment should be recycled, and the mercury retorted. Transportation, waste manifesting/profiling, and receipt certification should be coordinated with the recycling firm. Final documentation of disposal certification should be provided to the Owner for their records.

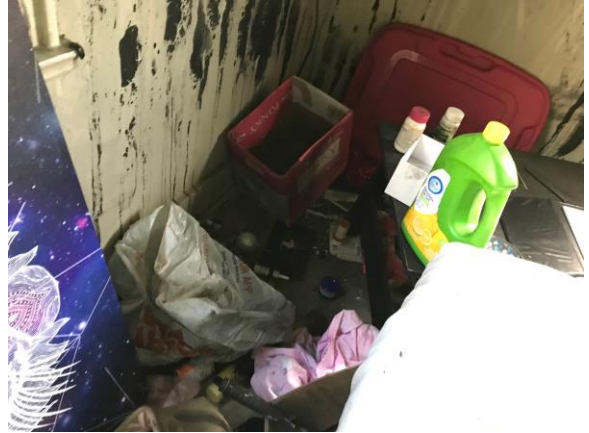
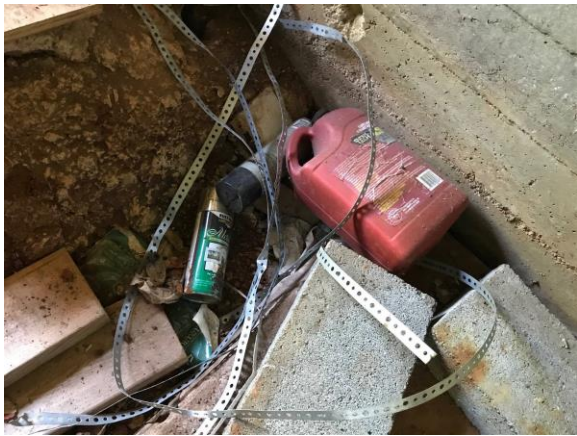
1151 Sevier Basement – spray paint, antifreeze, & oil containers

The visual assessment also noted miscellaneous cleaning compounds, an oil-bearing motor, paint containers, oils and lubricant containers, etc., mostly in the Basement of 1151 Sevier Avenue. When the equipment and containers are removed prior to demolition, methods should be utilized to ensure that no damage occurs to the equipment, containers, or contents. Transportation, waste manifesting/profiling, and disposal certification should be coordinated with a licensed recycling or disposal firm or licensed disposal facility. Final documentation of disposal certification should be maintained by the Owner for all hazardous materials.

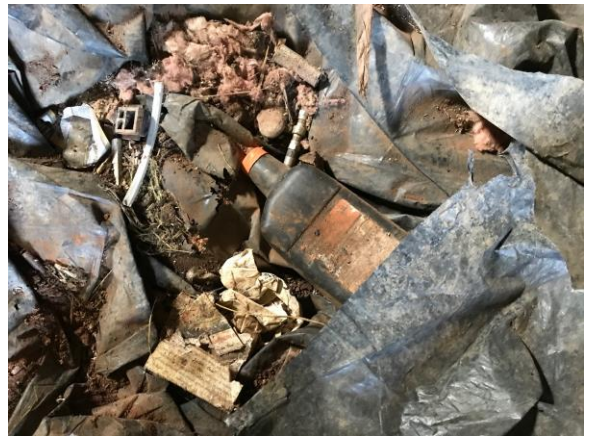
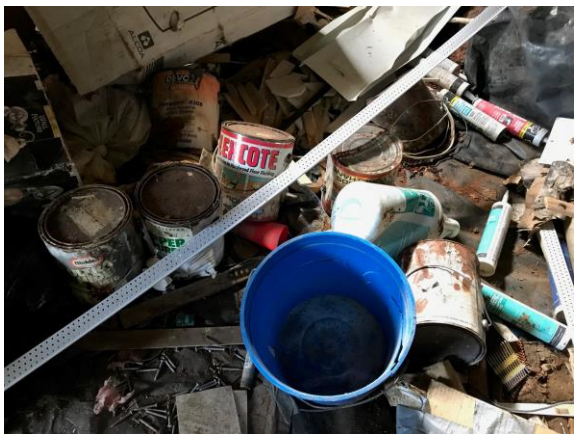
1151 Sevier Avenue Basement – paint and caulk containers

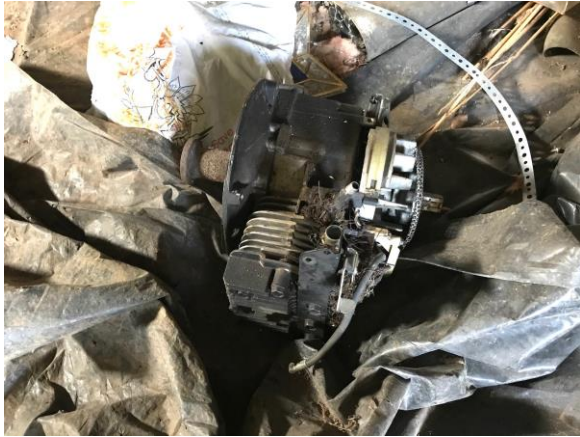
1151 Sevier Avenue Basement - motor

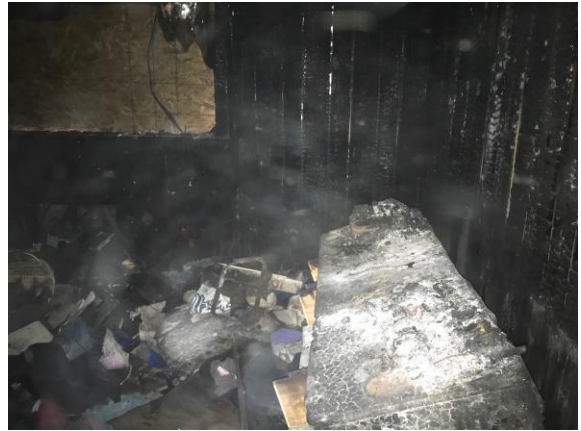
1151 Sevier Avenue burned back Bedroom

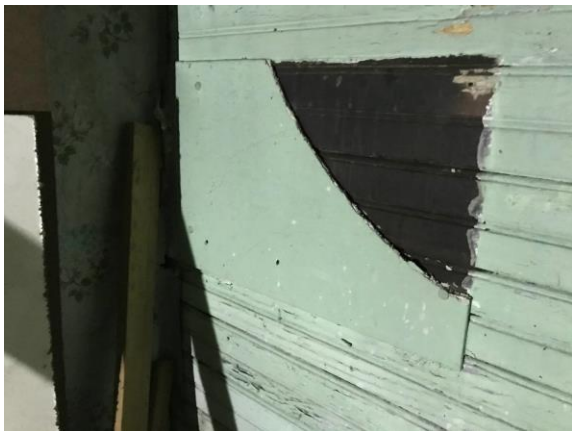
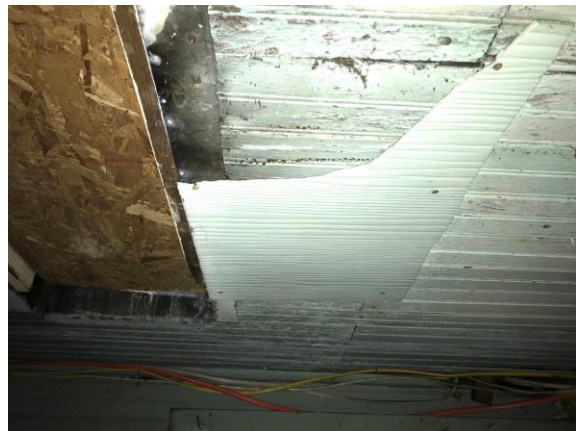
Three small (approximately 2 square feet each) asbestos-cement Transite panels were confirmed in the Basement of 1209 Island Home Avenue. Two of the panels have a ridged

texture (1209-12) and are mounted on the ceiling. The third panel (1209-13) is smooth and mounted on a wall. All three are painted a light green color.

1209 Island Home Basement – wall-mounted & ceiling-mounted Transite panels

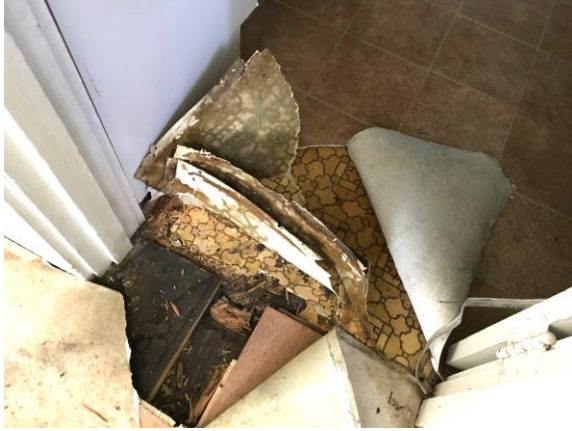
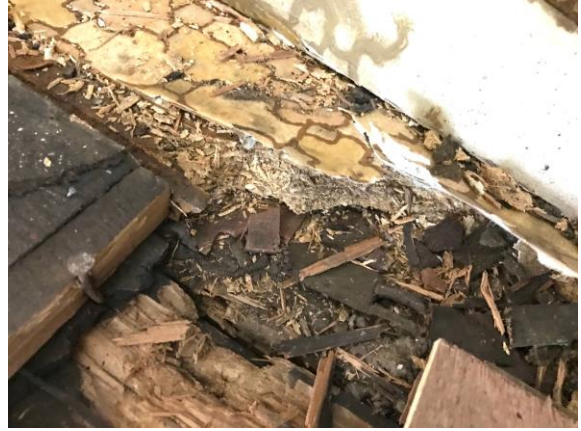
In the house at 1209 Island Home Avenue, one type of VFT (1209-9, reddish brown) and one type of vinyl sheet flooring (1209-8, brown patterned) were confirmed as ACMs. The ACM VFT and vinyl are layers in the same space in the Bathroom. Both layers are under non-ACM tan vinyl sheet flooring. The VFT is also under particle board sheeting. Four layers of the ACM vinyl sheet flooring are present in the doorway and may cover the entire Bathroom space.

1209 Island Home Bathroom – 4 layers patterned vinyl sheet flooring & reddish brown VFT underneath
