Subject: **REPORT OF LIMITED GEOTECHNICAL EXPLORATION
Clifton Road Development
Knoxville's Community Development Corporation (KCDC)
Knoxville, Tennessee
GEO Services Project No. 21-18941**

Observation Pit Logs

Clifton Road Development - KCDC - Knoxville, TN

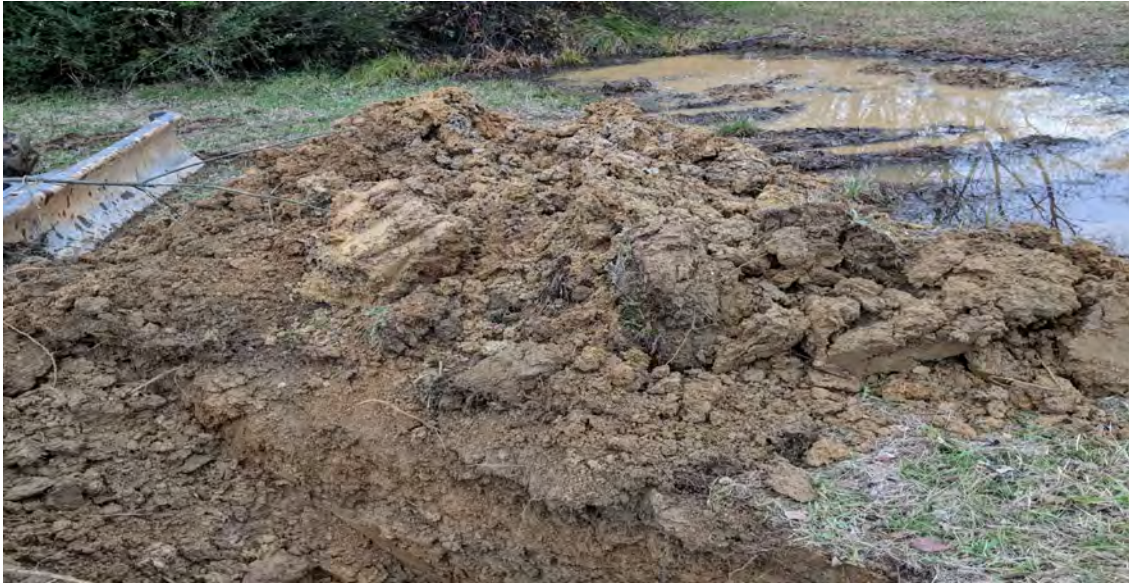
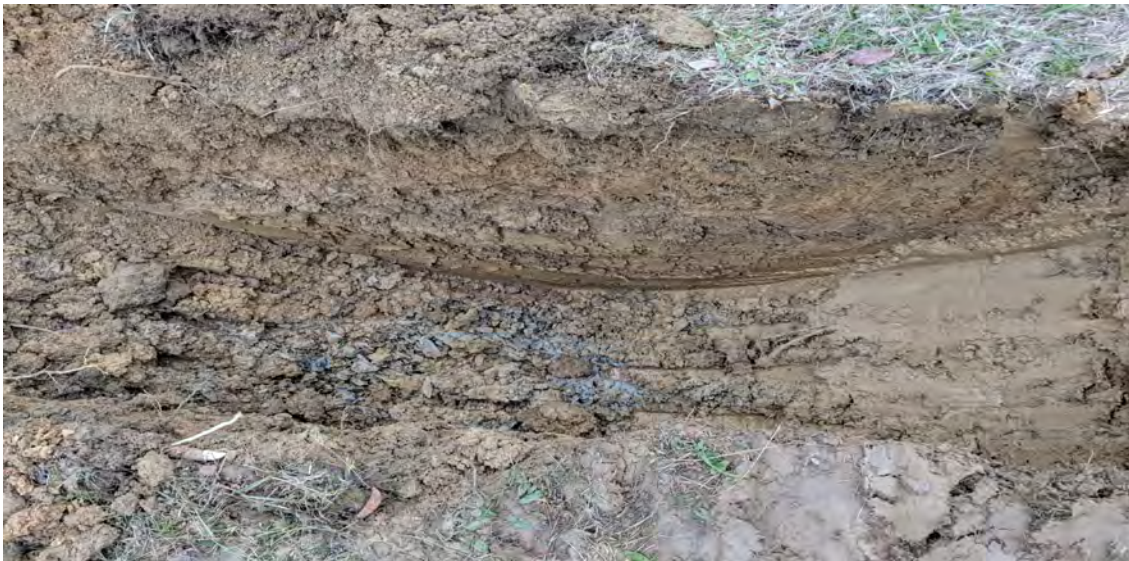
Location	Depth (ft.)		Material Type	Description	Comments
	from	to			
OP-1	0.0	0.8	Topsoil	Lean CLAY (CL) - with grass and root mat - brown - moist to wet	Soft
	0.8	2.0	Residuum	Lean CLAY (CL) - with trace root structures - orangish brown and brown - moist	Firm
	2.0	3.0	Residuum	Lean CLAY (CL) - with shale fragments and shale like structure - orangish brown and gray - moist	Stiff to Very Stiff
		3.0		Observation Pit Terminated at 3.0 Feet

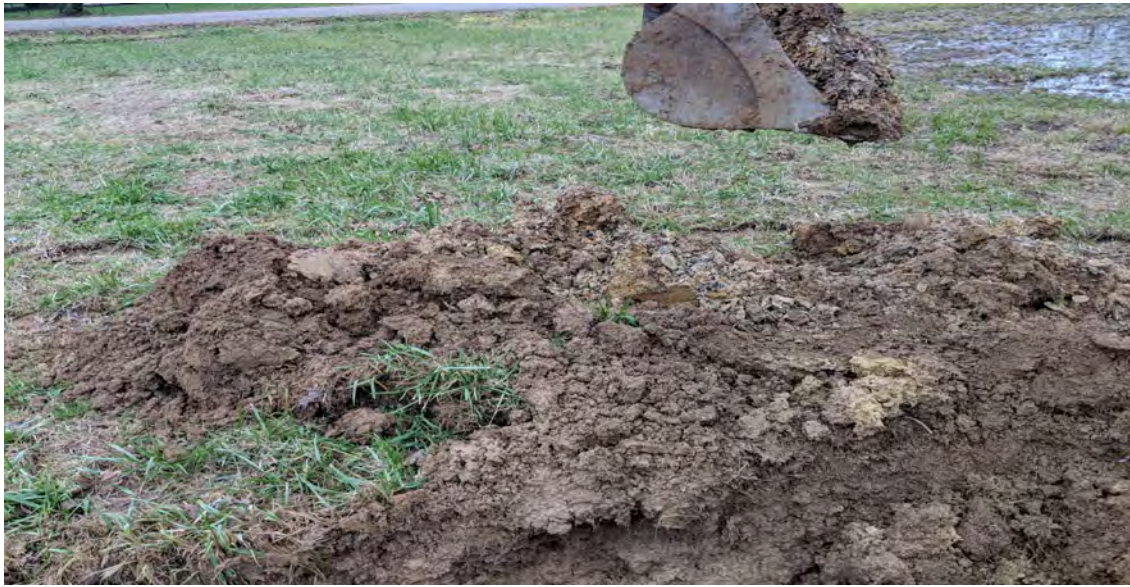
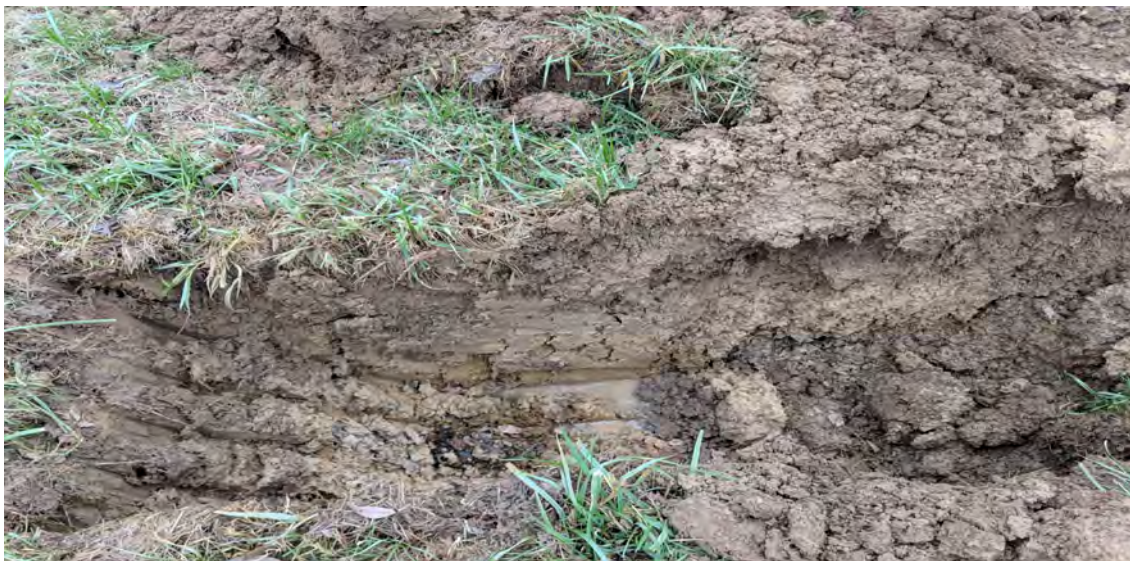
Location	Depth (ft.)		Material Type	Description	Comments
	from	to			
OP-2	0.0	1.0	Topsoil	Lean CLAY (CL) - with grass and root mat - brown - moist to wet	Soft
	1.0	2.0	Residuum	Lean CLAY (CL) - with trace root structures - orangish brown and brown - moist to wet	Soft to Firm
	2.0	3.0	Residuum	Lean CLAY (CL) - with shale fragments and shale like structure - orangish brown and dark brown - moist	Stiff to Very Stiff
		3.0		Observation Pit Terminated at 3.0 Feet

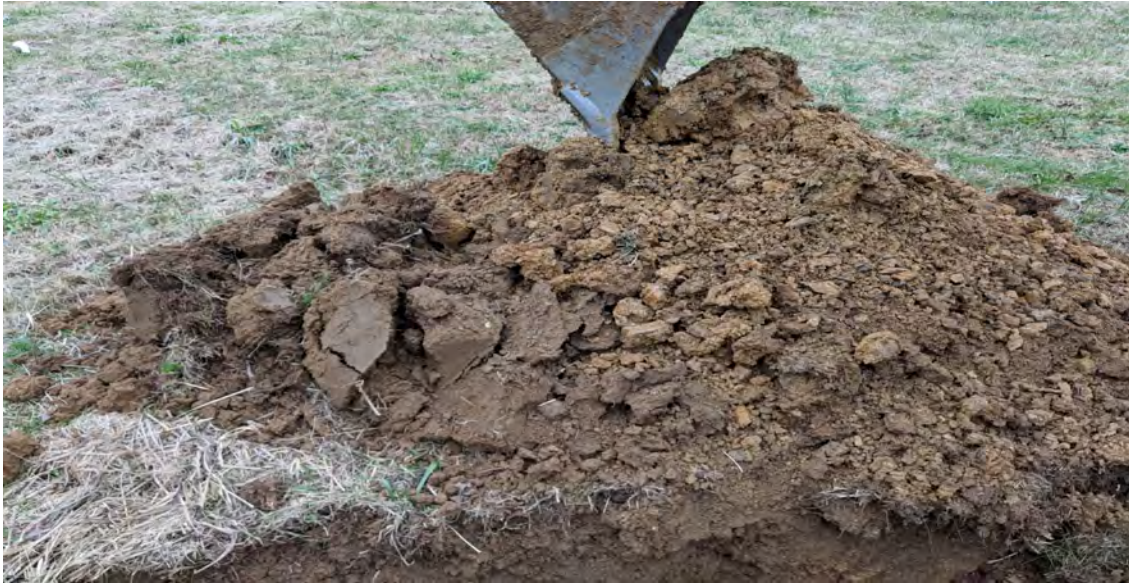
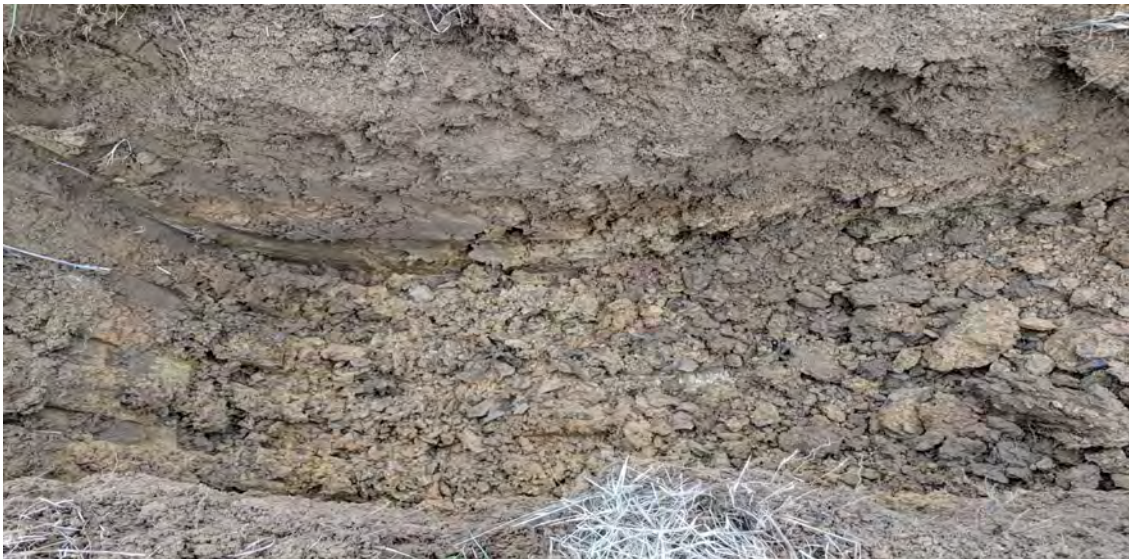
Location	Depth (ft.)		Material Type	Description	Comments
	from	to			
OP-3	0.0	1.0	Topsoil	Lean CLAY (CL) - with grass and root mat - brown - moist	Soft
	1.0	2.0	Residuum	Lean CLAY (CL) - with trace root structures - orangish brown and brown - moist	Firm
	2.0	3.0	Residuum	Lean CLAY (CL) - with shale fragments and shale like structure - orangish brown and dark brown - moist	Stiff
		3.0		Observation Pit Terminated at 3.0 Feet

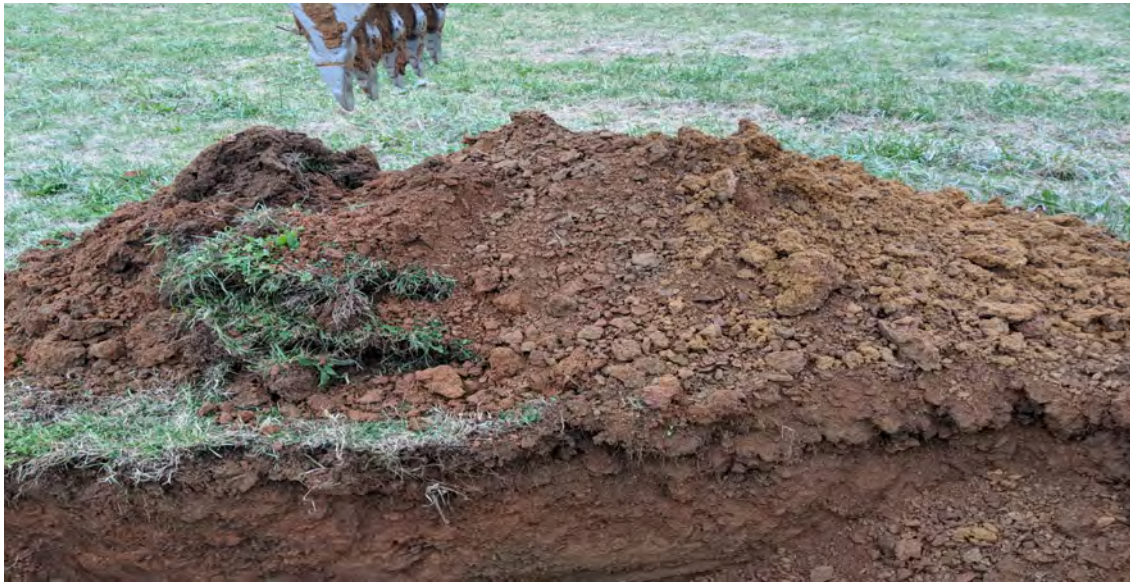
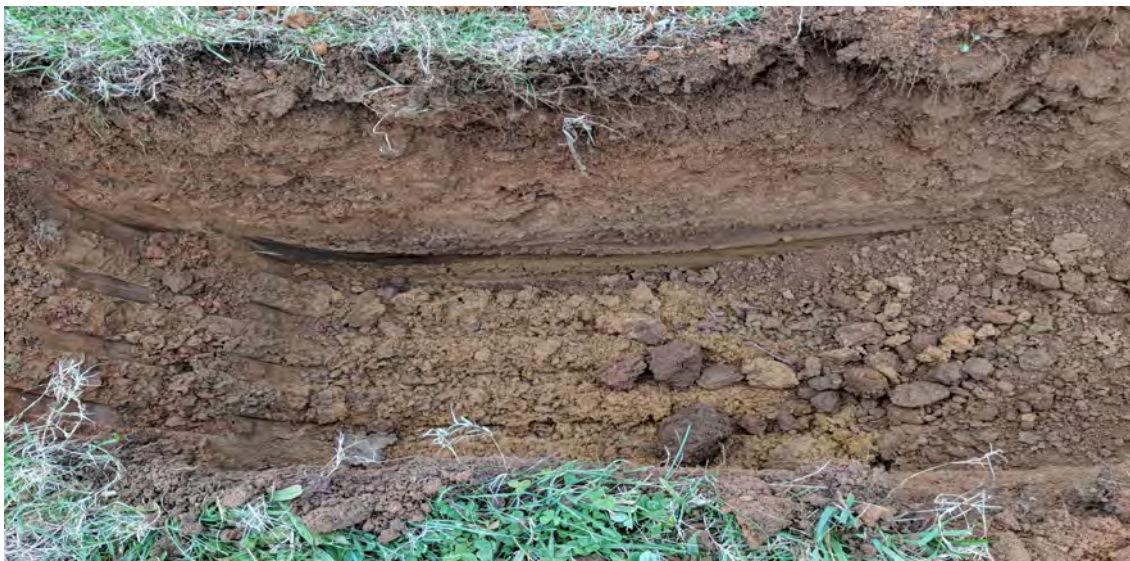
Location	Depth (ft.)		Material Type	Description	Comments
	from	to			
OP-4	0.0	0.8	Topsoil	Lean CLAY (CL) - with grass and root mat - brown - moist	Soft
	0.8	2.0	Residuum	Lean CLAY (CL) - with trace root structures - brown - moist	Firm
	2.0	3.0	Residuum	Lean CLAY (CL) - with trace shale fragments - orangish brown and dark brown - moist	Stiff
		3.0		Observation Pit Terminated at 3.0 Feet

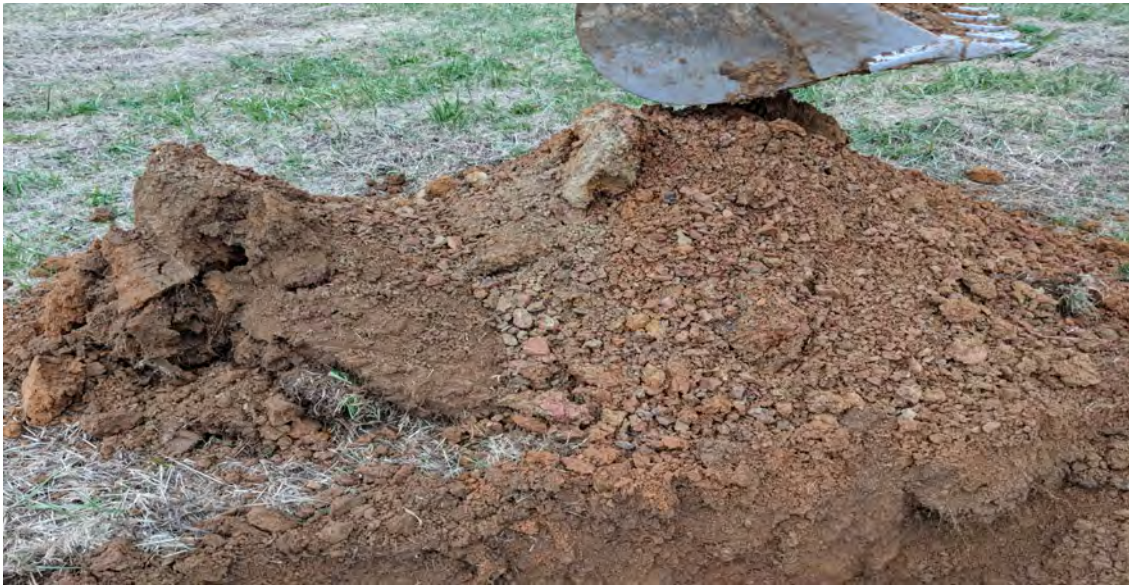
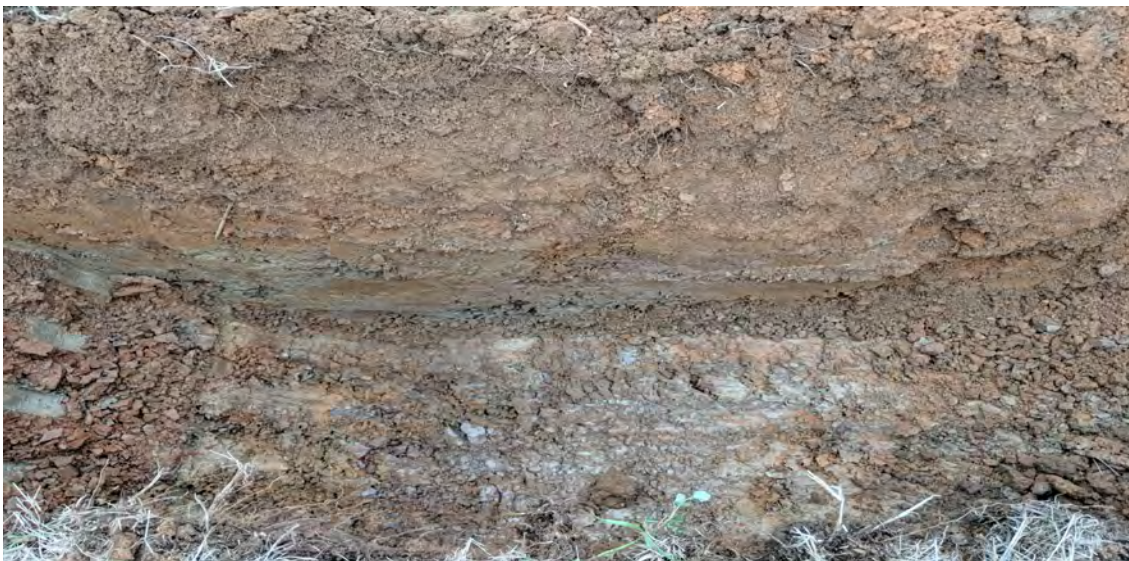
Location	Depth (ft.)		Material Type	Description	Comments
	from	to			
OP-5	0.0	0.5	Topsoil	Lean CLAY (CL) - with grass and root mat - brown - moist	Soft
	0.5	1.5	Residuum	Lean CLAY (CL) - with trace root structures - orangish brown - moist	Firm
	1.5	3.0	Residuum	Lean CLAY (CL) - with trace shale fragments - orangish brown and gray - moist	Stiff
		3.0		Observation Pit Terminated at 3.0 Feet

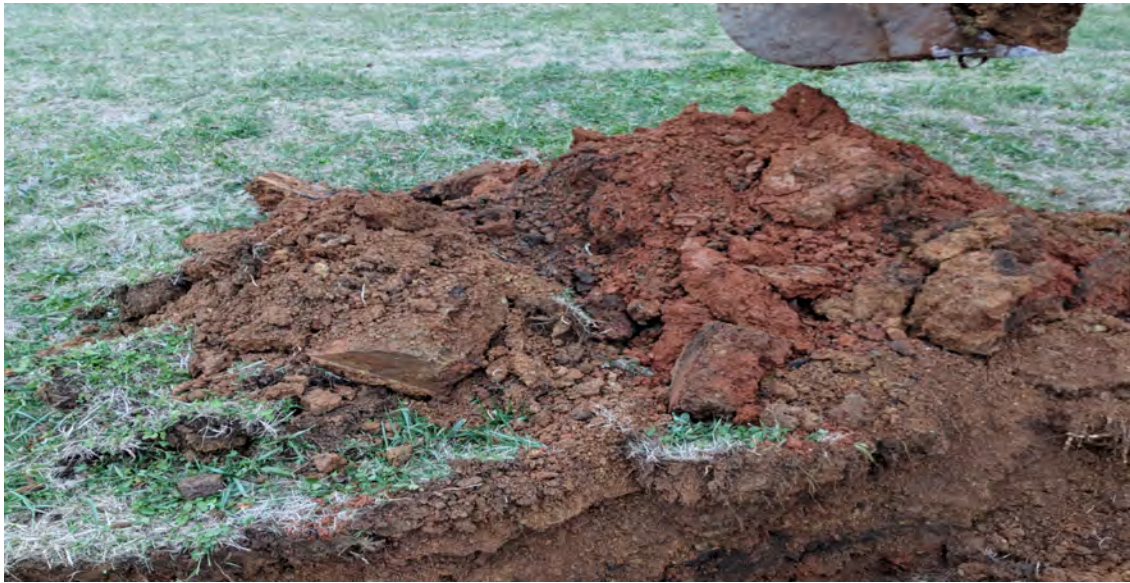
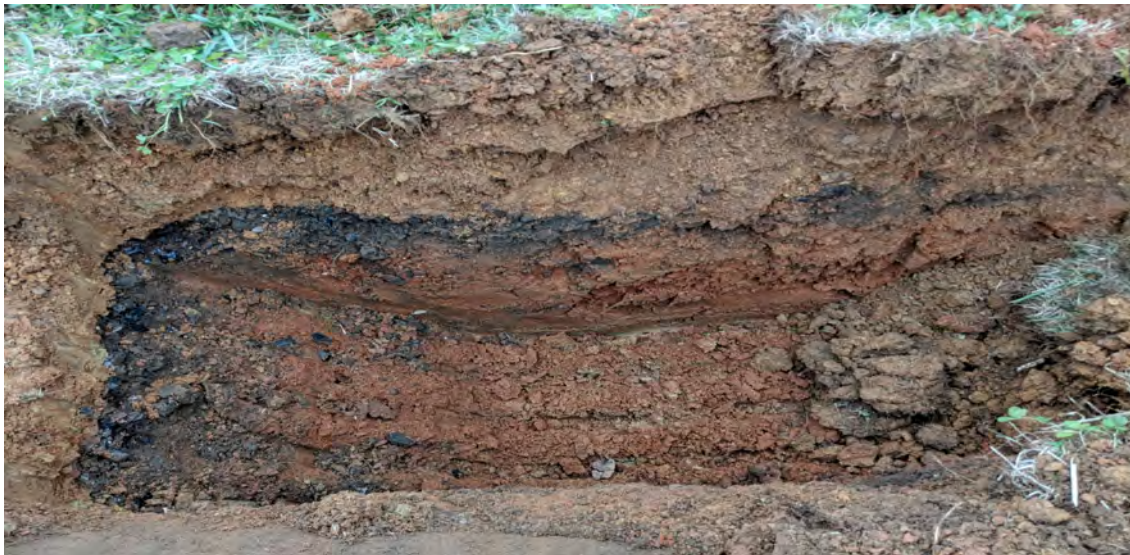
Beneath the surficial topsoil layer in observation pits OP-6 through OP-12, OP-14 and OP-15, a layer of fill was encountered to depths ranging from 1 to 6 feet beneath the existing surface. Note that the deeper zones of fill were encountered in observation pit OP-9. Additionally, the shallower fill zones were generally encountered in OP-11, OP-12, OP-14 and OP-15, where buried topsoil was encountered. Fill is defined as material that has been transported and placed by man. The fill

encountered generally consisted of brown lean clay (CL) with varying amounts of deleterious materials (e.g. trash, wood, cinders, organics, etc.). The fill was generally observed to be soft and often noted to be moist.

Location	Depth (ft.)		Material Type	Description	Comments
	from	to			
OP-6	0.0	0.3	Topsoil	Lean CLAY (CL) - with grass and root mat - brown - moist	Soft
	0.3	2.0	Fill	Lean CLAY (CL) - with concrete fragments, trash and cinders - reddish brown and black - moist	Unsuitable Materials
	2.0	3.0	Residuum	Fat CLAY (CH) - reddish brown - moist	Firm
	3.0	3.5	Residuum	Lean CLAY (CL) - with shale fragments - orangish brown and gray - moist	Stiff
		3.5		Observation Pit Terminated at 3.0 Feet

Existing fill material was encountered in nine of the observation pits that contained various amounts of deleterious materials (e.g. wood, construction debris, etc.). Additionally, buried topsoil was encountered in four of the observation pits below the existing fill. We recommend the existing fill (including buried topsoil) be completely removed and be disposed of according to state and local regulations. Additionally, as previously mentioned, portions of the site were once occupied by residential type structures that have been demolished. Therefore, the presence of underground utilities, foundations, or additional buried debris is possible. If encountered, these materials should

be completely removed and the resulting excavations should be backfilled with properly placed fill material. Structural fill recommendations are presented herein.

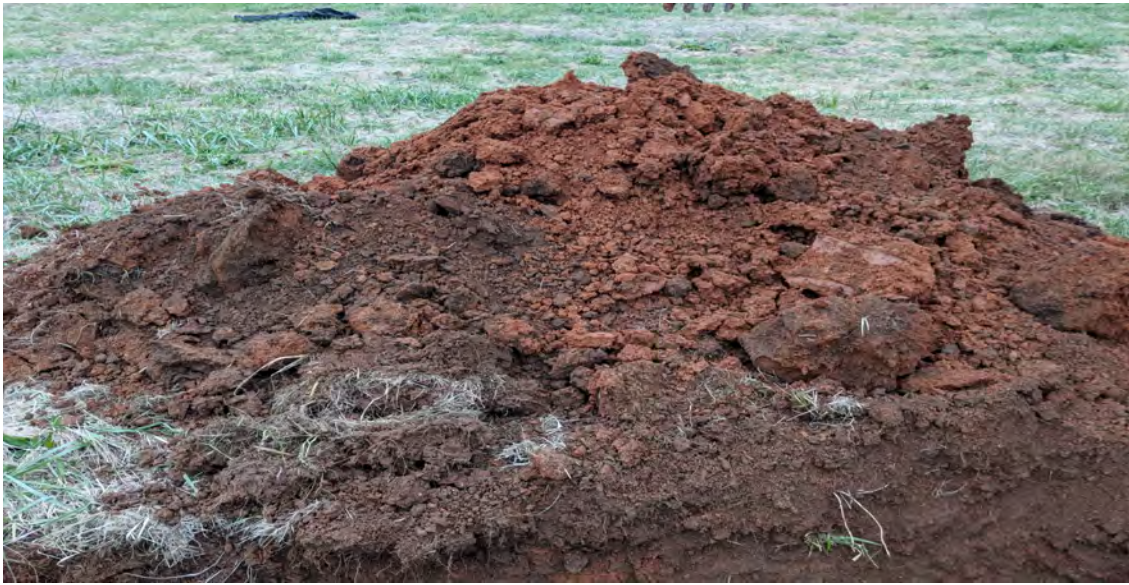
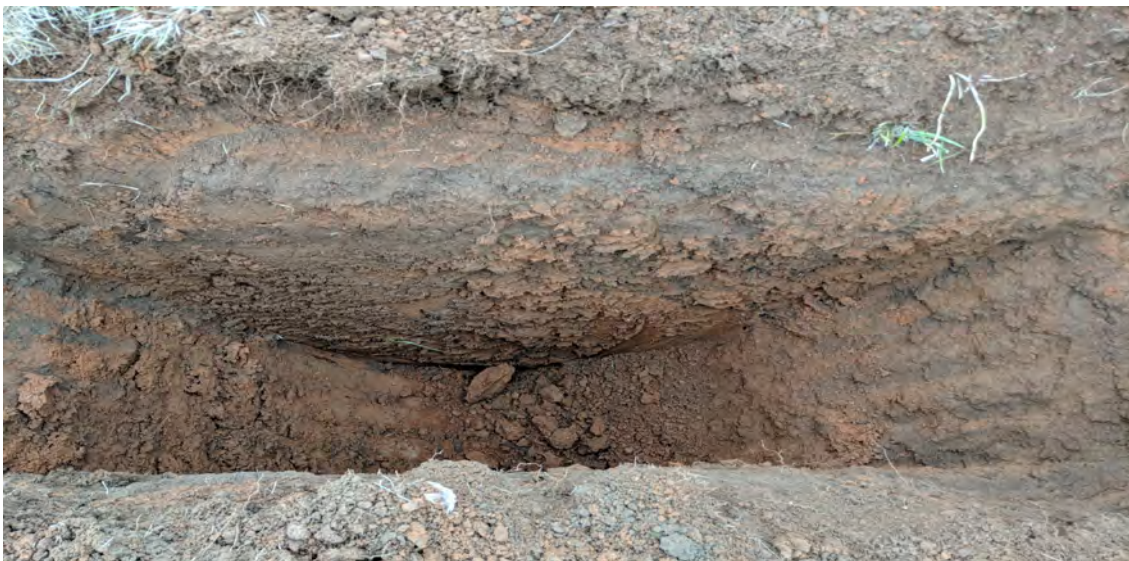
Location	Depth (ft.)		Material Type	Description	Comments
	from	to			
OP-7	0.0	0.3	Topsoil	Lean CLAY (CL) - with grass and root mat - brown - moist	Soft
	0.3	2.0	Fill	Lean CLAY (CL) - with trace root structures - orangish brown and dark brown - moist	Soft
	2.0	6.0	Residuum	Fat CLAY (CH) - with trace chert fragments - reddish brown - moist	Firm
		6.0		Observation Pit Terminated at 6.0 Feet

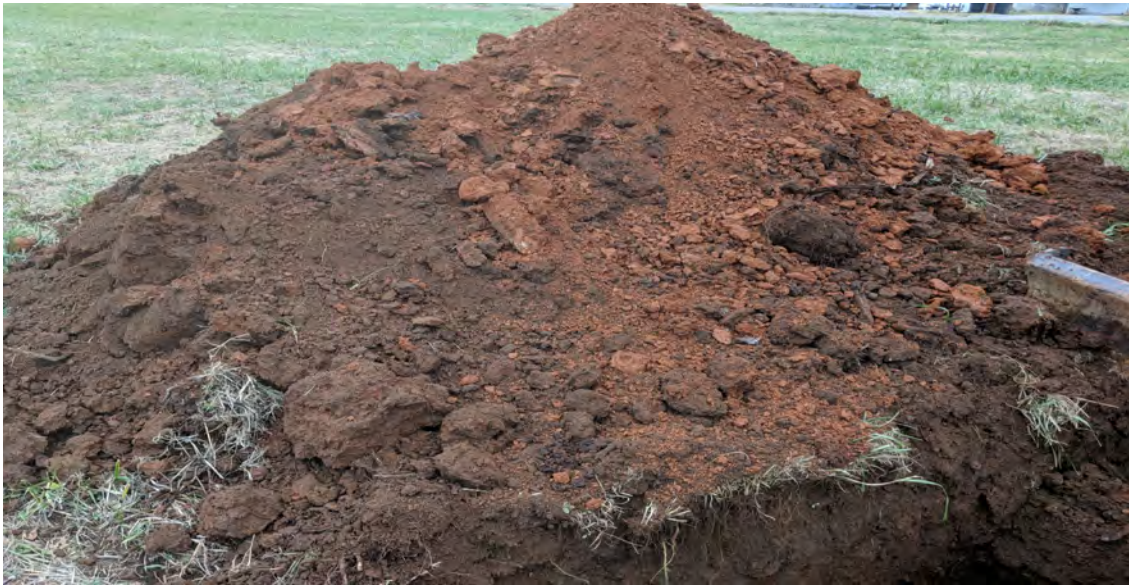
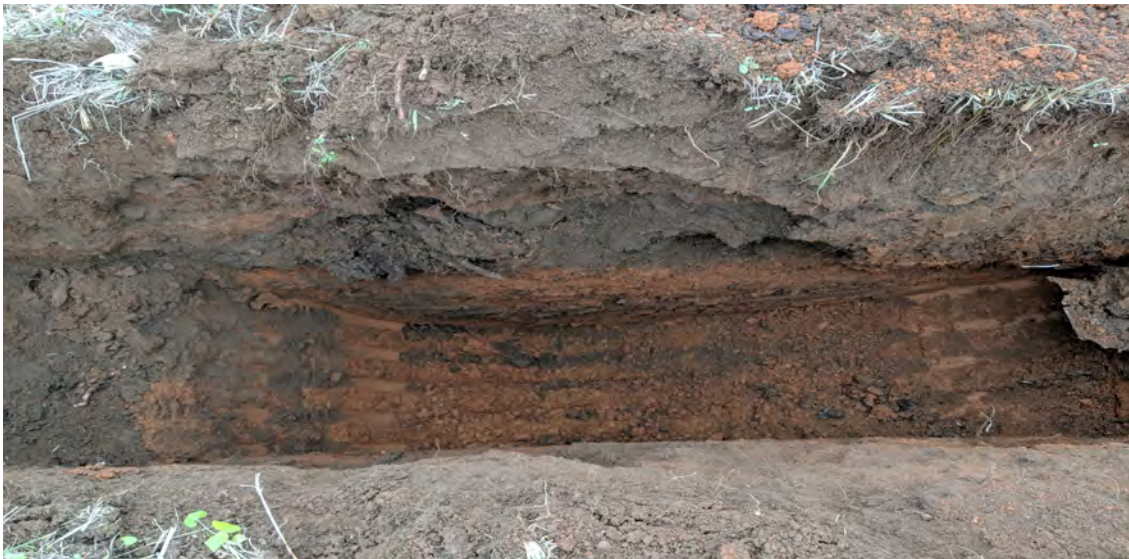
Location	Depth (ft.)		Material Type	Description	Comments
	from	to			
OP-8	0.0	0.3	Topsoil	Lean CLAY (CL) - with grass and root mat - brown - moist	Soft
	0.3	3.5	Fill	Lean CLAY (CL) - with trash, wheels, window frame - brown - moist	Unsuitable Materials
	3.5	6.5	Residuum	Fat CLAY (CH) - reddish brown - moist	Firm to Stiff
		6.5		Observation Pit Terminated at 6.5 Feet

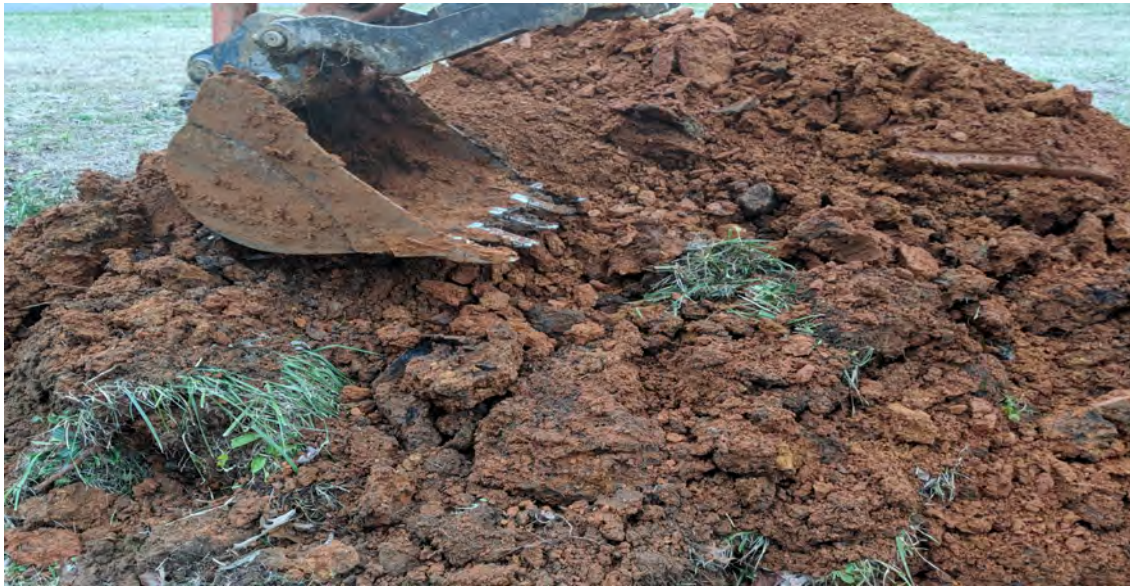
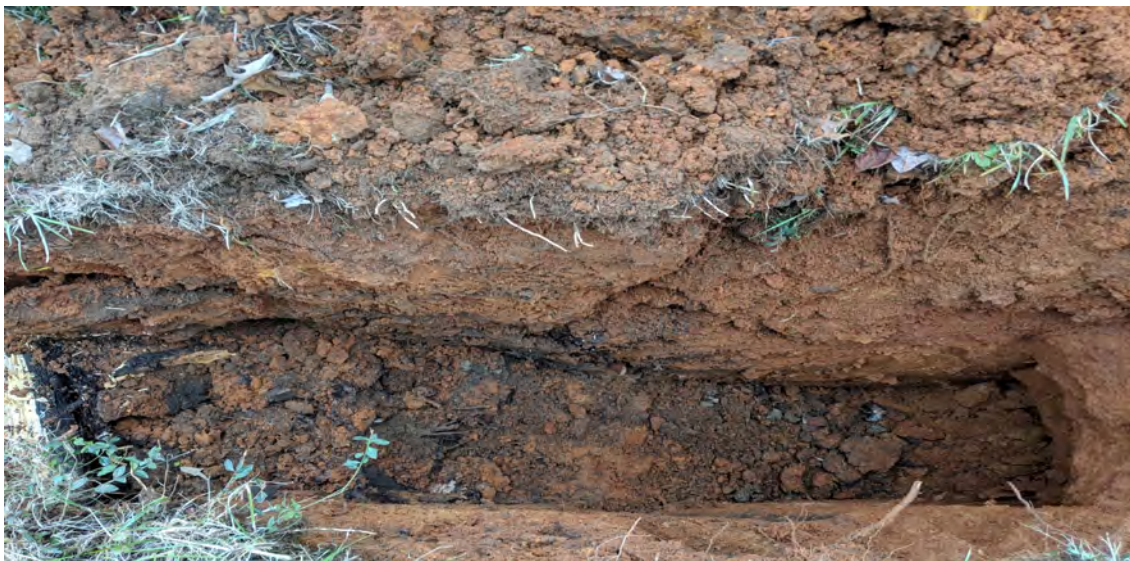
Location	Depth (ft.)		Material Type	Description	Comments
	from	to			
OP-9	0.0	0.3	Topsoil	Lean CLAY (CL) - with grass and root mat - brown - moist	Soft
	0.3	6.0	Fill	Lean CLAY (CL) - with trash, wood logs and a big stump - dark brown - moist	Unsuitable Materials
	6.0	8.0	Residuum	Lean CLAY (CL) - orangish brown and light brown - moist	Firm to Stiff
		8.0		Observation Pit Terminated at 8.0 Feet

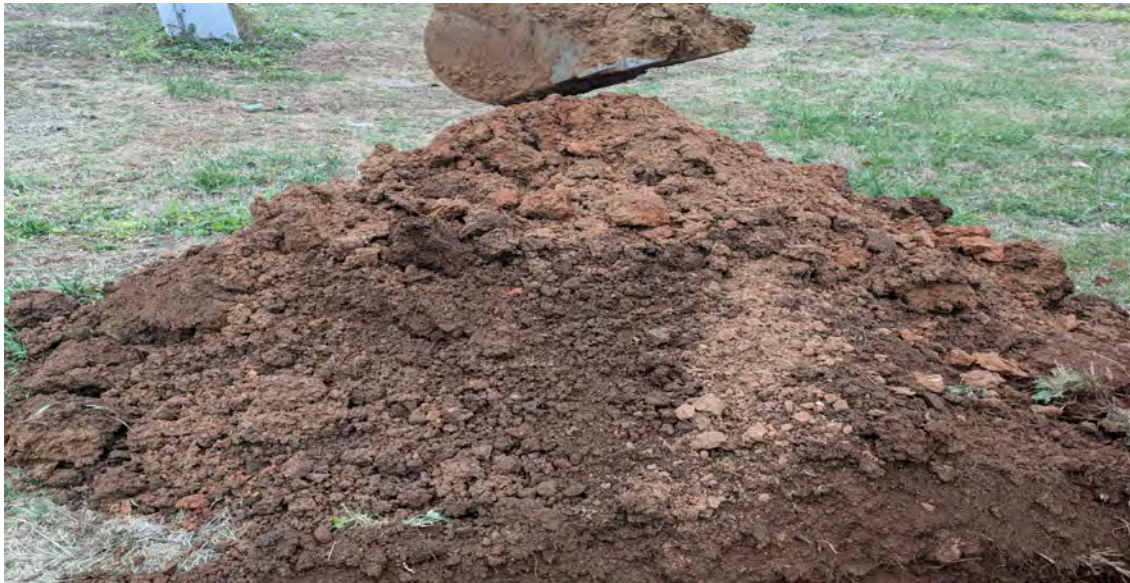
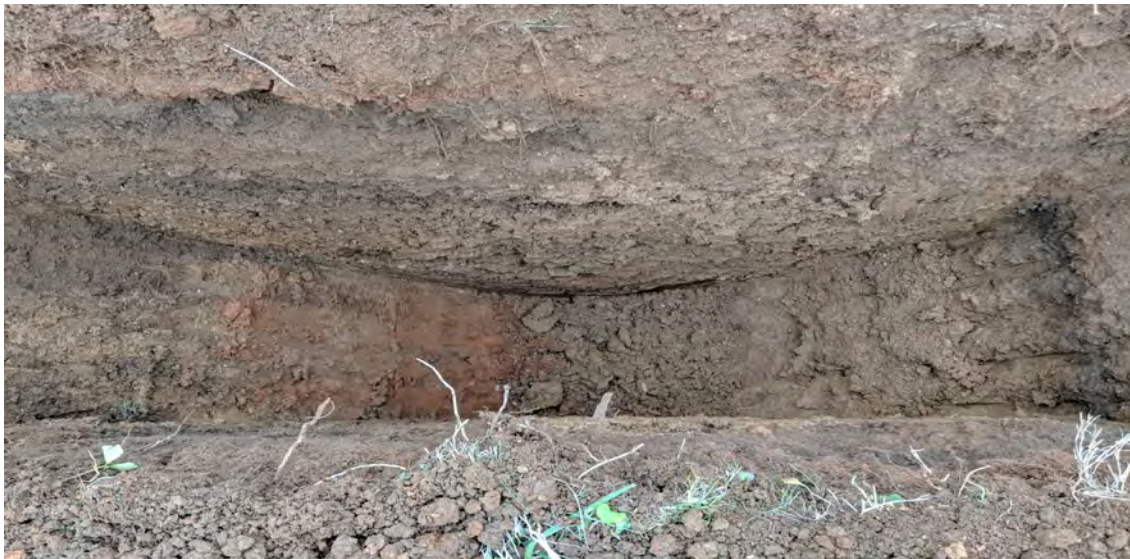
Location	Depth (ft.)		Material Type	Description	Comments
	from	to			
OP-10	0.0	0.3	Topsoil	Lean CLAY (CL) - with grass and root mat - brown - moist	Soft
	0.3	2.0	Fill	Lean CLAY (CL) - with trace organics - dark brown - moist	Unsuitable Materials
	2.0	4.0	Residuum	Fat CLAY (CH) - reddish brown - moist to wet	Soft to Firm
	4.0	7.0	Residuum	Lean CLAY (CL) - orangish brown - moist	Firm to Stiff
		7.0		Observation Pit Terminated at 7.0 Feet

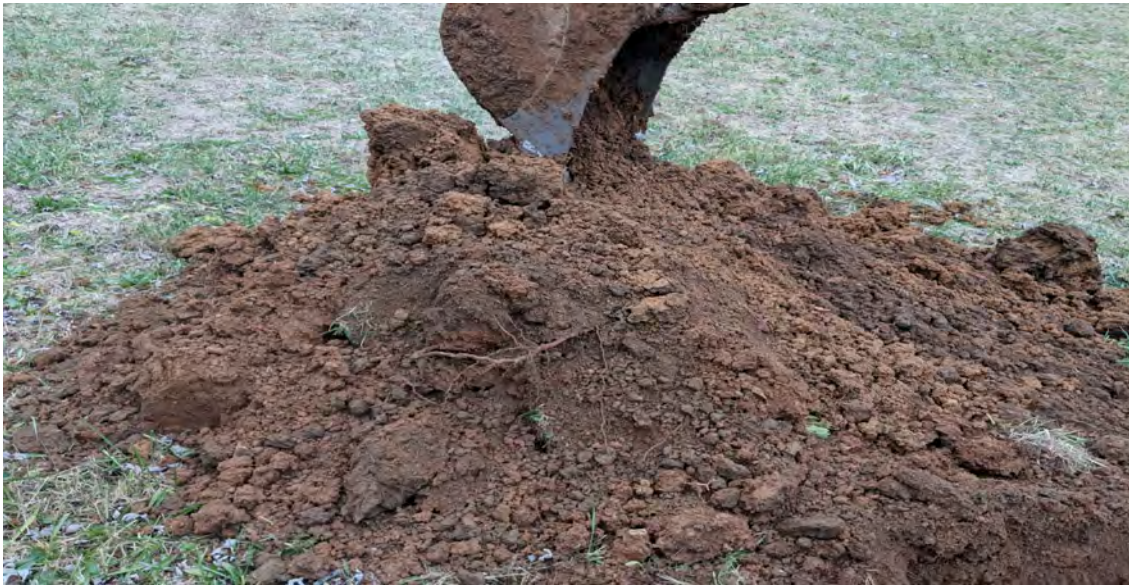
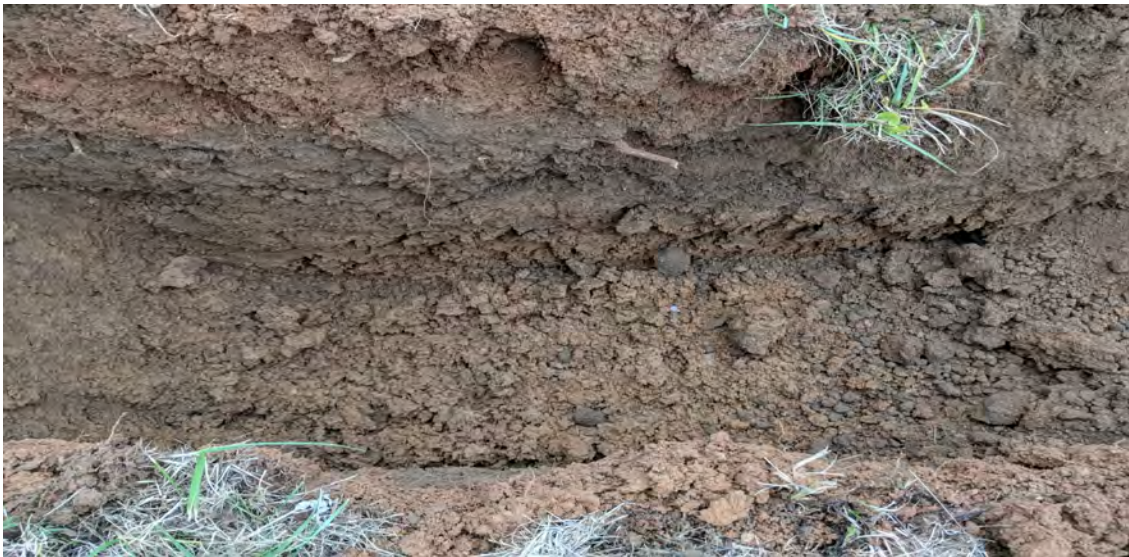
Location	Depth (ft.)		Material Type	Description	Comments
	from	to			
OP-11	0.0	0.2	Topsoil	Lean CLAY (CL) - with grass and root mat - brown - moist	Soft
	0.2	1.0	Fill	Lean CLAY (CL) - with gravel - reddish brown - moist	Firm
	1.0	2.0	Topsoil	Lean CLAY (CL) - with trace root structures - dark brown - moist	Soft
	2.0	3.5	Residuuum	Lean CLAY (CL) - with chert fragments - light brown - moist	Stiff to Very Stiff
		3.5		Observation Pit Terminated at 3.5 Feet

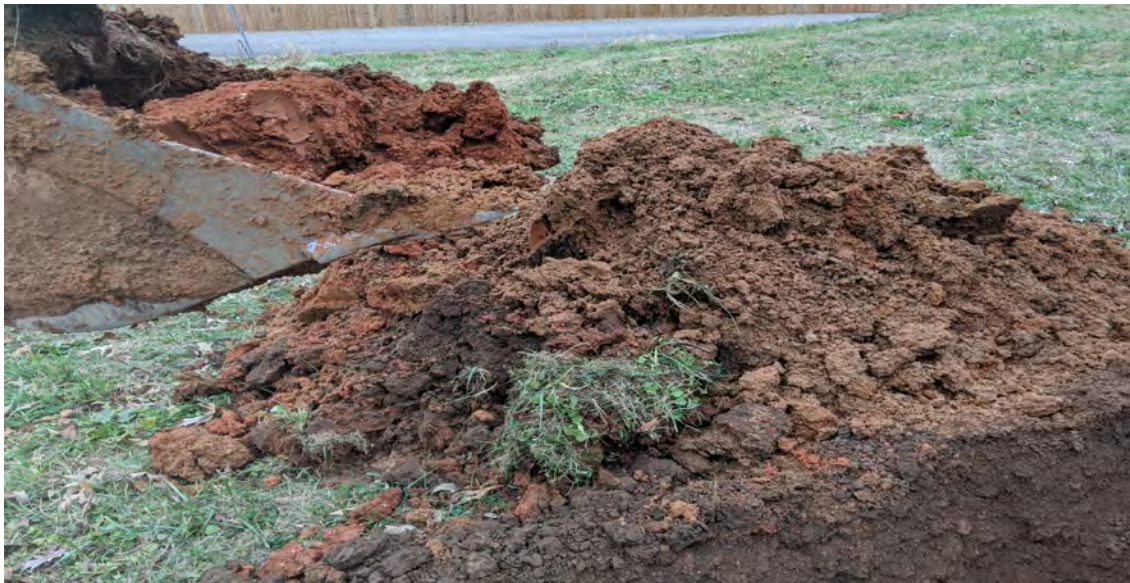
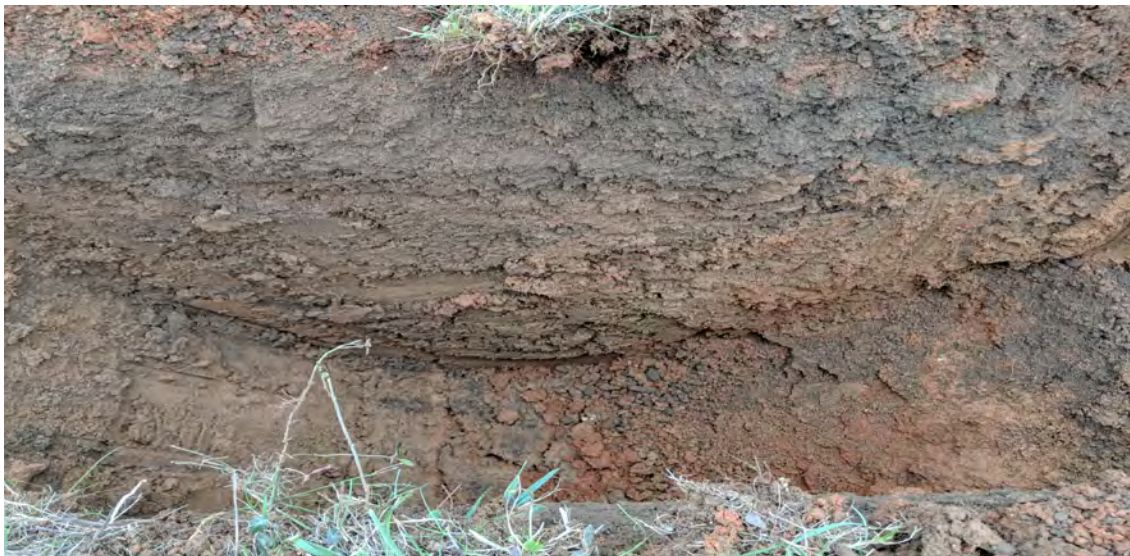
Location	Depth (ft.)		Material Type	Description	Comments
	from	to			
OP-12	0.0	0.2	Topsoil	Lean CLAY (CL) - with grass and root mat - brown - moist	Soft
	0.2	0.7	Fill	Fat CLAY (CH) - with gravel - reddish brown - moist	Firm
	0.7	1.5	Topsoil	Lean CLAY (CL) - with trace root structures - dark brown - moist	Soft
	1.5	3.5	Residuuum	Lean CLAY (CL) - with trace chert fragments - light brown - moist to wet	Firm
	3.5	6.5	Residuuum	Lean CLAY (CL) - with chert fragments - orangish brown and reddish brown - moist	Stiff
		6.5		Observation Pit Terminated at 6.5 Feet

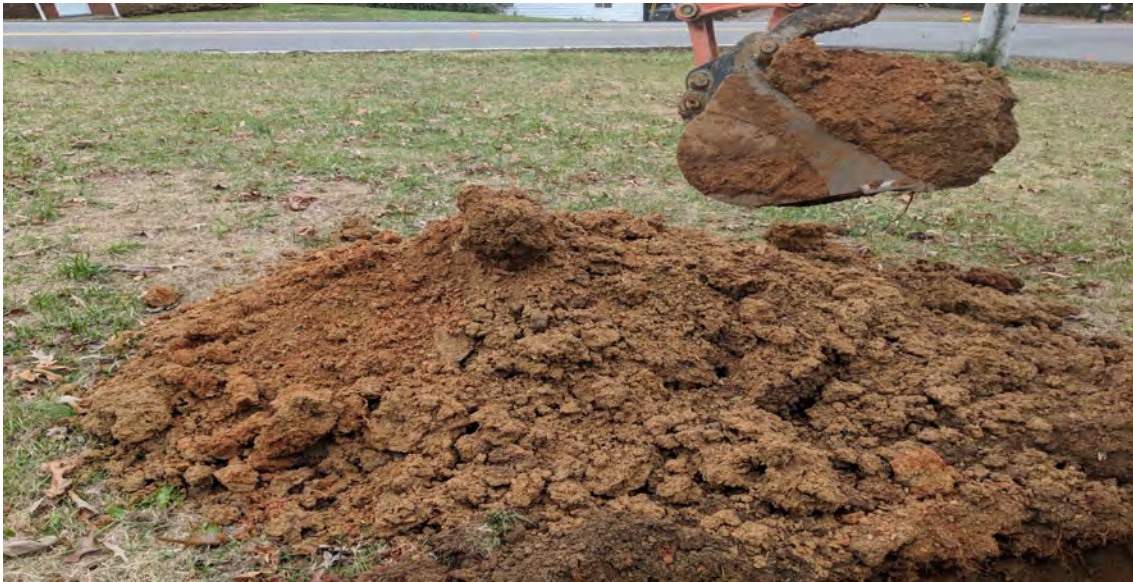
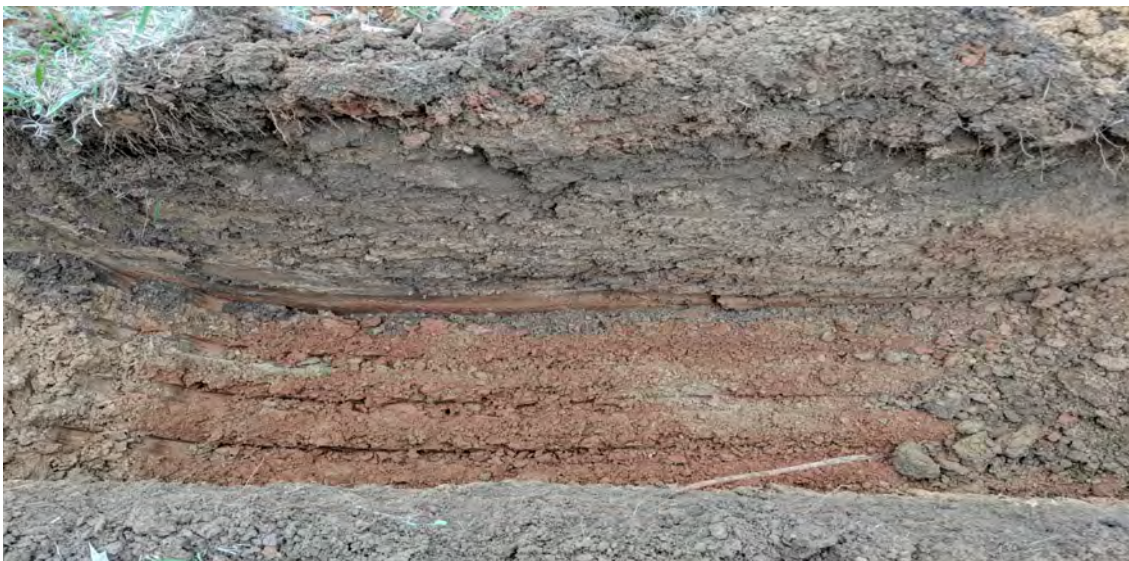
Location	Depth (ft.)		Material Type	Description	Comments
	from	to			
OP-13	0.0	1.0	Topsoil	Lean CLAY (CL) - with grass and root mat - brown - moist	Soft
	1.0	2.5	Residuum	Lean CLAY (CL) - light brown - moist	Soft to Firm
	2.5	3.5	Residuum	Lean CLAY (CL) - with shale fragments - reddish brown and orangish brown - moist	Stiff to Very Stiff
		3.5		Observation Pit Terminated at 3.5 Feet

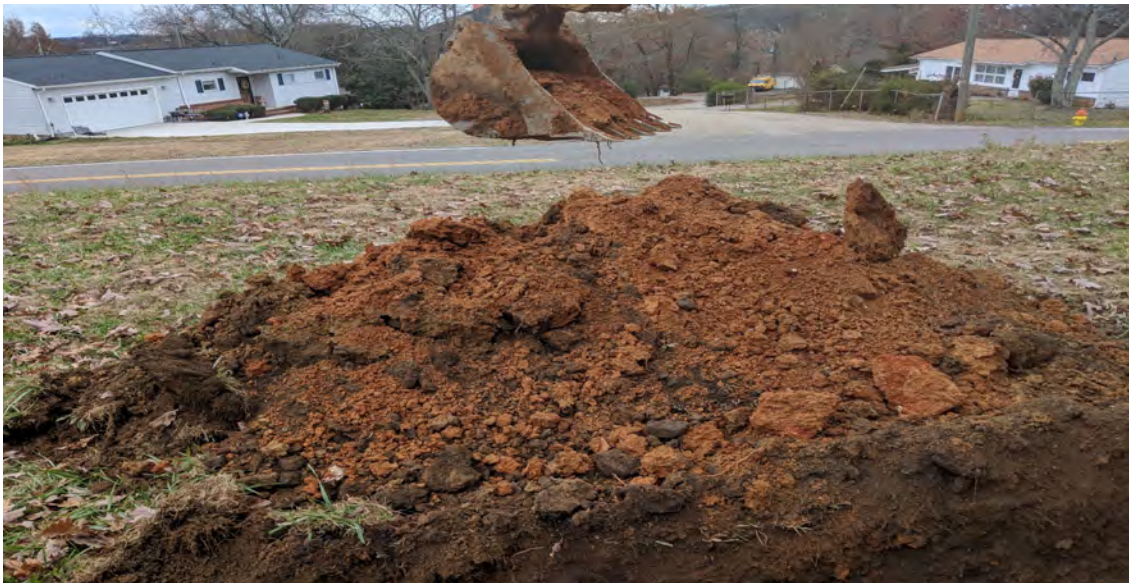
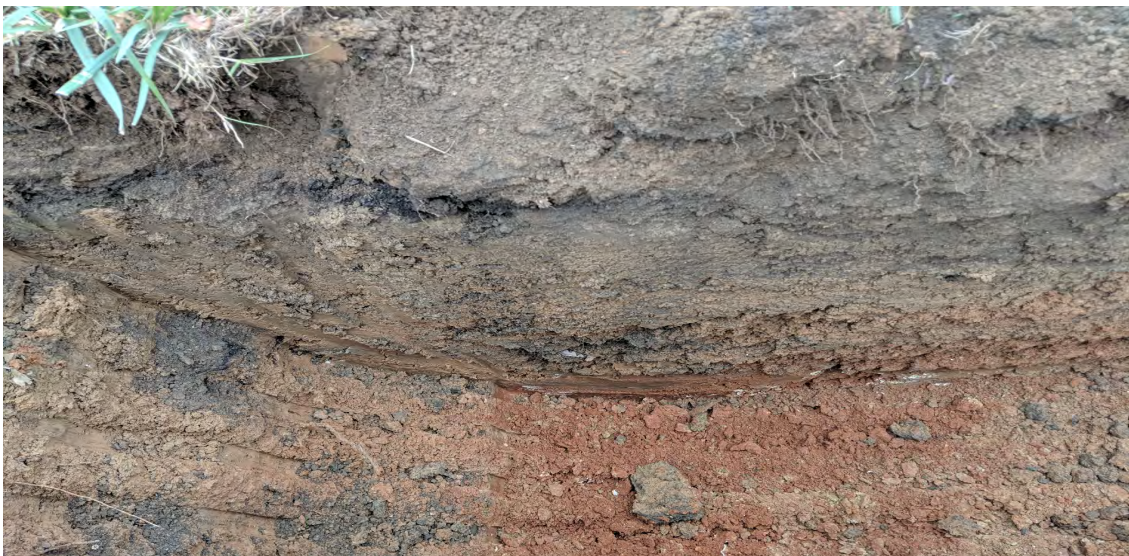
Location	Depth (ft.)		Material Type	Description	Comments
	from	to			
OP-15	0.0	0.3	Topsoil	Lean CLAY (CL) - with grass and root mat - brown - moist	Soft
	0.3	1.0	Fill	Lean CLAY (CL) - with trash, organics and cinders - dark brown - moist	Soft
	1.0	1.5	Topsoil	Lean CLAY (CL) - with trace root structures - dark brown and brown - moist	Soft
	1.5	3.5	Residuuum	Lean CLAY (CL) - with chert fragments - light brown and orangish brown - moist	Firm
	3.5	5.0	Residuuum	Fat CLAY (CL) - with chert fragments - reddish brown - moist	Stiff
		5.0		Observation Pit Terminated at 5.0 Feet
