**CITY OF BATTLE CREEK**  
**NOTICE OF INVITATION FOR BIDS**

**IFB# 2020-019B Demolition**

**HAZARDOUS MATERIAL SPECIFICATIONS**

**NESHAP RENOVATION / DEMOLITION INSPECTION OF  
ASBESTOS CONTAINING MATERIALS  
AND OTHER HAZARDOUS WASTE MATERIALS**

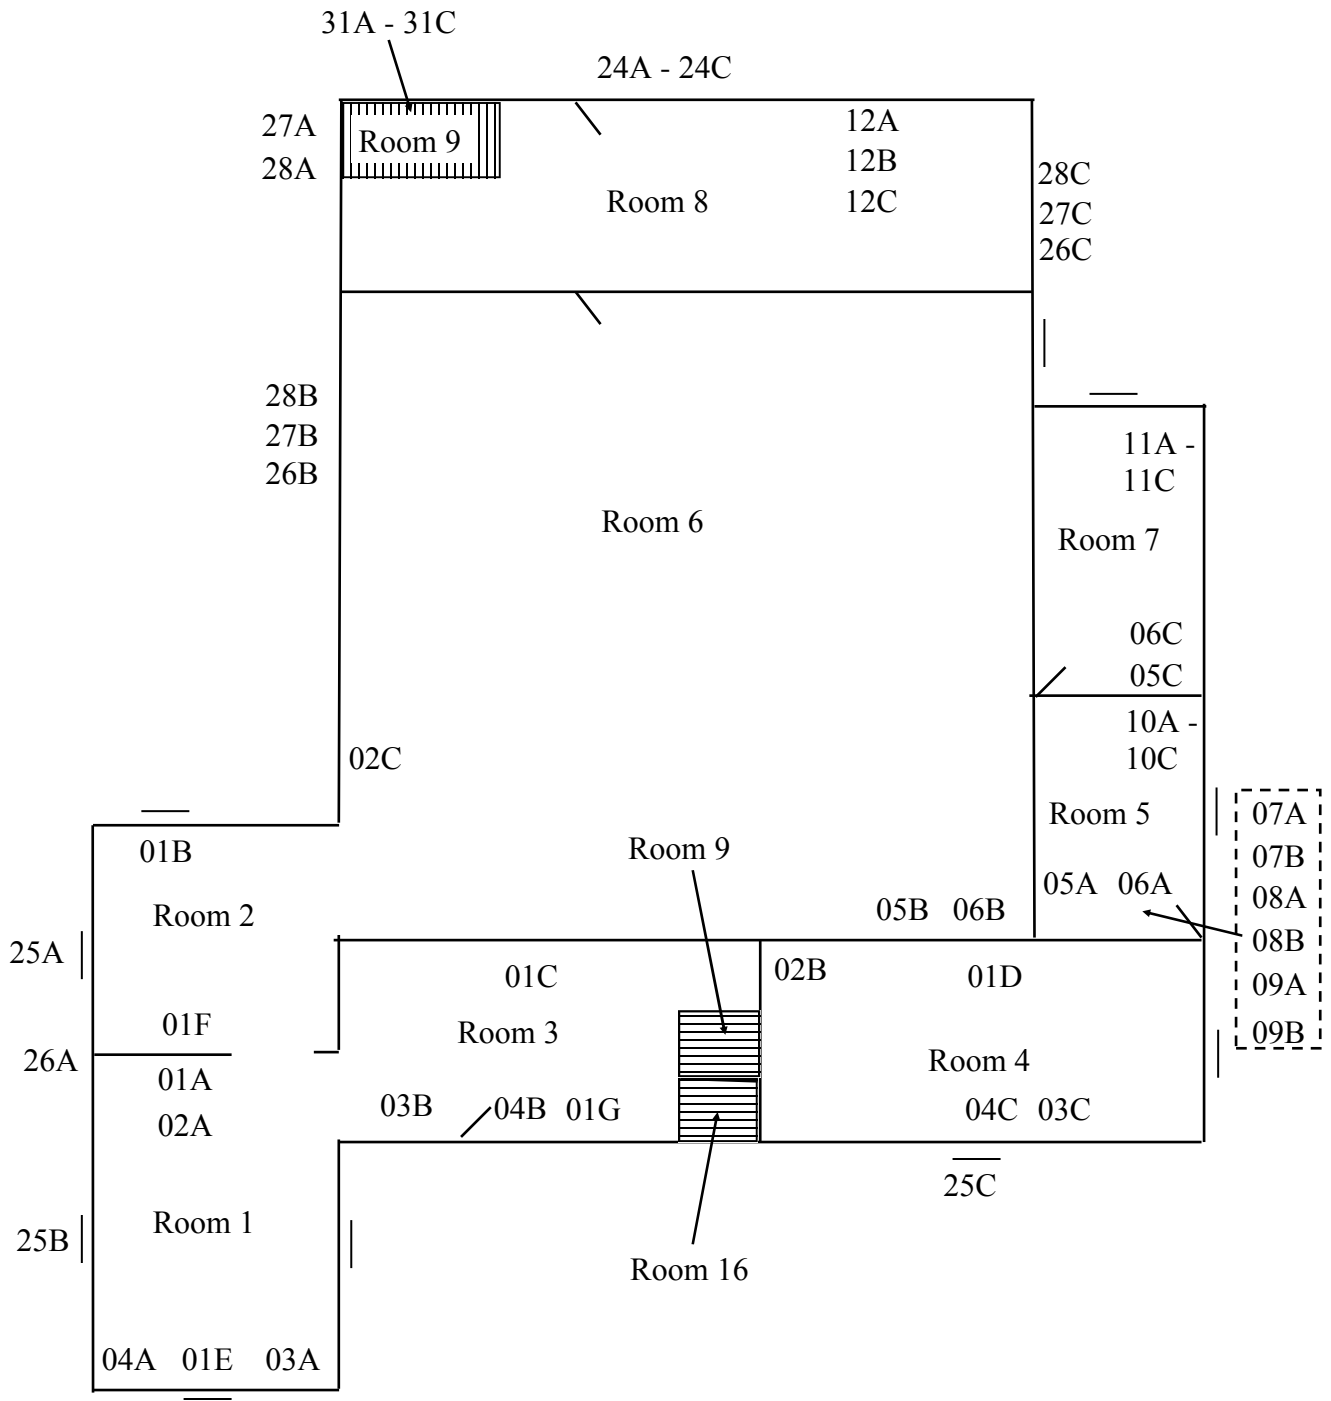
1st floor

15 Freemont Place, Battle Creek, MI 49017

Please Note: This is a rough floor plan only. All items, (doorways, Windows, etc.) may not be included in this illustration. Also, room and component sizes are not drawn to scale.

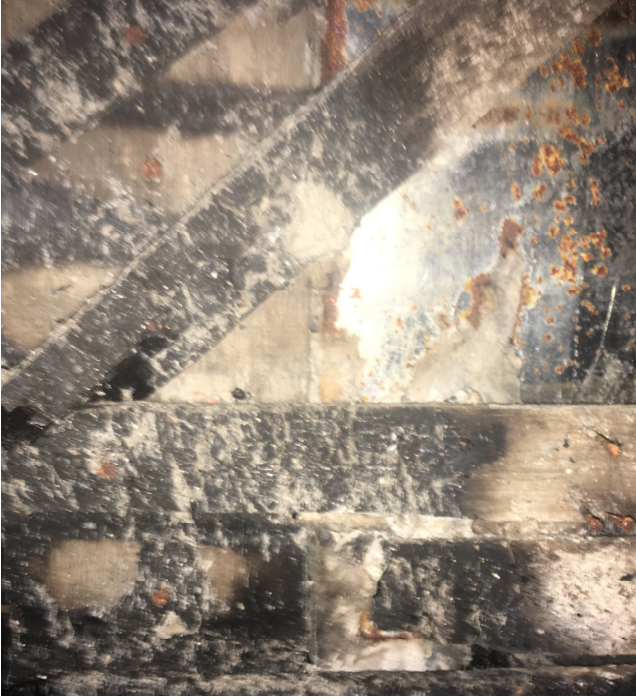
Pos. Duct Wrap

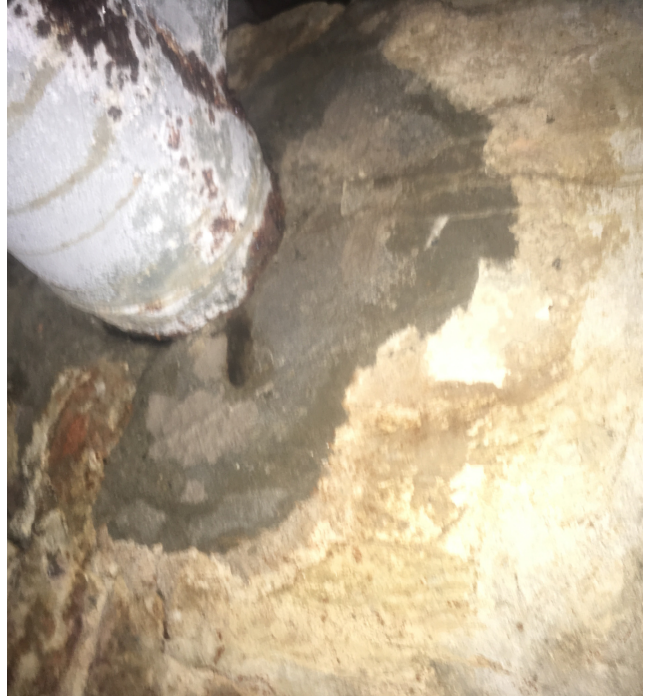
Pos. Stack Cement
