ASBESTOS ASSESSMENT

DWELLING DEMOLITION

605 NORTH MAPLE STREET
SUMMERVILLE, SOUTH CAROLINA 29483

ECS PROJECT NO. 49:11848

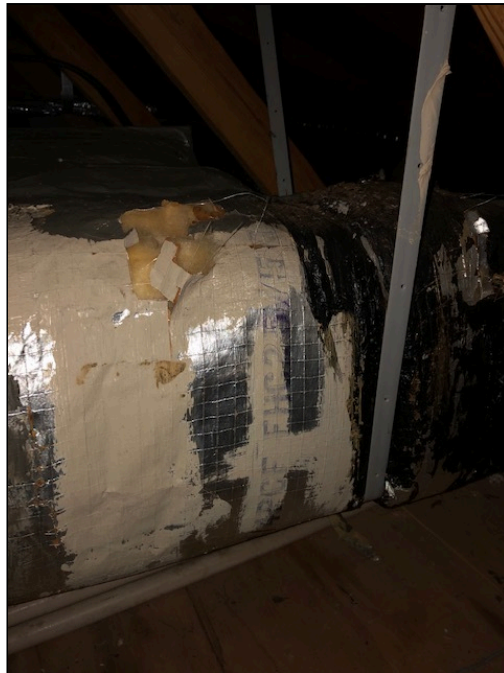
| Sample ID | Location | Material Description | Analytical Results | Category | Estimated Quantity |
|---|---|--|---|--|---|
| 04-01,02,03 | HVAC ducts | White, Grey and Black Duct Mastic | 5% Chrysotile | Non Friable/ Good Condition | 100 SF |

2 - Image of white, grey and black duct mastic: (Sample ID 04-01,02,03)

NESHAP requires the identification of friable ACM and non-friable ACM likely to become friable during demolition and/or renovation activities. NESHAP requires that the identified ACM be removed prior to initiating activities likely to disturb the ACM. Notification to the SC-DHEC is required for demolitions including move-off of a facility and the intentional burning of a facility within South Carolina. Notification is also required for renovations that include the disturbing or removal of regulated quantities of RACM; it is also required for planned renovations to occur at the same facility or project during a year's time. Each structure or facility must have a separate notification. Notification is required for facilities which do not contain asbestos as well. The starting date for demolition or renovation must be at least 10 working days from the date of submission of a complete notification to SCDHEC. ECS recommends abating asbestos containing materials in the structure prior to disturbance. Based on the square footage of friable asbestos containing material, the SCDHEC will require a project design for this abatement project.

ECS recommends that a project specification be prepared to delineate and quantify known and suspect hazardous and regulated materials in the buildings and to outline proper procedures for the abatement. This will help protect the owner's liability in better defining the scope of work and contractors' roles and responsibilities in the abatement process and holding the contractor accountable for the performance of the project. The specification typically defines the Contractor's scope of work and outline requirements and procedures that must be followed for the project. The intent of the specification is to give performance requirements for the Contractor so that the project can be completed safely and in compliance with applicable federal and state regulations. Typically, the specification document serves as part of the site owner's contract with the contractor.

If ACMs are to be removed, it is recommended that an industrial hygienist monitor the project. This involves collecting air samples from within and outside abatement work areas to monitor the asbestos abatement contractor's work practices over the course of the project. The industrial hygienist should evaluate if the asbestos abatement work is in accordance with project specifications, U.S. EPA regulation 40 CFR Part 61-National Emission Standards for Hazardous Air Pollutants Subpart M: National Emission Standard for Asbestos, and U.S. Occupational Safety and Health Administration (OSHA) regulation 29 CFR 1926.1101 – Asbestos in Construction. The industrial hygienist should assess each work area to monitor the removal of ACMs. Only after the industrial hygienist has determined the identified ACMs have been removed should final clearance air samples be collected (if necessary).

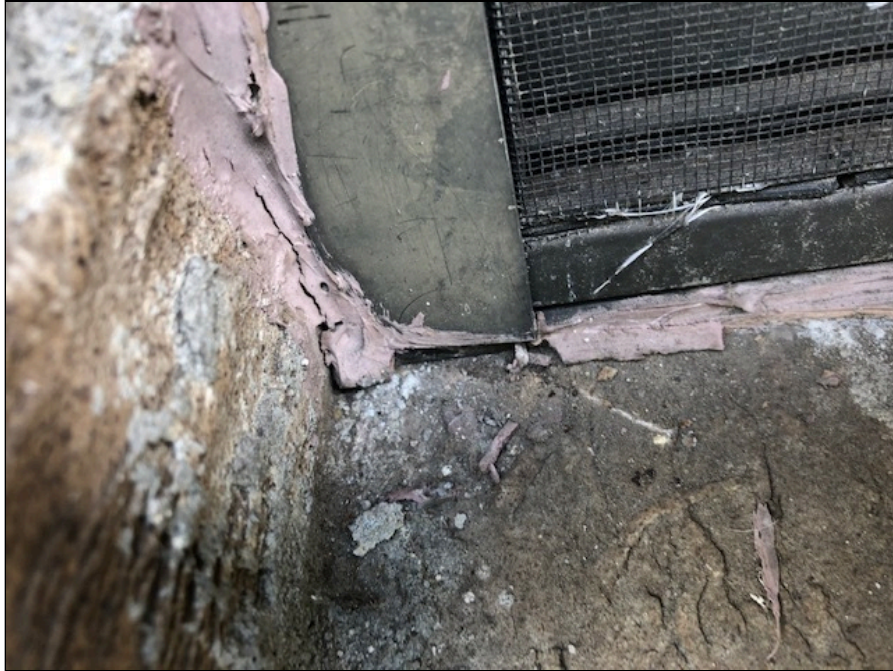
| Sample ID | Location | Material Description | Analytical Results | Category | Estimated Quantity |
|---|---|--|---|--|---|
| 05-01,02,03 | Windows | Window Caulking | 2% Chrysotile | Non Friable/ Good Condition | 50 LF |

3 - Image of window caulking: (Sample ID 05-01,02,03)

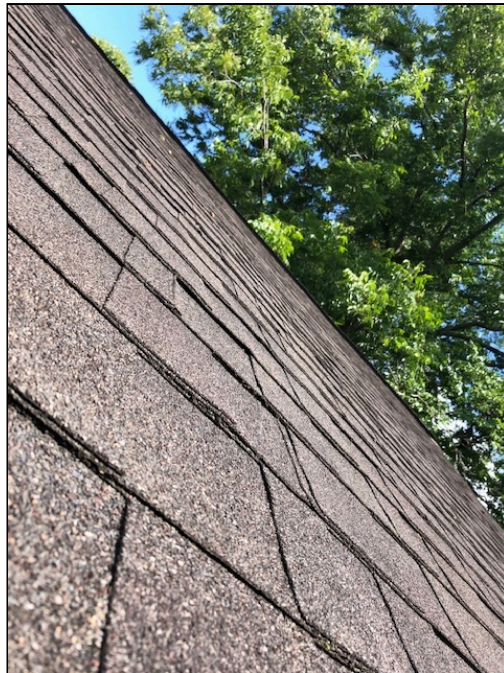
| Sample ID | Location | Material Description | Analytical Results | Category | Estimated Quantity |
|---|---|--|---|--|---|
| 08-01,02,03 | Roof | Roof Shingle & Felt Paper | None Detected | Non Friable/ Good Condition | 1,300 SF |

4 - Image of roof shingle & felt paper

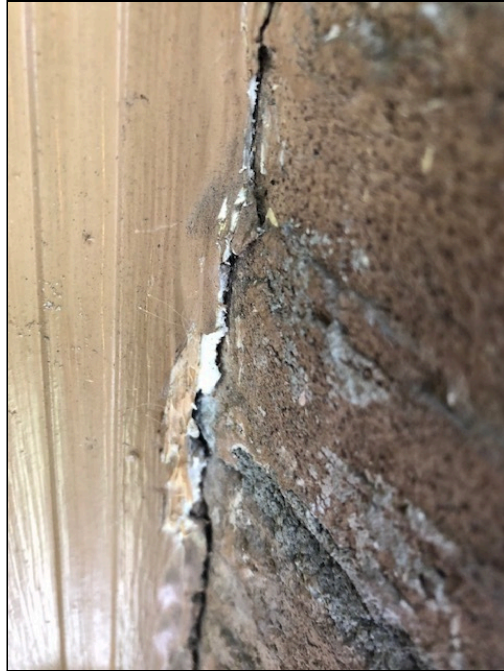
| Sample ID | Location | Material Description | Analytical Results | Category | Estimated Quantity |
|---|---|--|---|--|---|
| 06-01,02,03 | Doors | Door Caulking | None Detected | Non Friable/ Good Condition | 16 LF |

5 - Image of door caulking

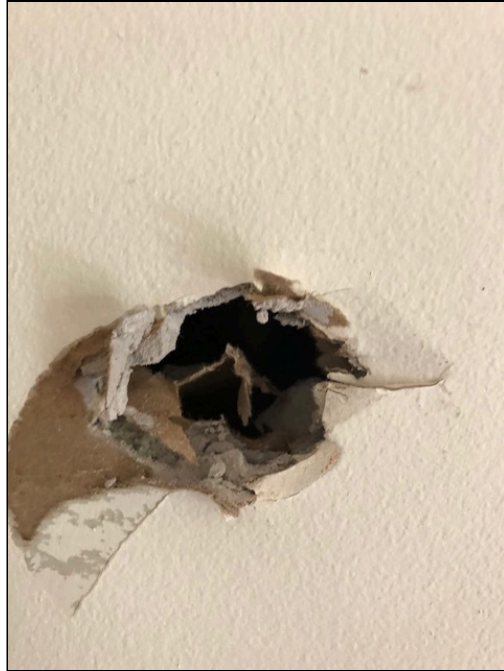
| Sample ID | Location | Material Description | Analytical Results | Category | Estimated Quantity |
|---|---|--|---|--|---|
| 02-01,02,03 | Throughout | Drywall | None Detected | Friable/ Good Condition | 2,200 SF |

7 - Image of drywall sample

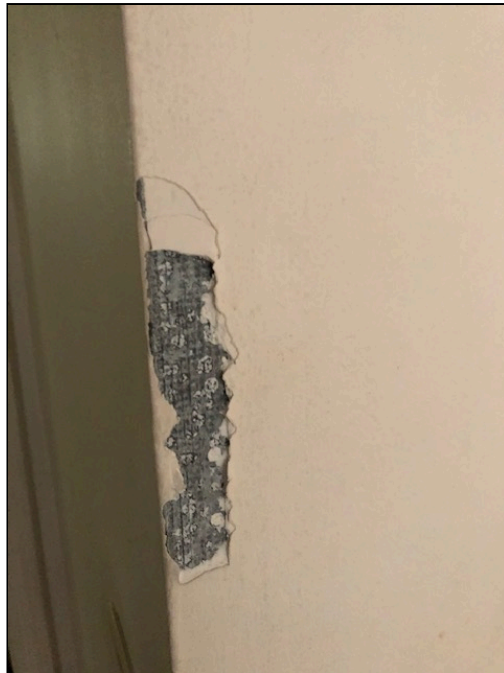
| Sample ID | Location | Material Description | Analytical Results | Category | Estimated Quantity |
|---|---|--|---|--|---|
| 03-01,02,03,04,05 | Throughout | Joint Compound | None Detected | Friable/ Good Condition | 2,200 SF |

8 - Image of joint compound sample

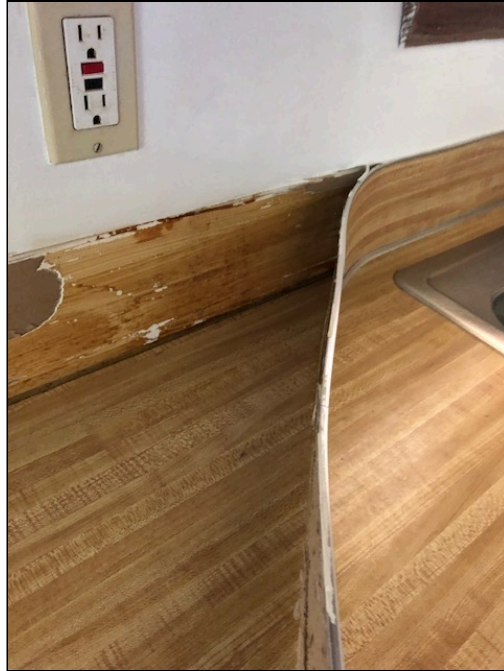
| Sample ID | Location | Material Description | Analytical Results | Category | Estimated Quantity |
|---|---|--|---|--|---|
| 01-01,02,03 | Kitchen & bathroom | Brown Wall Panel Mastic | None Detected | Non Friable/ Good Condition | 20 SF |

9 - Image of brown wall panel mastic
