Report of Subsurface Exploration and
Geotechnical Engineering Services

1425 N Quincy Street
Arlington, VA

ECS Project Number 01:29354

September 19, 2019

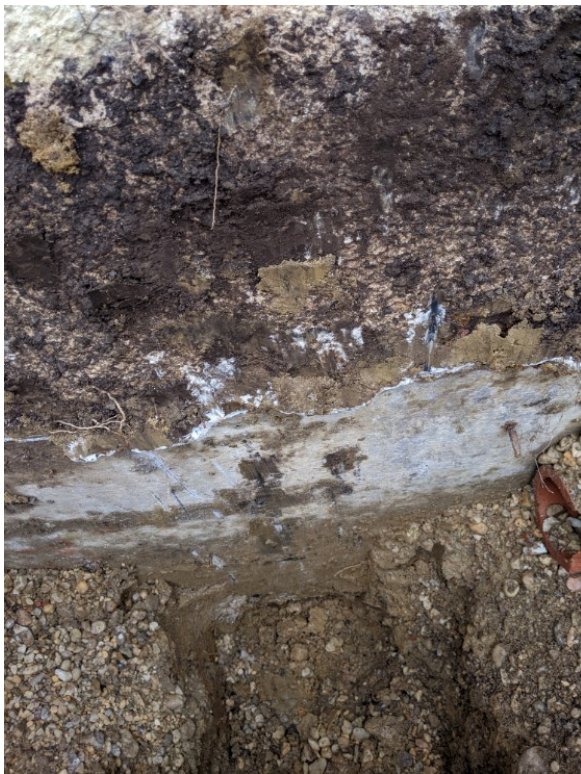
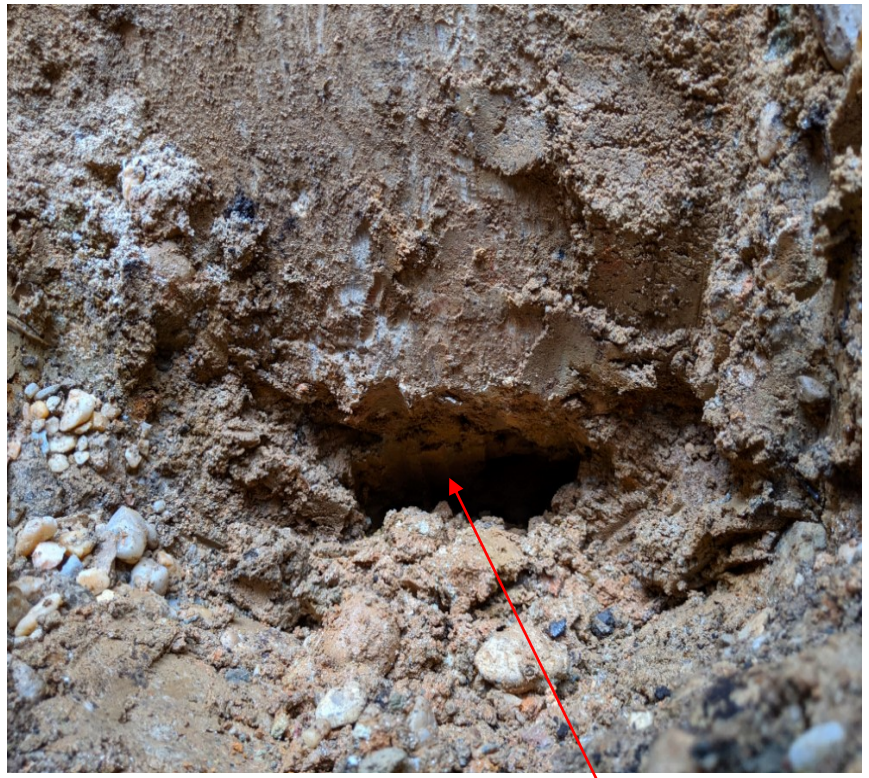
2. View of Test Pit TP-1

Bottom of concrete

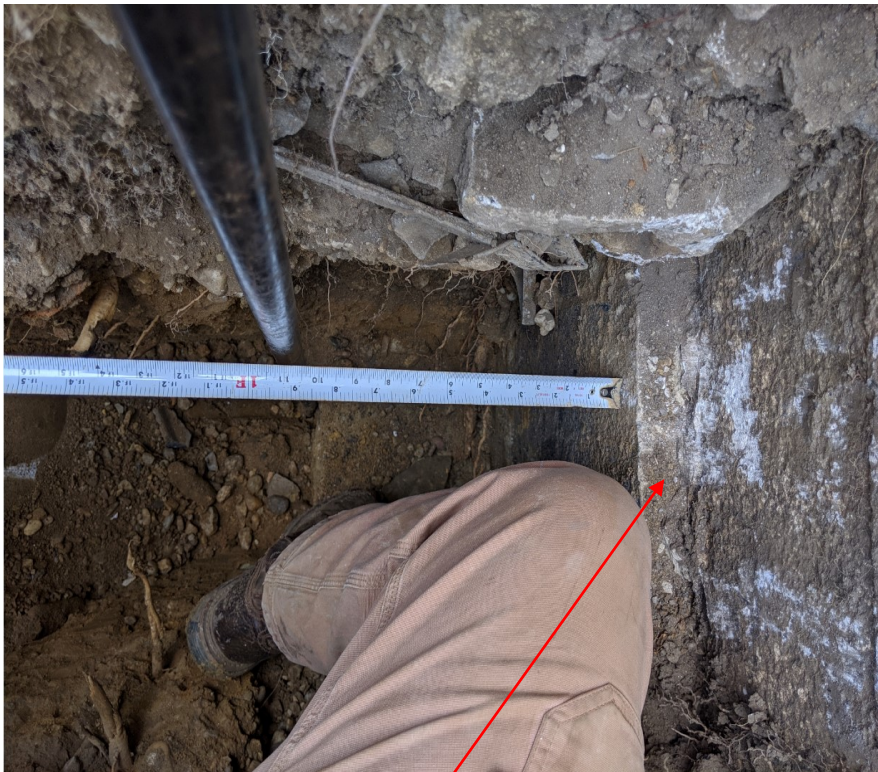
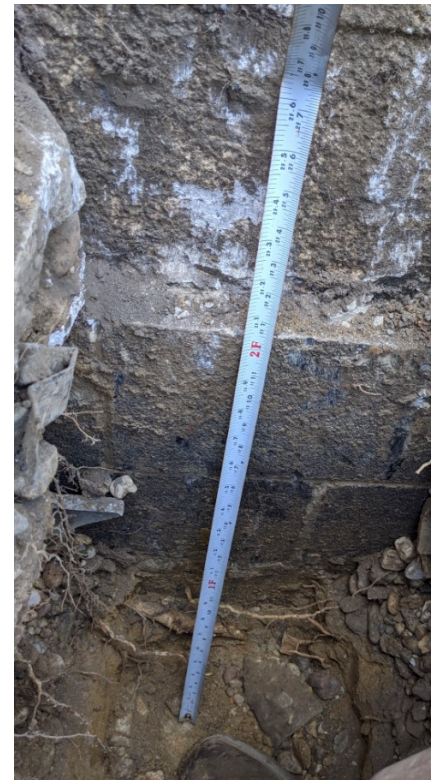
Stepping brick

4. View of Test Pit TP-2
