## SECTION 02 82 00 ASBESTOS ABATEMENT SPECIFICATION

The Fayette County Public School (Owner) has acquired the residential property located at 1345 Greendale Road in Lexington, Kentucky. The property consist of the following features which will be demolished:

August 14, 2023 | Report Number: N1237356

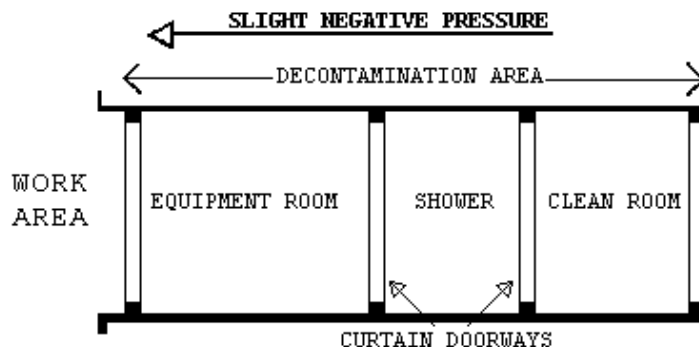
4. The PDF shall be as follows: Clean room at the entrance followed by a shower room followed by an equipment room leading to the regulated area. Each doorway in the PDF shall be a minimum of 2 layers of 6-mil opaque fire retardant poly.

**NOTE: Kentucky regulations require a 5-stage personnel decontamination facility; the personnel decontamination facility shall meet Kentucky requirements. A worker decontamination enclosure system shall be provided, consisting of a clean room, shower room, and equipment room, each separated from each other and from the work area by air locks and accessible through doorways protected with two (2) overlapping 6-mil polyethylene sheets. "Air lock" means a system of enclosures within the containment area consisting of two (2) doorways, curtained with 6-mil polyethylene sheeting, at least three (3) feet apart.**

1. Clean Room: The clean room must be physically and visually separated from the rest of the building to protect the privacy of personnel changing clothes. The clean room shall be constructed of at least 3 layers of 6-mil opaque fire retardant poly to provide an air tight room. Provide a minimum of 2 – 900 mm (3 foot) wide 6-mil poly opaque fire retardant doorways. One doorway shall be the entry from outside the PDF and the second doorway shall be to the shower room of the PDF. The floor of the clean room shall be maintained in a clean, dry and sanitary condition. Shower overflow shall not be allowed into the clean room. Provide 1 storage locker per person. A portable fire extinguisher, minimum 10 pounds capacity, Type ABC, shall be provided in accordance with OSHA and NFPA Standard 10. All persons entering the regulated area shall remove all street clothing in the clean room and dress in disposable protective clothing and respiratory protection. Any person entering the clean room does so either from the outside with street clothing on or is coming from the shower room completely naked and thoroughly washed. Male/Females required to enter the regulated area shall be ensured of their privacy throughout the entry/exit process by posting guards at both entry points to the PDF so no male/female can enter or exit the PDF during his/her stay in the PDF.

- Hose down all shower surfaces after each shift and clean any debris from the shower pan. Residue is to be disposed of as asbestos waste.
3. Equipment Room: The Competent Person shall provide an equipment room which shall be an air tight compartment for the storage of work equipment/tools, reusable personal protective equipment, except for a respirator and for use as a gross decontamination area for personnel exiting the regulated area. The Competent Person shall ensure that most gross contamination is removed from the outside of PPE, suits and respirators in the regulated work area, prior to entering the Equipment Room. The equipment room shall be separated from the regulated area by a minimum 3 foot wide door made with 2 layers of 6-mil opaque fire retardant poly. The equipment room shall be separated from the regulated area, the shower room and the rest of the building by air tight walls and ceiling constructed of a minimum of 3 layers of 6-mil opaque fire retardant poly. Damp wipe all surfaces of the equipment room after each shift change. Provide an additional loose layer of 6-mil fire retardant poly per shift change and remove this layer after each shift. If needed, provide a temporary electrical sub-panel equipped with GFCI in the equipment room to accommodate any equipment required in the regulated area.

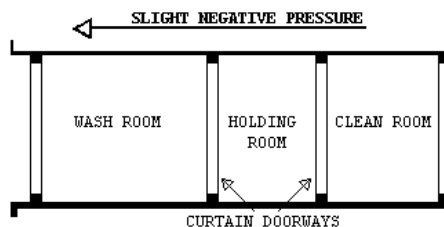
- e. The W/EDF shall be as follows: Wash Room leading to a Holding Room followed by a Clean Room leading to outside the regulated area. See diagram.

- d. Clean Room: Provide a clean room to isolate the holding room from the exterior of the regulated area. Construct the clean room using 2 inches x 4 inches wood framing or approved equivalent and 2 layers of 6-mil fire retardant poly. The clean room shall be located so as to provide access to the holding room from the building exterior. Doorways to the clean room shall be constructed of 2 layers of 6-mil fire retardant poly. When a negative pressure differential system is used, a rigid enclosure separation between the W/EDF clean room and the adjacent areas shall be provided.

**2. Waste/Equipment Decontamination Procedures:** At the washdown station in the regulated area, thoroughly wet clean contaminated equipment and/or sealed polyethylene bags and pass into Wash Room after visual inspection. When passing anything into the Wash Room, close all doorways of the W/EDF, other than the doorway between the washdown station and the Wash Room. Keep all outside personnel clear of the W/EDF. Once inside the Wash Room, wet clean the equipment and/or bags. After cleaning and inspection, pass items into the Holding Room. Close all doorways except the doorway between the Holding Room and the Clean Room. Workers from the Clean Room/Exterior shall enter the Holding Room and remove the decontaminated/cleaned equipment/bags for removal and disposal. At no time shall personnel from the clean side be allowed to enter the Wash Room.

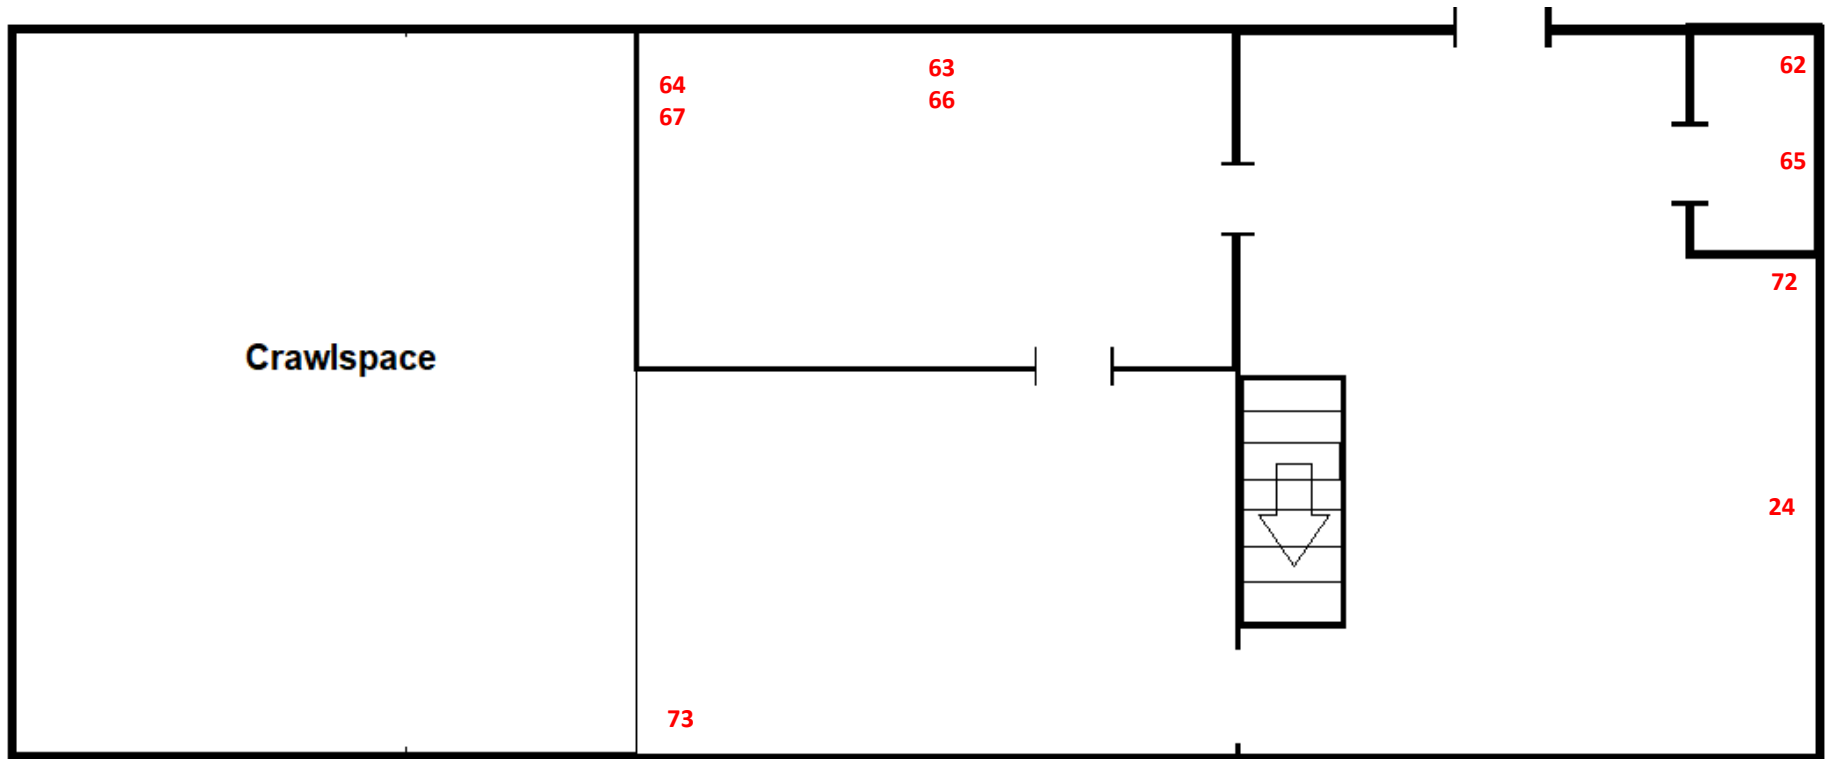
<b>Exhibit</b>
2

<b>Basement Sample Location Diagram</b>
Residential House 1345 Greendale Road Lexington, Kentucky

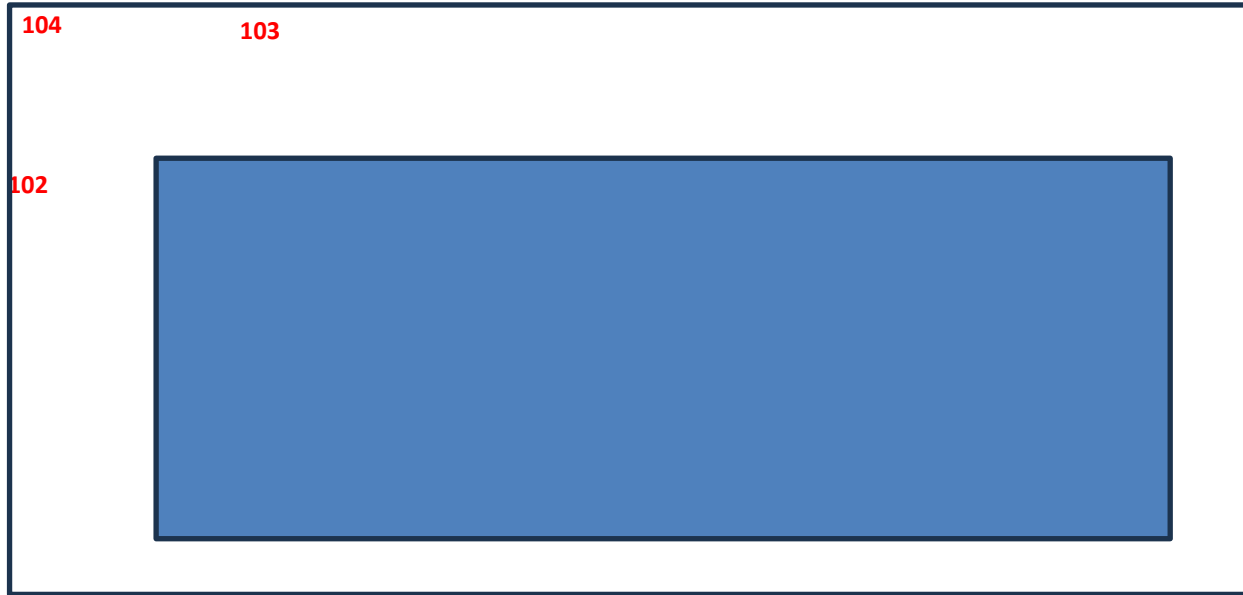
Project No. N1237356	  <p>Consulting Engineers and Scientists</p> <p>611 Lunken Park Drive Cincinnati, Ohio 45226 PH. (513) 321-05816 FAX (513) 321-0294</p>	<b>Inground Swimming Pool Sample Location Diagram</b>	<b>Exhibit</b>
Inspection Date: August 2, 2023		Residential House 1345 Greendale Road Lexington, Kentucky	5
Project Manager: Josh Vogel			
APR: Joe Tussey

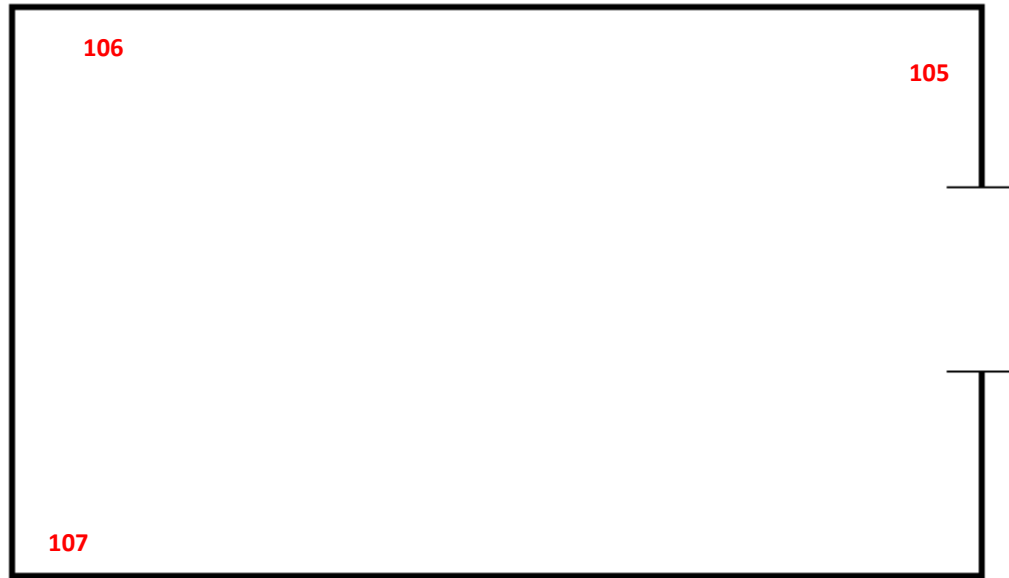
Project No. N1237356	  <p>Consulting Engineers and Scientists</p> <p>611 Lunken Park Drive Cincinnati, Ohio 45226 PH. (513) 321-05816 FAX (513) 321-0294</p>	<p><b>200 Square Foot (Southwest) Shed Sample Location Diagram</b></p>	<p><b>Exhibit</b></p>
Inspection Date: August 2, 2023		<p>Residential House 1345 Greendale Road Lexington, Kentucky</p>	<p>6</p>
Project Manager: Josh Vogel			
APR: Joe Tussey
